2016 ANNUAL DAM AND DIKE INSPECTION REPORT

**Fly Ash Dams 1, 2
&
Bottom Ash Pond Complex**

**Cardinal PLANT
BRILLIANT, OHIO**

Dam & Dike Inspection Report Fly Ash Dams I, II, and Bottom Ash Complex

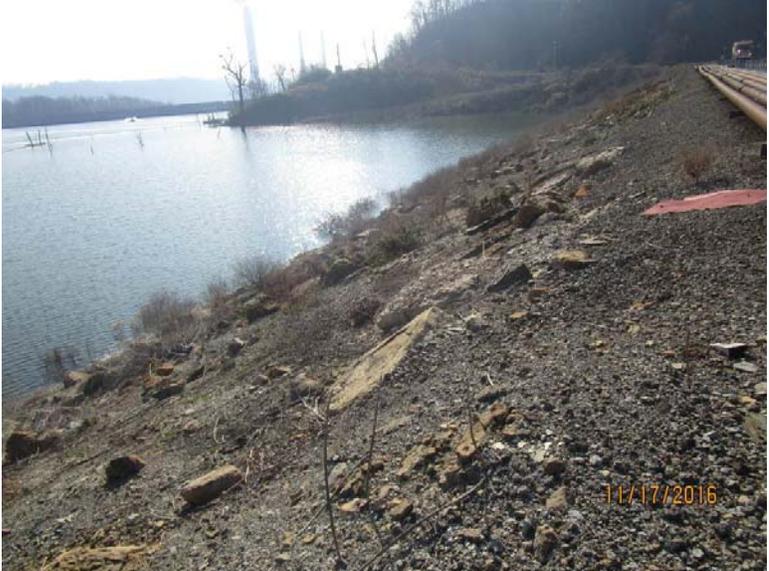
1. The downstream slope of FAD 1 was well protected with rockfill. Increase in vegetative growth was noticed (Photo Nos. 1 and 2). No significant erosion or slumping was observed.
2. Typical view of the FAD 1 emergency spillway showing minor vegetative growth (Photograph No. 3). No significant erosion was observed along the spillway (Note that the spillway conveys contact water from the FGD landfill and noncontact water from the upper reaches of the west branch of Blockhouse Hollow).
3. Surface water collection pipe installed at the right groin of FAD 1 is partially damaged and needs fix (Photograph No. 4).

<p>Photo # 1 FAD 1</p> <p>View of the downstream slope of the FAR 1 dam.</p>

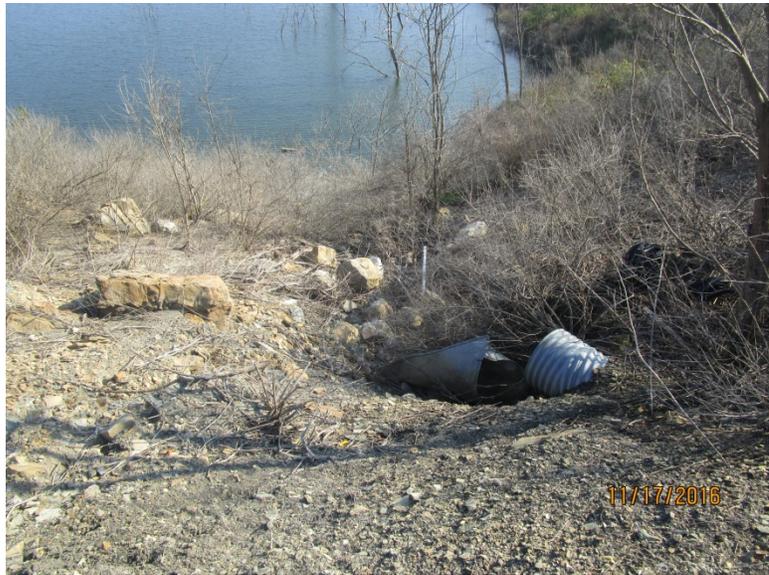
Right Groin of FAD 1 showing a
damaged surface water pipe.

- Vegetation control on the outboard slopes is to be kept under control by mowing or spraying.
- Damaged pipes at the right groin are to be fixed and/or backfilled.

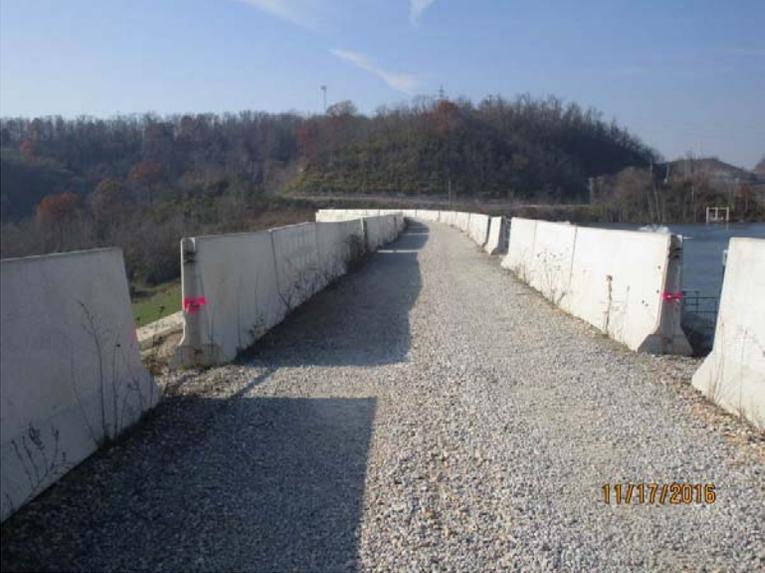
<p>Photo # 5 FAD 2</p> <p>Typical crest view showed good conditions with no indications of misalignment, rutting or erosion.</p>

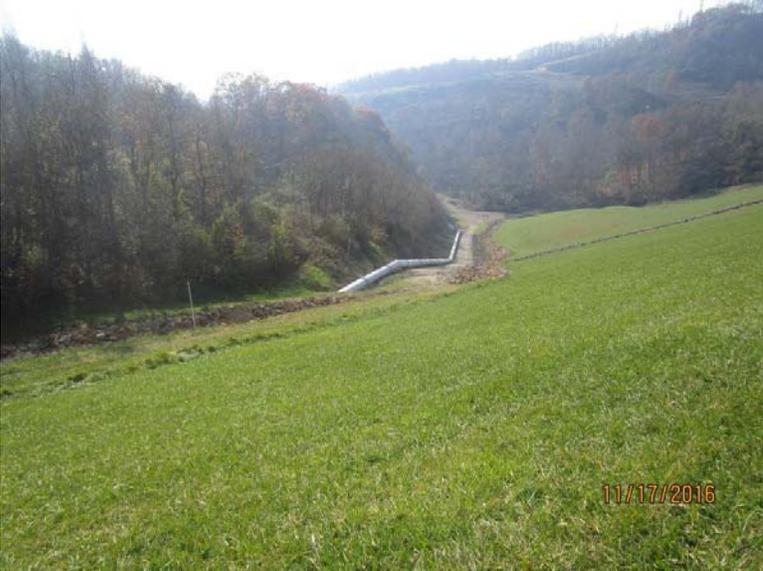
7. The downstream slope of the dam appeared to be in good condition with good vegetative growth as shown in Photograph Nos. 16& 17. No significant erosion was observed and the slopes appeared to be uniform with no slumping or bulges.

<p>Photo # 17 FAD 2</p> <p>Typical view of the downstream slope showing good conditions. No significant erosion was observed along the contact between the RRC and the vegetative cover. No bulging or slumping was observed. The slopes appeared to be uniform.</p>

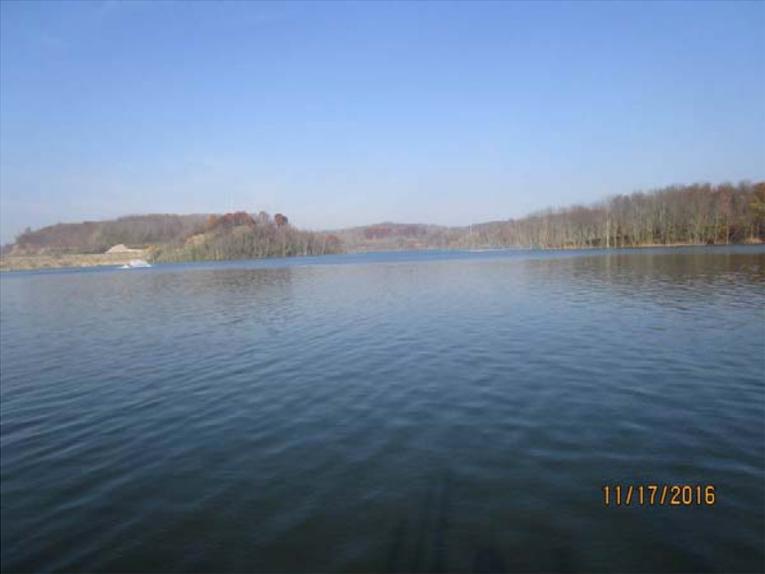
<p>11/17/2016</p>
<p>Photo # 28 FAD 2</p> <p>Typical view of the ash sluice lines discharging into the FAR 2 pond. The increase in pool stage has inundated additional area including the discharge lines ends.</p>

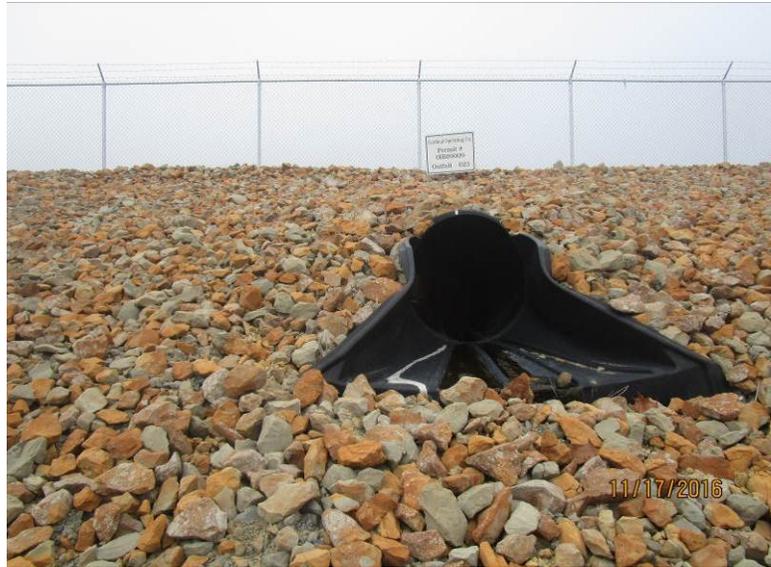
Photo # 37 BAP

2. The RCP overflow pipe, concrete and riprap appeared in good condition as shown in Photograph No. 37 and 39. The upstream concrete inlet structure was also in satisfactory condition. The pond water level was well below the invert of the steel weir (Photograph No. 39).

Typical view showing good condition of the rip rap and downstream outlet of the RCP discharge pipe.

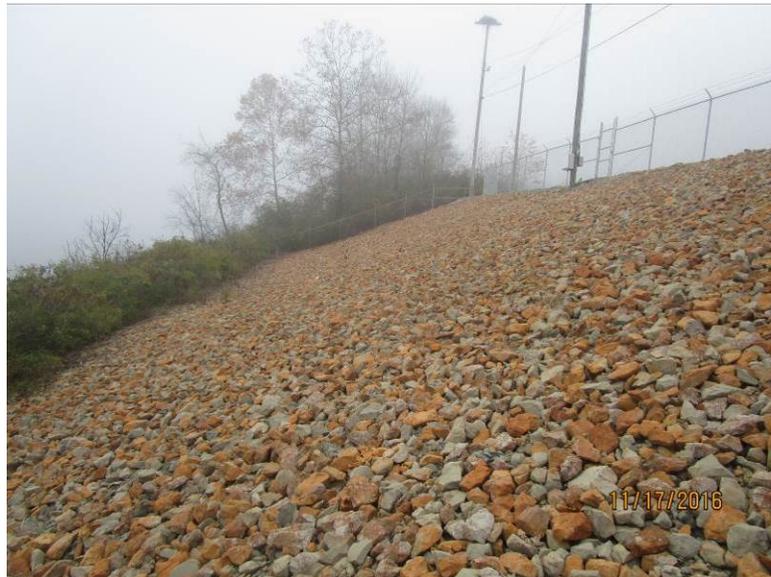
Photo # 38 BAP

1. The BAP and RCP downstream slope along the Ohio River was well protected with vegetation or riprap as typically shown in Photographs Nos. 34 to 38. The vegetation showed a good established growth and is maintained by mowing every year (Photographs Nos. 34 to 36). The trees shown in the photographs along the riverbank are generally located below the toe of the slope and serve to protect the river bank from erosion. Oversized rock at the very southern end of the recirculation pond was replaced with an inverted filter drain to control seepage emanating from the impoundment as shown in Photograph Nos. 37 to 38.

Typical view showing good condition of the rip rap. An inverted filter drain was extended in late 2009 through this area to control seepage emanating from the pond.

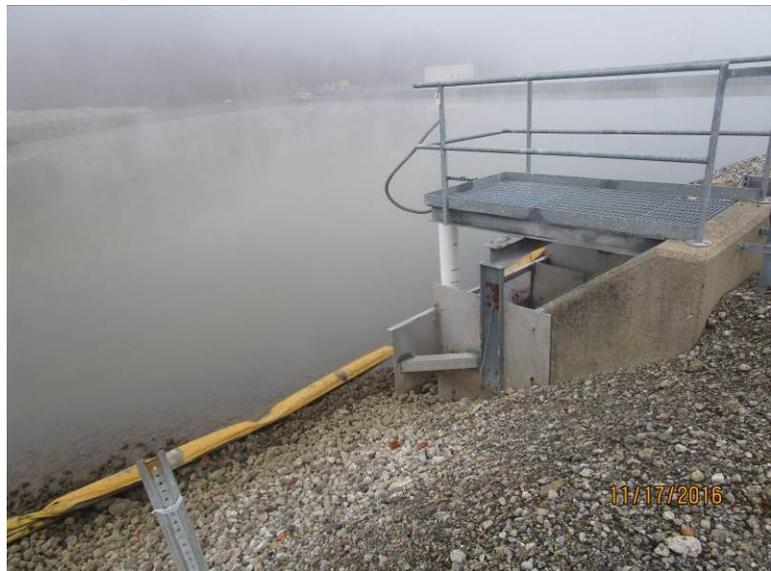
Photo # 39 BAP

The RCP overflow structure's concrete was observed to be in good condition. No spalling or cracking of the concrete was observed. The RCP overflow structure has been retrofitted with a steel weir.

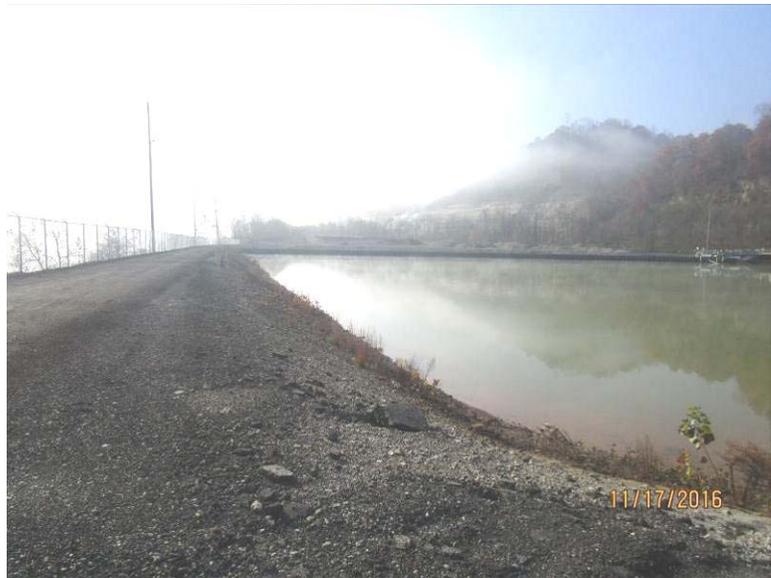
Photo # 40 BAP

The road crest showed good conditions with no indications of misalignment, rutting or erosion. The piezometer in the foreground is well protected and is currently being monitored by plant personnel.

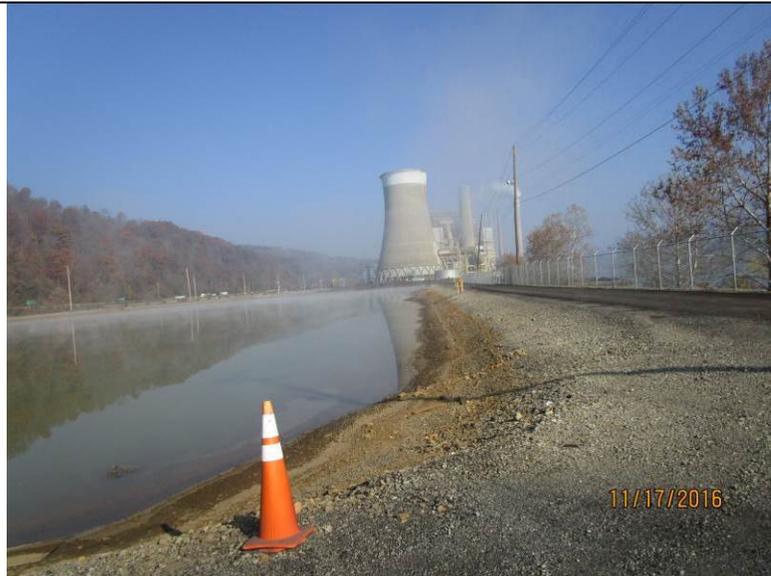
Photo # 41 BAP

Typical view showing good conditions of interior slopes and crest of the bottom ash pond.

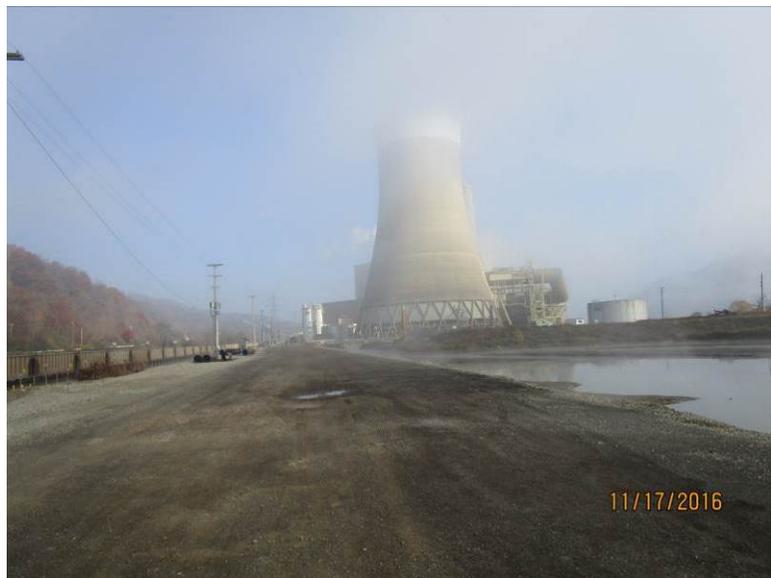
Photo # 42 BAP

Typical view showing good conditions of interior slopes and crest of the bottom ash pond west dike. One rut was noticed at the dike crest

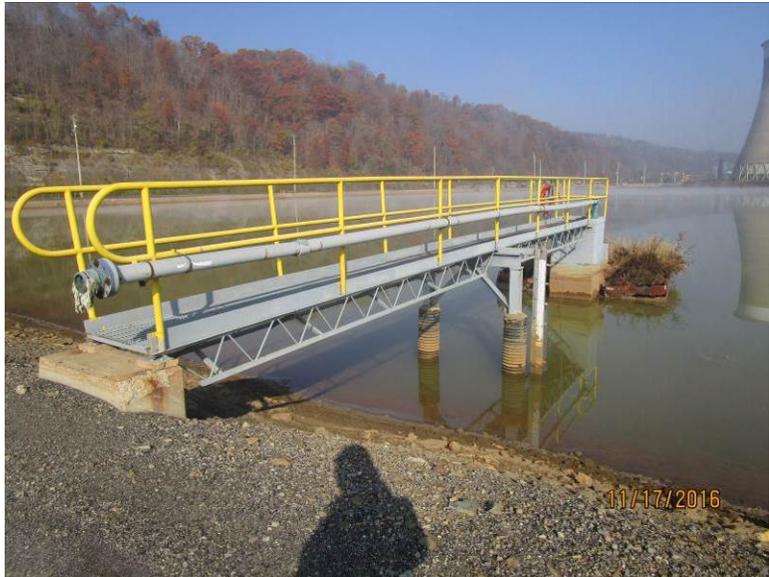
Photo # 43 BAP

4. The BAP discharge structure concrete and steel platform were in good condition, as shown in Photograph No. 43. The railings are showing minor rust and the steel support members to the walkway are showing fair conditions with minor corrosion.

Typical view of the BAP discharge structure. The concrete drop inlet structure was observed to be in good condition. New Staff Gage and Max Operating Level Mark were installed Recently.

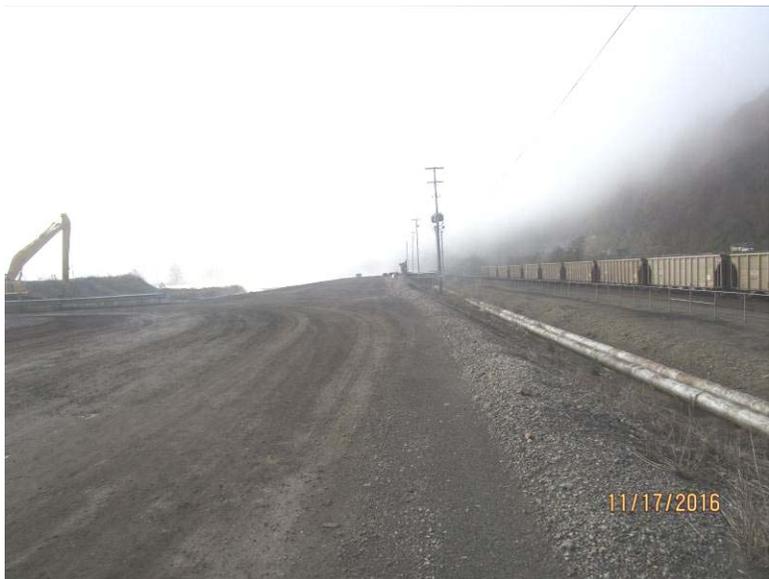
Photo # 44 BAP

Typical view showing satisfactory conditions of exterior slopes and some minor seepage/ drainage along the toe of the embankment.

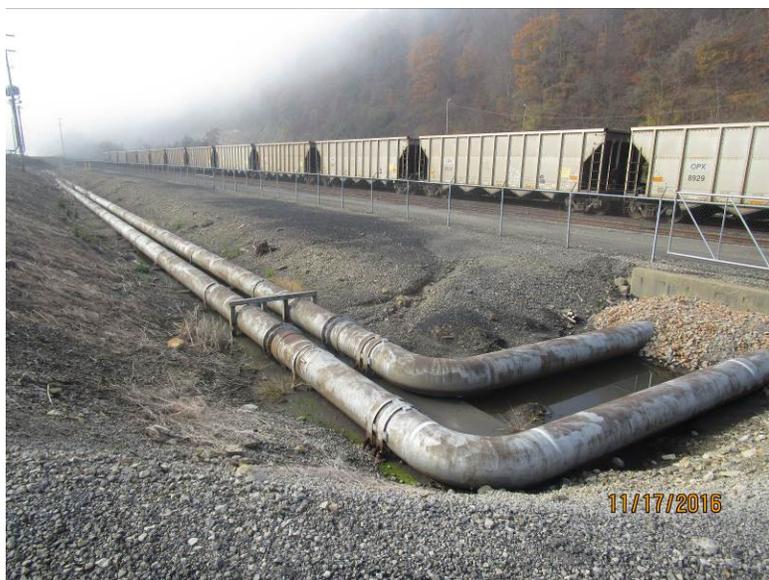
Photo # 45 BAP

Typical view showing satisfactory conditions of exterior slopes and some minor seepage/ drainage along the toe of the embankment.

No significant erosion gullies, slumping or bulges were observed.

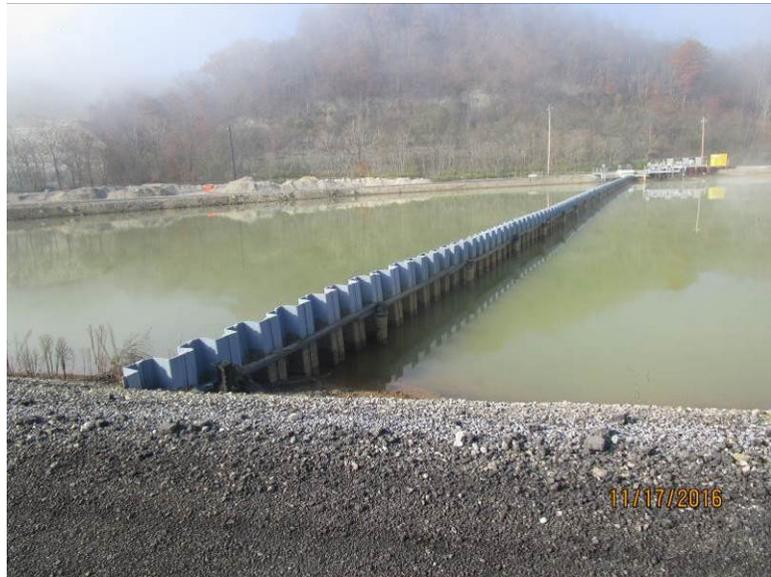
Photo # 49 BAP

7. The PVC sheet piling installed across the width of the recirculation pond appears to be stable with no change noted along the slight bulge in the sheet pile alignment previously noted at the time of installation (Photo Nos. 48 and 49).

Typical view showing good conditions of the sheet piling wall that splits the RCP pond.

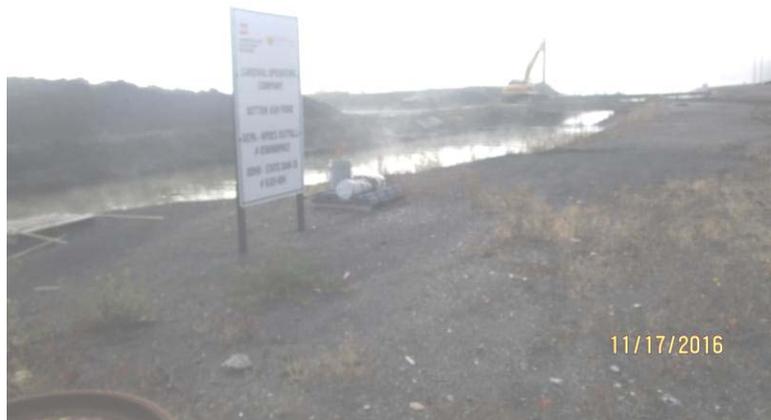
Photo # 50 BAP

Typical view of the bridge across the bottom ash pond discharge channel into the pond. The channel appeared to be in good condition and flow was unobstructed.

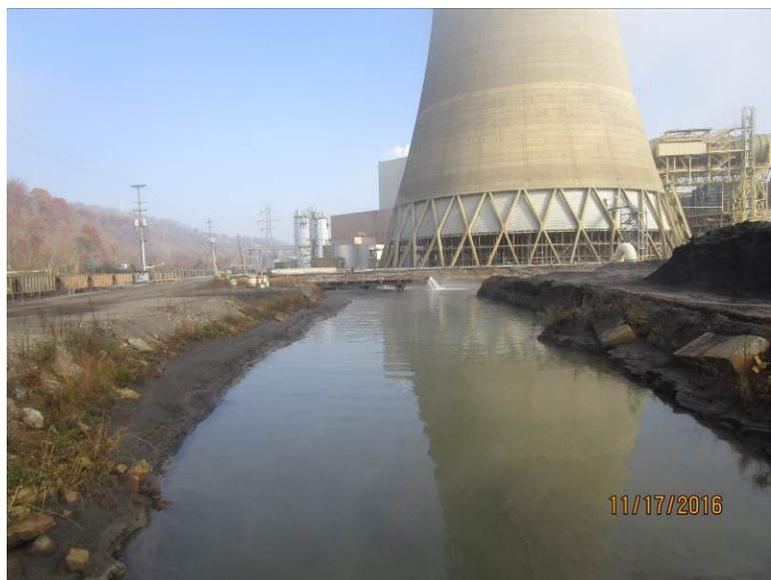
Photo # 51 BAP

Typical view showing good conditions of the bottom ash discharge pipes. Access to the discharge lines is being maintained, Discharge into the channel and flow through the channel was unobstructed.

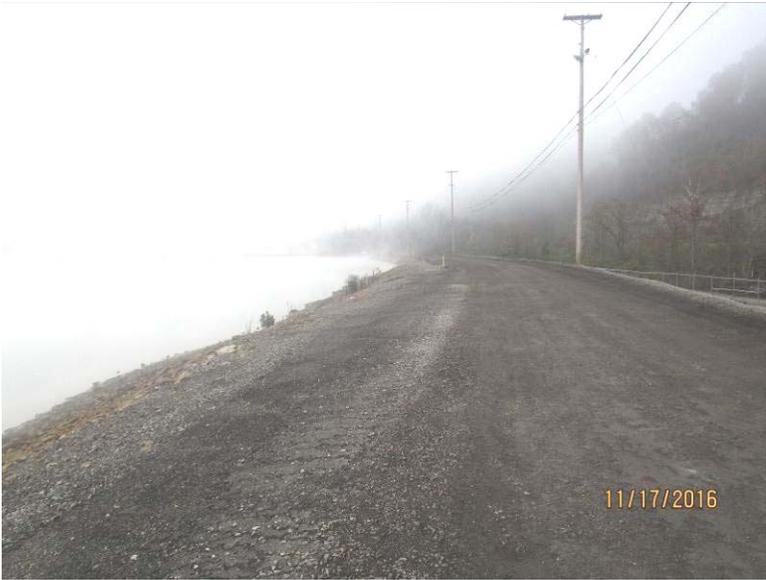
<p>Photo # 52 BAP</p>

<p>The road crest showed good conditions with no indications of misalignment, and minimal rutting or erosion.</p> <p>11/17/2016</p>
<p>Photo # 53 BAP</p>

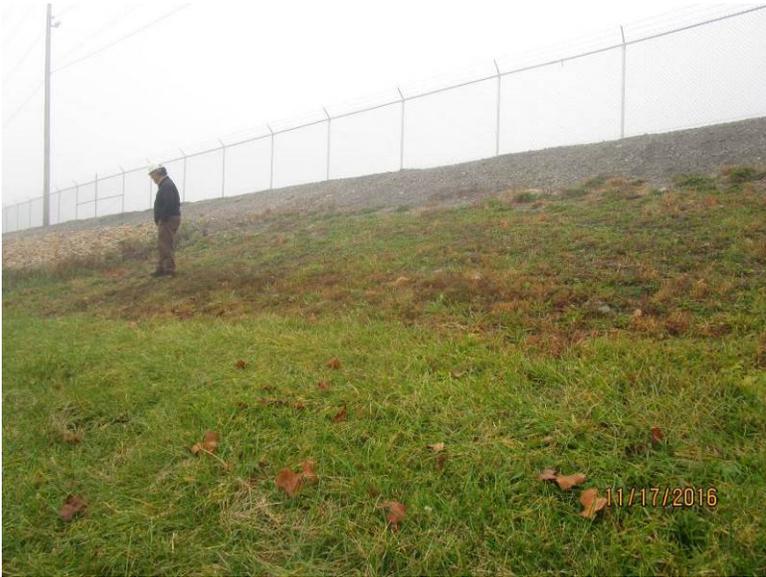
9. Three seepage areas with minimal flow were found along the downstream slope of the eastern dike during quarterly inspections and persisted through this annual inspection. Seep areas are to be monitored on weekly basis (Photos No.53 through 56).

<p>General View of the Location of Seep #1.</p> <p>11/17/2016</p>
<p>Photo # 54 BAP</p>

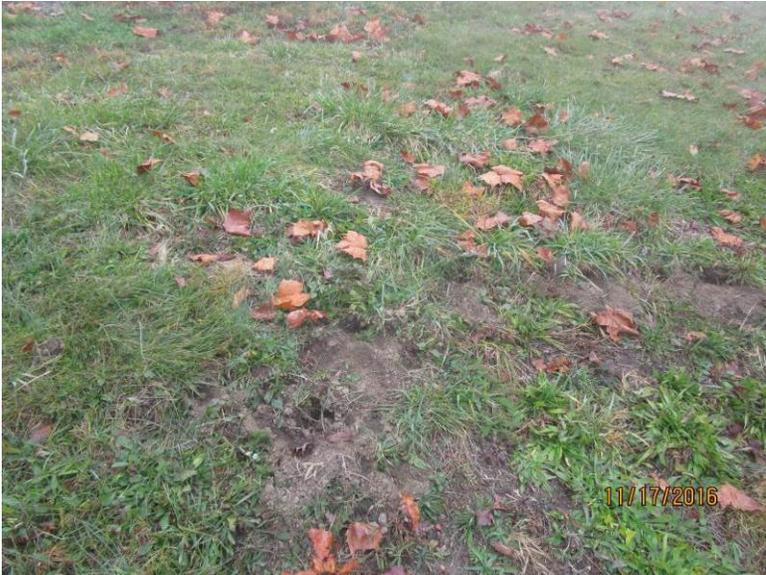
<p>Photo # 55 BAP</p>

<p>General View of the Location of Seep #2.</p>	
<p>Photo # 56 BAP</p>

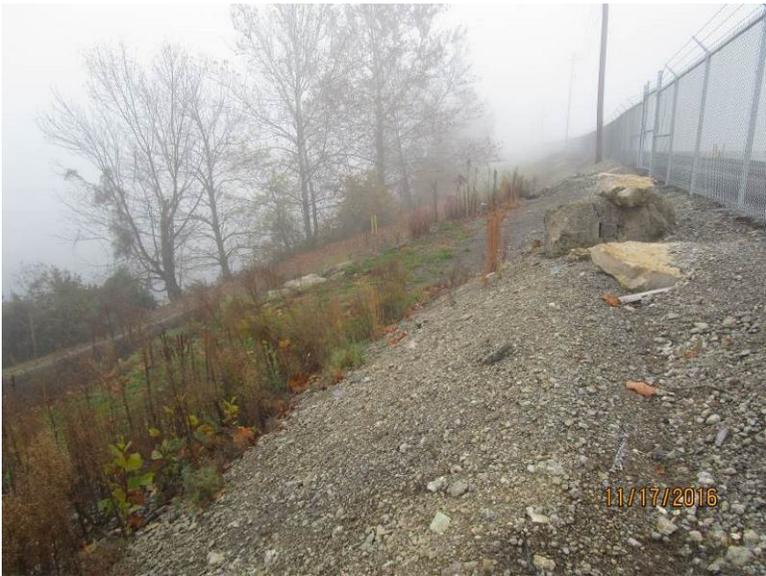
<p>General View of the Location of Seep #3.</p>
