**2015 INSPECTION REPORT
FLY ASH DAMS I, II
AND
BOTTOM ASH COMPLEX**

**CARDINAL PLANT
BRILLIANT, OHIO**

GERS-15-027

**Dam & Dike Inspection Report
Fly Ash Dams I, II, and
Bottom Ash Complex**

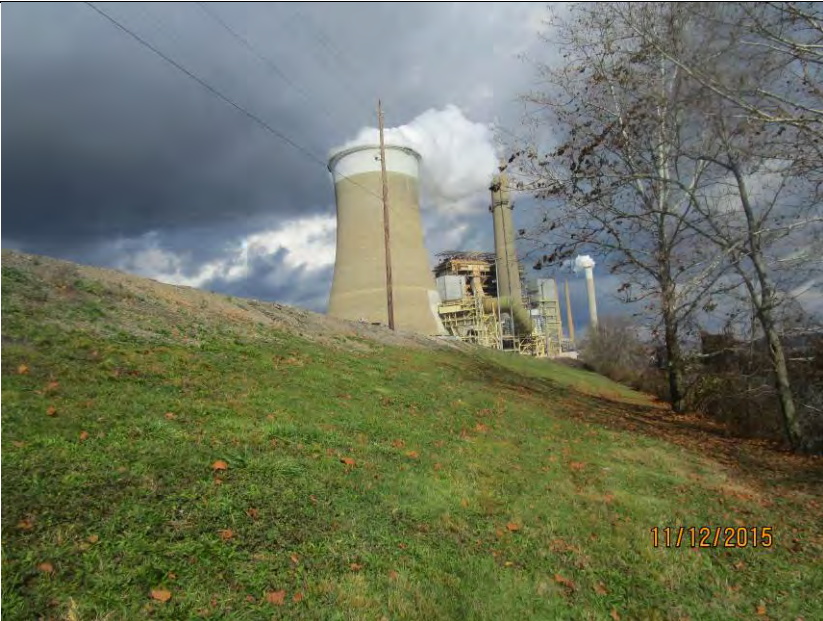
<p>Photo # 1 BAP</p>

1. The BAP and RCP downstream slope along the Ohio River was well protected with vegetation or riprap as typically shown in Photographs Nos. 1 to 3. The vegetation showed a good established growth and is maintained by mowing every year (Photographs Nos. 1 to 3). The trees shown in the photographs along the riverbank are generally located below the toe of the slope and serve to protect the river bank from erosion. Oversized rock at the very southern end of the recirculation pond was replaced with an inverted filter drain to control seepage emanating from the impoundment as shown in Photograph Nos. 3 to 6.

<p>The embankment along the Ohio River showed a good growth of vegetative cover and is regularly controlled by mowing. No slumping, or bulges was observed. The trees are located along the Ohio River and are being left in place to protect the riverbank.</p> <p>Please see pjotos 52 through 56 for new seepage points</p>	
<p>Photo # 2 BAP</p>

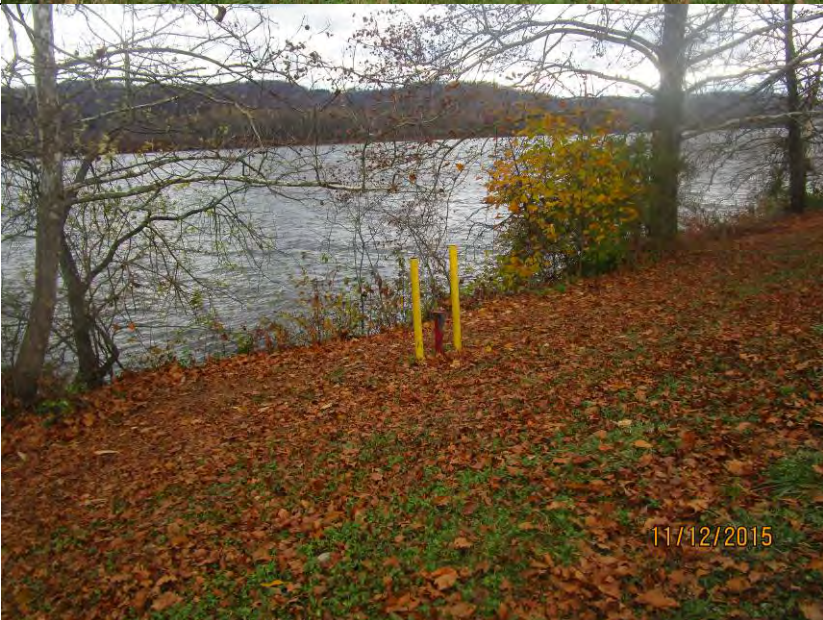
<p>2009 installed piezometer along the toe of the embankment. The trees are located along the Ohio River and are being left in place to protect the riverbank.</p>	
<p>Photo # 3 BAP</p>

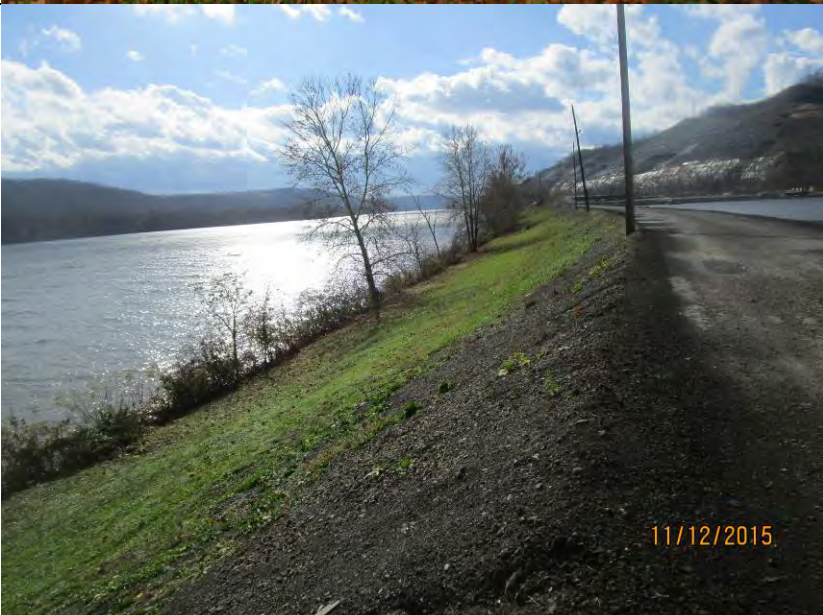
<p>No slumping, bulges was observed. The trees are located along the Ohio River and are being left in place to protect the riverbank.</p>

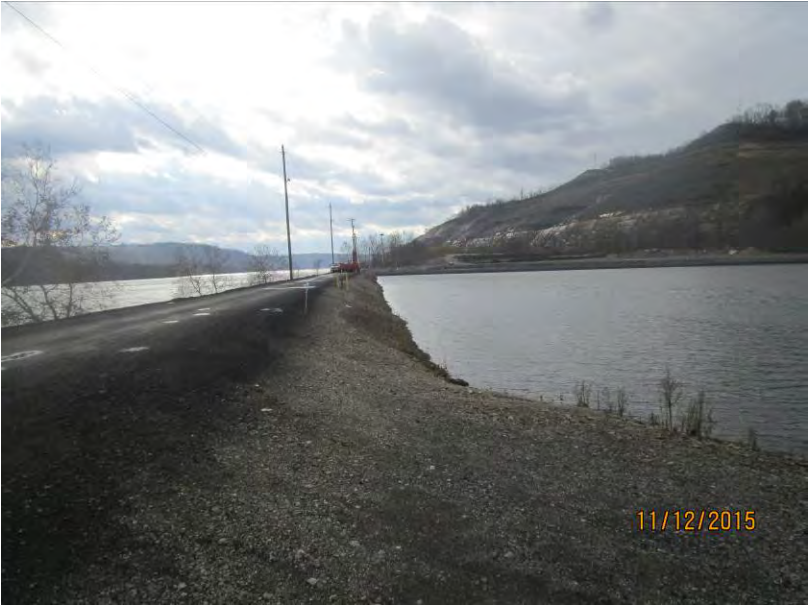
<p>Photo # 7 BAP</p>

3. The crest and interior slopes of the BAP and the Recirculation Pond were in generally good condition as shown in Photograph Nos. 7, 8, 9, and 15.
4. The BAP discharge structure concrete and steel platform were in good condition, as shown in Photograph No. 10. The railings are showing minor rust and the steel support members to the walkway are showing fair conditions with minor corrosion.

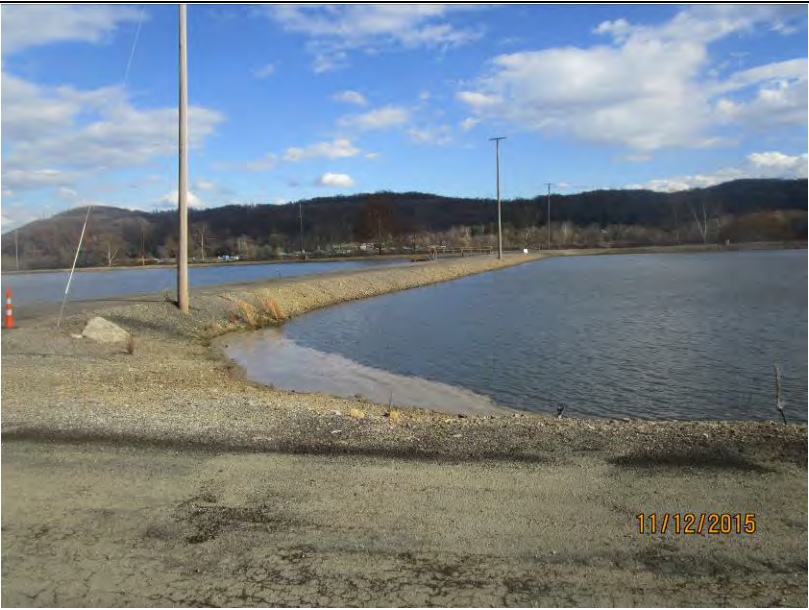
<p>Photo # 13 BAP</p>

6. Photograph Nos. 10 and 13 show the upstream, crest and downstream of the splitter dike conditions. Minor erosion was noticed at the corners of the dike.

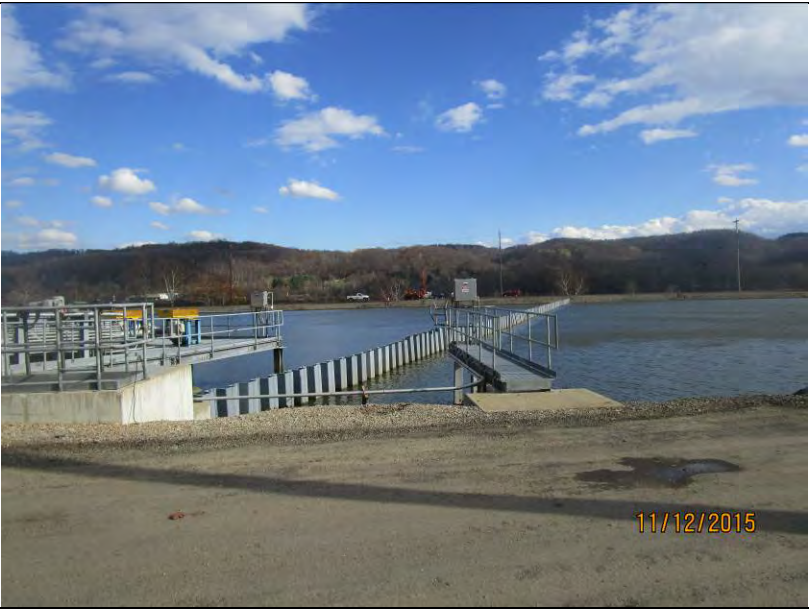
7. The PVC sheet piling installed across the width of the recirculation pond appears to be stable with no change noted along the slight bulge in the sheet pile alignment previously noted at the time of installation (Photo Nos. 14 and 15).

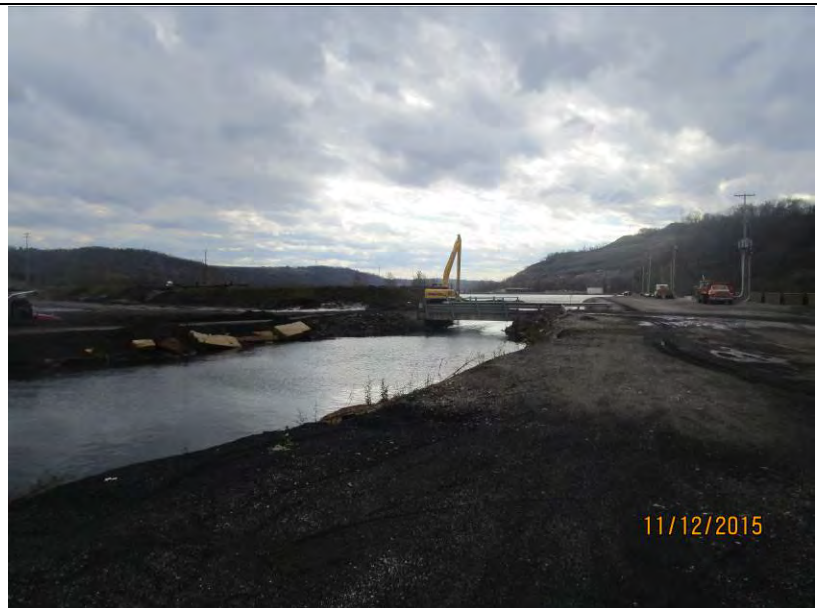
Photo # 16 BAP

8. The contractor constructed a bridge across the bottom ash pond channel to continue reclamation of the bottom ash from the pond (Photo No.16). The bottom ash sluice lines were generally clear allowing for unobstructed flow into the pond (Photo No.17).
9. Three seepage areas with minimal flow were found along the downstream of the eastern dike during quarterly inspections and persisted through this annual inspection. Piezometers are being installed to determine the source of the seeping water and to provide a fix (Photos No.52 through 56).

Typical view of the bridge across the bottom ash pond discharge channel into the pond. The channel appeared to be in good condition and flow was unobstructed.

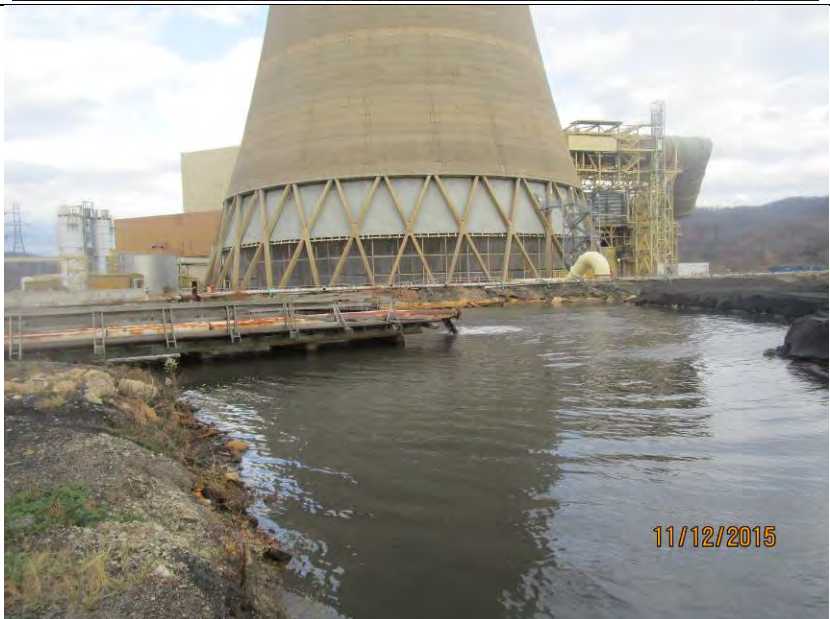
Photo # 17 BAP

Typical view showing good conditions of the bottom ash discharge pipes. Access to the discharge lines is being maintained, Discharge into the channel and flow through the channel was unobstructed.

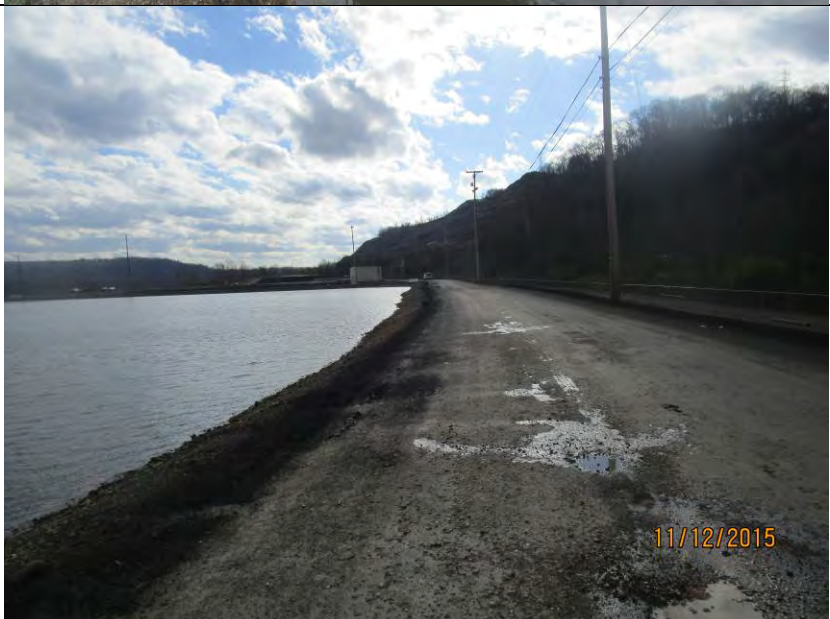
Photo # 18 BAP

In general, the Bottom Ash- Recirculating Pond Complex was observed to be in good condition with no visible evidence of misalignment, significant rutting, erosion or settlement (Photo No.18).

The road crest showed good conditions with no indications of misalignment, and minimal rutting or erosion.

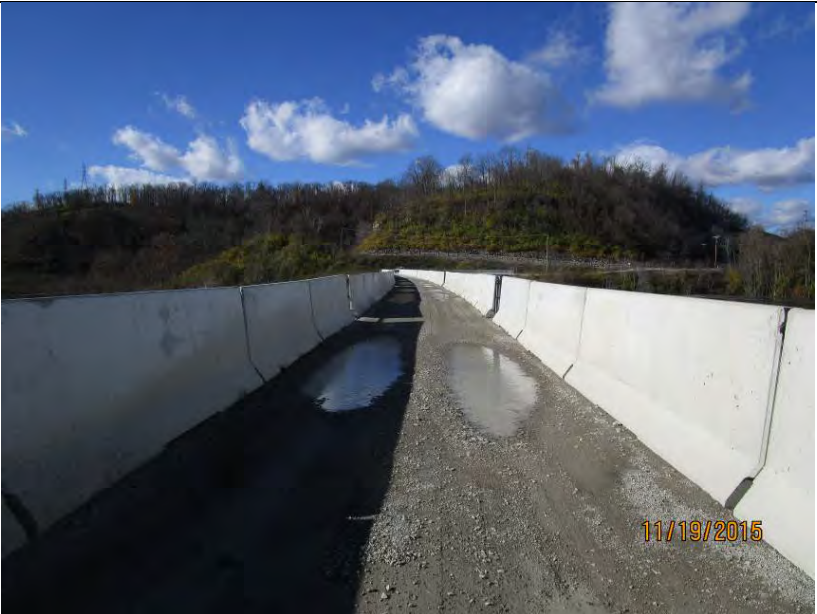
<p>Photo # 19 FAD 2</p>

1. Photographs Nos. 19 & 20 shows the overall view of the FAD2 as taken from the FAD2 access road.
2. The discharge structure was inspected closely at the locations of the diagonal joint and diagonal crack in the RCC face, as shown in Photographs Nos. 21-25. There was no visual evidence of significant differential movement of the structure chute or steps. Visual portions of the structure's concrete, diagonal joint and steps appeared to be in good condition. The diagonal crack in the underlying RCC has weathered and infilled and is no longer visible. The overlying diagonal construction joint in the skimmer chute continues to exhibit no differential movement and was caulked and sealed in anticipation of it being inundated during the next pool raising.

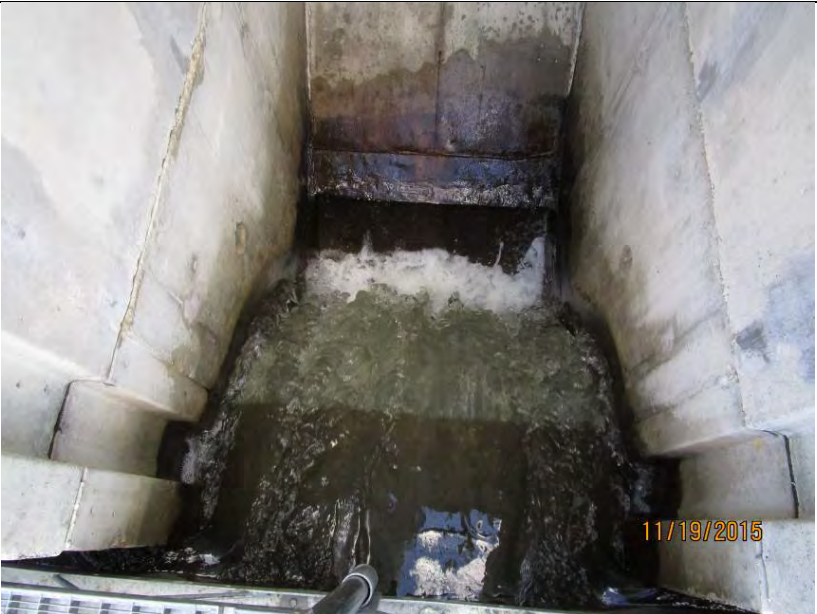
<p>Photo # 22 FAD 2</p>

<p>11/19/2015</p>
<p>Typical view of Principal spillway flow.</p> <p>Dam Raising Construction is underway.</p>	
<p>Photo # 23 FAD 2</p>

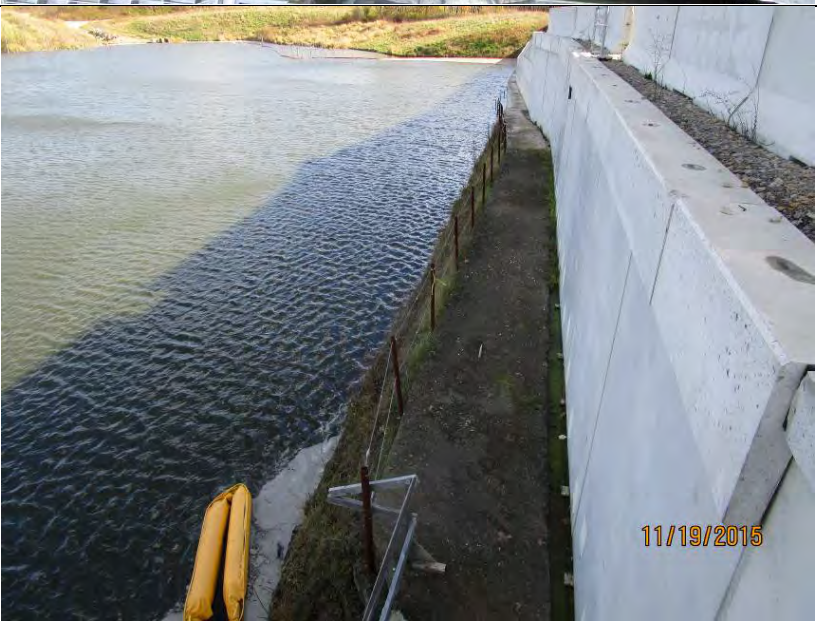
<p>11/19/2015</p>
<p>Typical view of the upstream MSE wall on the east (right) side of the decant structure</p>	
<p>Photo # 24 FAD 2</p>

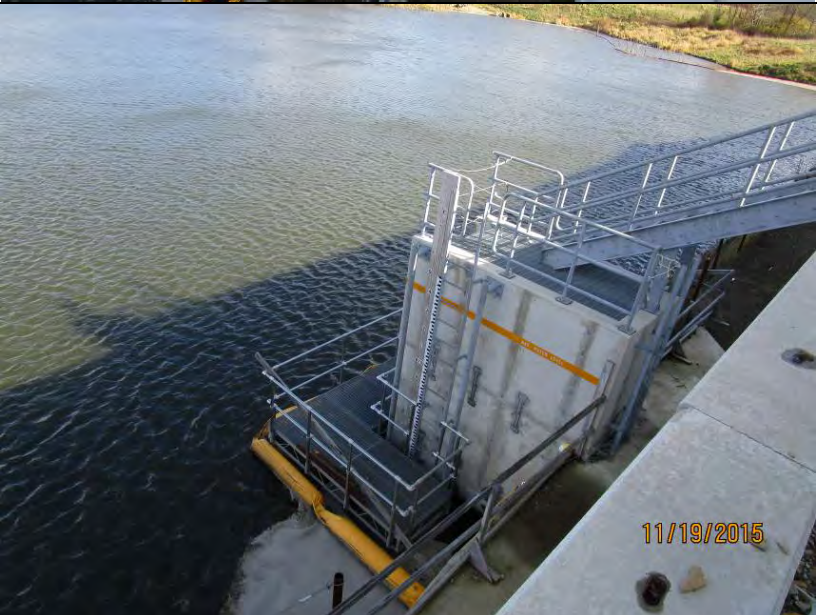
<p>11/19/2015</p>
<p>Typical view of the west side of the decant structure, skimmer and stairs showing good conditions.</p>

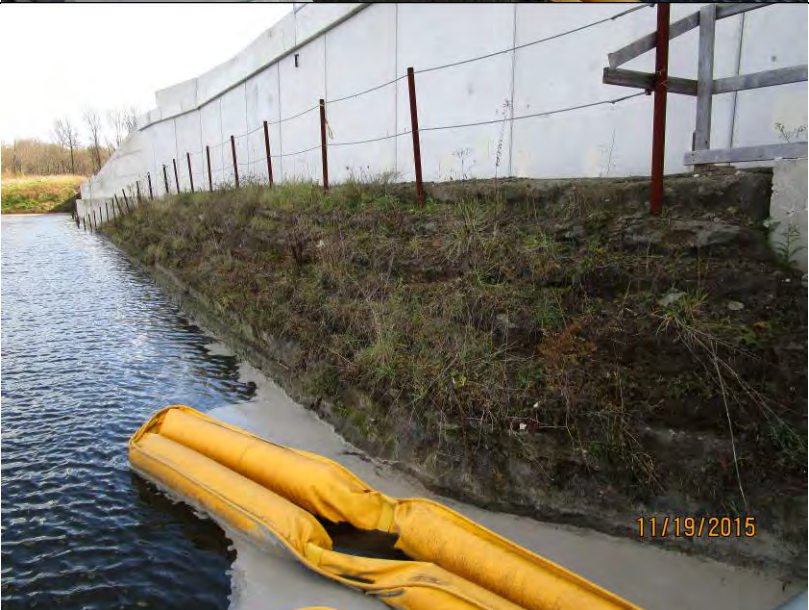
3. The upstream RCC slope appeared to be stable with no significant wave cut erosion, slumping or cracking (Photos Nos. 26 and 27).
4. The RCC crest surface is mostly covered by the new MSE Wall construction. The top surface of the gravel road appears to be in good conditions with no signs of major rutting or settlement

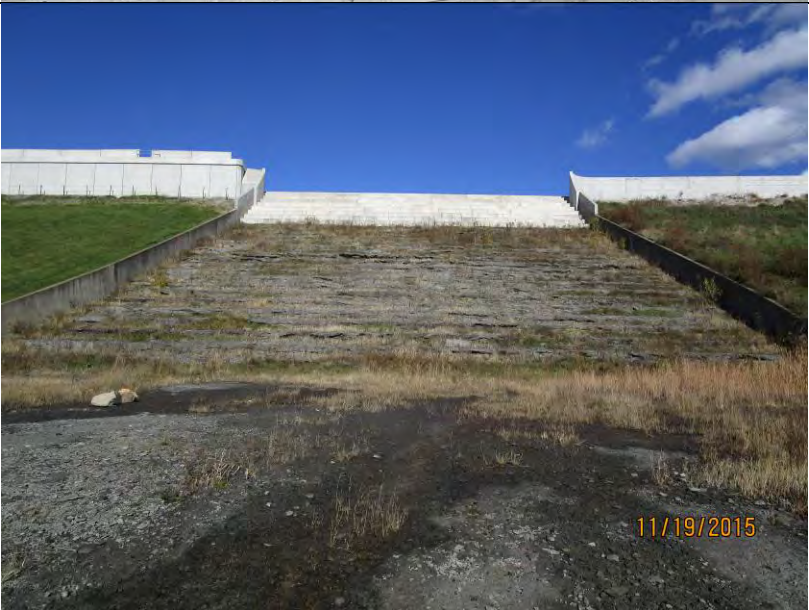
6. The emergency spillway has a downstream slope channel constructed of RCC steps and berms between the concrete retaining walls as shown in Photograph No. 29. The concrete walls and concrete steps appeared to be in good condition while the spillway's 2-ft high RCC steps continue to weather.

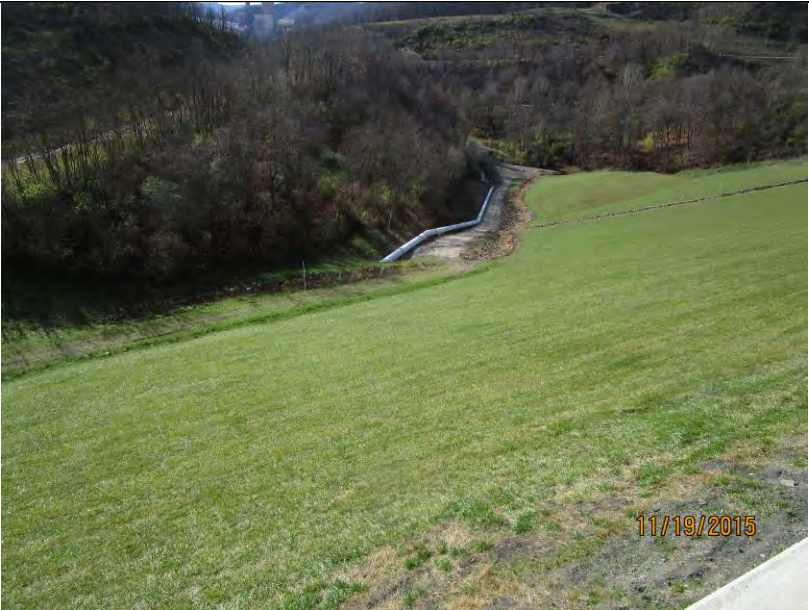
7. The downstream slope of the dam appeared to be in good condition with good vegetative growth as shown in Photograph Nos. 30& 31. No significant erosion was observed and the slopes appeared to be uniform with no slumping or bulges.

<p>Photo # 31 FAD 2</p> <p>Typical view of the downstream slope showing good conditions. No significant erosion was observed along the contact between the RRC and the vegetative cover. No bulging or slumping was observed. The slopes appeared to be uniform.</p>

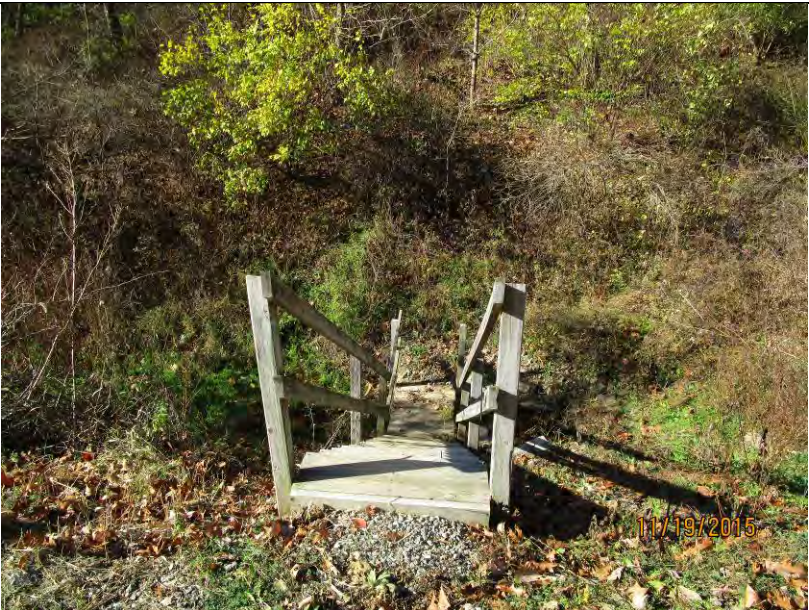
<p>11/19/2015</p>
<p>Photo # 35 FAD 2</p> <p>Typical view showing good conditions for access (stairs) to measure the dam's internal drain.</p>

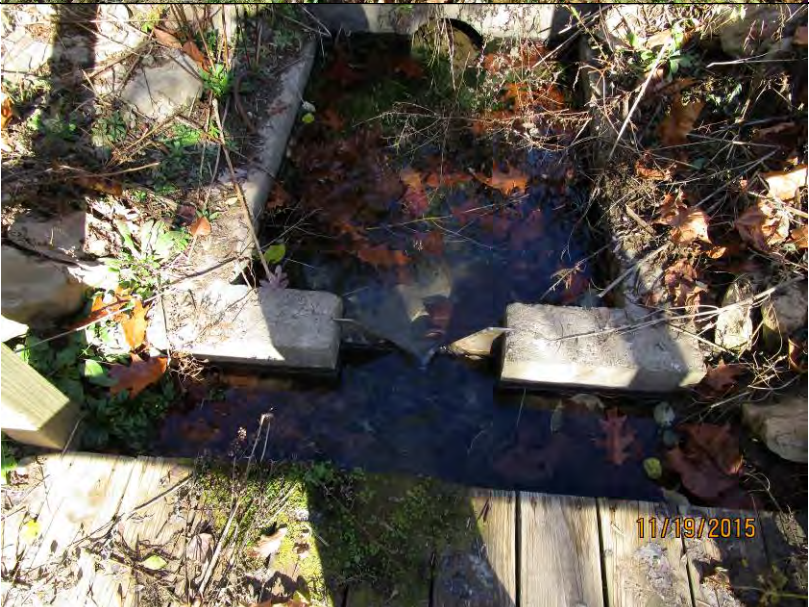
<p>11/19/2015</p>
<p>Photo # 36 FAD 2</p> <p>Typical view of the discharge from the dam's internal drain showing a visually clear discharge. Flow was unobstructed and the concrete weir box is in good condition. The discharge was measured to be 21 gpm and is consistent with previous measurements.</p>

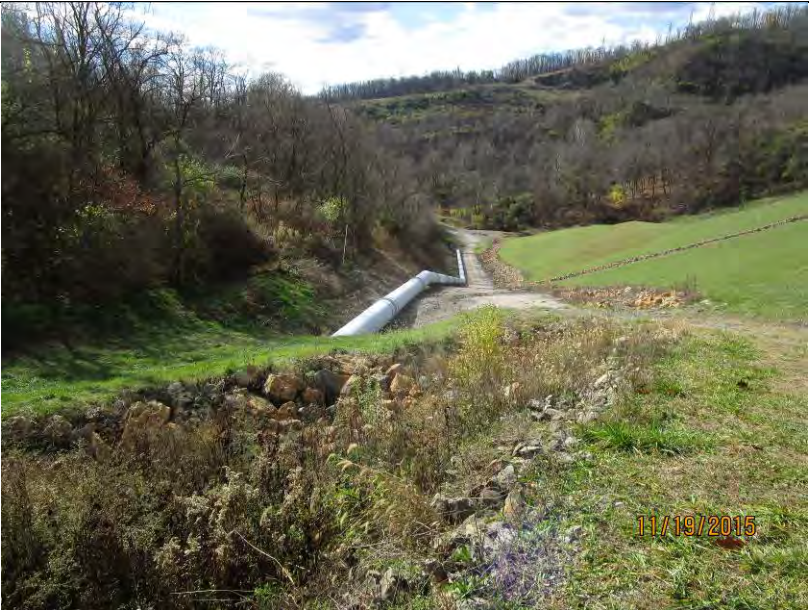
<p>Photo # 37 FAD 2</p>

10. The left groin ditches and discharge pipe were observed to be in good conditions. The vegetation was cut back to the left of the pipeline allowing excellent visual observation of the abutment. No significant uncontrolled seepage along this portion of the abutment or as the discharge pipe enters into the ground prior to its connection to the energy dissipater structure was observed. No significant erosion, slumping or bulges were observed. Minor vegetation growth within the groin ditch need to be eliminated using spry chemicals (Photograph No. 37).

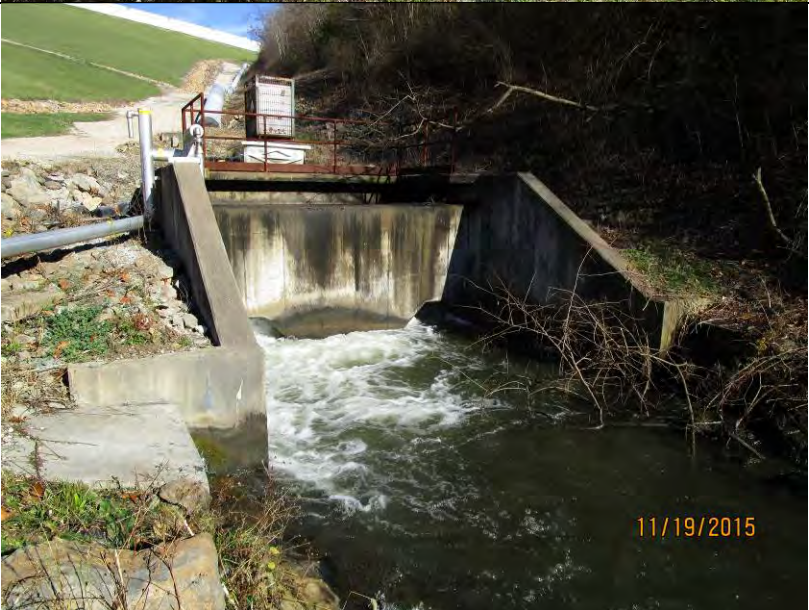
<p>Photo # 38 FAD 2</p>

11. The energy dissipator structure and downstream channel appeared to be in good condition (Photograph Nos. 38).
12. The dam's concrete flume (identified as Drain 14 (NPDES Permit Outfall # 000)) was observed to be in excellent condition and flow was unobstructed.

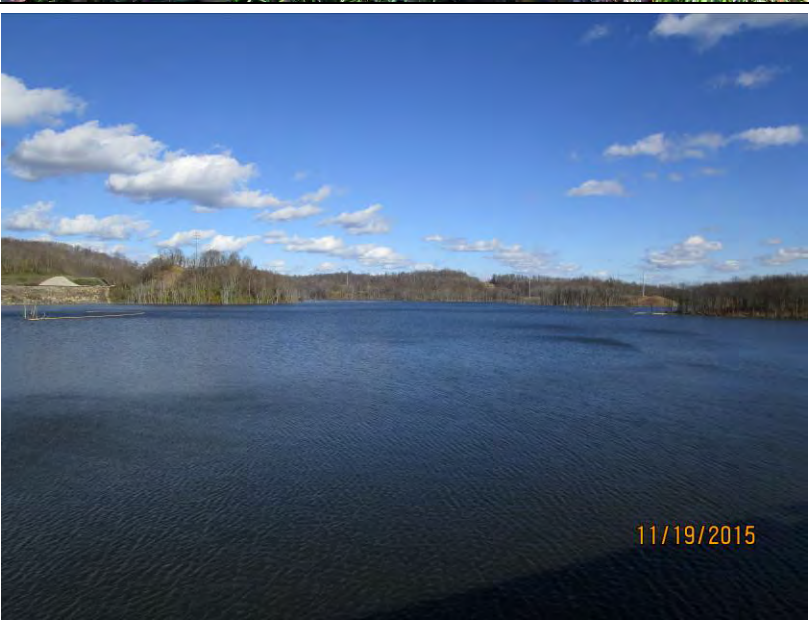
<p>11/19/2015</p>
<p>Photo # 41 FAD 2</p> <p>Typical view of the FAR 2 impoundment.</p> <p>The pond pool stage was 963.0 ft (NGVD-29) at the time of the inspection.</p>

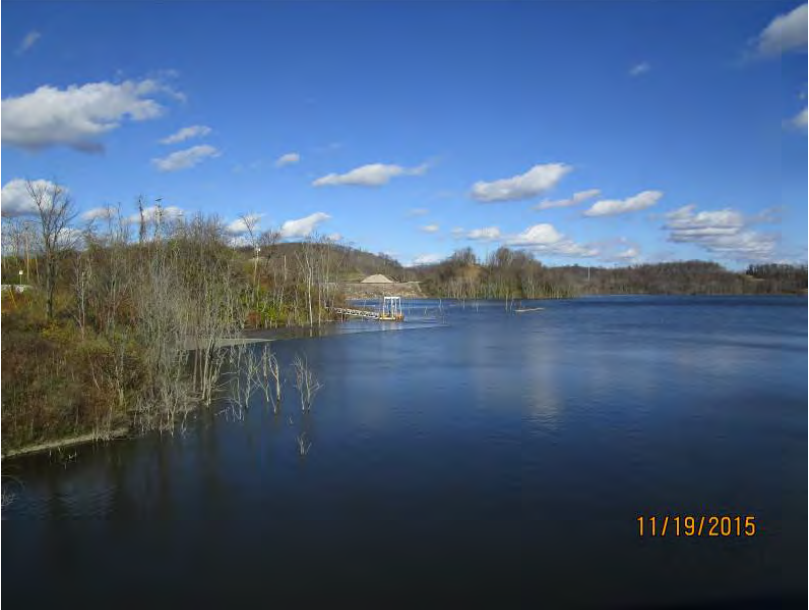
<p>Photo # 48 FAD 2</p> <p>Two aerators are operating in the FAR 2 pond and are used to keep the impoundment from stratifying and direct the cenospheres to move towards the shoreline allowing greater penetration of sunlight into the pond and promote the growth of algae.</p>

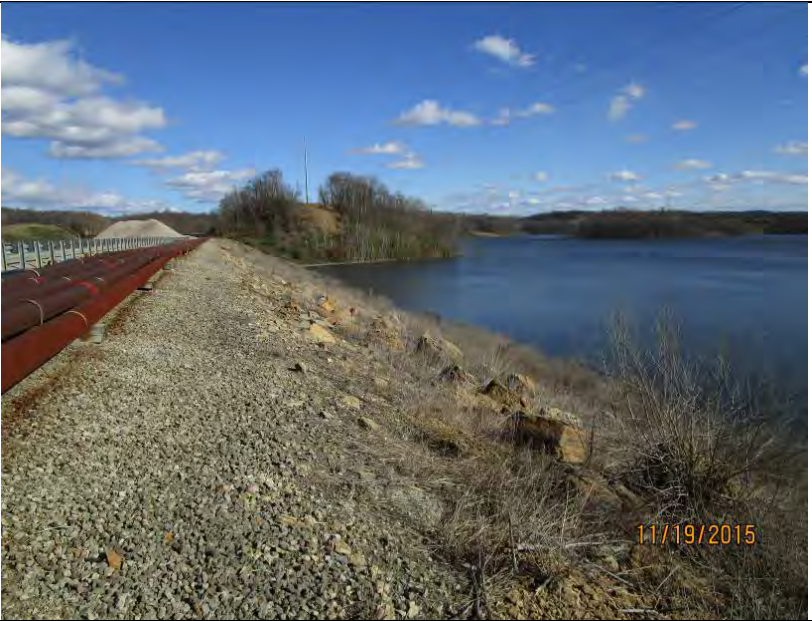
<p>Photo # 49 FAD 1</p> <p>View of the downstream slope of the FAR 1 dam.</p>

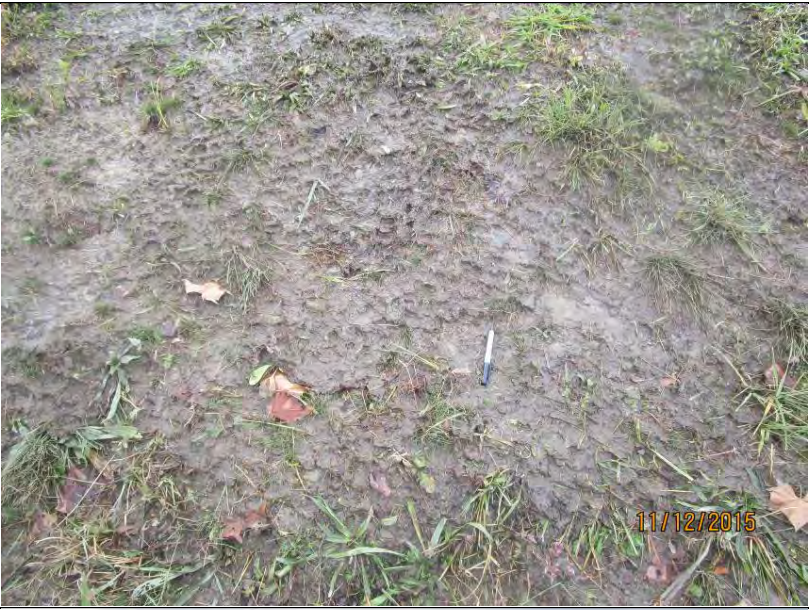
<p>A close-up photograph of a muddy, saturated area on the ground, likely a seep. There are some green plants and fallen leaves scattered around. A date stamp '11/12/2015' is visible in the bottom right corner of the photo.</p>
<p>Close-up of Seep #1.</p>	
<p>Photo # 54 BAP</p>

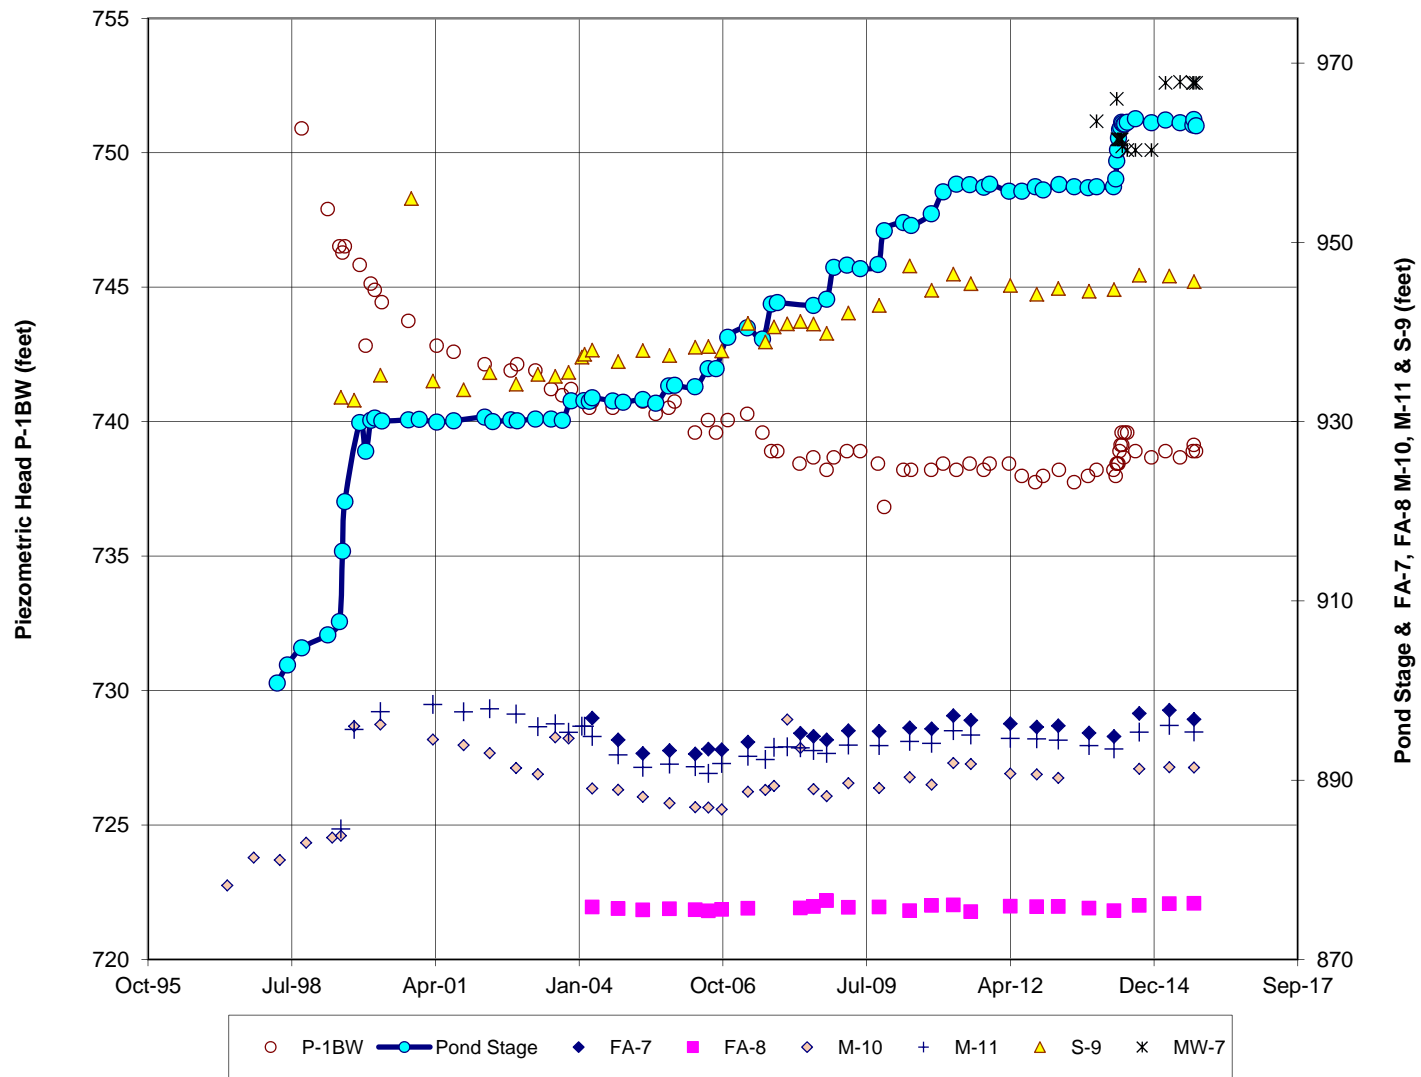
Figure 5n
Cardinal Far 2
Centerline of Dam
Drain Piezometers & Right Abutment Piezometers

- Two standpipe type piezometers were installed in 2004 into the right bedrock abutment to monitor seepage (FA-7 & FA-8). Both of these piezometers are installed into the Morgantown Sandstone member, a well fractured and jointed, medium to coarse grained sandstone. Piezometer FA-7 also forms a clustered well site with M-11 (also screened within the Morgantown Sandstone) and S-9 (screened in the Connellsville Sandstone – a zone noted for seepage in the FAR 1 inspection reports). M-10 is located away from the dam site but is also screened within the Morgantown Sandstone and is used to help illustrate the following trends (Figure 5n).

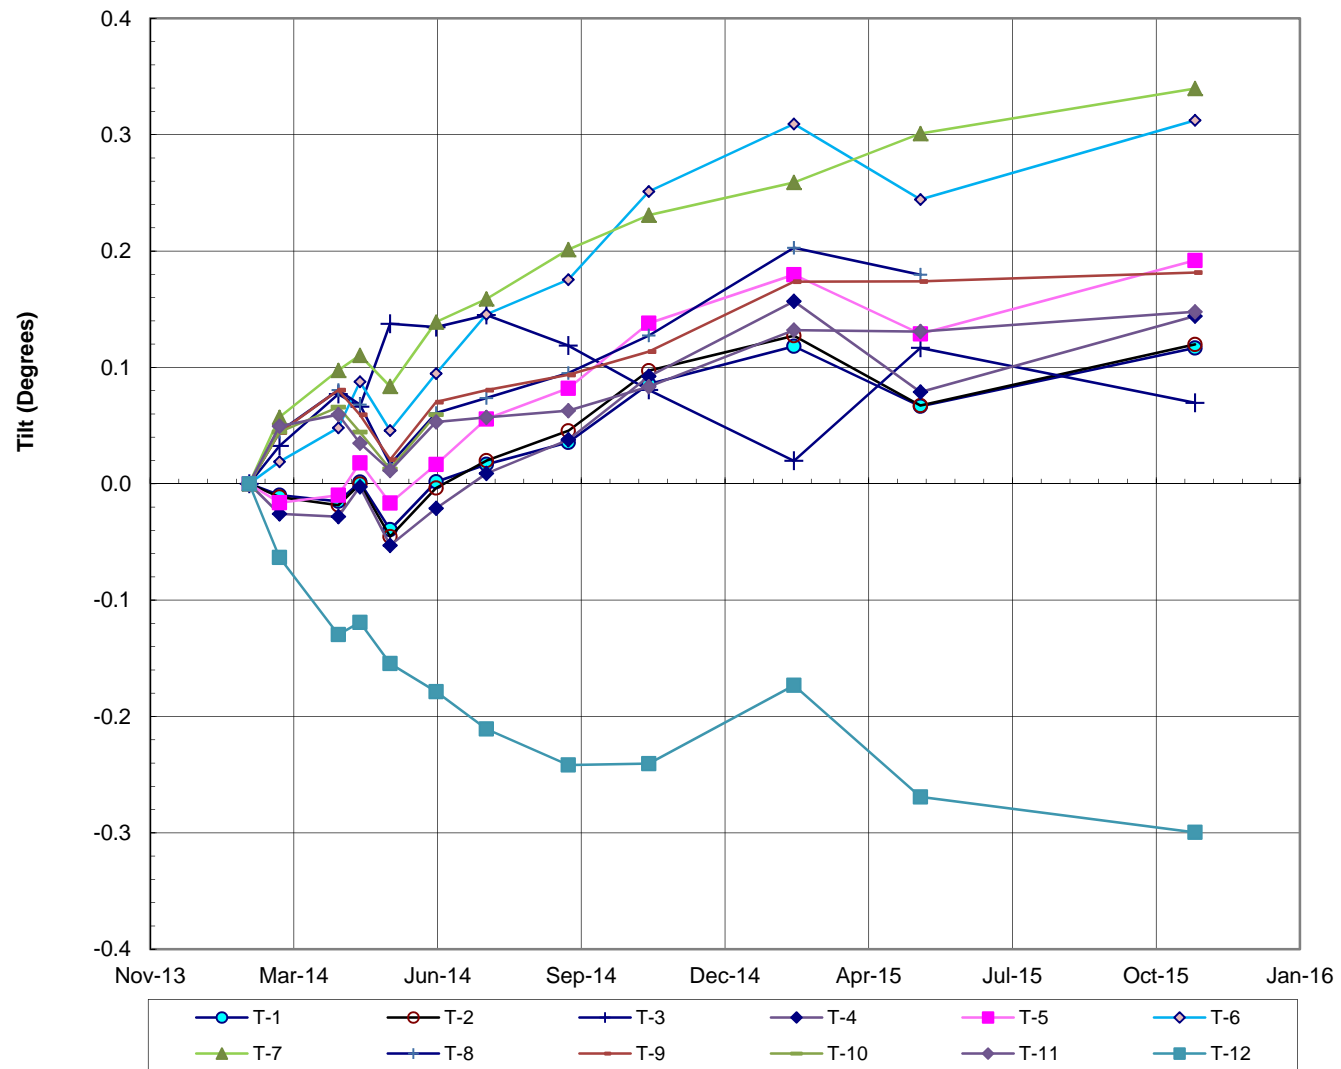
Figure 5o
 Cardinal Far 2
 Centerline of Dam
 Tiltmeters at MSE Wall Concrete Pannels

Top of dam monuments for 33 (i.e. 29901 thru 29933) were covered due to the 2014 dam raising. Replacement top of dam deformation monuments (1401 thru 1433) were installed and a base measurement were established. In addition, 12 tiltmeters were installed at the MSW wall concrete panels with less than 0.5° tilt recorded to date (Figure 5o).
