# **2016 LANDFILL INSPECTION REPORT**

**GERS-16-004**

**CARDINAL PLANT  
BRILLIANT, OHIO**

# Landfill Inspection Report Fly Ash Reservoir Landfill

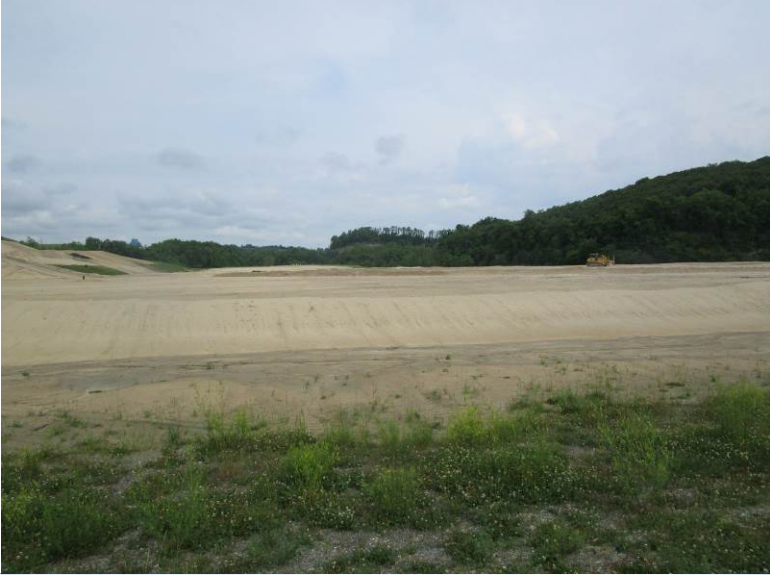
<p><b>Photo No. 4</b></p> <p>Cell 3 South Line Looking North.</p> <p>Active placement area in Cell 3</p>

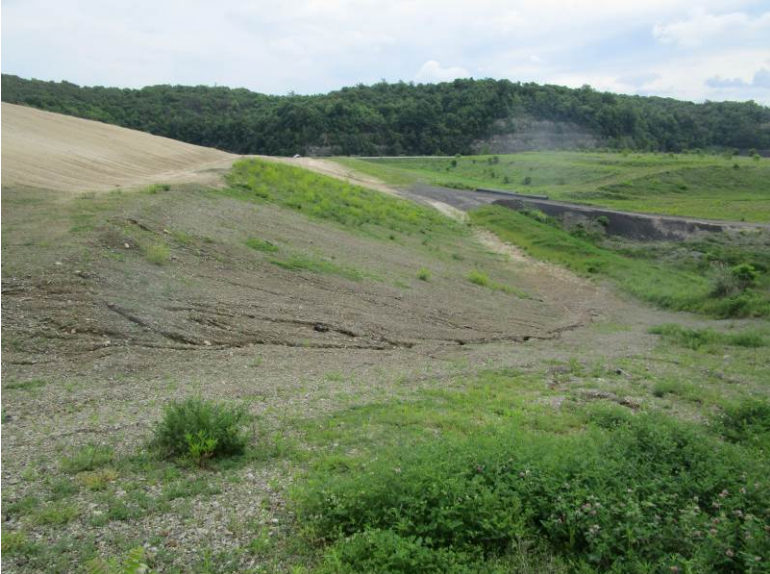
<p><b>Photo No. 5</b></p> <p>Cell 1 Southwest corner Line Looking East.</p> <p>Cell 1/2 Berm and temporary cover.</p> <p>minor erosion rills</p>
 	<p><b>Photo No. 6</b></p> <p>Cell 1 Southwest corner Line Looking East.</p> <p>Cell 1/2 Berm and temporary cover</p> <p>minor erosion rills</p>

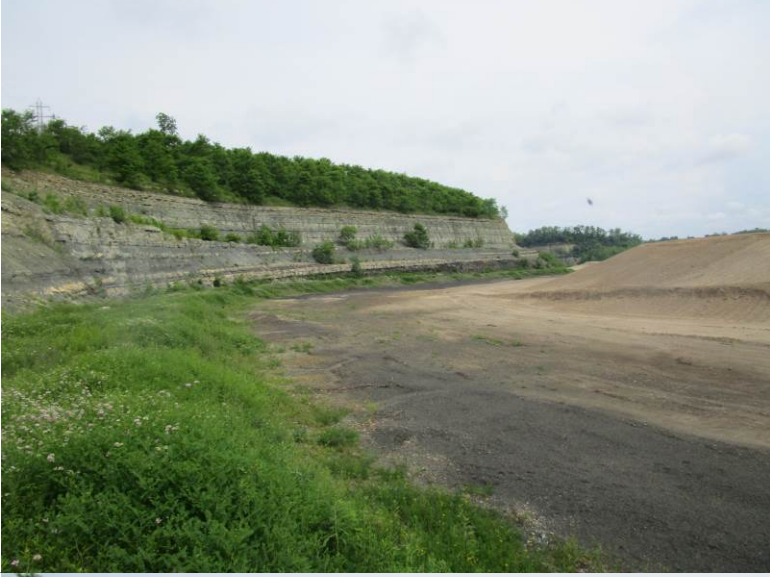
A photograph showing a steep, rocky highwall on the left side of a landfill cell. The highwall is covered with sparse vegetation and some small trees. The ground in the foreground is a mix of gravel and grass. In the background, there are more landfill cells and a line of trees under a cloudy sky.	<p><b>Photo No. 7</b></p> <p>Cell 1 West Line Looking North.</p> <p>Stabilized highwall conditions</p>

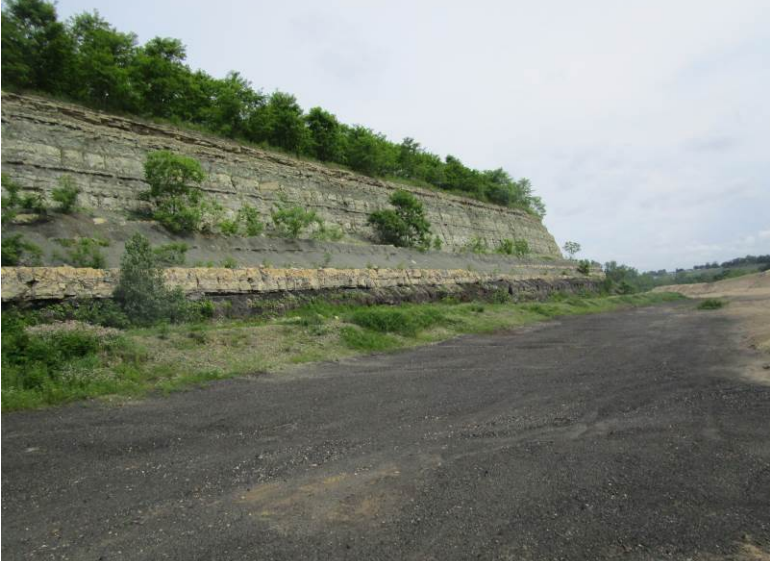
A photograph showing a wide view of a landfill cell. On the left, there is a steep, rocky highwall with some vegetation. The ground in the foreground is a mix of gravel and grass. In the background, there are more landfill cells and a line of trees under a cloudy sky.	<p><b>Photo No. 8</b></p> <p>Cell 1 West Line Looking North.</p> <p>Waste Internal slopes conditions</p>

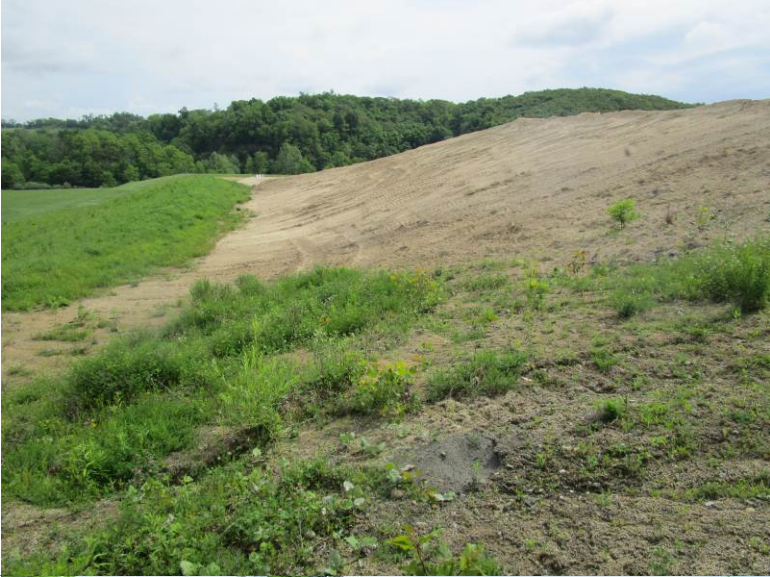
<p><b>Photo No. 10</b></p> <p>Cell 1 Northwest Line Looking East.</p> <p>Closed Area conditions/Waste outer slopes conditions</p>

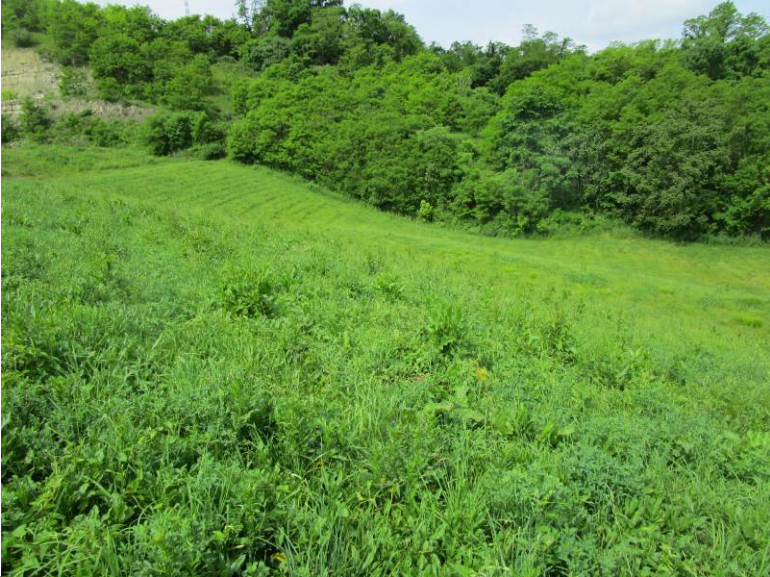
<p><b>Photo No. 11</b></p> <p>Cell 1/3 Line North crest Looking West.</p> <p>Closed Area conditions</p> <p>Limited area missed during the recent mowing cycle.</p>
 	<p><b>Photo No. 12</b></p> <p>Cell 1/3 Line North Looking West.</p> <p>Closed Area conditions</p>

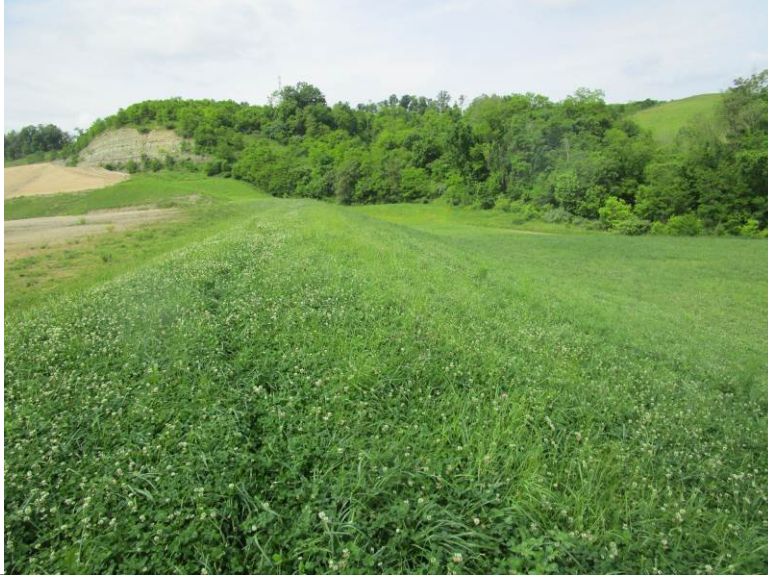
**Photo No. 13**

Cell 3 Northeast corner crest  
Looking West.

Closed Area conditions

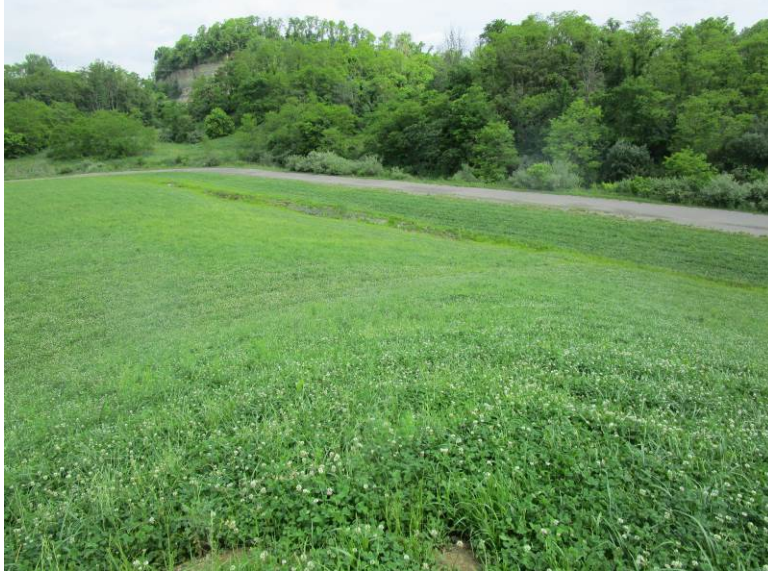
**Photo No. 14**

Cell 3 Northeast corner crest  
Looking Northeast.

Closed Area conditions

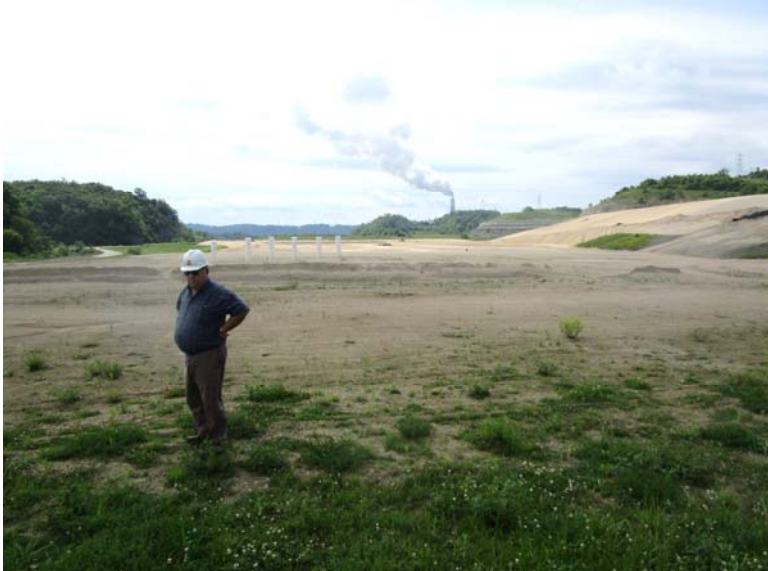
**Photo No. 15**

Cell 3 Northeast crest Looking  
South.

Cell 3 North Placement Area  
Conditions Including Raised  
monitoring wells

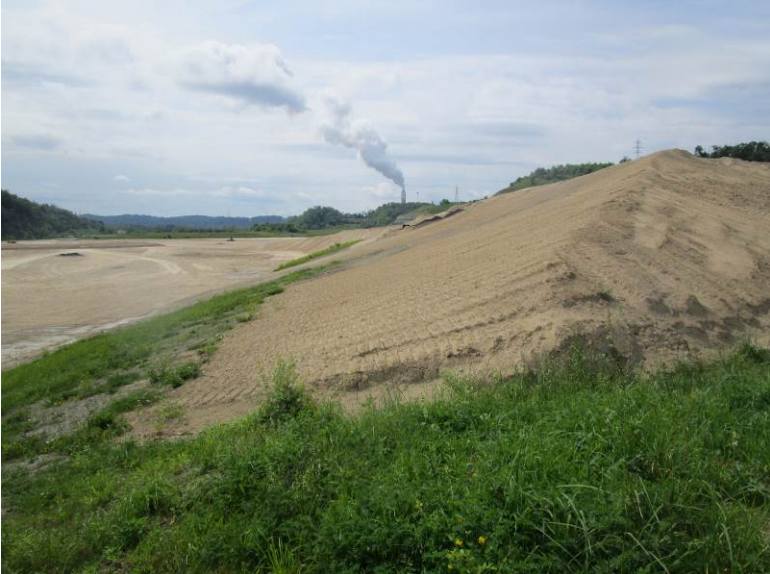
<p><b>Photo No. 16</b></p> <p>Cell 1/3 Line North crest Looking South.</p> <p>Cell 1/3 Line</p>

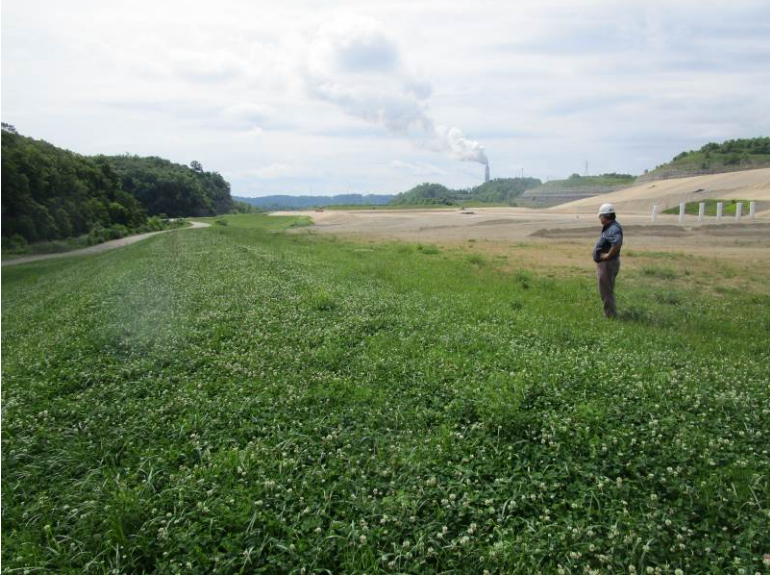
<p><b>Photo No. 17</b></p> <p>Cell 3 Northeast corner crest Looking South.</p> <p>Berm Crest Conditions</p>

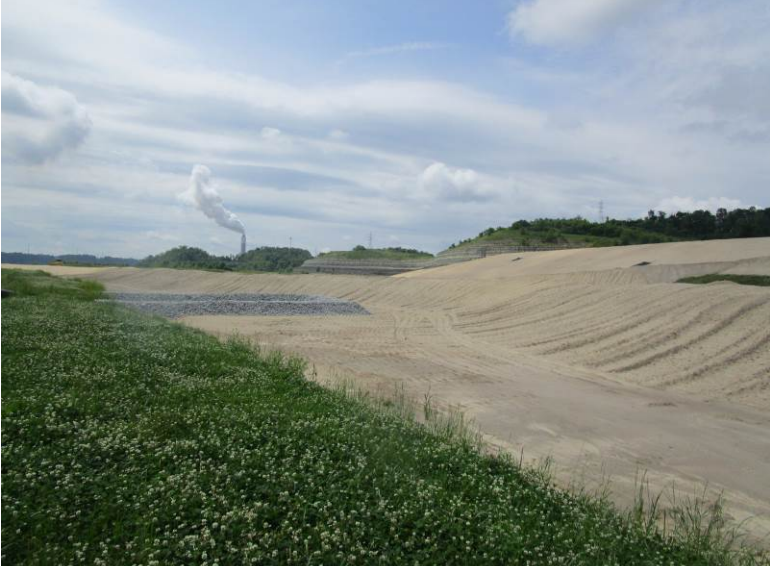
<p><b>Photo No. 18</b></p> <p>Cell 3 Northeast corner crest Looking South.</p> <p>Active area Placement Conditions</p>

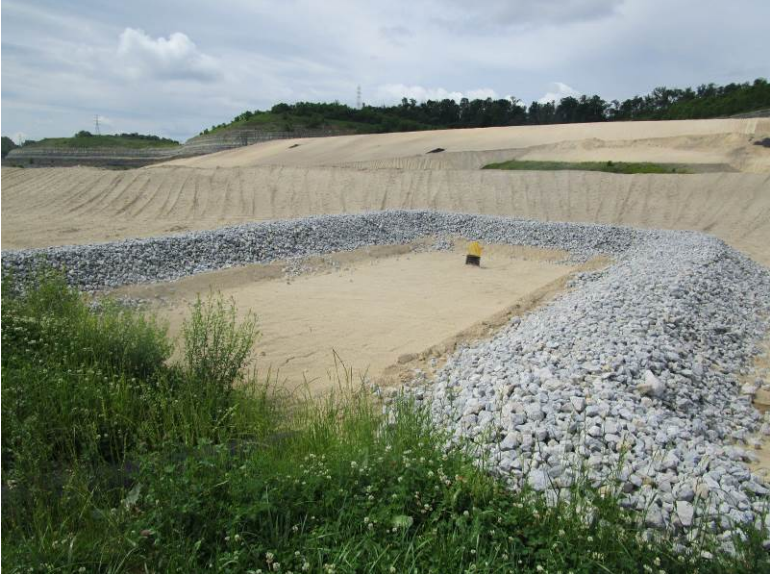
<p><b>Photo No. 19</b></p> <p>Cell 3 Center of North Swale Looking West.</p> <p>Active area Placement Conditions</p> <p>Recently improved inlet.</p>

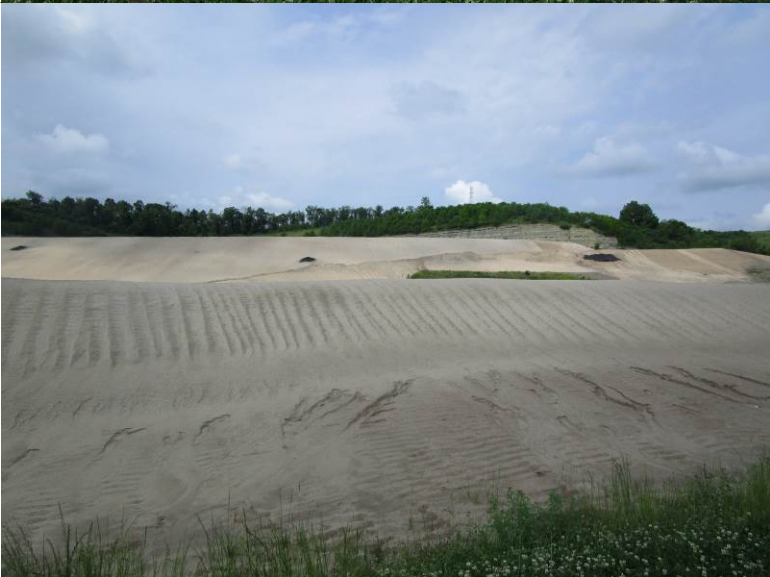
<p><b>Photo No. 20</b></p> <p>Cell 3 North/South Dividing Line Looking West.</p> <p>Active area Placement Conditions</p>

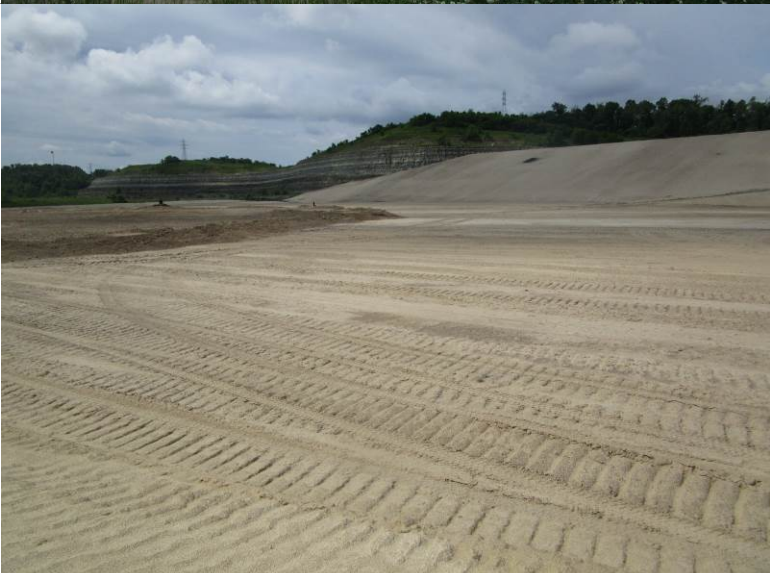
<p><b>Photo No. 21</b></p> <p>Cell South Looking West.</p> <p>Active area Placement Conditions showing Chimney Drain</p>

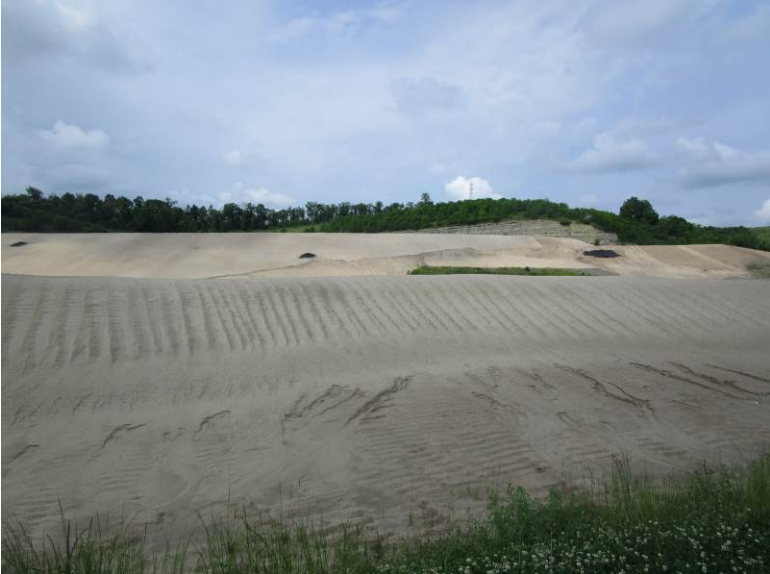
<p><b>Photo No. 25</b></p> <p>Cell 3 South Swale Line Looking North.</p> <p>Outer slopes of Active Placement Area and External Berm Conditions</p>
 	<p><b>Photo No. 26</b></p> <p>Cell 3 South Swale Line Looking South.</p> <p>Manhole #2 and External Berm Conditions</p>

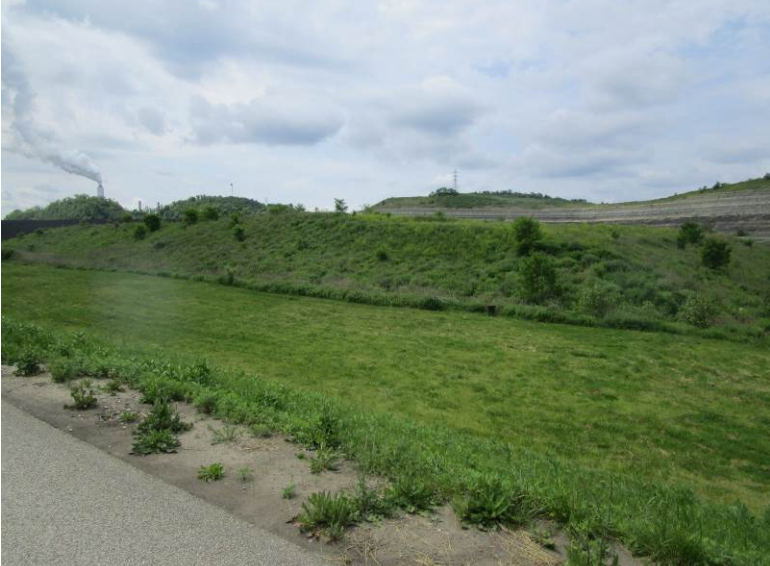
<p><b>Photo No. 27</b></p> <p>Future Cell 3/4 West Line Looking Northwest.</p> <p>Preload</p>

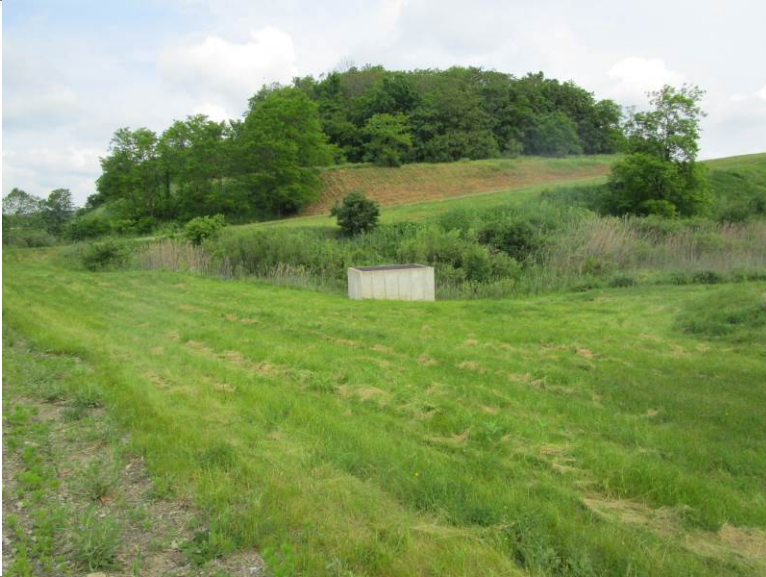
**Photo No. 31**

Cell 6 East Looking East.

Leachate Pretreatment Structure

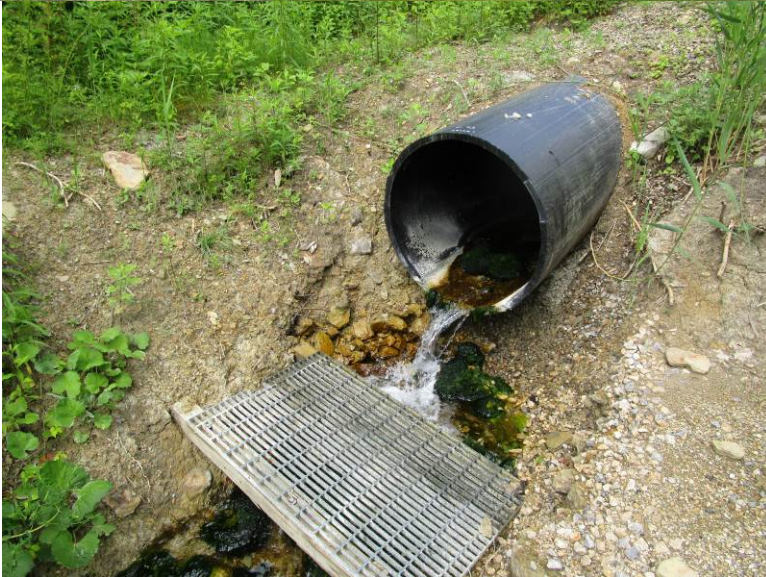
**Photo No. 32**

Cell 5 East Looking West.

Leachate outfall to FAR II Pond

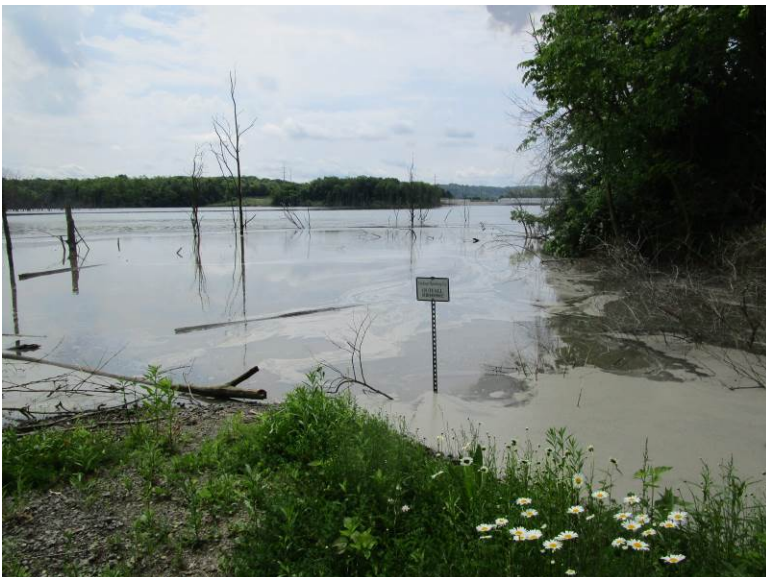
**Photo No. 33**

Cell 5 East Looking West.

FAR II Pond
