# 2017 ANNUAL DAM AND DIKE INSPECTION REPORT

**Fly Ash Dams 1, 2  
&  
Bottom Ash Pond Complex**

**Cardinal PLANT  
BRILLIANT, OHIO**

**Dam & Dike Inspection Report  
Fly Ash Dams 1, 2, and  
Bottom Ash Pond Complex**

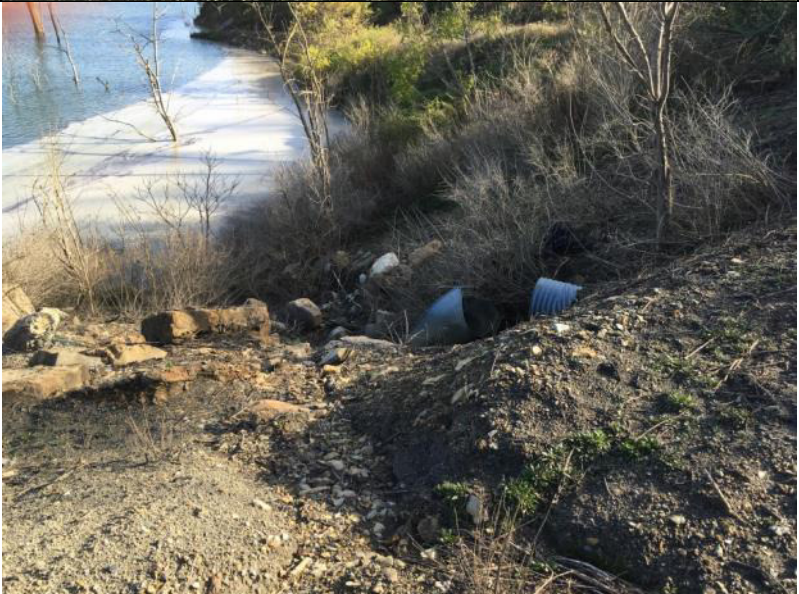
A photograph showing a typical view of the downstream slope of the FAR 1 dam. The slope is covered in dark, rocky material and has some sparse vegetation. A road or path is visible at the top of the slope. The water of the reservoir is on the left side of the frame. The sky is clear and blue.
<p>Photo # 3 FAD 1</p> <p>Typical view of the right groin area of FAR 1 dam showing a damaged surface water pipe.</p>

A photograph showing the right groin area of the FAR 1 dam. The area is characterized by a rocky and gravelly surface with sparse vegetation. A damaged surface water pipe is visible, with a blue cap or cover. The water of the reservoir is on the left side of the frame. The sky is clear and blue.

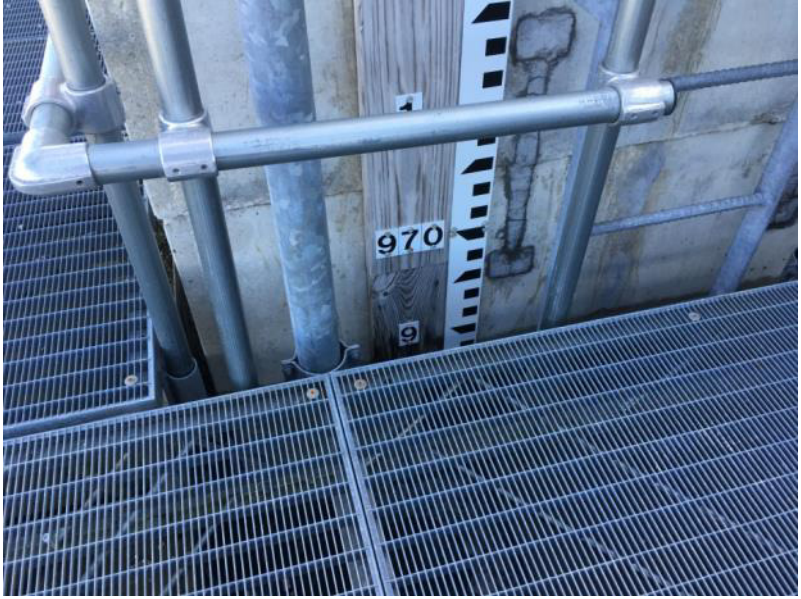
<p>Typical view looking down the access stair to the decant structure. Stairs, railings and platform appeared in good condition.</p>	
<p>Photo # 5 FAD 2</p>

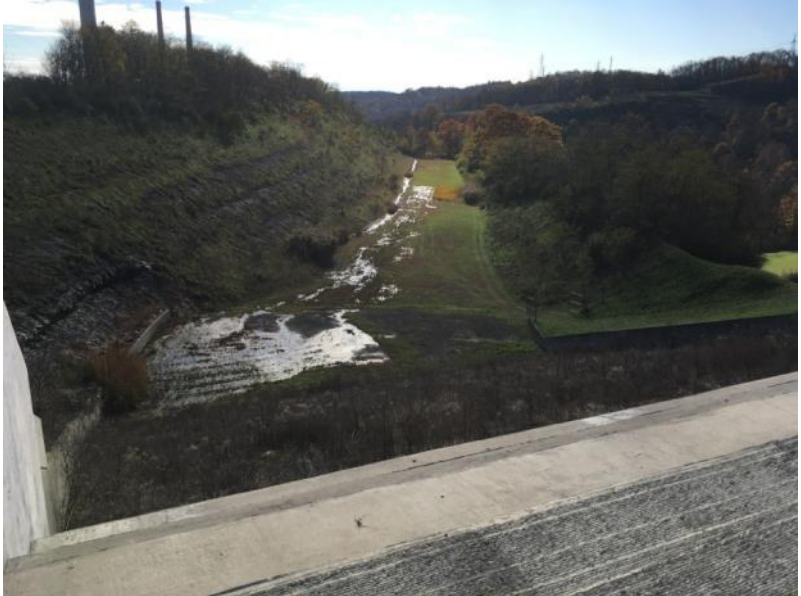
<p>Photo # 10 FAD 2</p> <p>Typical view of the emergency discharge channel showing good conditions. Vegetative control is well maintained. Historic seep from the rock slope at the left abutment has slightly increase in rate as a result of the increased upstream gradient as a result of rising the pool elevation by approximately 5 ft.</p>

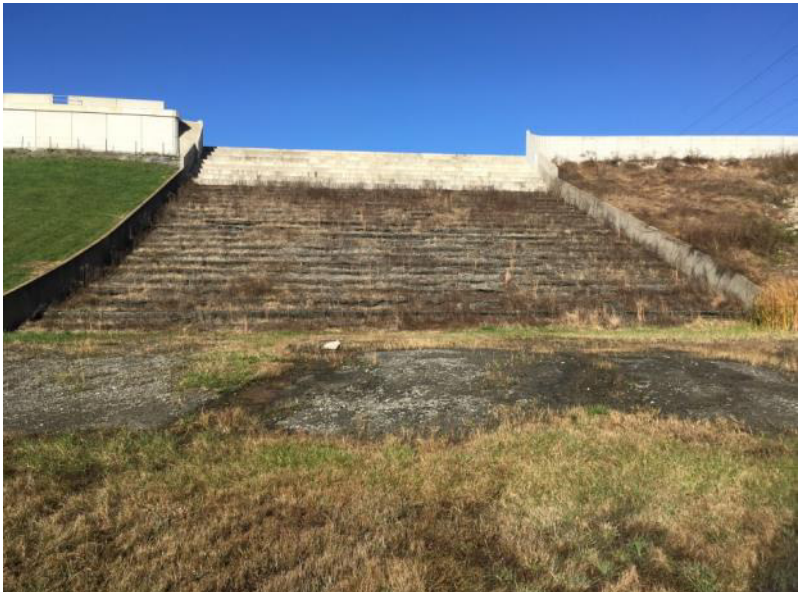
<p>Photo # 12 FAD 2</p> <p>Typical view of the Concrete and RCC emergency spillway discharge channel "steps."</p> <p>The RCC steps have experienced a moderate amount of differential erosion but appear to be in fair condition.</p>

7. The emergency spillway has a downstream slope channel constructed of RCC steps and berms between the concrete retaining walls. The concrete walls and concrete steps appeared to be in good condition while the spillway's 2-ft high RCC steps continue to weather (Photograph No. 12).

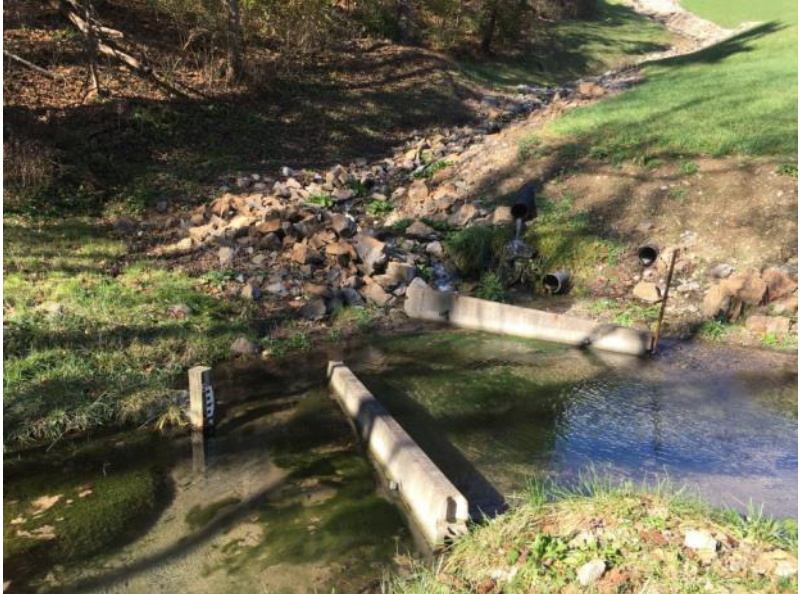
<p>Photo # 19 FAD 2</p> <p>Typical view of Drain no. 2 that discharges from the right abutment drainage blanket. The discharge was visually clear but has increased.</p> <p>Flow measurements are taken of the seep drains that let down into the pooling area. A v-notch weir is used to measure flow.</p>

10. The right downstream groin ditch was in good condition (Photographs No. 17 and 18). The rip rap is a hard limestone and showed minor weathering or deterioration. The discharges from several seepage drains were clear and no sediment deposits were observed in the pooling area. The groin appeared to be generally in good condition (Photograph No. 19).

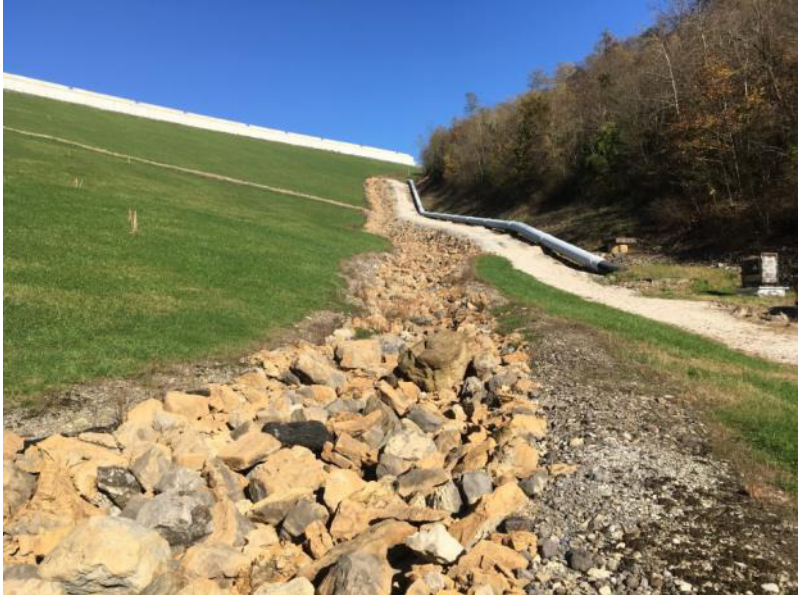
<p>Photo # 20 FAD 2</p> <p>Typical view of the left groin ditch. The rip rap is a hard limestone and showed no significant weathering or deterioration.</p>

significant erosion, slumping or bulges were observed. Minor vegetation growth within the groin ditch needs to be eliminated using spry chemicals (Photograph No. 20).

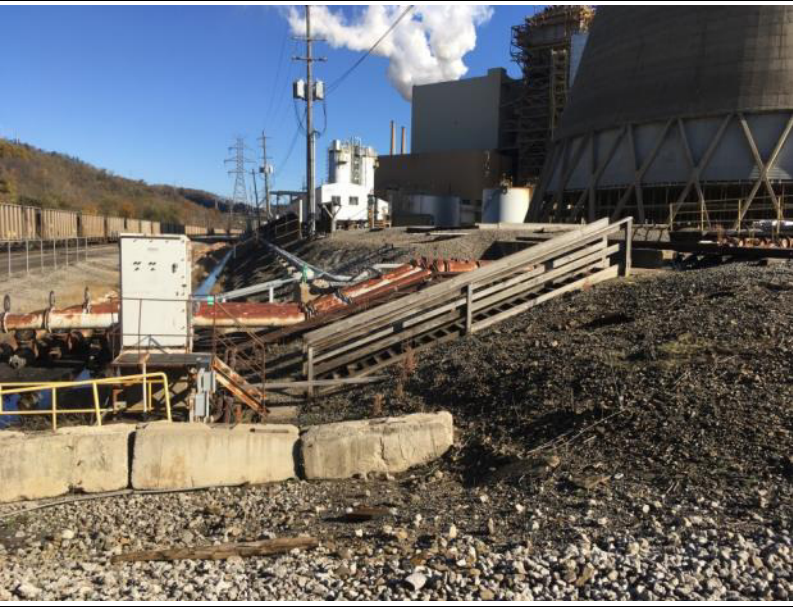
<p>Typical view showing satisfactory condition of exterior slope and some minor seepage / drainage along toe of the embankment.</p> <p>No significant signs of erosion, slumping or bulges were observed.</p>	
<p>Photo # 2 BAP</p>

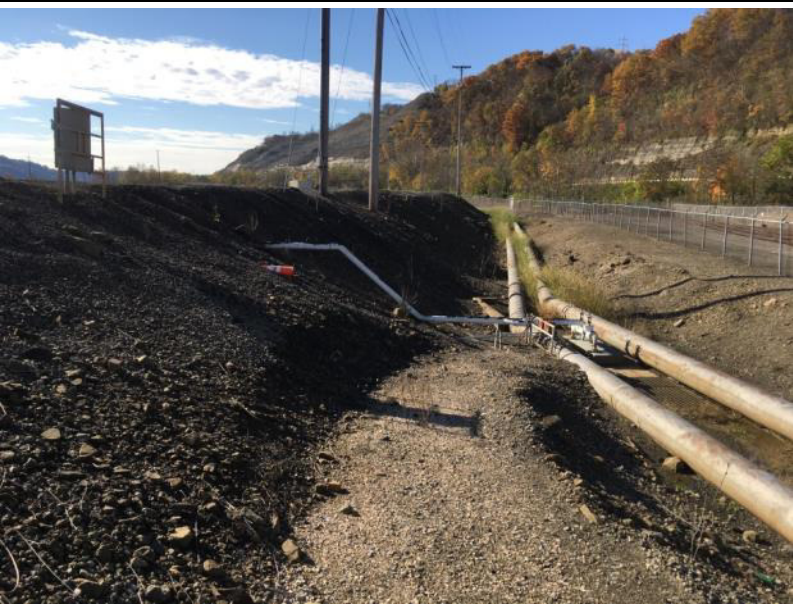
<p>Typical view showing satisfactory condition of exterior slope and access stair to the ash sluice lines along toe of the embankment.</p> <p>No significant signs of erosion, slumping or bulges were observed.</p>	
<p>Photo # 3 BAP</p>

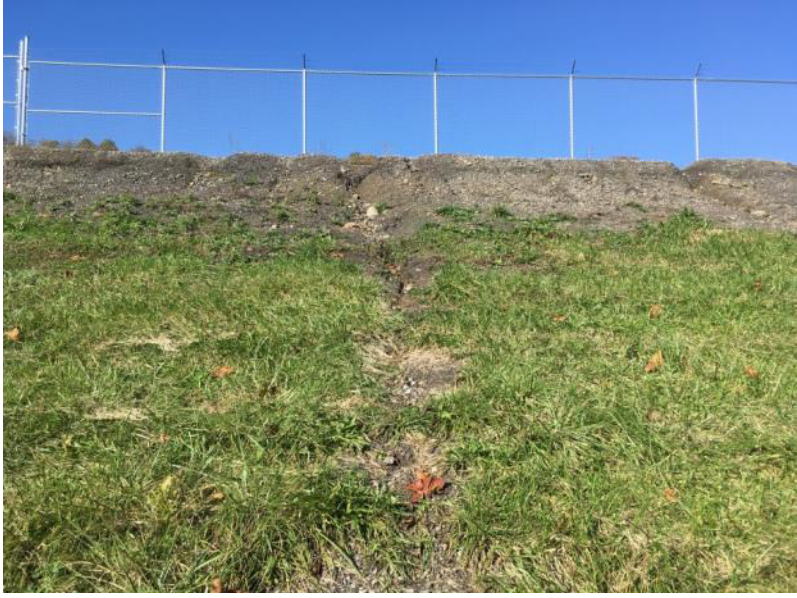
downstream slope and crest meet. These erosion rills are most likely caused by storm water runoff from the crest area (Photograph No. 9).

<p>View of the exterior slope along the Ohio River showing some erosion rills forming at the top of slope where water runs off of the crest area.</p>

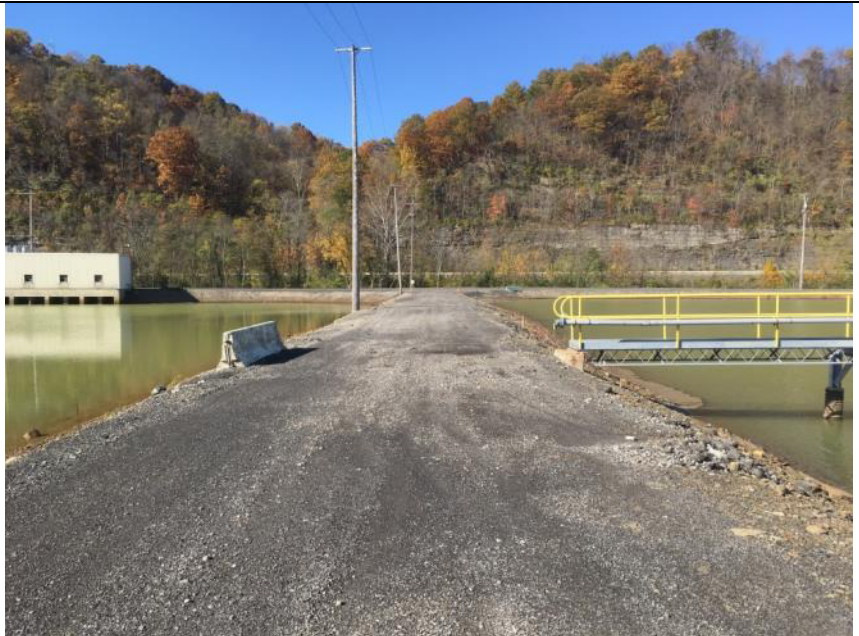
Photo # 11 BAP

Typical view showing good conditions of the splitter dike between the bottom ash pond and the RCP pond with minor erosion at the corners.

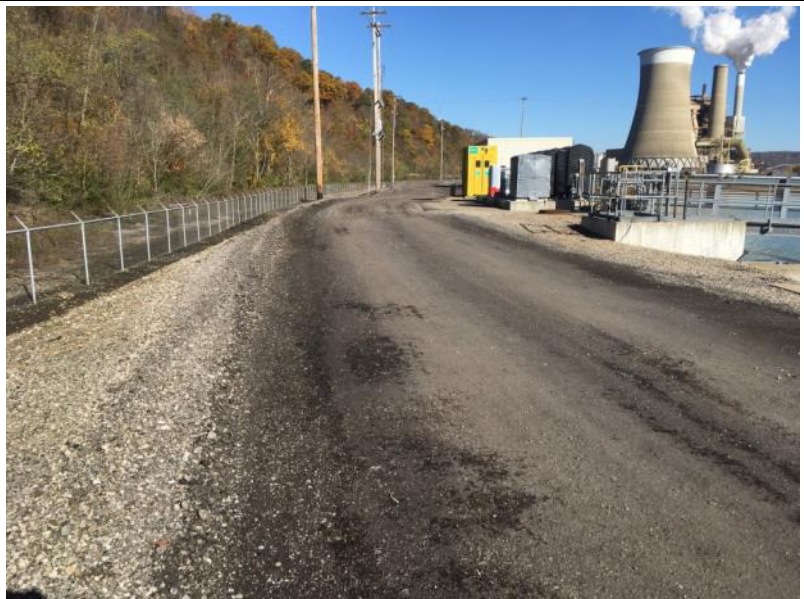
Photo # 12 BAP

Typical view of the crest area along the RCP. The crest conditions were good with no indications of misalignment, and minimal rutting or erosion.

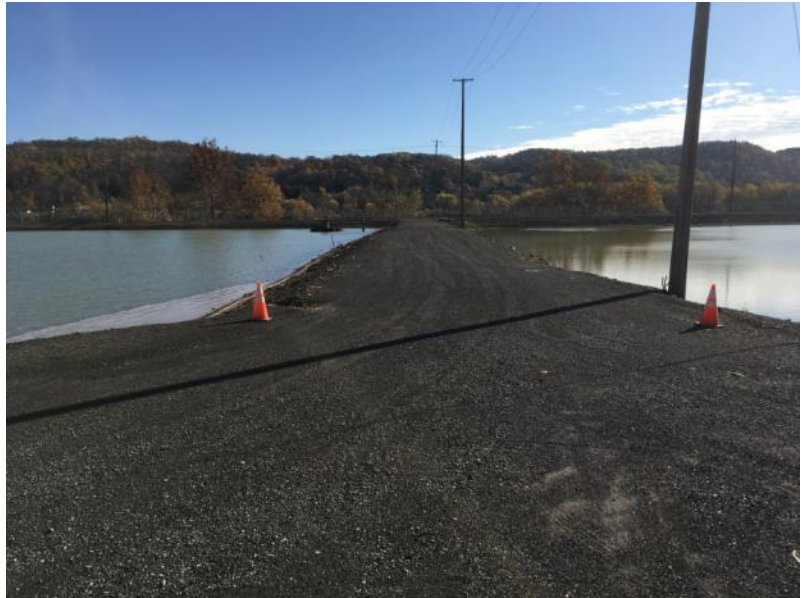
Photo # 13 BAP

Typical view showing conditions of the splitter dike between the bottom ash pond and the RCP with minor erosion at the corners.

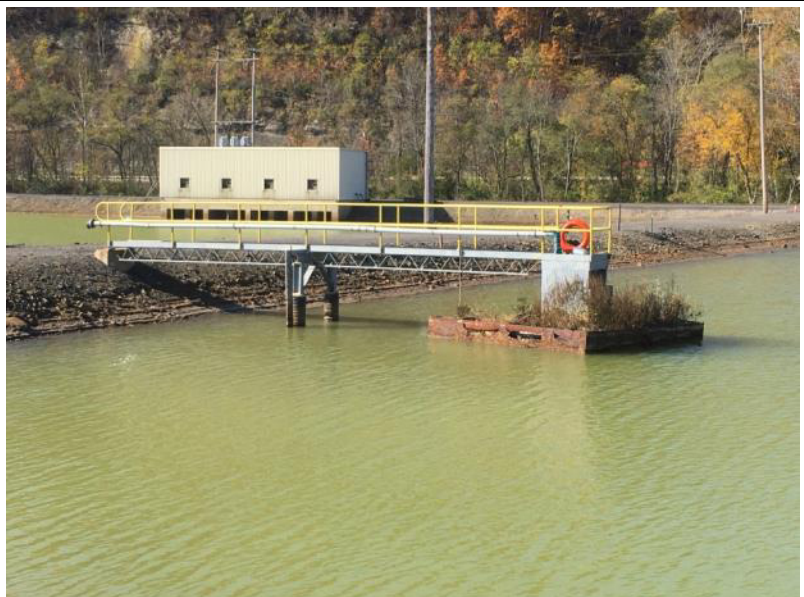
Photo # 18 BAP

Typical view of the BAP discharge structure. The concrete drop inlet structure was observed to be in good condition.

The metal skimmer is significantly rusted and in poor condition.

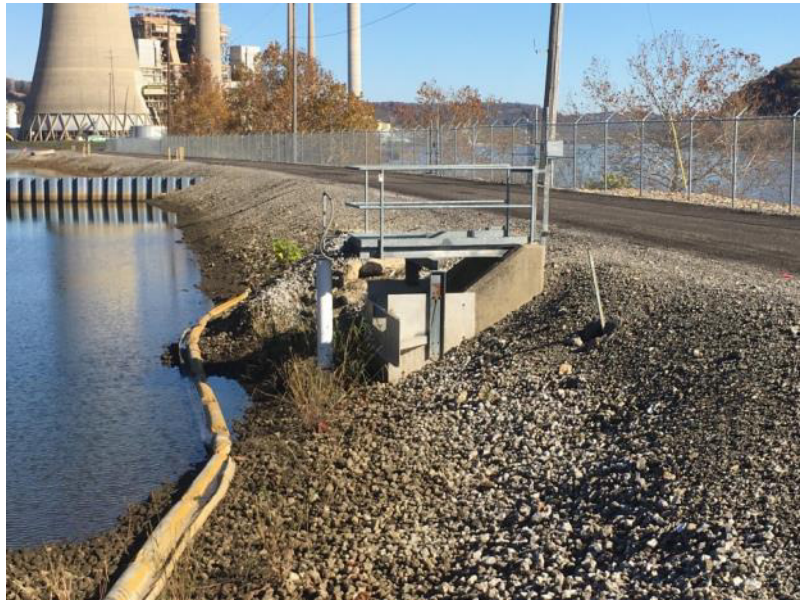
Photo # 19 BAP

The RCP overflow structure appeared to be in good condition. No spalling or cracking of the concrete was observed. The RCP overflow structure has been retrofitted with a steel weir.

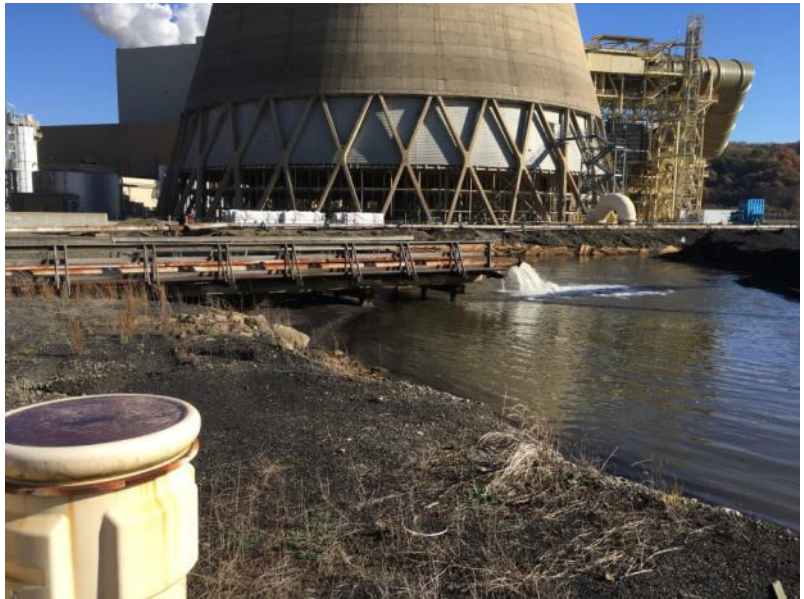
Photo # 20 BAP

Typical view showing good conditions of the bottom ash discharge pipes. Access to the discharge lines is being maintained, discharge into the channel and flow through the channel was unobstructed.

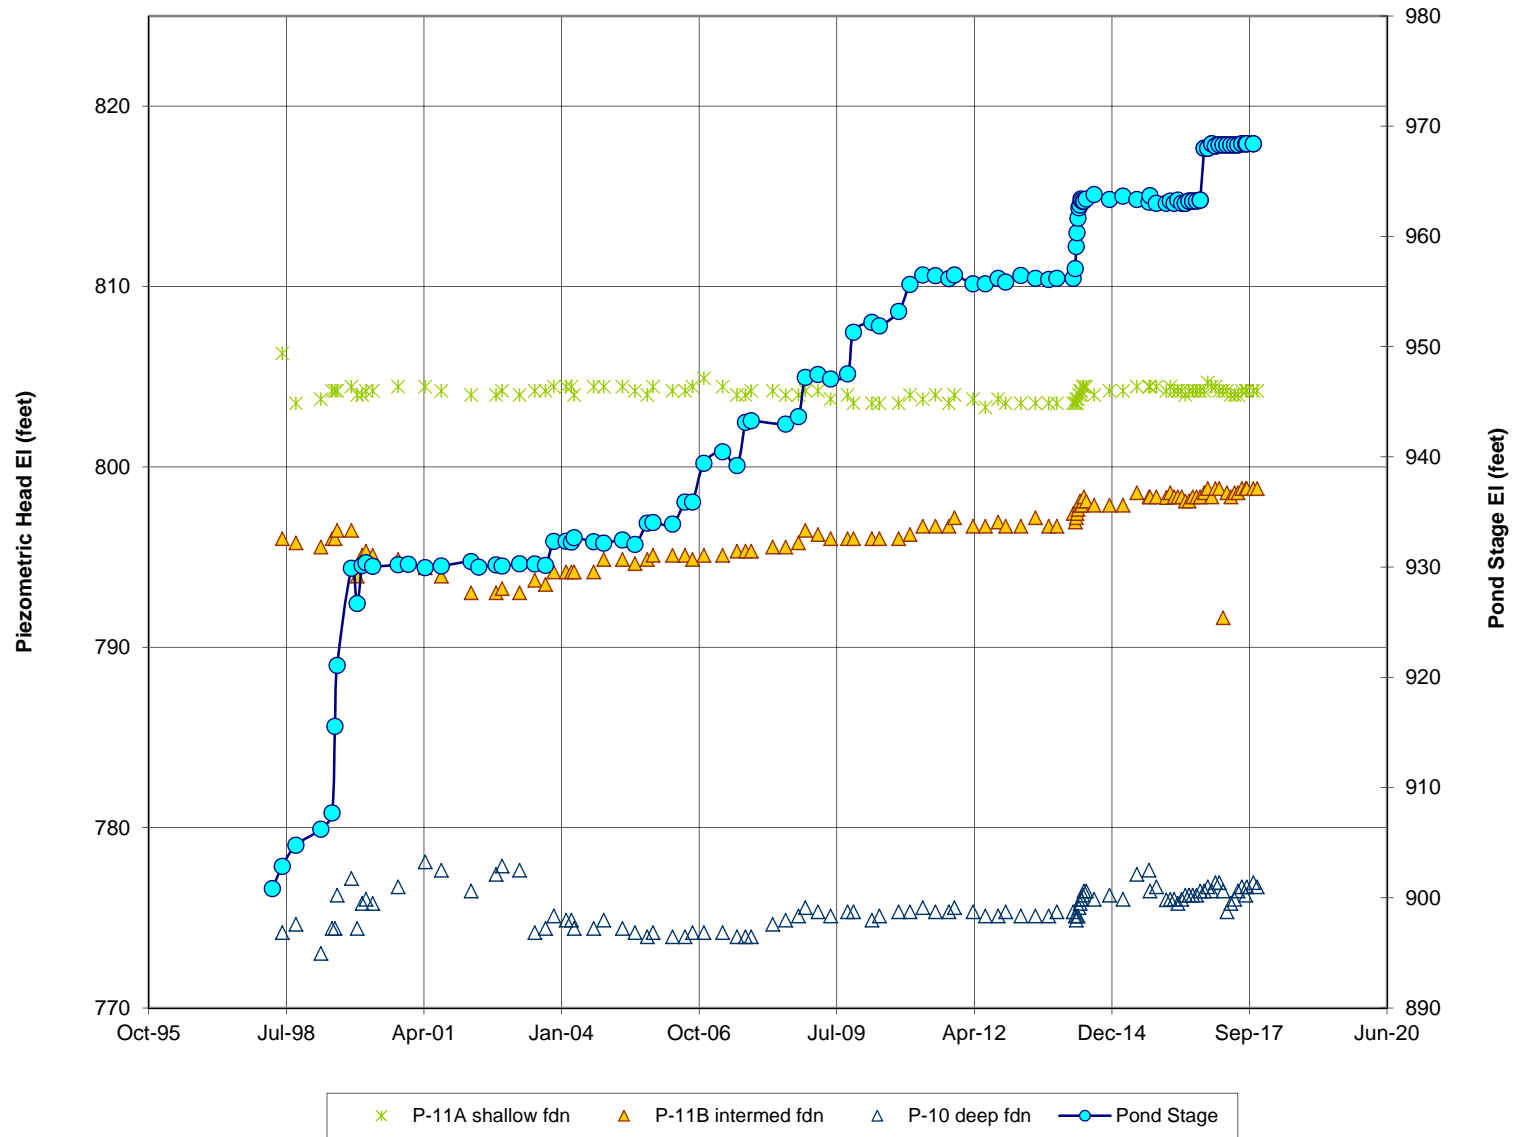
Figure 5c  
Cardinal FAD 2  
Right of Center  
Foundation Piezometers

- Water levels in the shallow, intermediate and deep foundation showed none or a minor increase corresponding to raising the pond stage that took place in October 2016 (Figures 5c & 5d).

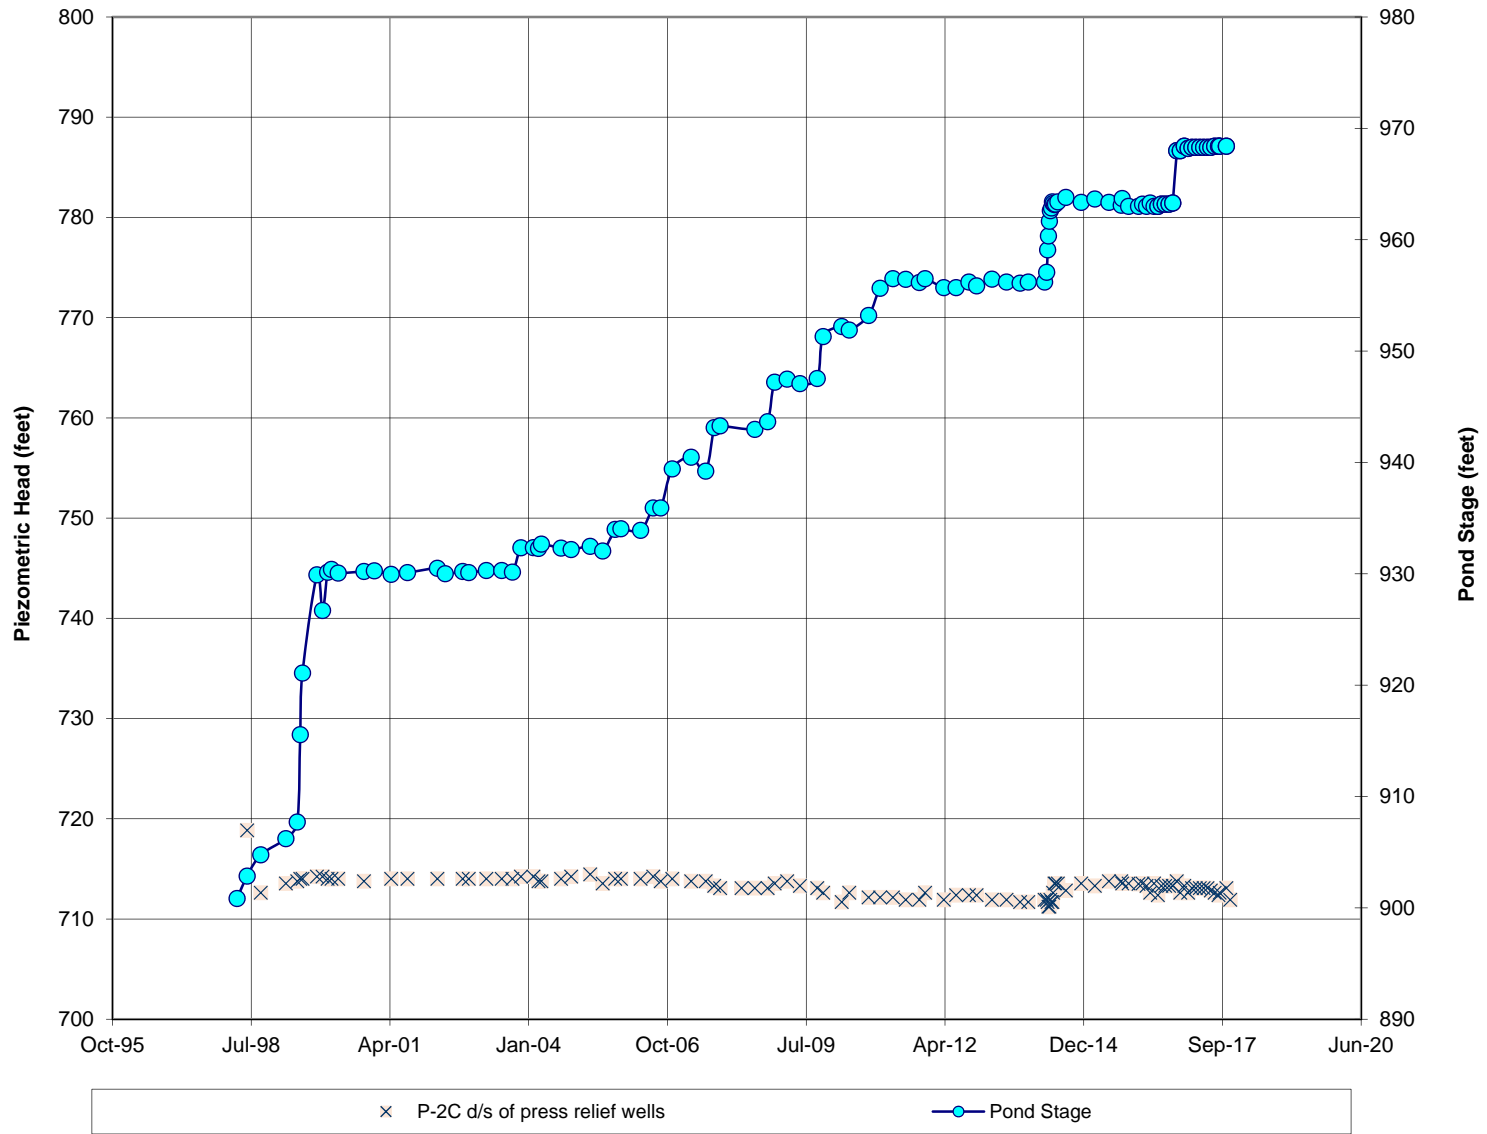
Figure 5k  
Cardinal FAD 2  
Centerline of Dam  
Foundation Piezometers

- Piezometer P-2C, installed within the foundations of the dam show no increase corresponding to raising the pond stage (Figure 5k).
- Two standpipe type piezometers were installed in 2004 into the right bedrock abutment to monitor seepage (FA-7 & FA-8). Both of these piezometers are installed into the Morgantown Sandstone member, a well fractured and jointed, medium to coarse grained sandstone. Piezometer FA-7 also forms a clustered well site with M-11 (also screened within the Morgantown Sandstone) and S-9 (screened in the Connellsville Sandstone). M-10 is located away from the dam site but is also screened within the Morgantown Sandstone and is used to help illustrate the following trends (Figure 5n).
