2018 Annual Landfill Inspection Report

Cardinal Plant Fly Ash Reservoir I Landfill

Project number: 60583548

January 9, 2019

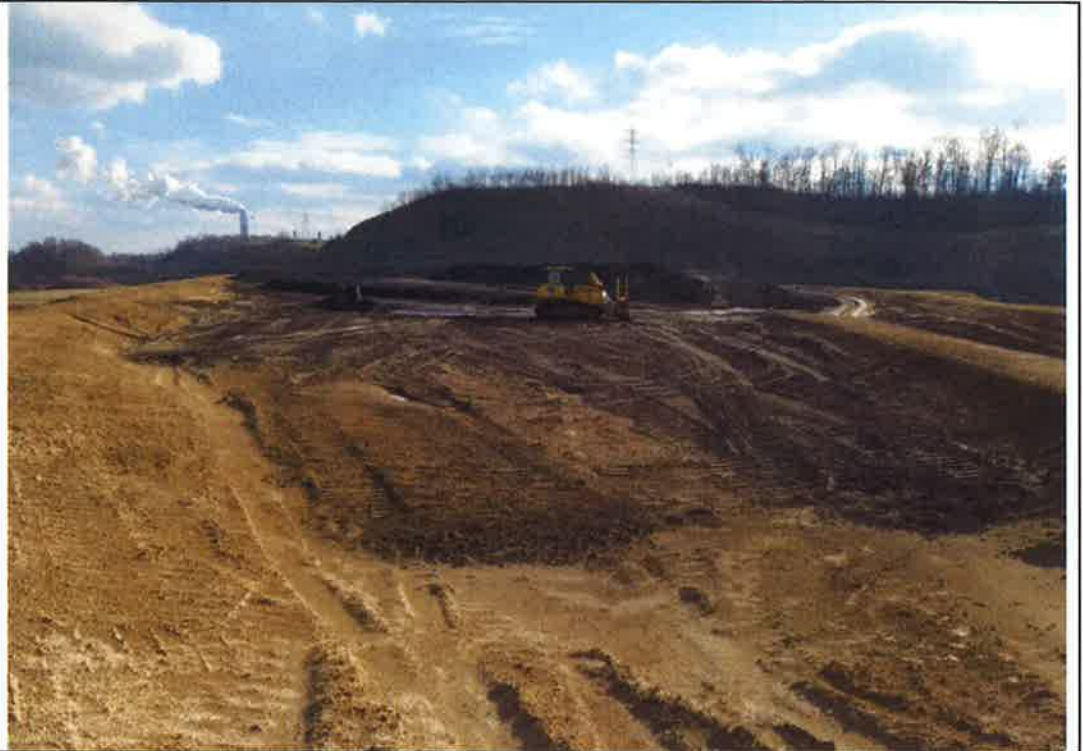
| Photo No. 6 | Date: 12/17/18 |

| Description: Cell 1 southwest corner line. Cell 1&2 waste outer slopes and temporary cover. | |

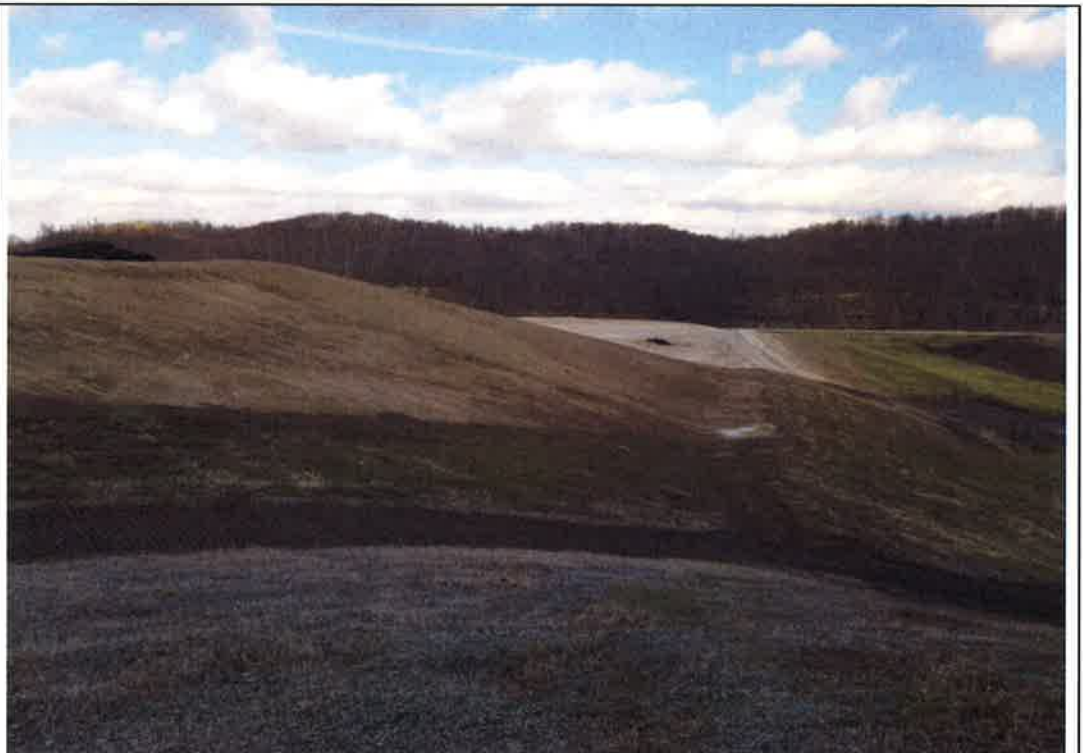
Facility Name:
Cardinal FAR 1 Landfill**Site Location:**
306 County Road 7 East, Brilliant, OH, 43913**Project No.**
60583548**Photo No.**
7**Date:**
12/17/18**Direction Photo Taken:**

Cell 1 west line stabilized highwall conditions.

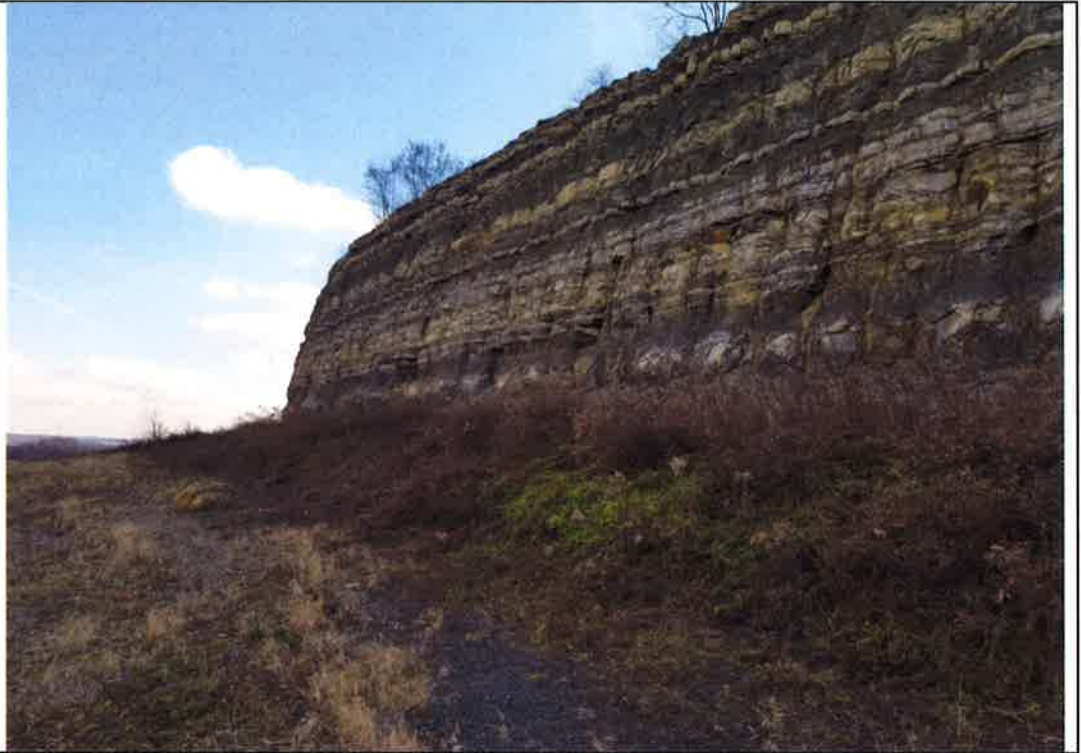
**Photo No.**
8**Date:**
12/17/18**Direction Photo Taken:**

Cell 1 west line waste internal slope conditions.

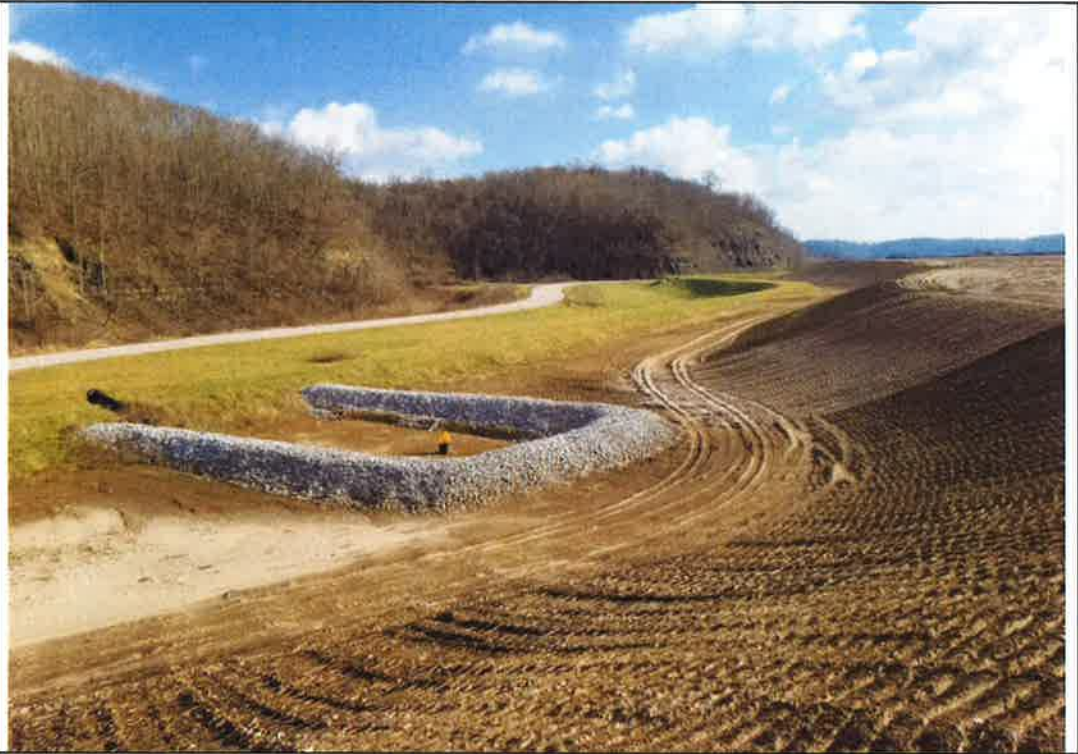
| Photo No. 20 | Date: 12/17/18 |

| Description: Cell 3 active area placement conditions | |

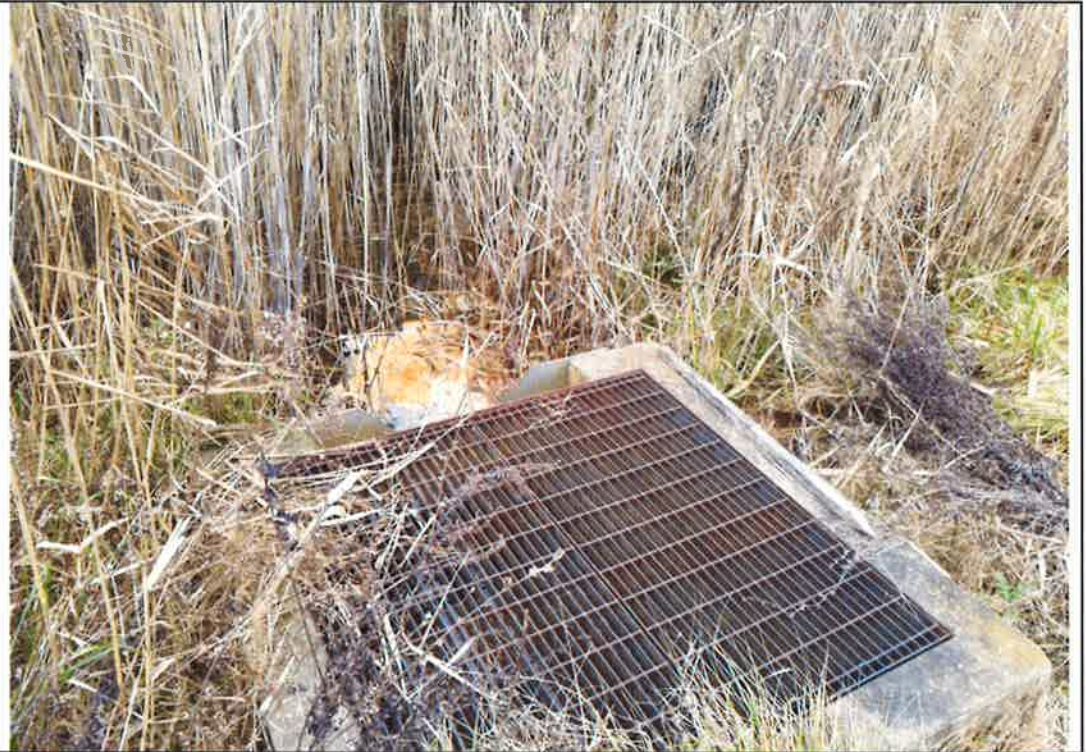
A subsurface drainage layer (SDL) was incorporated in the landfill design to prevent uplift conditions to the landfill liner. The system consists of a SDL 2-foot thick (minimum), a geotextile placed above the SDL as a separator, 6" diameter perforated HDPE subsurface drainage pipes, 6" diameter solid HDPE transmission pipes, and an outfall that discharges to FAR II, as shown in Photograph No. 29 in Appendix B.

Subsurface Drainage Layer outfall in Cell 6.

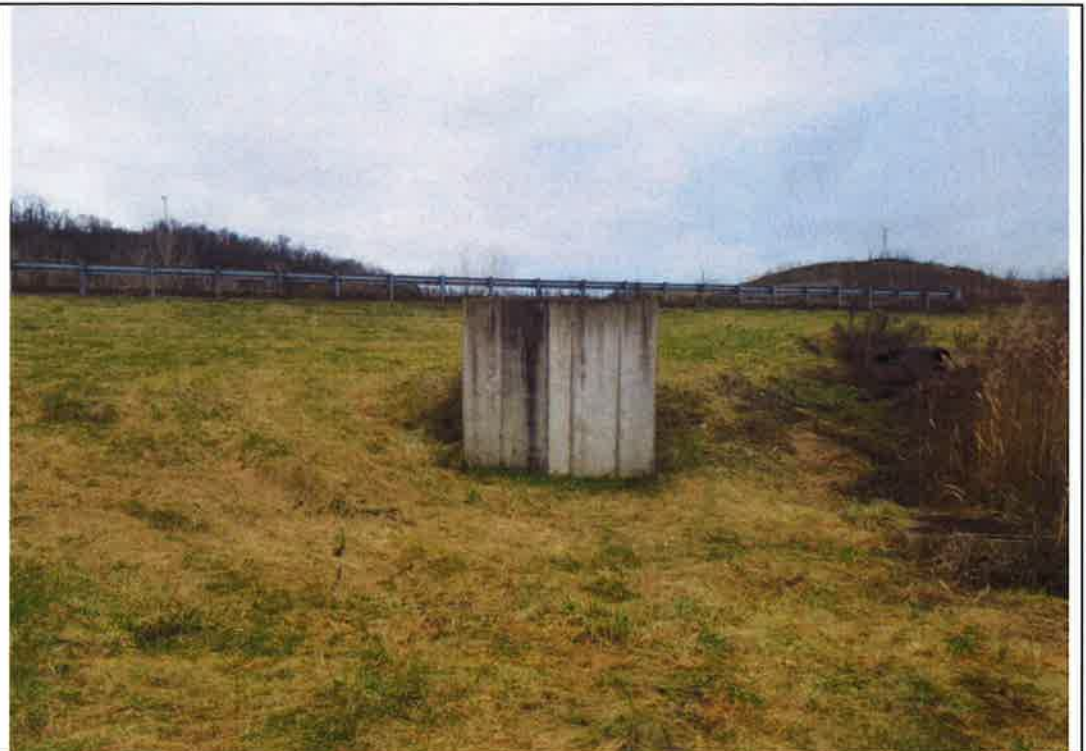
**Photo No.****30****Date:**

Leachate Pretreatment Structure.

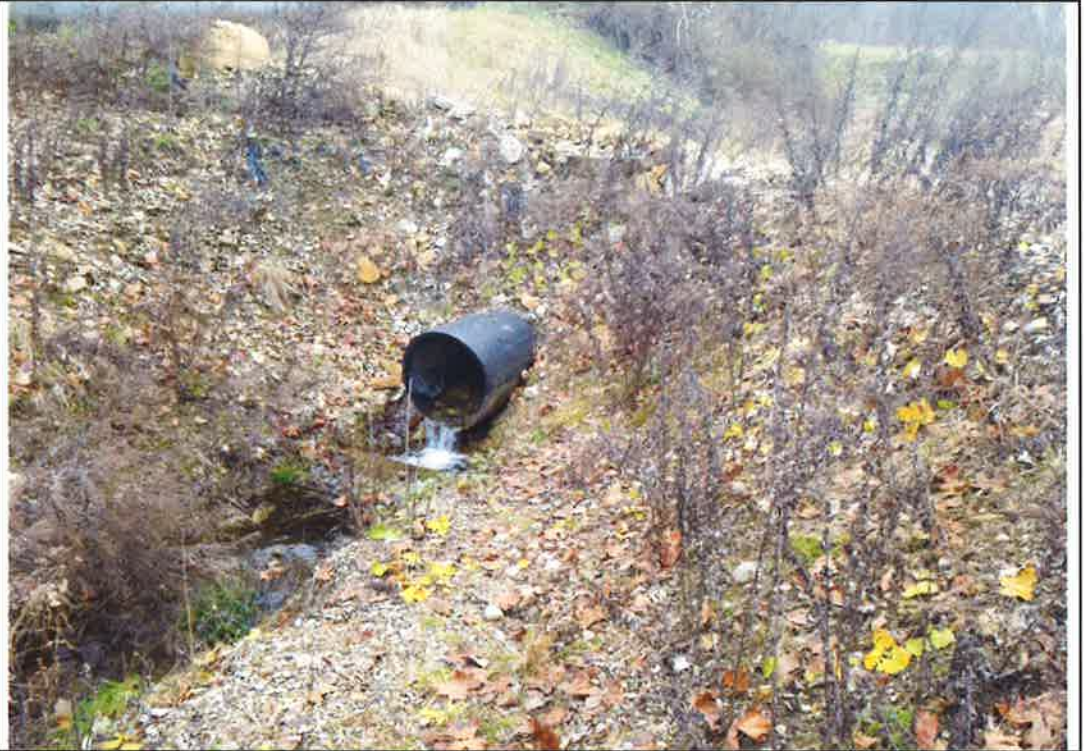
Facility Name:
Cardinal FAR 1 Landfill**Site Location:**
306 County Road 7 East, Brilliant, OH, 43913**Project No.:**
60583548**Photo No.:**
31**Date:**
12/4/18**Direction Photo Taken:**

The leachate collection system at FAR I Landfill was constructed in 2007. The system includes leachate collection materials, collection pipes, risers, a pretreatment structure and an outlet pipe. The landfill Leachate Collection System is graded to drain to the east side of the landfill, the leachate is then routed into leachate collection manholes which are connected by leachate transmission pipe, becoming progressively larger from 24" diameter in the north to 36" diameter at the south end. The Leachate Collection System discharges to FAR II via the 36" nominal diameter HDPE leachate transmission pipe, as shown in Photograph No. 31 in Appendix B.

Cell 5 leachate outfall to FAR II Pond.

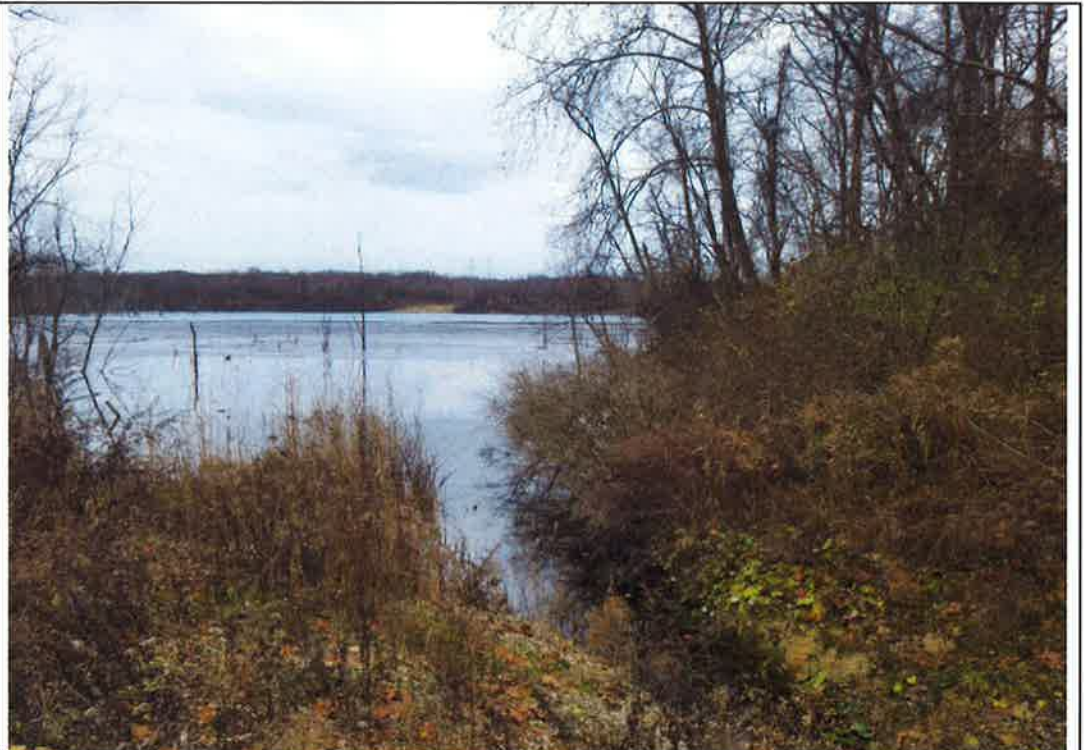
**Photo No.:**
32**Date:**
12/4/18**Direction Photo Taken:**

View of FAR II Pond from Cell 5.

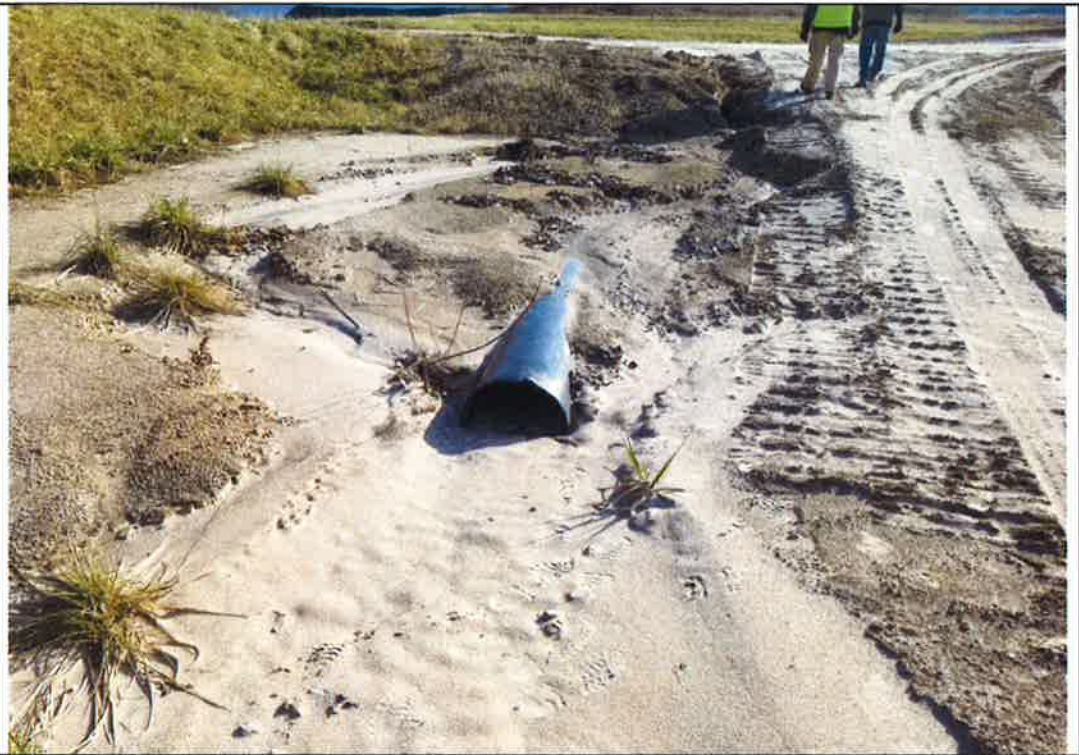
Facility Name:
Cardinal FAR 1 Landfill**Site Location:**
306 County Road 7 East, Brilliant, OH, 43913**Project No.:**
60583548**Photo No.:**
33**Date:**
12/17/18**Direction Photo Taken:**

It was also noted that a stormwater drainage pipe in the southeast corner of Cell 3 is partially obstructed by silt deposits. There are no signs of erosion or instability; however, the Cardinal Operating Company staff has been notified and will remove the silt as soon as practical. See Photo No. 33 of Appendix B.

Surface water drainage pipe at the southeast corner of Cell 3 shows signs of silt deposit.

1. Remove the sediment deposited near the stormwater pipe in the southeast corner of Cell 3 as shown in Photo No. 33 of Appendix B.

Plant staff notified and will remove silt as part of regular maintenance.

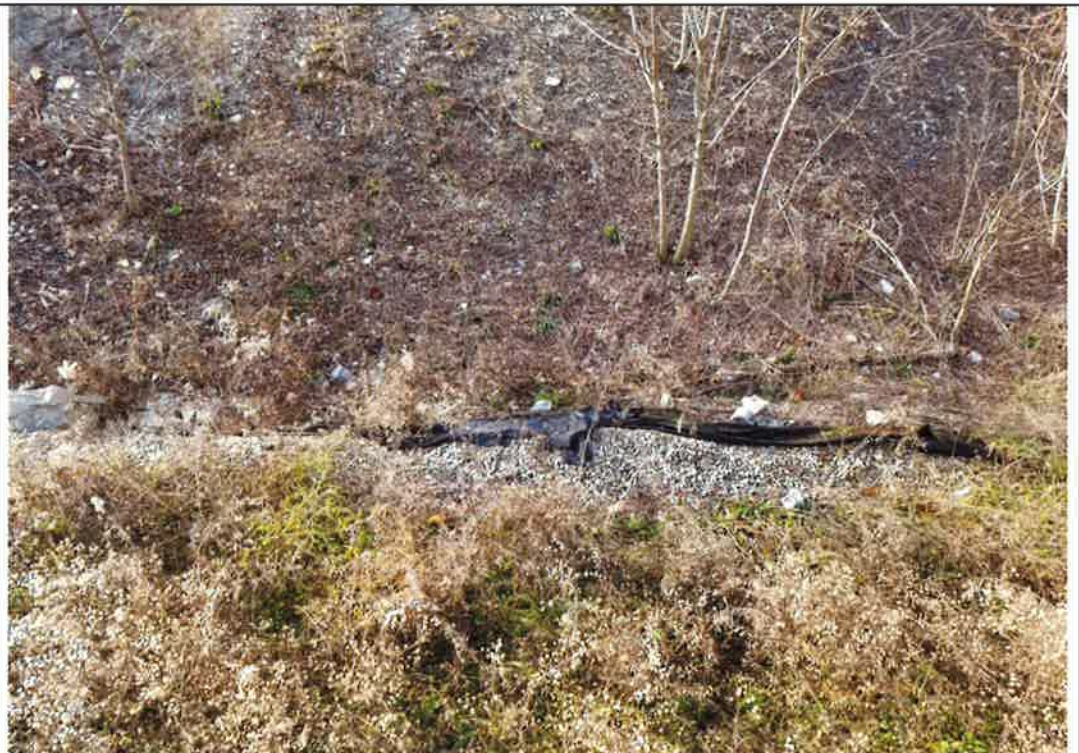
**Photo No.:**
34**Date:**
12/17/18**Direction Photo Taken:**

Highwall seepage collection piping at the toe of highwall. Noted minor sparse vegetative cover at the north end.
