Landfill Inspection Report Fly Ash Reservoir Landfill

GERS-17-013

CARDINAL PLANT BRILLIANT, OHIO

INSPECTION DATE May 24, 2017

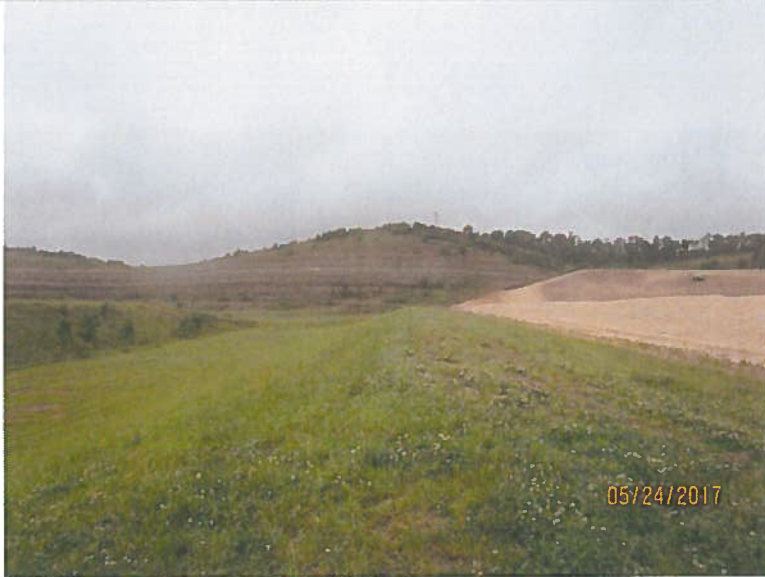
Photo No. 1

Parts of the landfill's constructed areas that are currently active showed no significant erosional activity. Parts of the landfill's constructed areas that are currently inactive slopes (Cell 1/2 line- see photos 5 and 6) have a temporary cover of cohesive soil showed minor erosion. Parts of the landfill's constructed areas that are currently inactive (other than Cell 1/2 line) have been treated with an approved polymer to prevent or reduce erosion. The vegetation growth along the downstream slopes of the earthen berms was in good conditions (See photos 1, 2, 23 and 23).

Cell 3 South east corner Looking West from Crest.

Overview of General Condition

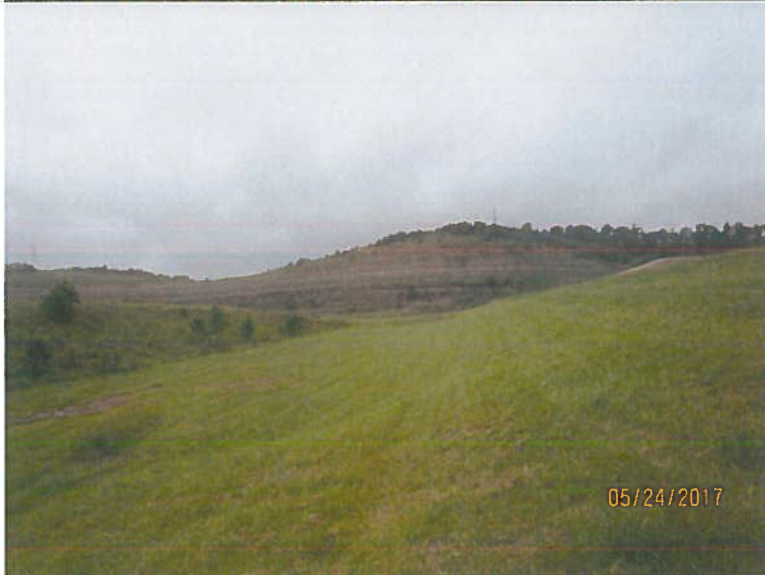
Photo No. 2

Cell 3 South east corner Looking West from Middle slope.

Overview of General Condition

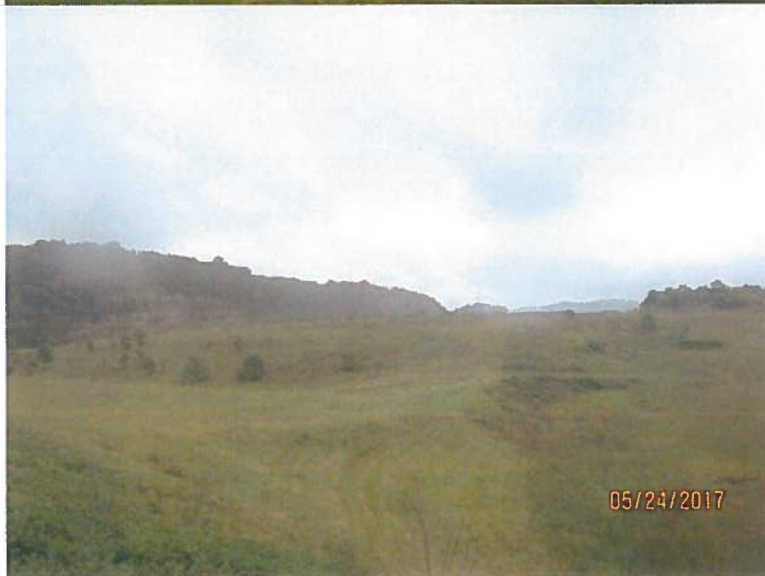
Photo No. 3

Cell 1/3 South Line Looking South.

Preload in Cell 4 and 5

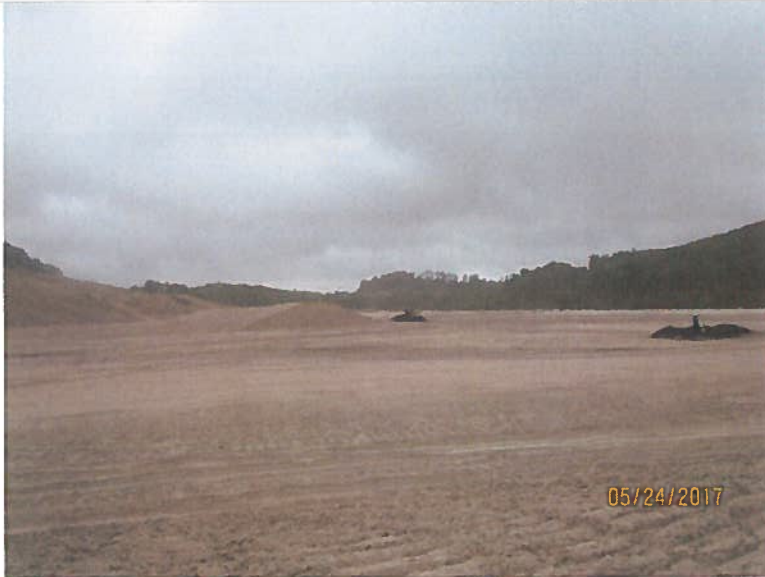
Photo No. 4

Cell 3 South Line Looking North.

Active placement area in Cell 3

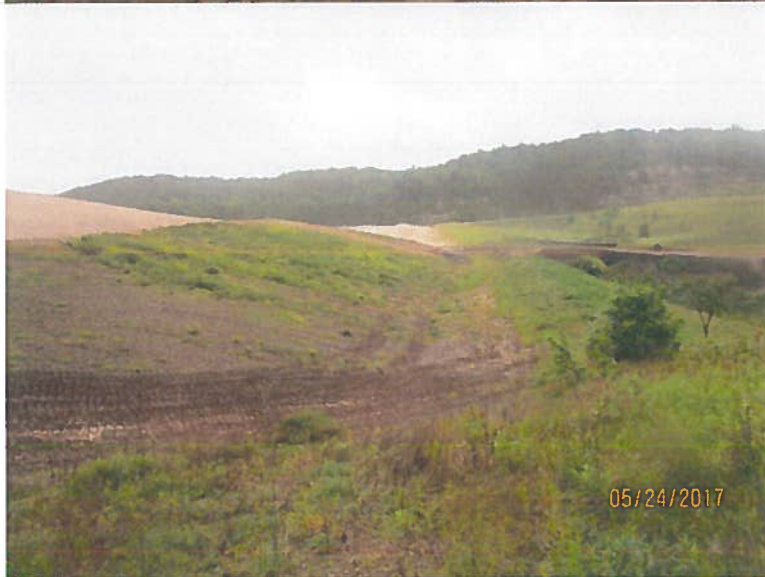
Photo No. 5

Cell 1 Southwest corner Line
Looking East.

Cell 1/2 Berm and temporary
cover.

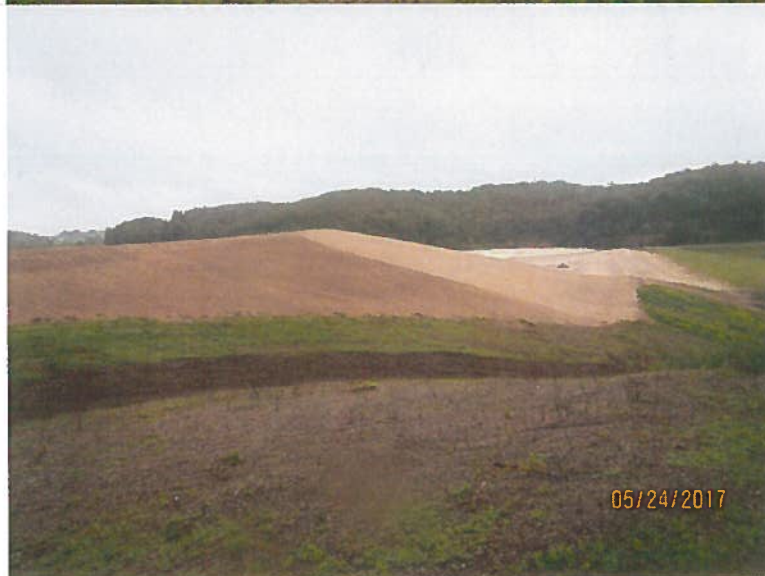
Photo No. 6

Cell 1 Southwest corner Line
Looking East.

Cell 1/2 Waste outer slopes and
temporary cover

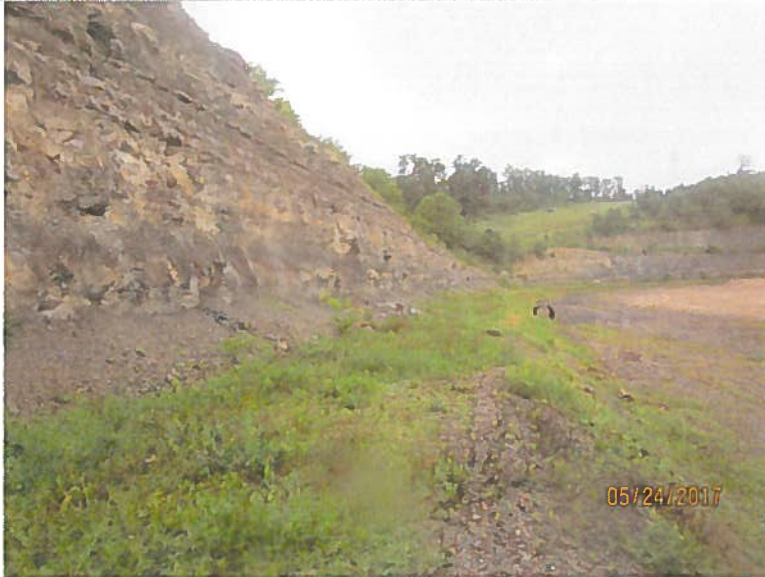
Photo No. 7

Cell 1 West Line Looking North.

Stabilized highwall conditions

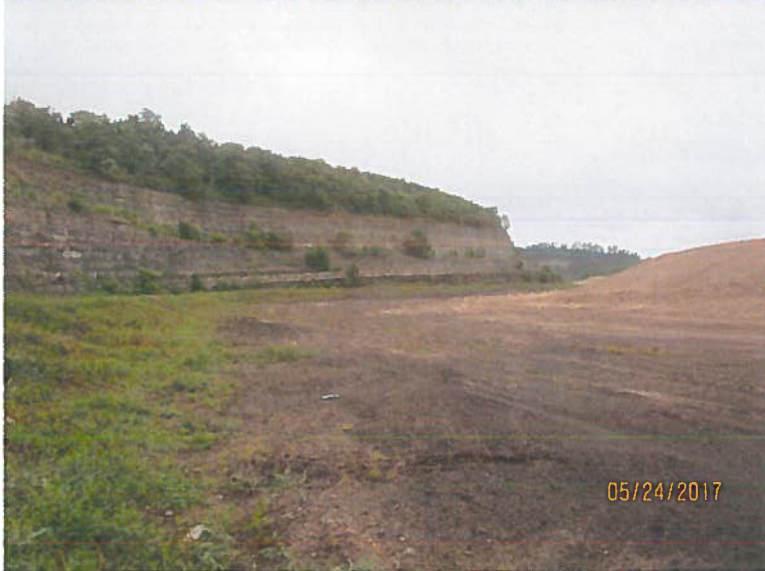
Photo No. 8

Cell 1 West Line Looking North.

Waste Internal slopes conditions

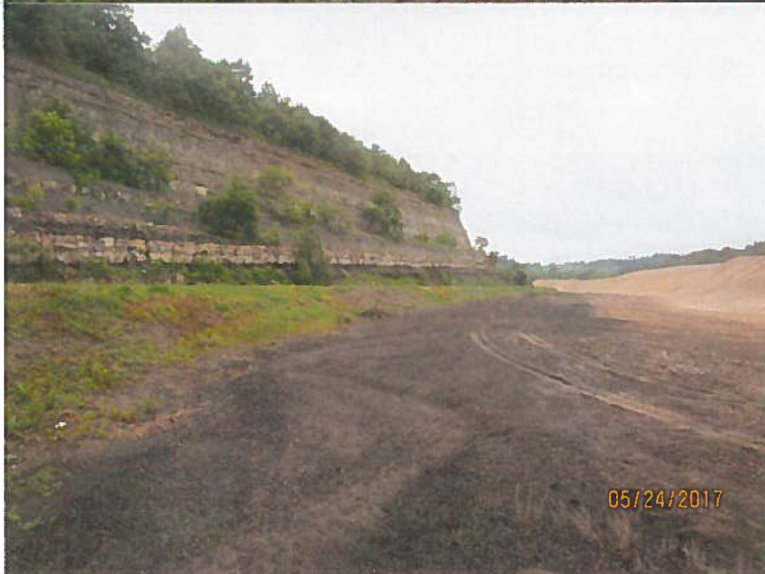
Photo No. 9

Cell 1 West Line Looking North.

Stabilized highwall conditions

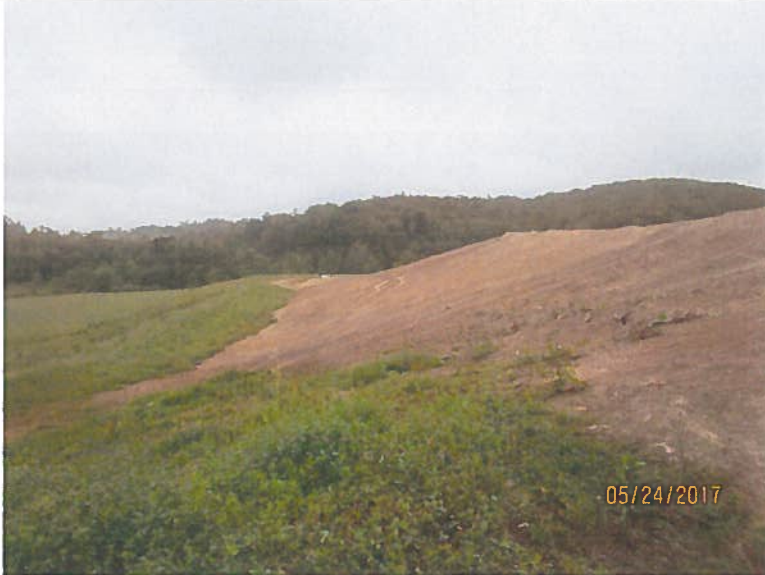
Photo No. 10

Cell 1 Northwest Line Looking East.

Closed Area conditions/Waste outer slopes conditions

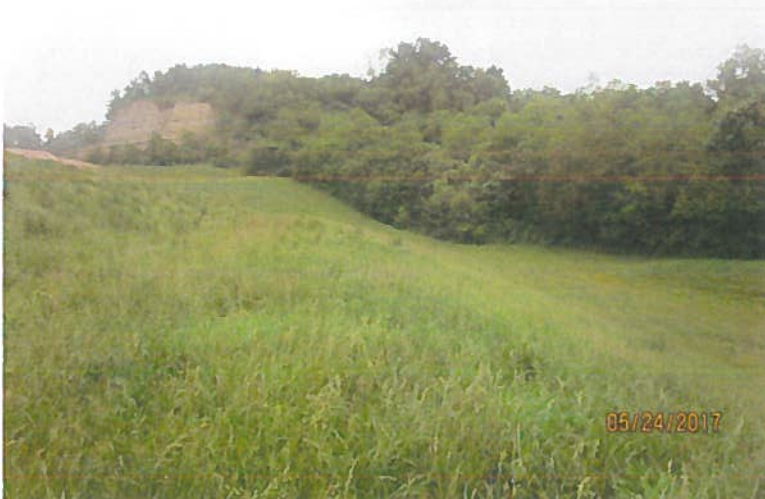
Photo No. 11

Cell 1/3 Line North crest Looking West.

Closed Area conditions

Limited area missed during the recent mowing cycle.

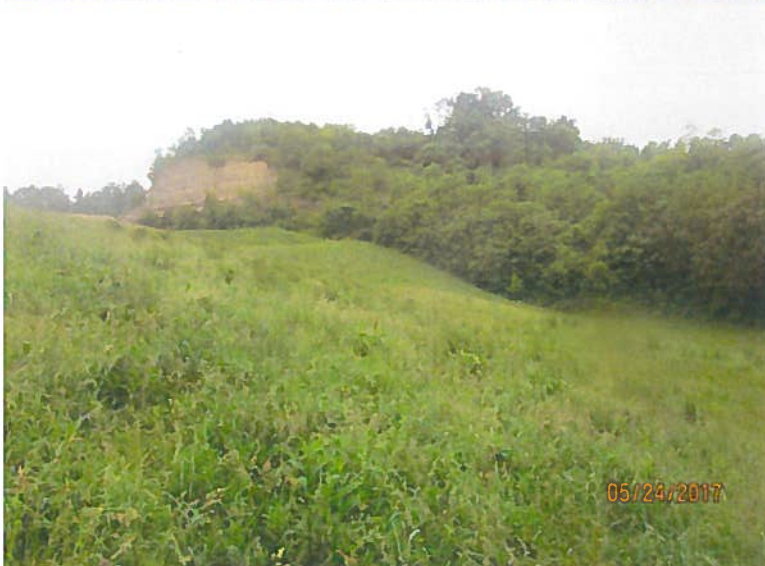
Photo No. 12

Cell 1/3 Line North Looking West.

Closed Area conditions

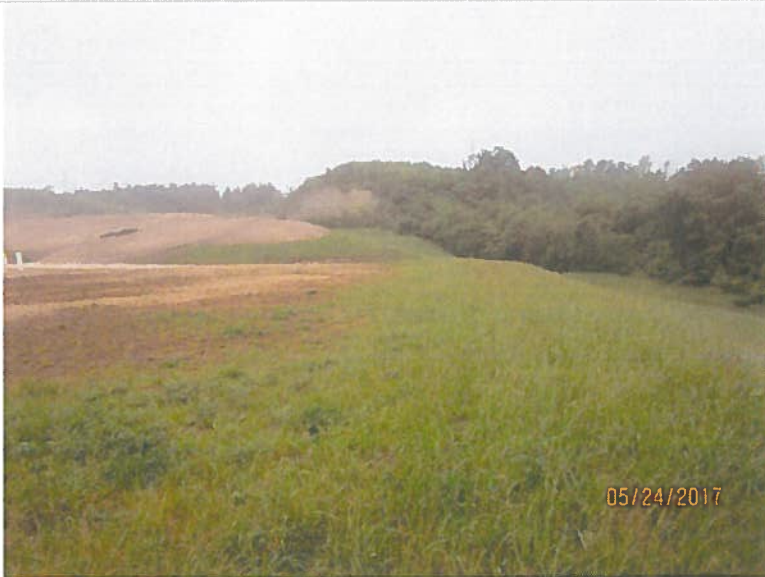
Photo No. 13

Cell 3 Northeast corner crest
Looking West.

Closed Area conditions

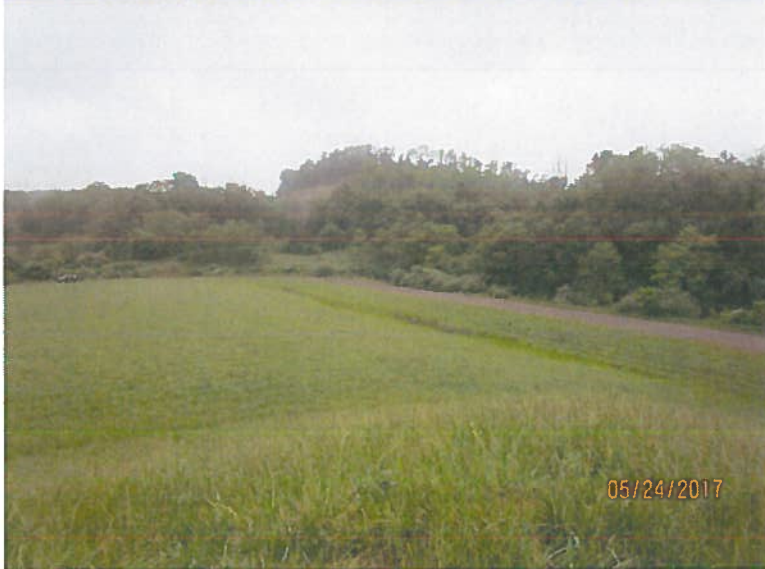
Photo No. 14

Cell 3 Northeast corner crest
Looking Northeast.

Closed Area conditions

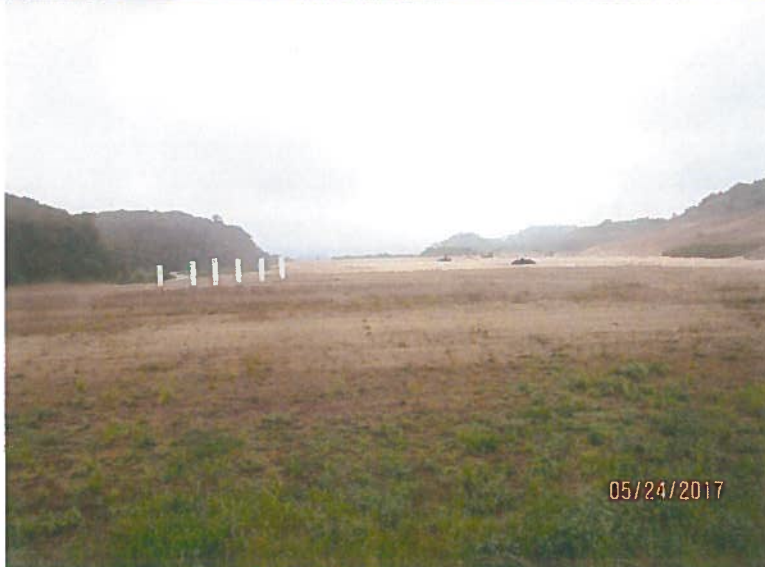
Photo No. 15

Cell 3 Northeast crest Looking
South.

Cell 3 North Placement Area
Conditions Including Raised
monitoring wells

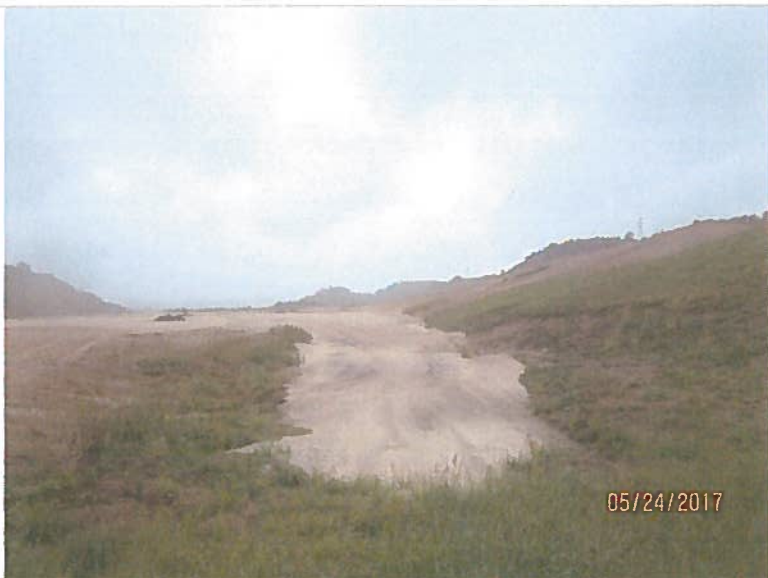
Photo No. 16

Cell 1/3 Line North crest Looking South.

Cell 1/3 Line

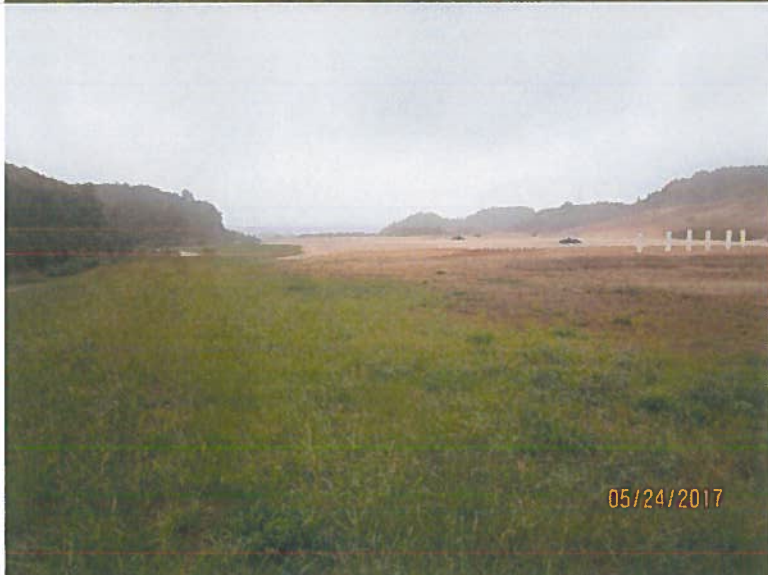
Photo No. 17

Cell 3 Northeast corner crest Looking South.

Berm Crest Conditions

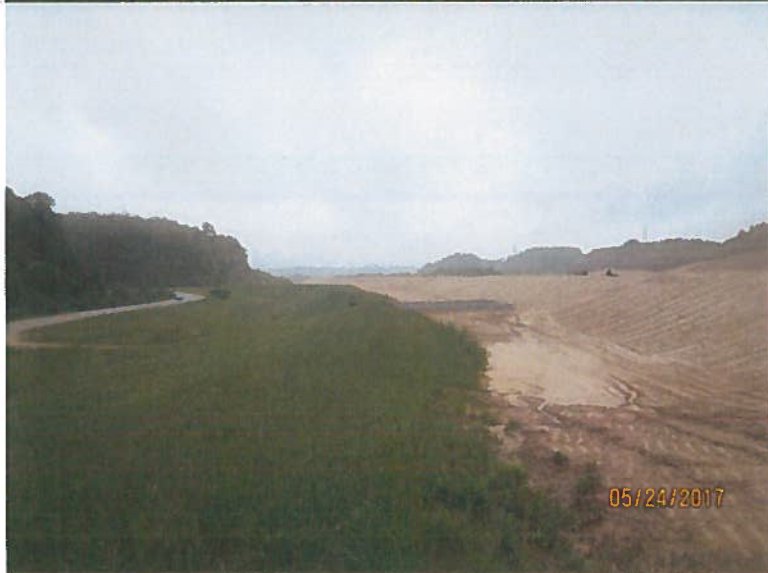
Photo No. 18

Cell 3 Northeast corner crest Looking South.

Active area Placement Conditions

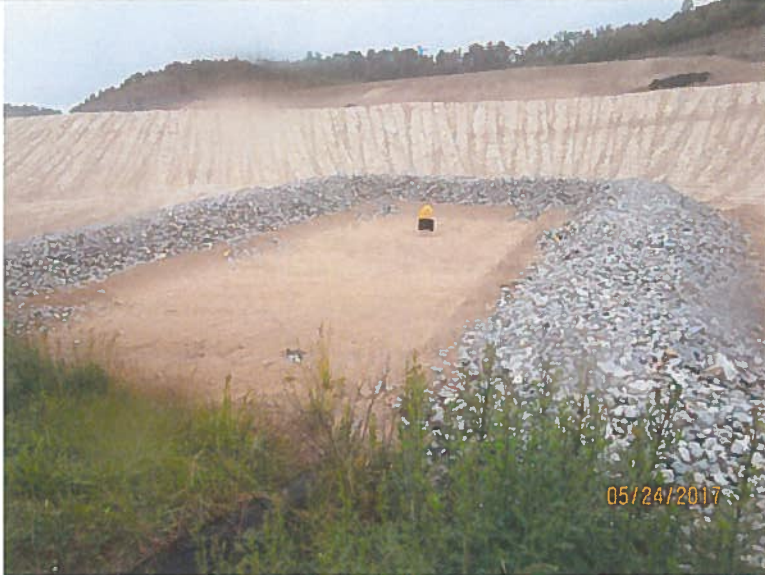
Photo No. 19

Cell 3 Center of North Swale
Looking West.

Active area Placement Conditions

Recently improved inlet.

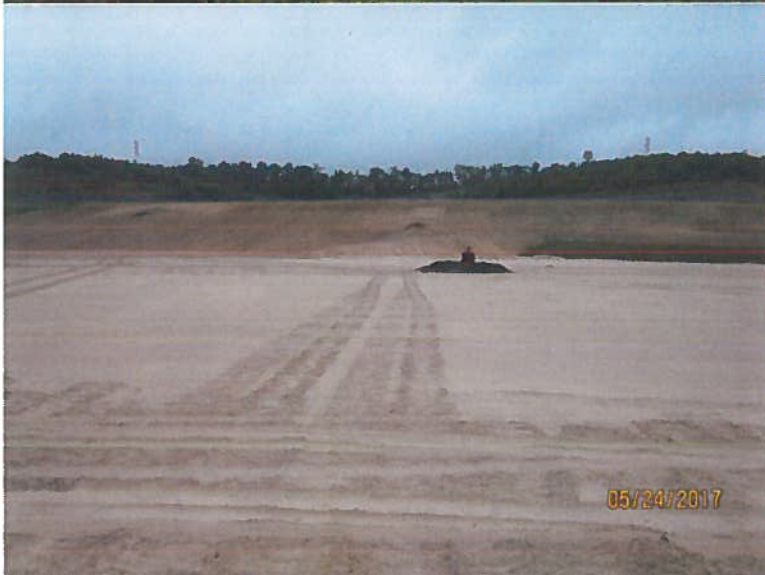
Photo No. 20

Cell 3 North/South Dividing Line
Looking West.

Active area Placement Conditions
showing Chimney Drain

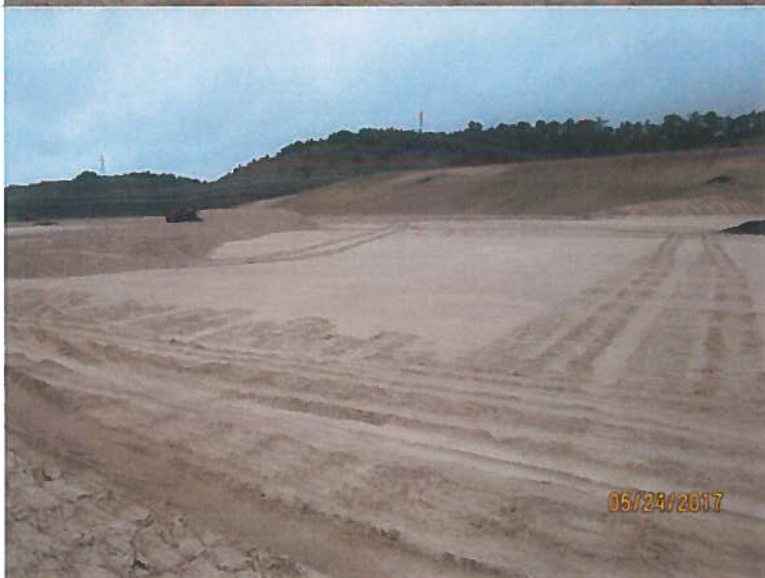
Photo No. 21

Cell South Looking West.

Active area Placement Conditions
showing Chimney Drain

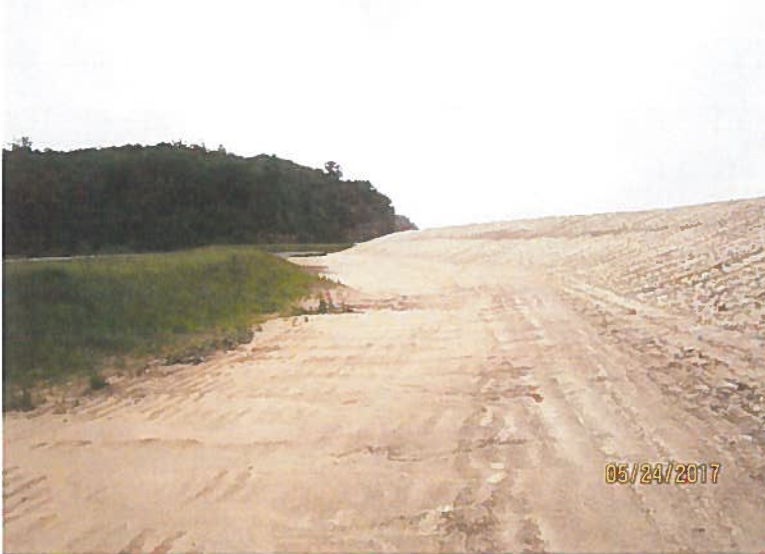
Photo No. 22

Cell 3 North/South Dividing Line
Looking South.

Outer slopes of Active area
Placement Conditions

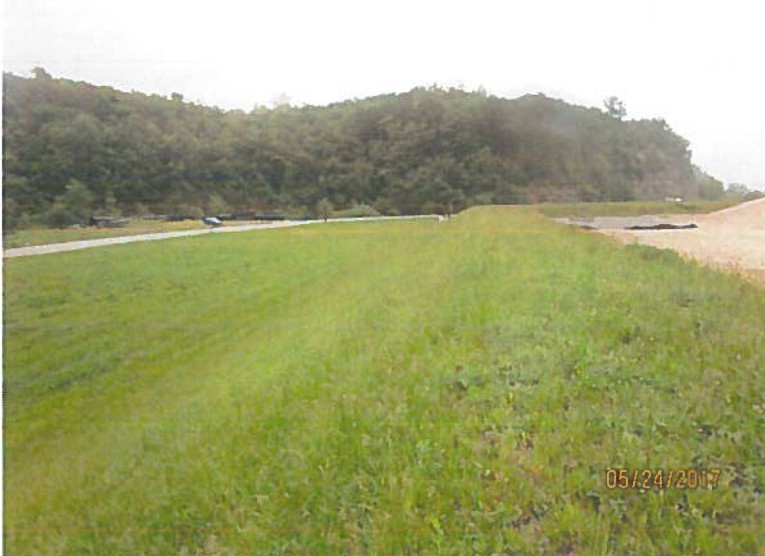
Photo No. 23

Cell 3 North/South Dividing Line
Looking South.

Outer slopes of External Berm
Conditions

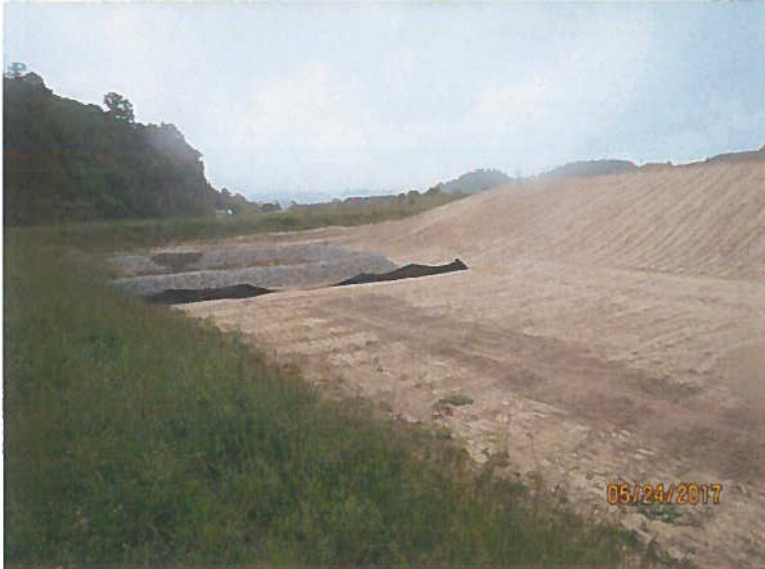
Photo No. 24

Cell 3 South Swale Line Looking
South.

Outer slopes of Active area
Placement Conditions

Recently improved inlet.

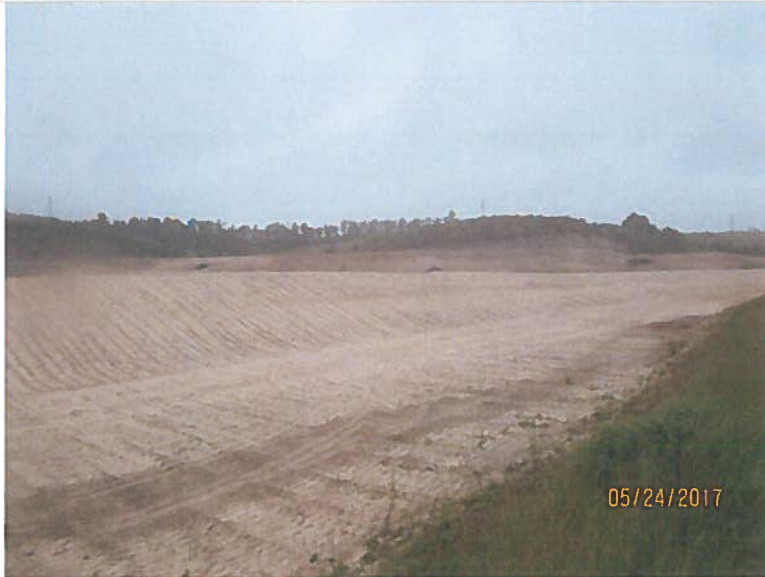
Photo No. 25

Cell 3 South Swale Line Looking North.

Outer slopes of Active Placement Area and External Berm Conditions ✓

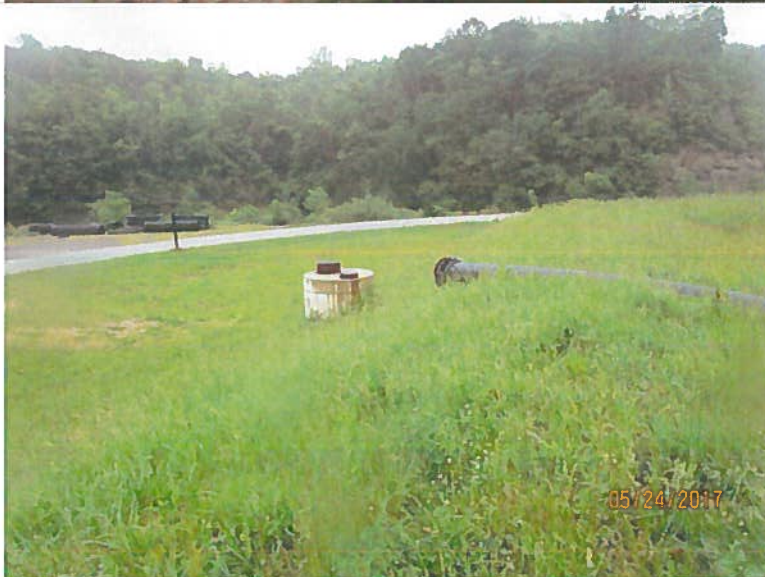
Photo No. 26

Cell 3 South Swale Line Looking South.

Manhole #2 and External Berm Conditions

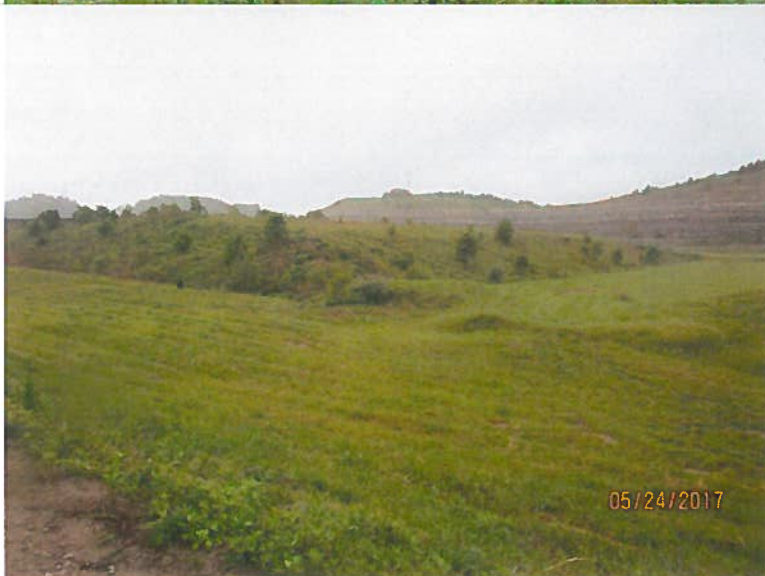
Photo No. 27

Future Cell 3/4 West Line Looking South west.

Preload

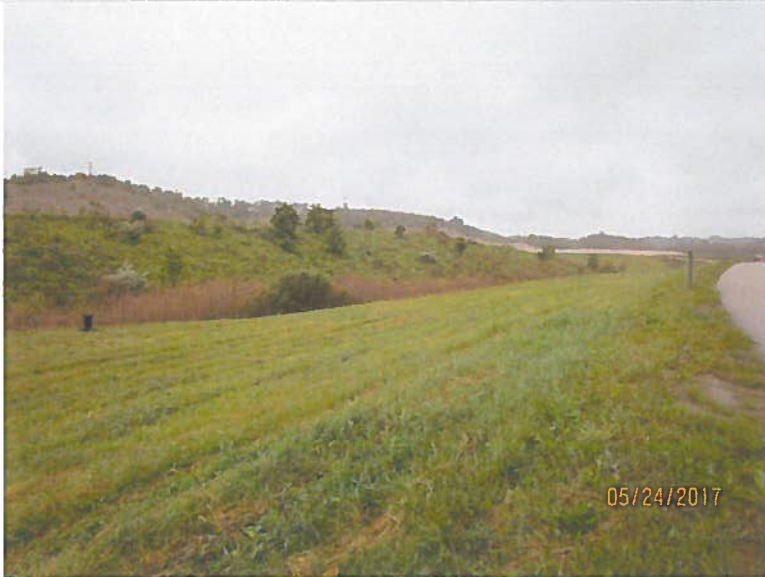
Photo No. 28

Cell 3 Southeast Corner Looking North.

Preload in Cell 4 and 5

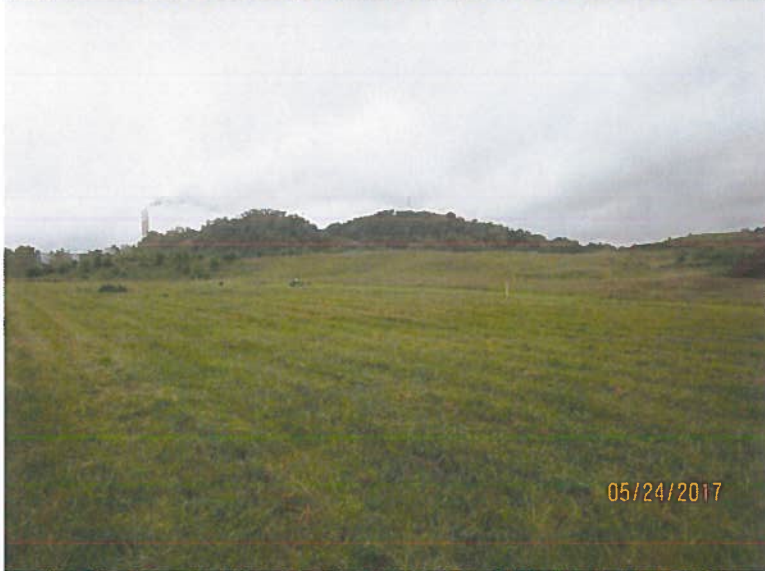
Photo No. 29

Future Cell 5/6 West Line Looking Southwest.

Clay Stockpile in cell 5 and 6

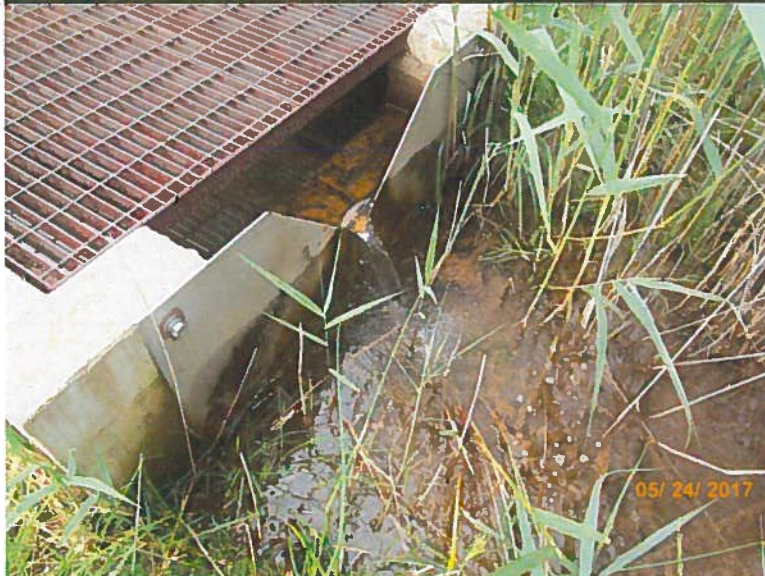
Photo No. 30

Cell 6 East Looking West.

Subsurface Drainage Layer outfall

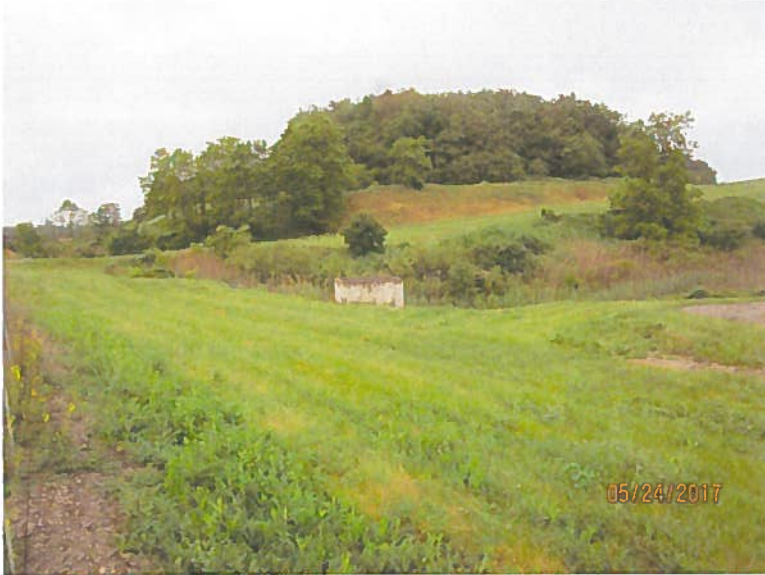
Photo No. 31

Cell 6 East Looking East.

Leachate Pretreatment Structure

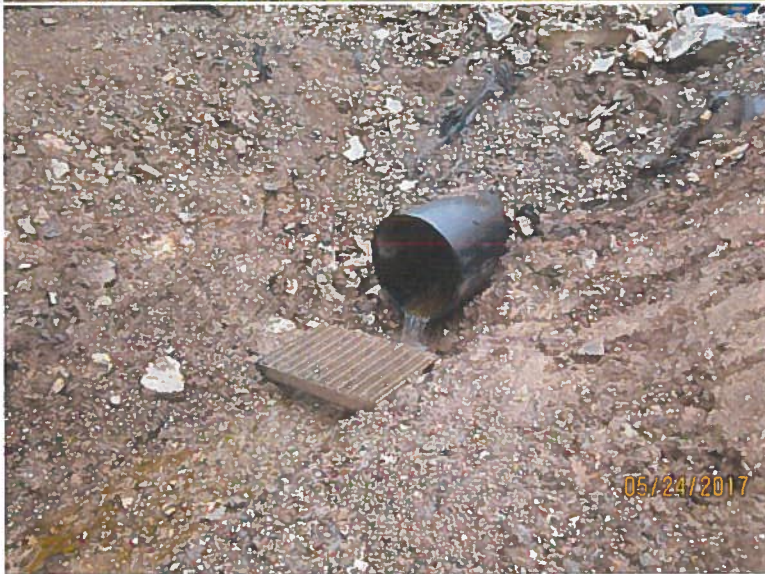
Photo No. 32

Cell 5 East Looking West.

Leachate outfall to FAR II Pond

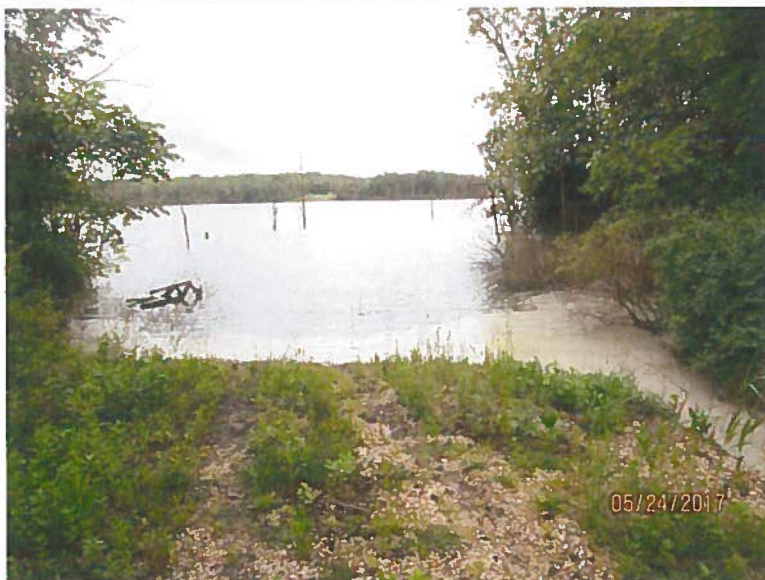
Photo No. 33

Cell 5 East Looking West.

FAR II Pond
