2018 Annual Dam and Dike Inspection Report

Cardinal Plant Fly Ash Dams 1, 2 & Bottom Ash Complex

Project number: 60583548

January 9, 2019

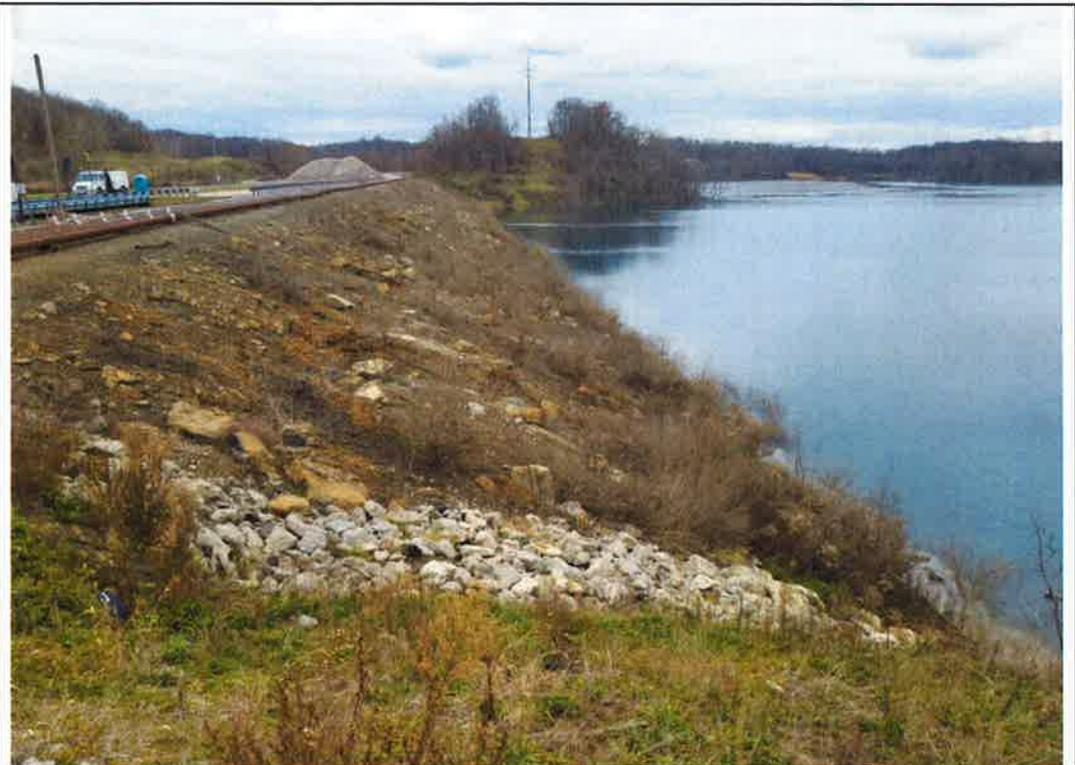
2. The downstream dam surface is sparsely vegetated (brushy vegetation), but is covered with rock fill material. The rock fragments are broken up or deteriorating in some cases, but the material is still protecting the surface of the dam. Overall, the rock fill protection is in fair condition (Photograph No. 1 and 2).

Photo No. 1	Date: 12/4/18
Direction Photo Taken: East	
Description: View of the downstream slope of the FAR 1 dam. The surface water discharge pipe crushed concrete erosion control at the right groin is shown at the bottom of the photo.

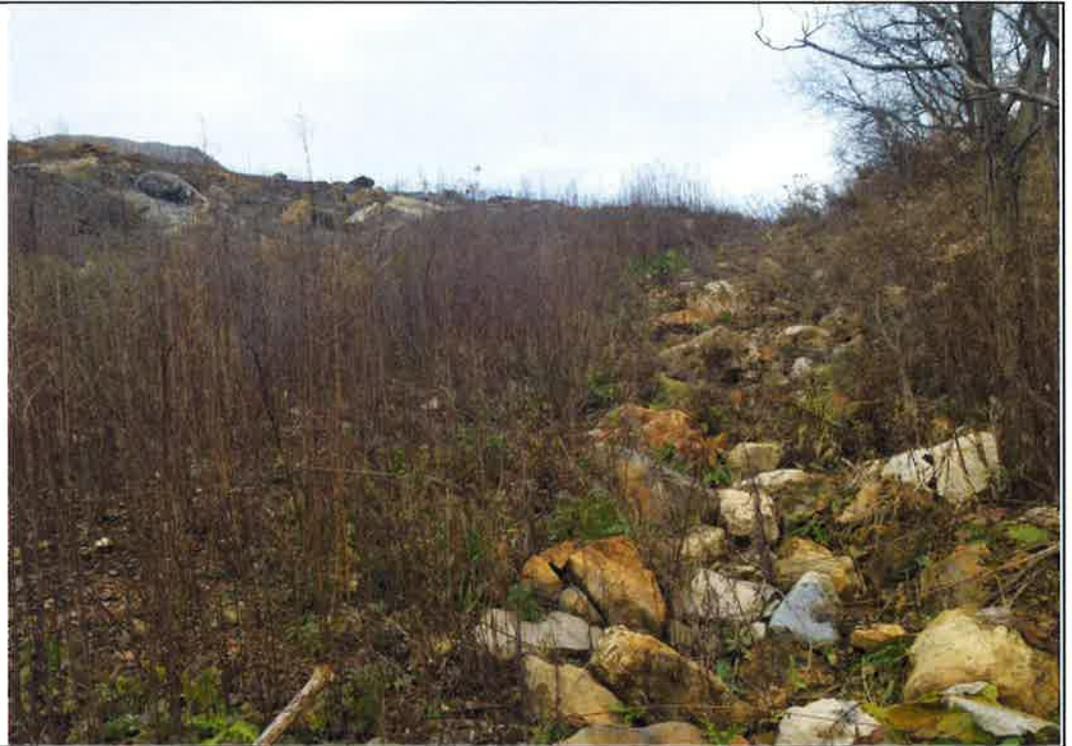
6. No woody vegetation was observed on the downstream slope.
7. No significant erosion was observed along the groin areas of the downstream slope (Photograph No. 1, 3 and 4). Both right and left abutments are protected with rock fill/rip-rap that is in good condition. Some brush was present near the right abutment of the dam, and some small trees were present near (not on) the left abutment.

Impoundment Name:
Cardinal Fly Ash Dam 1**Site Location:**
306 County Road 7 East, Brilliant, OH, 43913**Project No.**
60583548**Photo No.**
3**Date:**
12/4/18**Direction Photo
Taken:**
North**Description:**
View of rip rap let down at
the left groin area looking
upslope.

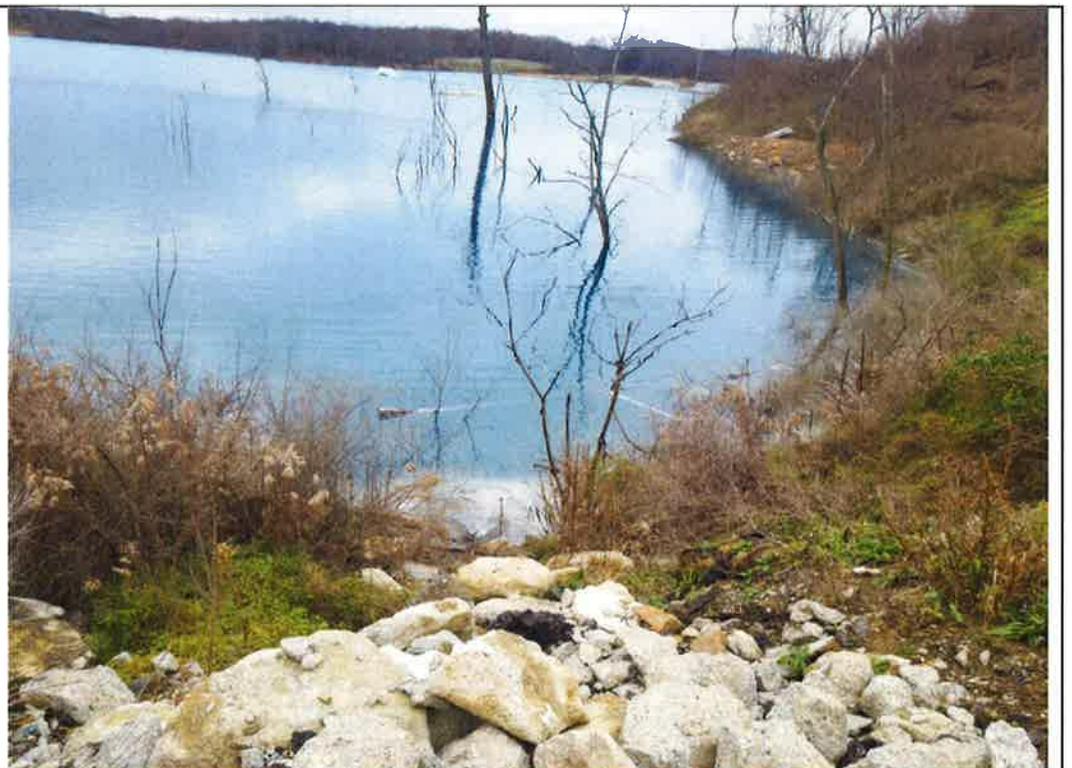
**Photo No.**
4**Date:**
12/4/18**Direction Photo
Taken:**
South**Description:**
Typical view of the right
groin area of the FAR 1
dam.

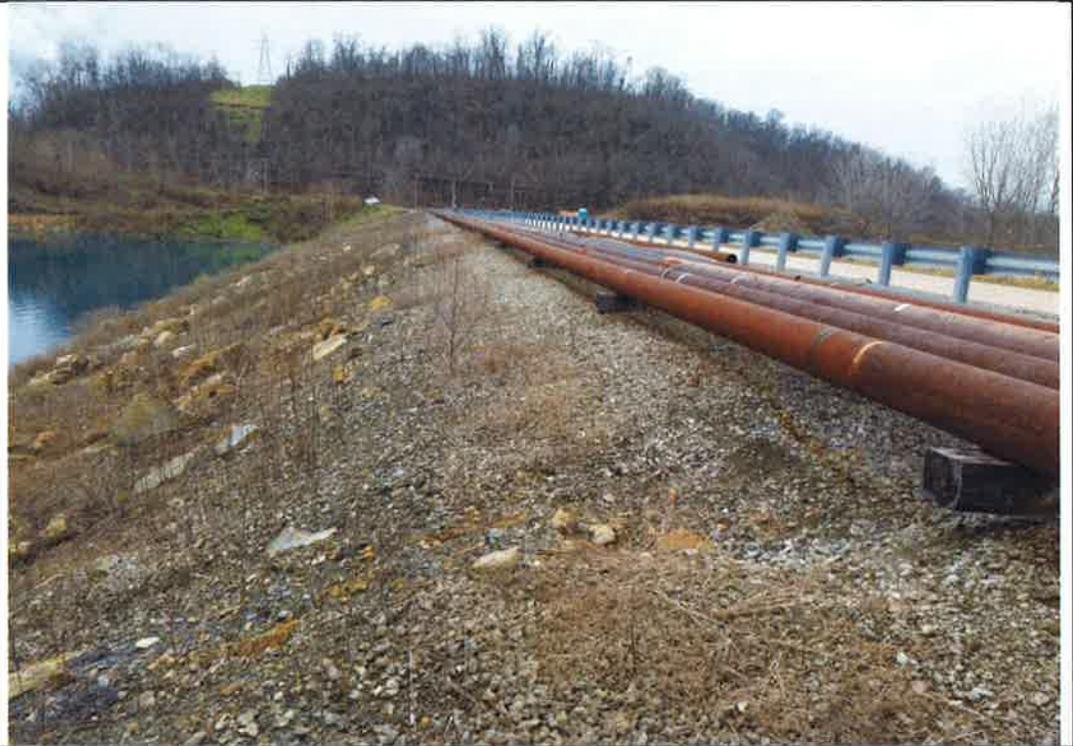
1. The crest of the dam was in good condition, with no signs of significant erosion, rutting, or misalignment (Photograph No. 5). The crest of the dam supports a heavy duty concrete roadway that is accessed by haul trucks. The roadway was in good condition.

Impoundment Name:
Cardinal Fly Ash Dam 1**Site Location:**
306 County Road 7 East, Brilliant, OH, 43913**Project No.**
60583548**Photo No.**
5**Date:**
12/4/18**Direction Photo
Taken:**
West**Description:**
View of the ash discharge
pipes along the crest of
the FAR 1 dam.

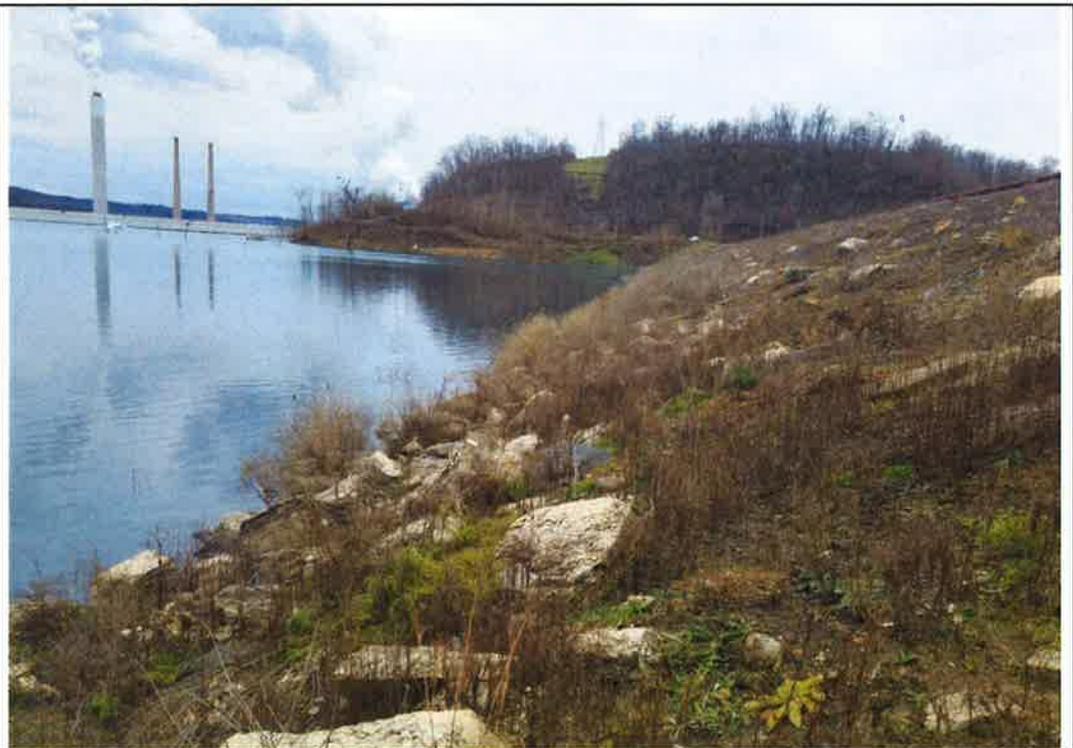
**Photo No.**
6**Date:**
12/4/18**Direction Photo
Taken:**
West**Description:**
View of downstream slope
of FAD I.

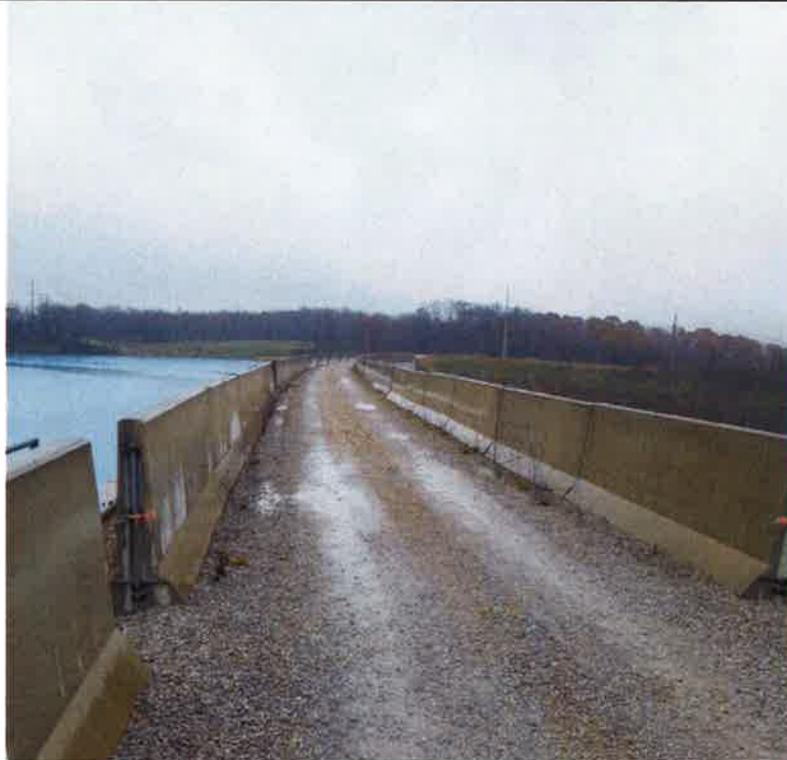
View of the access road along the crest of dam looking east. The dam crest appeared in good condition with no signs of settlement, misalignment, rutting, or erosion.

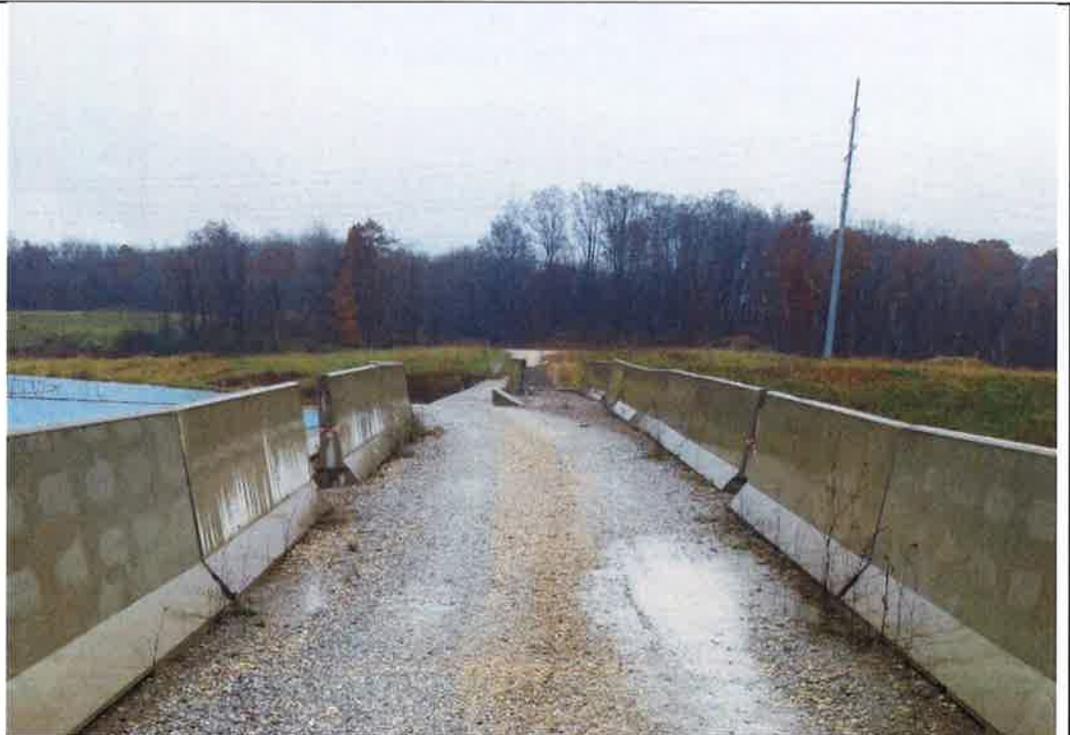
Photo No.
2

View of the crest area looking east. The dam crest appeared in good condition with no signs of settlement, misalignment, rutting, or erosion.

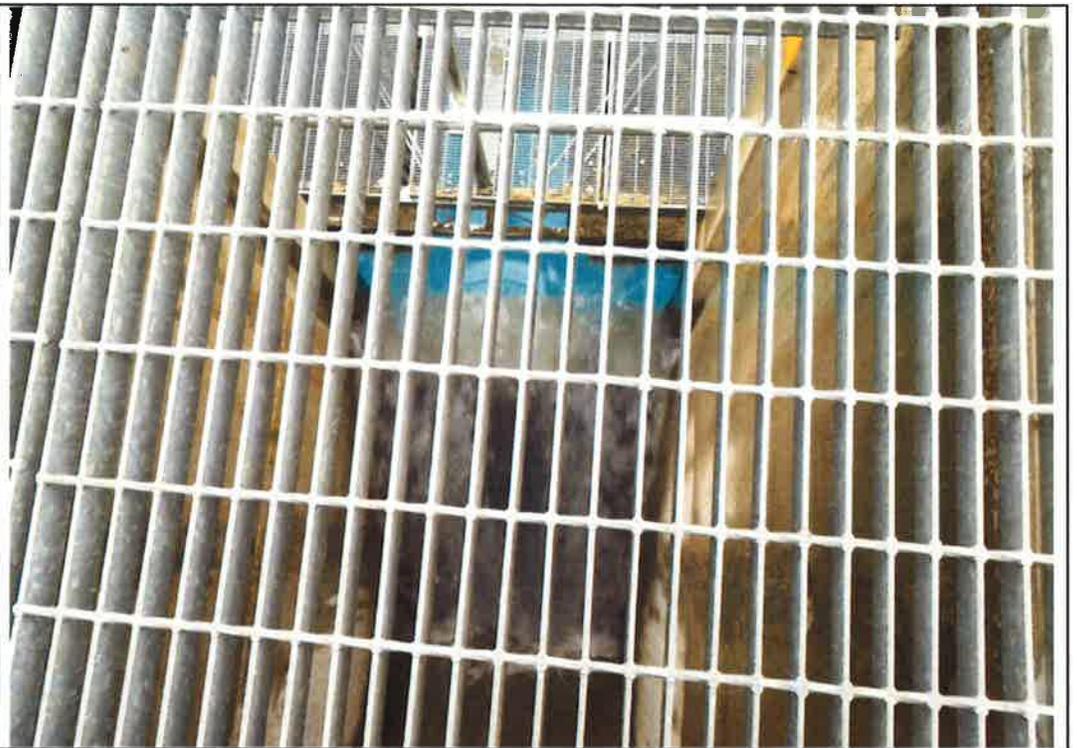
Photo No. 3	Date: 11/20/18
Direction Photo Taken: N/A	
Description: View of the unobstructed stoplog primary spillway. Note metal bar grating is in good condition

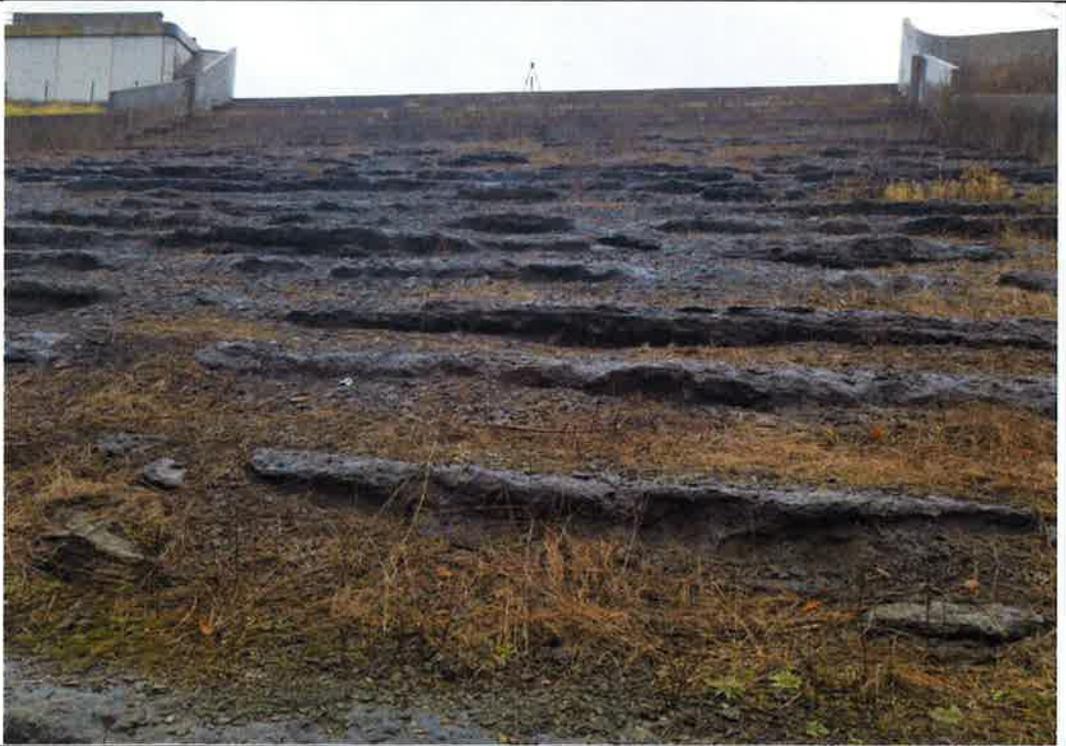
Direction Photo Taken: North		
Description: View of the Concrete and RCC emergency spillway discharge channel steps. The steps have weathered since construction and are monitored per ODNR inspection comment.

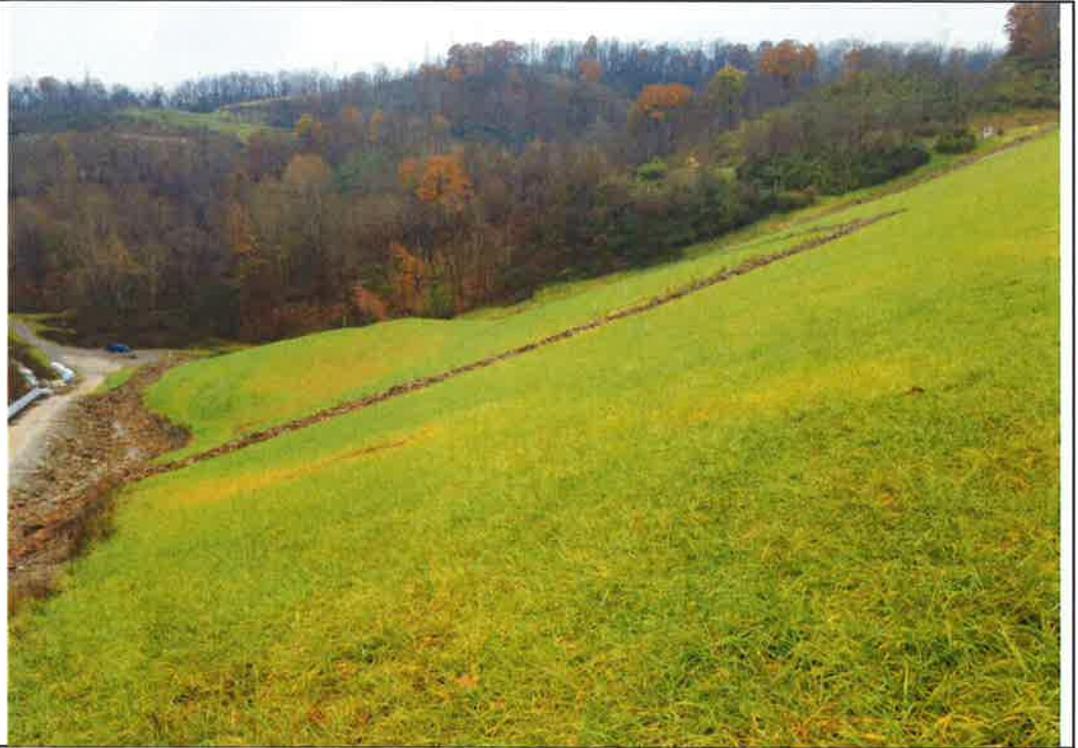
Photo No. 13	Date: 11/20/18
Direction Photo Taken: South west	
Description: View of the downstream slope. Showing good vegetative cover and no signs of erosion or instability.

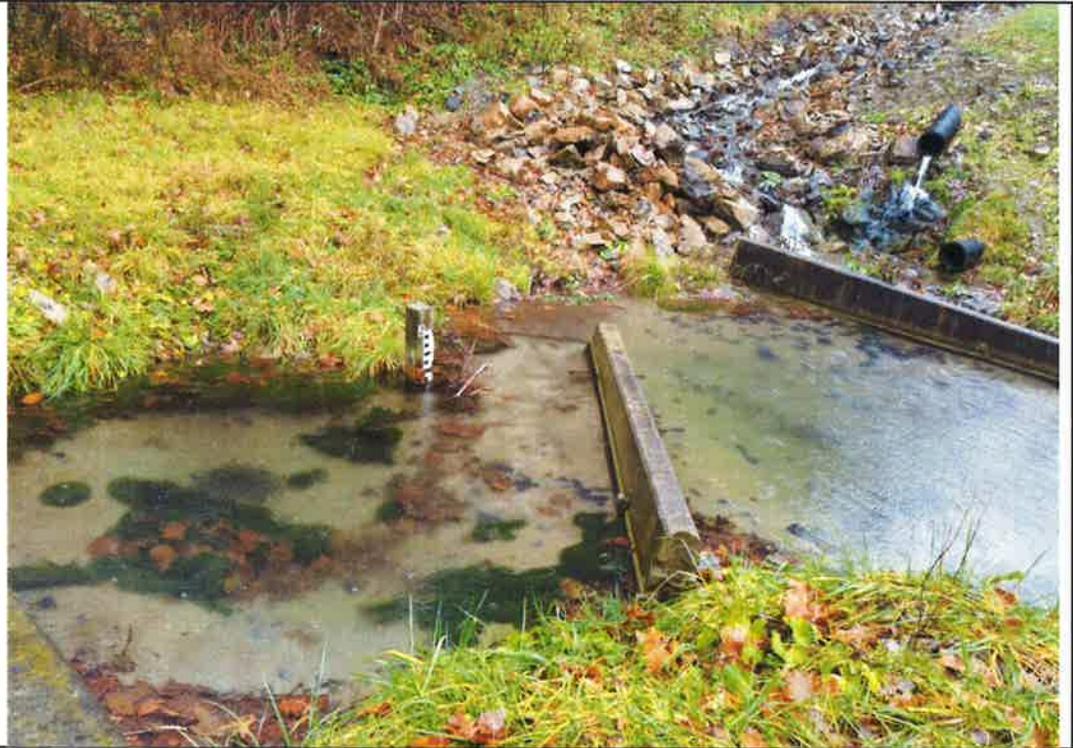
A v-notch weir just downstream of the baffling is used to measure flow. The seepage has increased at this location but, is still clear.

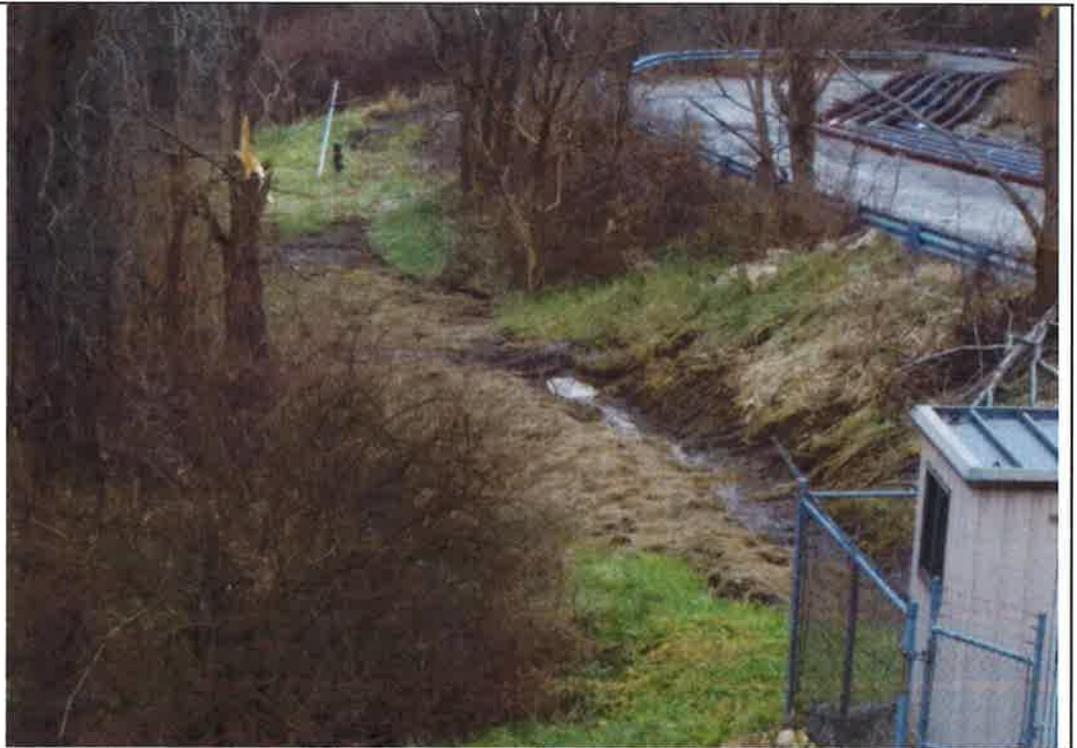
Photo No.
28

Installation of v-notch weir for new seepage drain and seepage zone #17 on the right abutment.

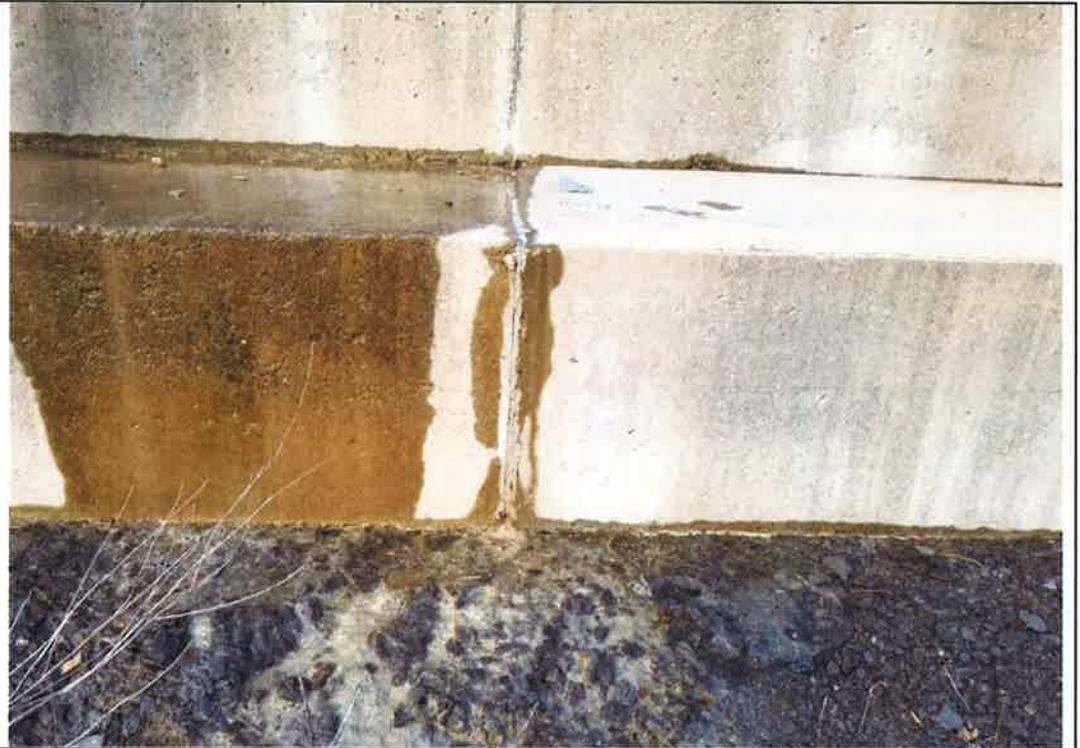
View of the lowest stair of concrete portion of the Emergency Spillway after the newest raising. The concrete stair was damp indicating possible seepage through the water stops.

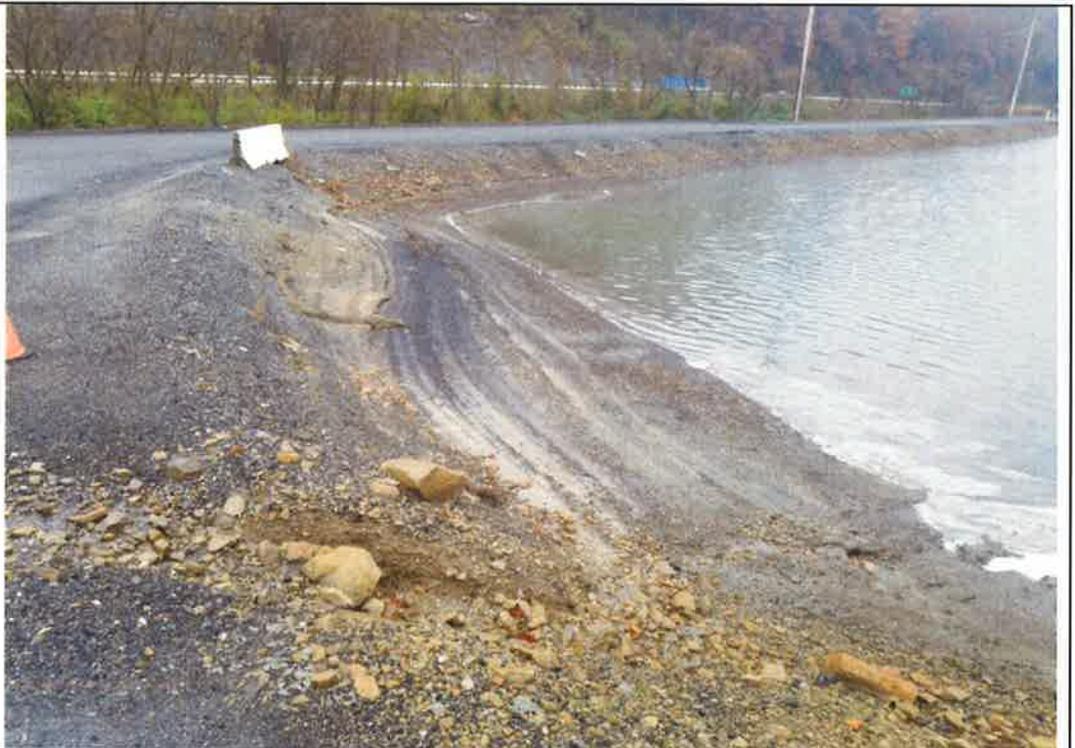
Photo No. 14	Date: 11/20/18
Direction Photo Taken: West	
Description: View of the interior slope of the SW corner of the Bottom Ash Pond. Note minor wave erosion.

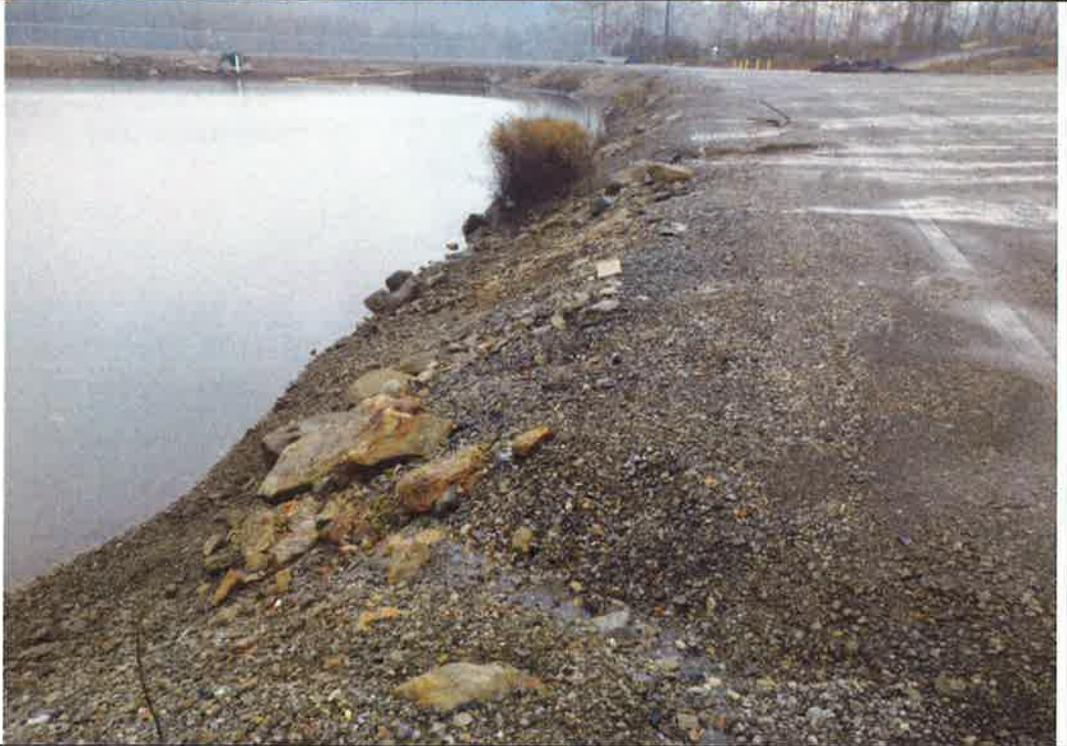
Direction Photo Taken: N/A		
Description: View of erosion rills from runoff from the access road along the east dike of the Recirculation Pond.		
Photo No. 24	Date: 11/20/18

Direction Photo Taken: East		
Description: View of erosion rills from runoff from the access road along the east dike of the Recirculation Pond.

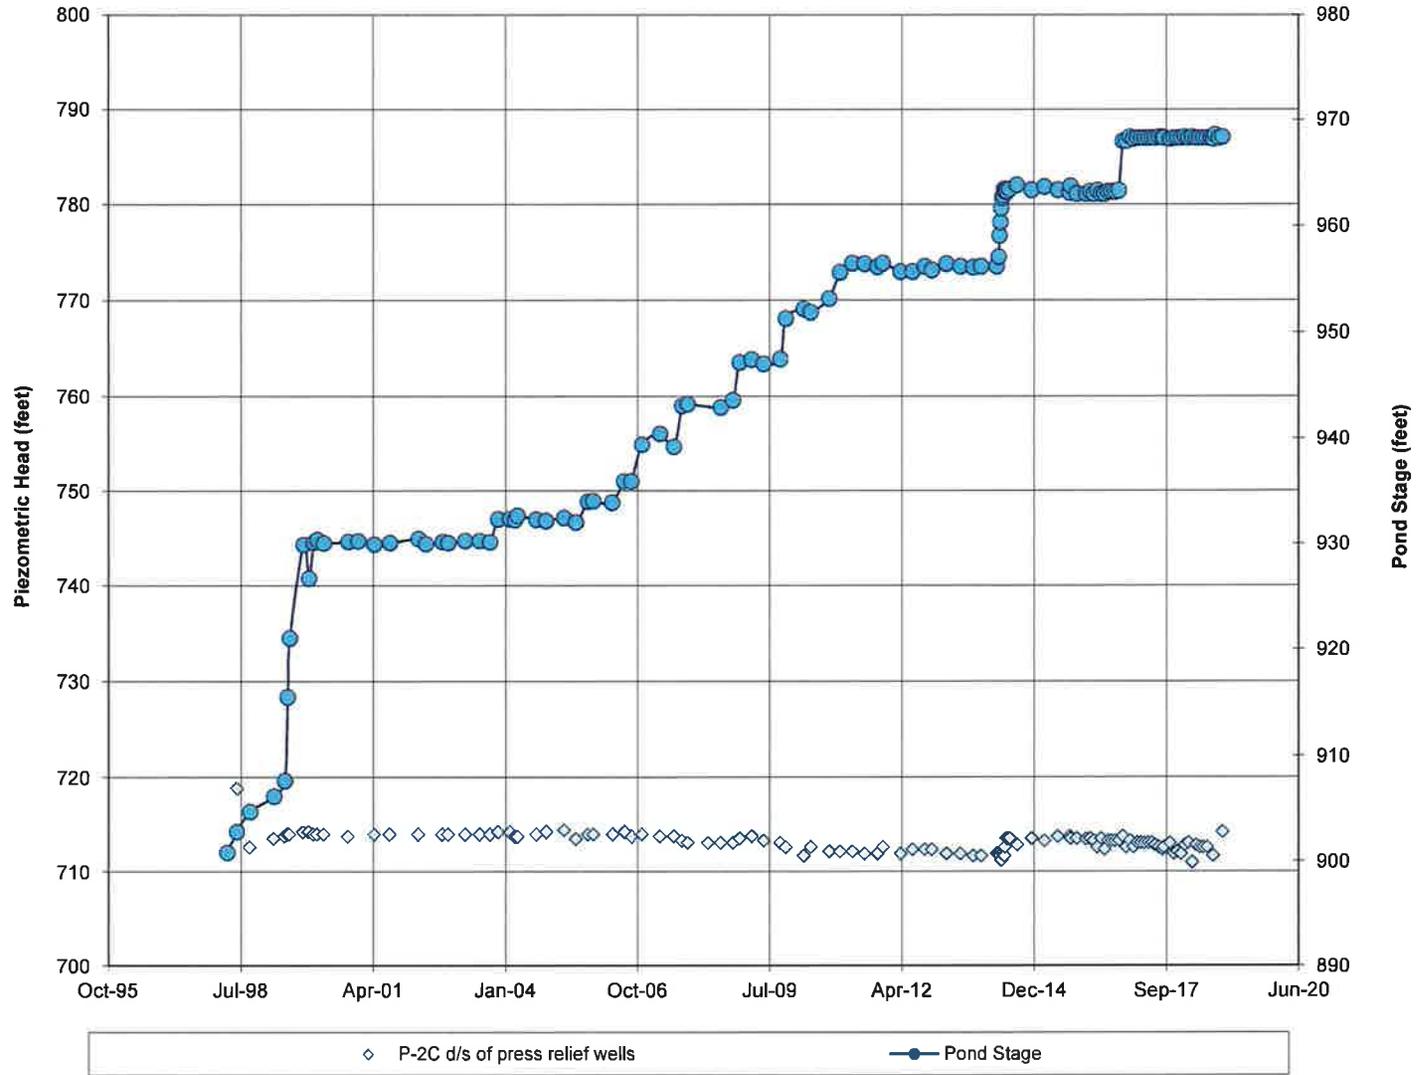
Figure 5k
Cardinal FAD 2
Centerline of Dam
Foundation Piezometers

4. Piezometer P-2C, installed within the foundations of the dam showed a minor increase in piezometric head (Figure 5k).
5. Piezometer P-2BE, installed within the drain, reflects a higher-pressure head (about 28.5 ft) in comparison to P-2BW. Most piezometers showed minor increase in piezometric head (Figures 5j, 5l and 5m).

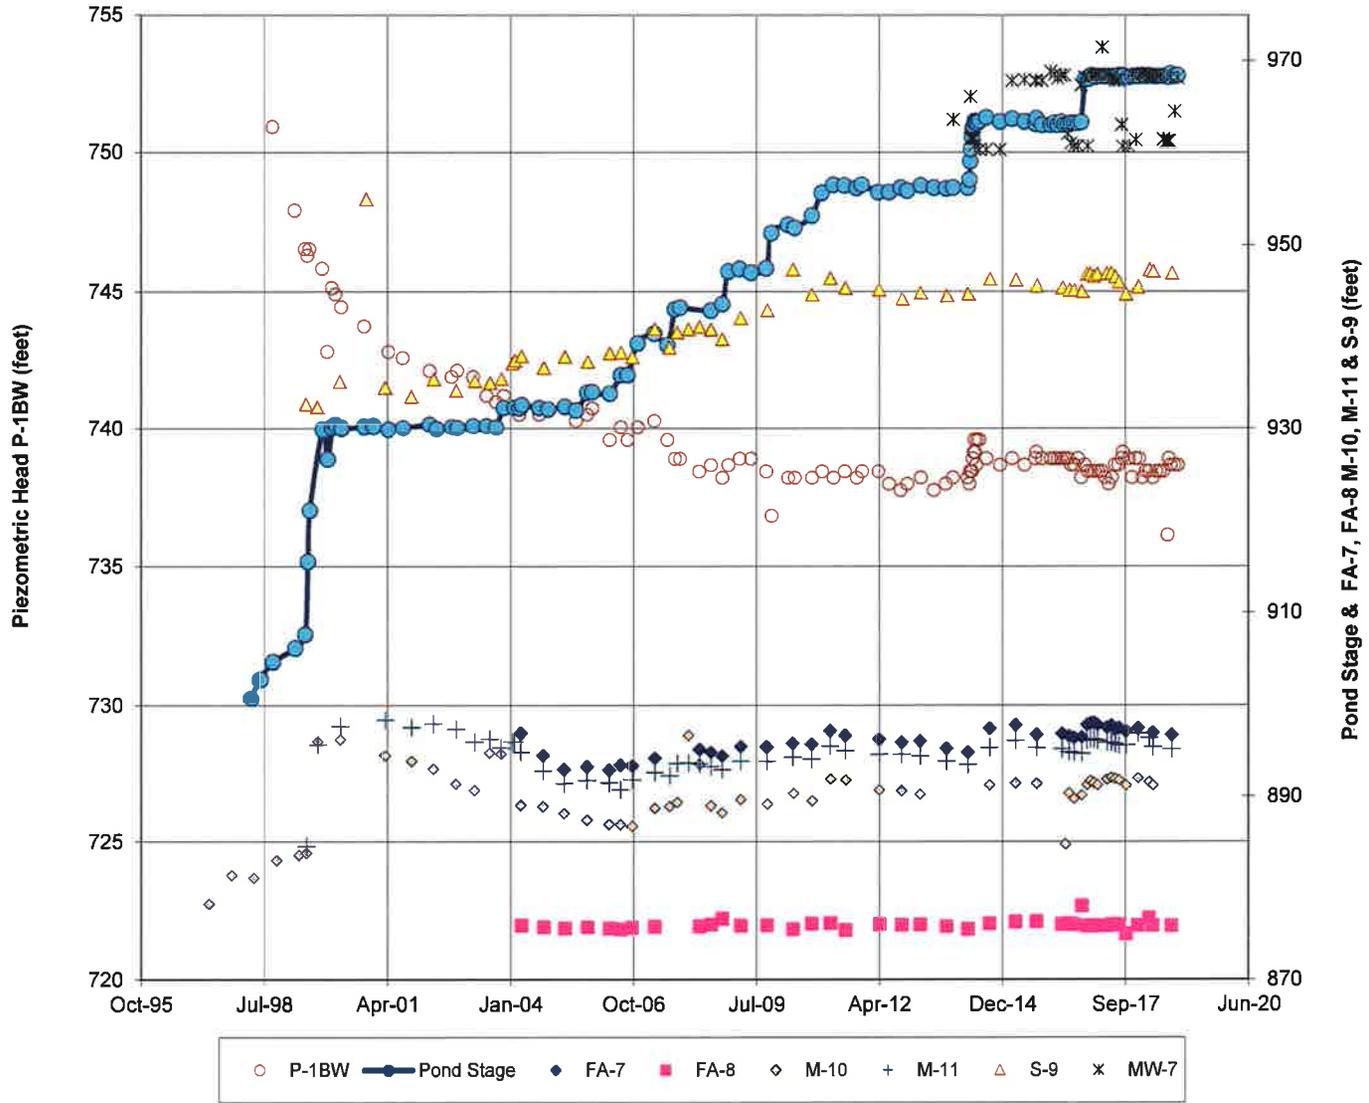
**Figure 5n
Cardinal FAD 2
Centerline of Dam
Drain Piezometers & Right Abutment Piezometers**

7. Monitoring wells M-10 & M-11 showed a minor decrease in static water levels. Piezometer FA-7 monitors a 1 inch wide open joint (observed by a borehole camera survey prior to well installation) and reflects a steady decline, followed by a leveling off that closely correlates with the declines observed in the drain piezometer P-1BW, M-10 and M-11 (Figure 5n). Monitoring well S-9 showed a minor increase in static water levels.
