2019 Annual Landfill Inspection Report

Cardinal Plant Fly Ash Reservoir I Landfill

January 2, 2020

Project Number: 60613809

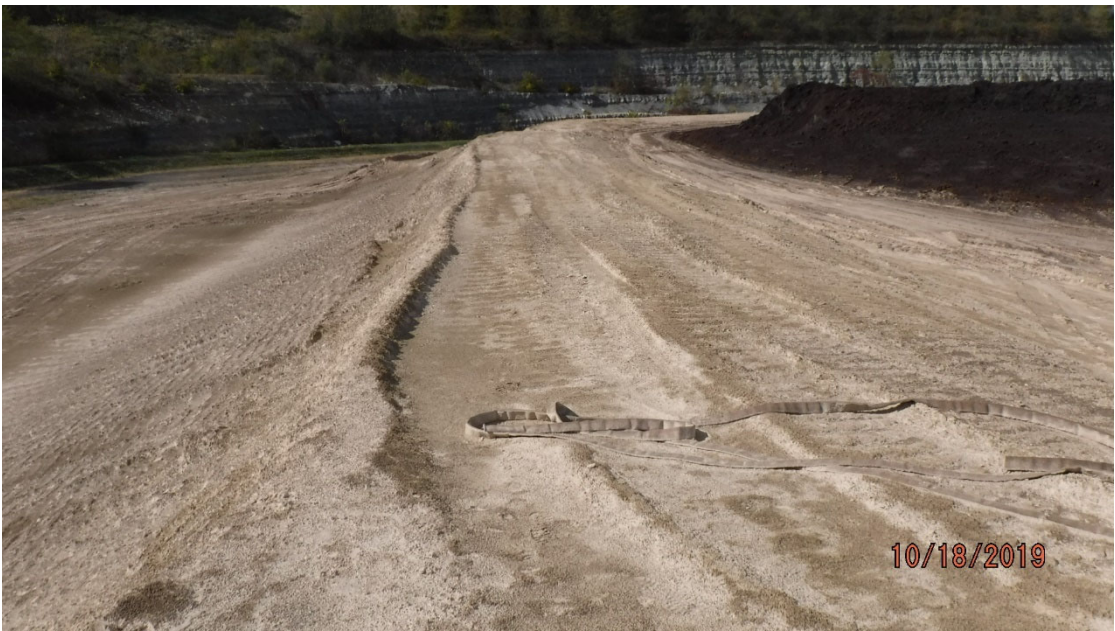
Photo No. 8	Date: 10/18/19

Direction Photo Taken: North		
Description: Cell 1 west line waste internal slope conditions. Polymer dust suppressant has been sprayed on slope and crest surfaces. Note WWTP waste in photo.

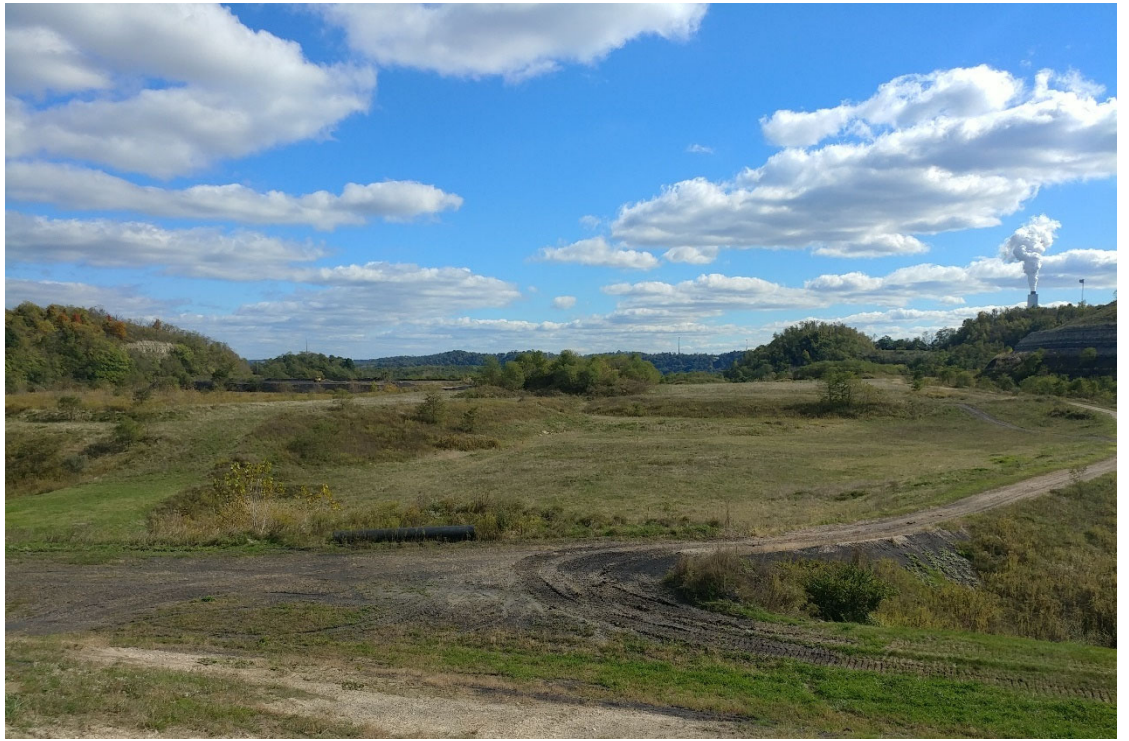
Photo No. 27	Date: 10/18/19
Direction Photo Taken: Southeast	
Description: Standing at Cell 1 southern perimeter, view of Cells 2/4/5 inactive/future area. Earthen stockpiles seen in view (stockpiles in cells 2 and 4 have temporary vegetative cover).

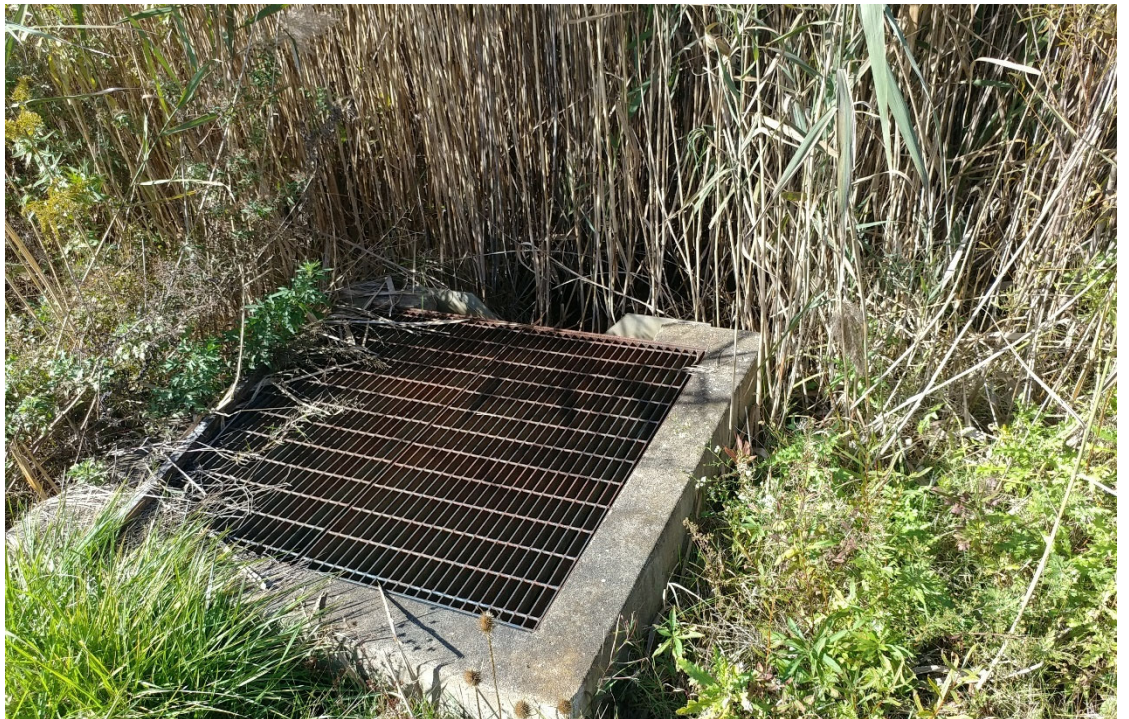
The junction structures for the leachate collection system and spring drain/SDL were observed to be in good condition (See Photos 28 and 29 in Appendix B) and were freely flowing on the date of the inspection.

Photo No. 28	Date: 10/18/19
Direction Photo Taken: East	
Description: Subsurface Drainage Layer outfall in Cell 6. Outfall was flowing freely on date of inspection.
