2019 Annual Dam and Dike Inspection Report

Cardinal Plant Fly Ash Dams 1, 2 & Bottom Ash Complex

Project Number 60613809

January 2, 2020

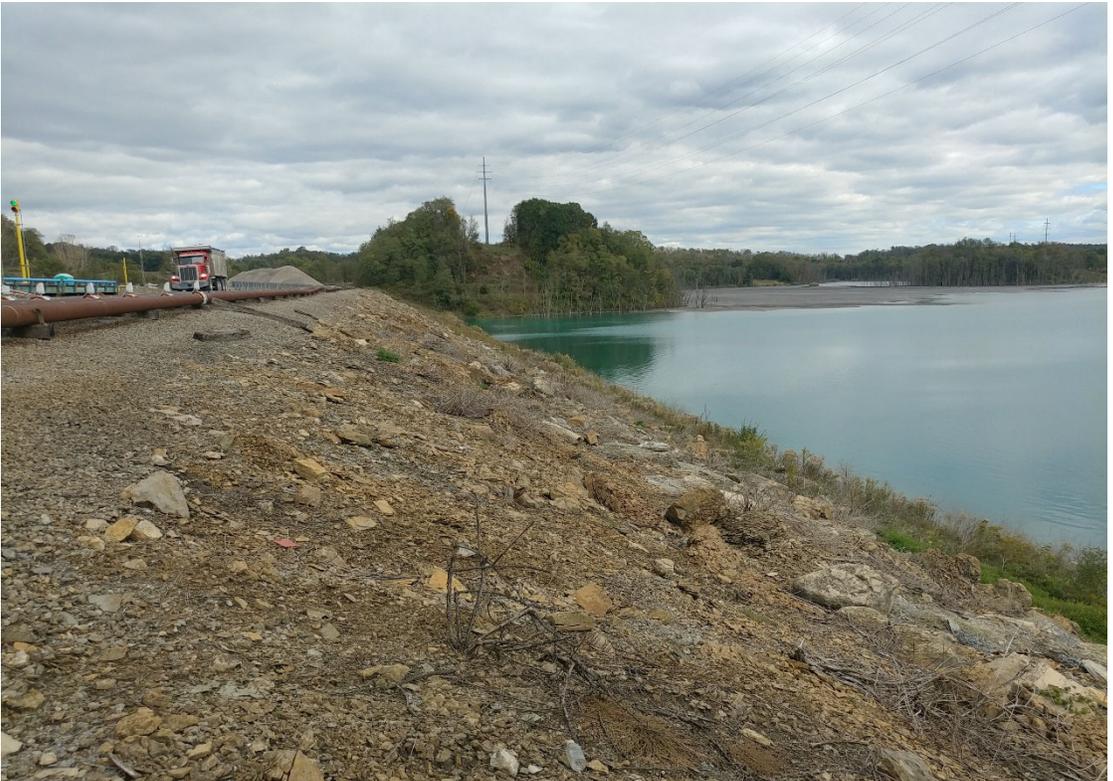
Photo No. 1	Date: 10/18/19

4. The downstream dam surface is sparsely vegetated (brushy vegetation), but is covered with rock fill material. As noted in the 2018 inspection, the rock fragments are broken up or deteriorating in some cases, but the material is still protecting the surface of the dam. Overall, the rock fill protection is in fair condition and has not adversely changed since 2018 (Photograph No. 1 and 2).

8. As noted in 2018, a surface water drain pipe discharges near the crest of the right abutment (Photograph No. 1). The flow line is well protected with large rip-rap and no signs of erosion or deterioration has been noted.

Direction Photo Taken: Northeast		
Description: View of the downstream slope of the FAR 1 dam. The surface water discharge pipe crushed concrete erosion control at the right groin is shown at the bottom of the photo.

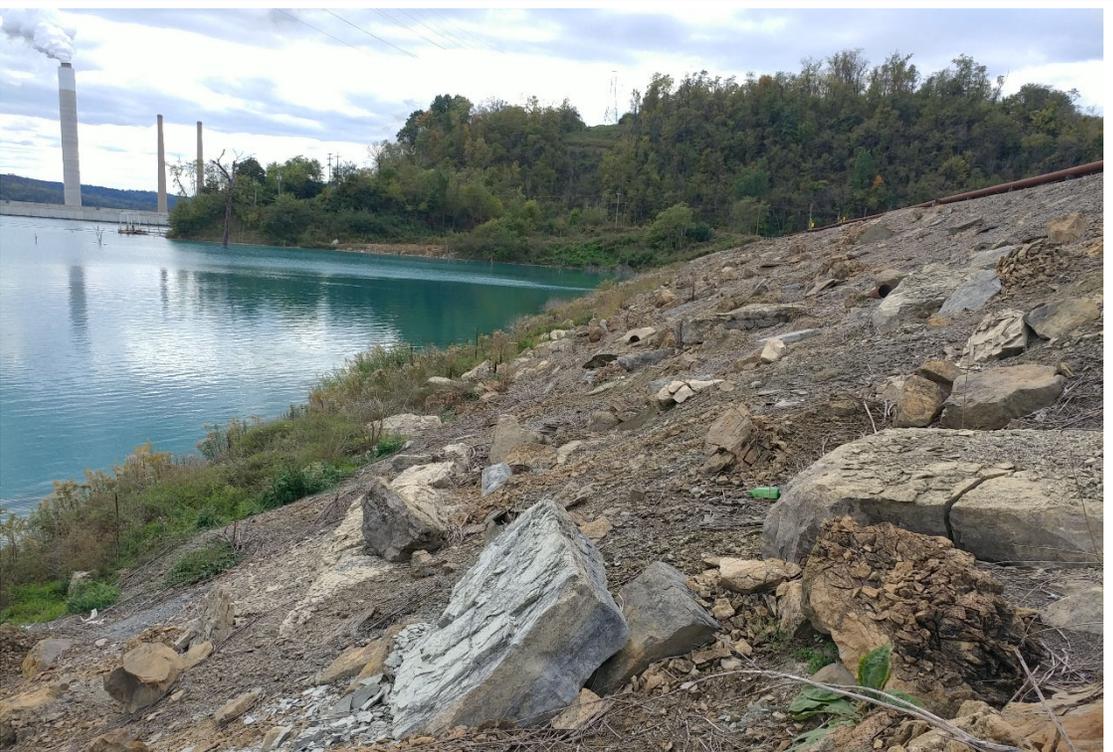
Photo No. 2	Date: 10/18/19

Direction Photo Taken: Southwest		
Description: View of the downstream slope of the FAR 1 dam.

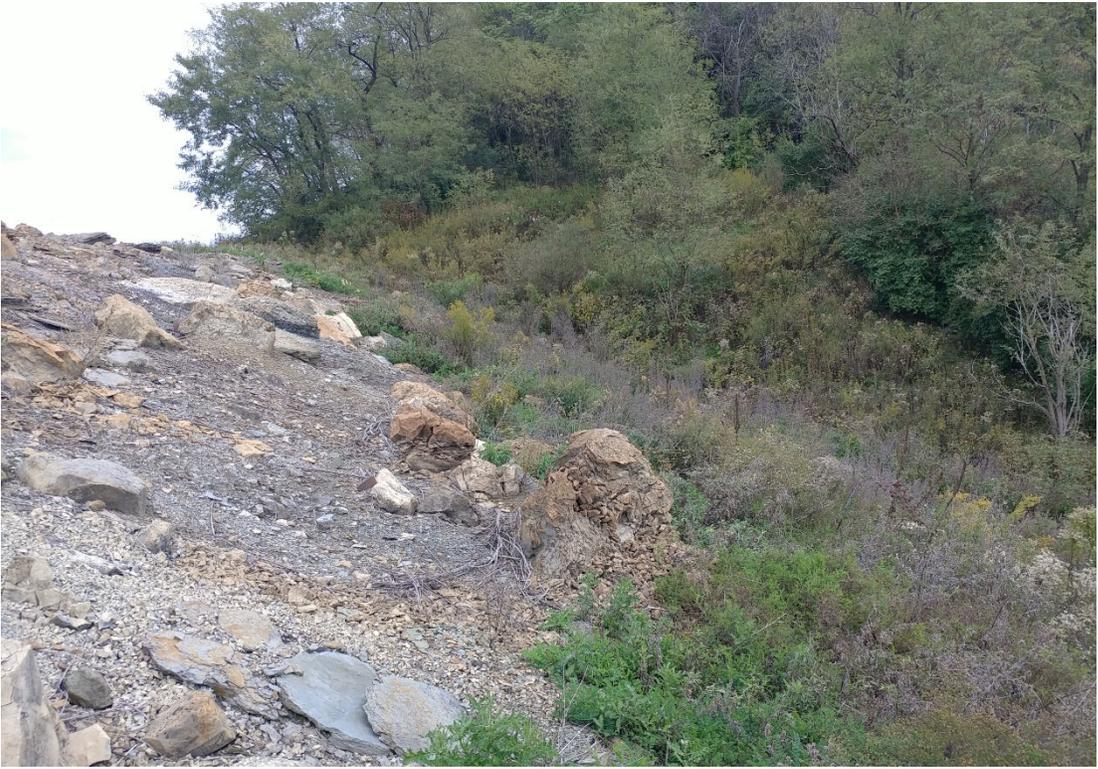
Photo No. 3	Date: 10/18/19

6. No woody vegetation was observed on the downstream slope of the dam. Some shrubby vegetation is present at the toe of the exposed slope at the FAR 2 waterline. Shrubby vegetation is also present along the left groin, making access and visibility for inspection somewhat difficult (Photo 3).

Direction Photo Taken: West		
Description: View of left groin. Rip rap let down is present but not visible through vegetation at right side of photo.

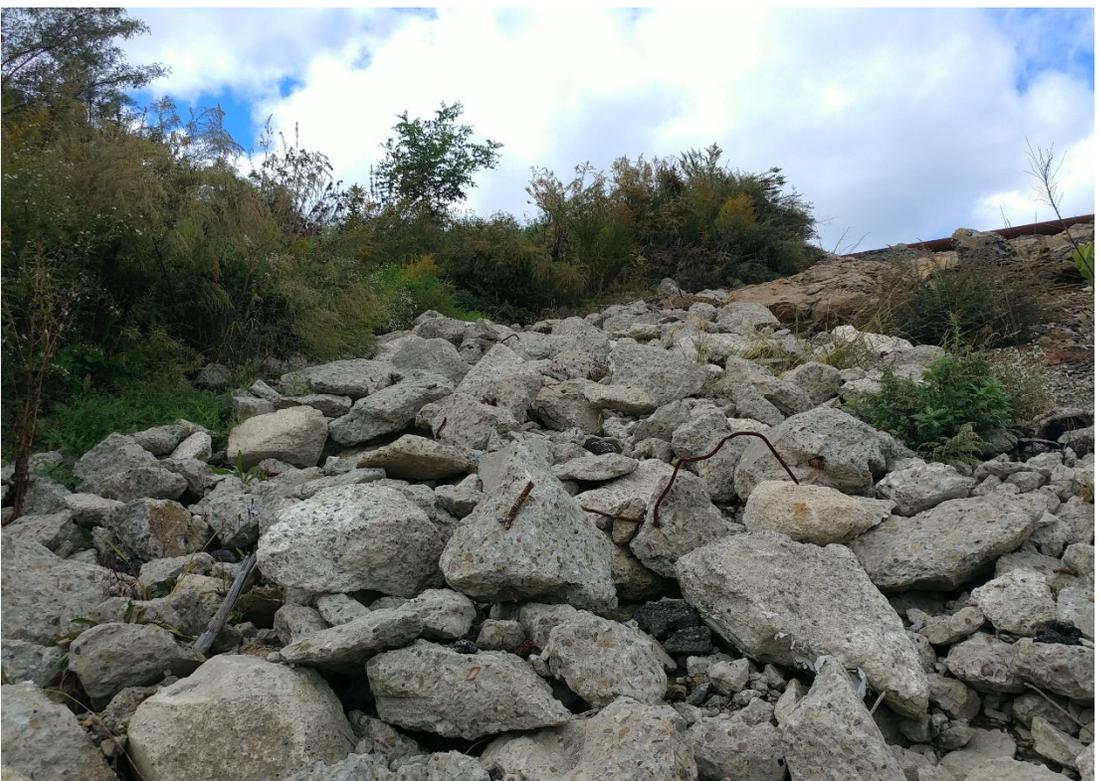
Photo No. 4	Date: 10/18/19

7. No significant erosion was observed along the groin areas of the downstream slope (Photograph No. 1, 3 and 4). Both right and left abutments are protected with rock fill/rip-rap that is in good condition. Some brush was present near the right abutment of the dam, and some small trees were present near (not on) the left abutment.

Direction Photo Taken: West		
Description: View of the right groin area of the FAR 1 dam.

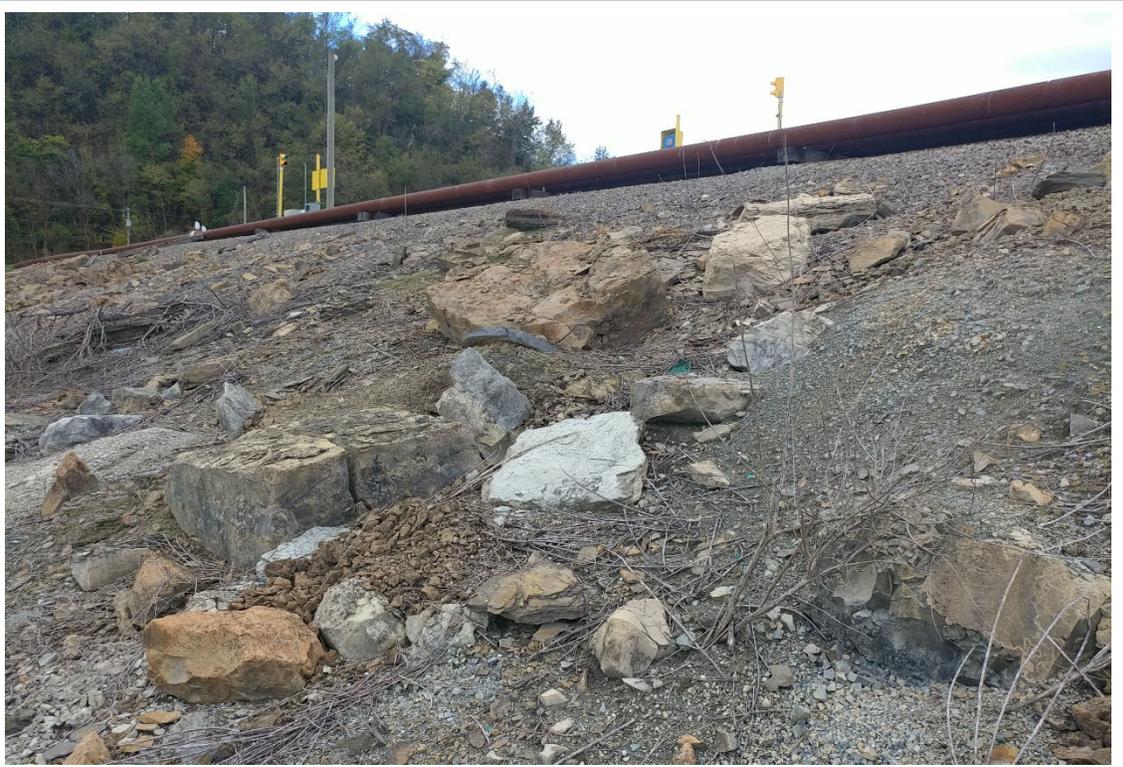
1. The crest of the dam was in good condition, with no signs of significant erosion, rutting, or misalignment (Photograph No. 5). The crest of the dam supports a heavy duty concrete roadway that is accessed by haul trucks. The roadway was in good condition.

Photo No. 5	Date: 10/18/19
Direction Photo Taken: West	
Description: View of the ash discharge pipes along the crest of the FAR 1 dam.

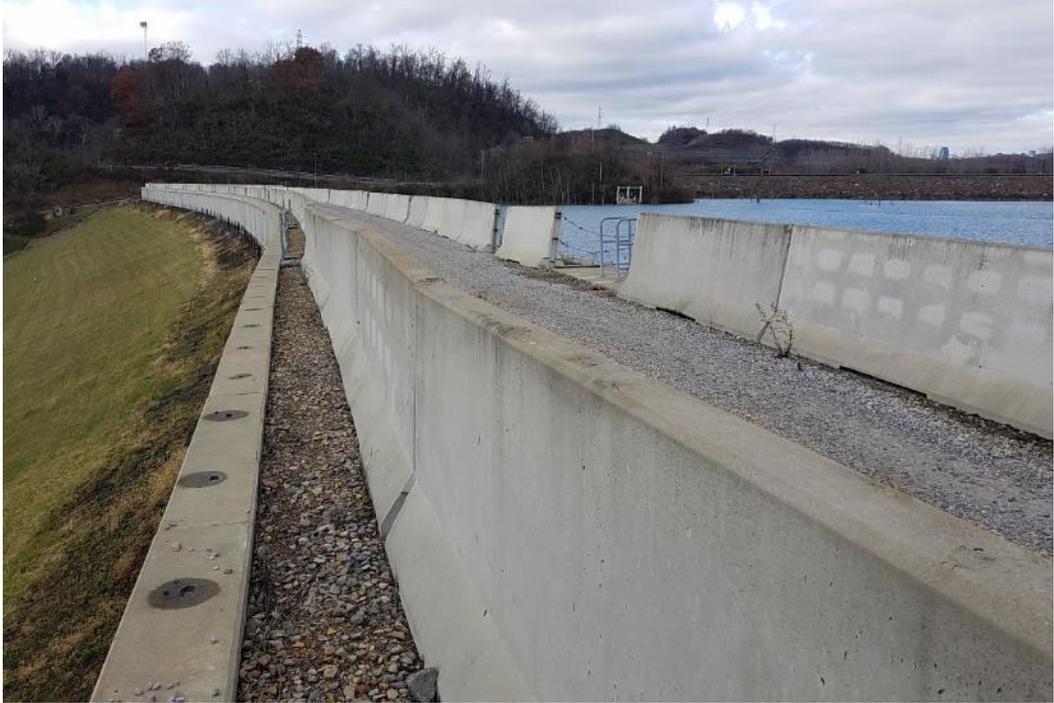
Photo No. 1	Date: 11/22/19

Direction Photo Taken: West		
Description: View of the access road along the crest of dam looking west. The dam crest appeared in good condition with no signs of settlement, misalignment, rutting, or erosion.

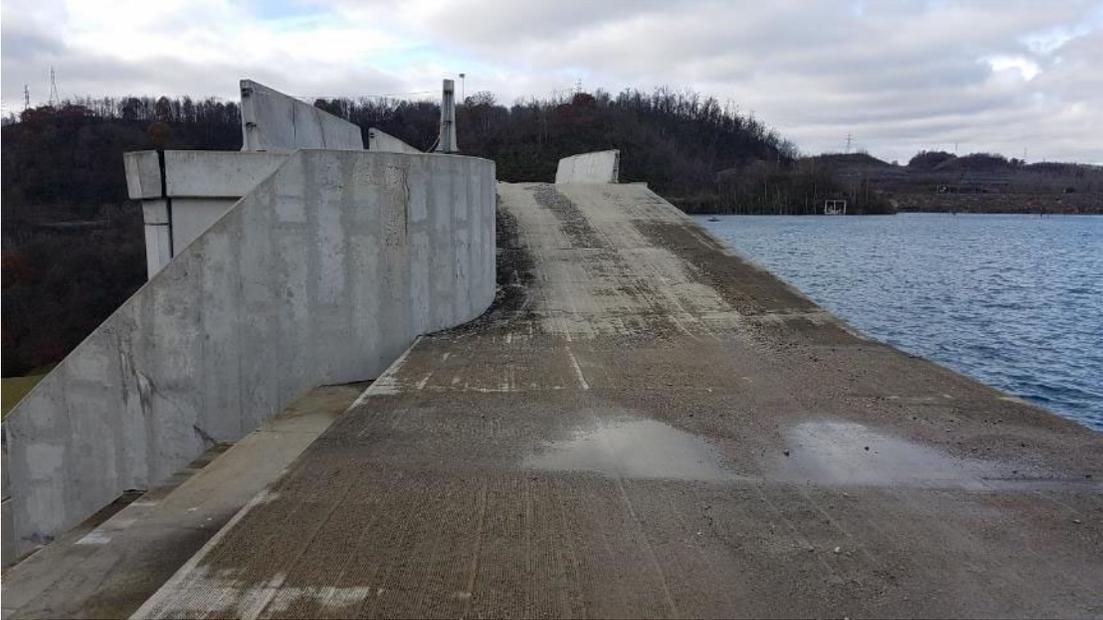
Photo No. 2	Date: 11/22/19

Direction Photo Taken: West		
Description: View of the crest area looking east from top of emergency spillway. The dam crest appeared in good condition with no signs of settlement, misalignment, rutting, or erosion.

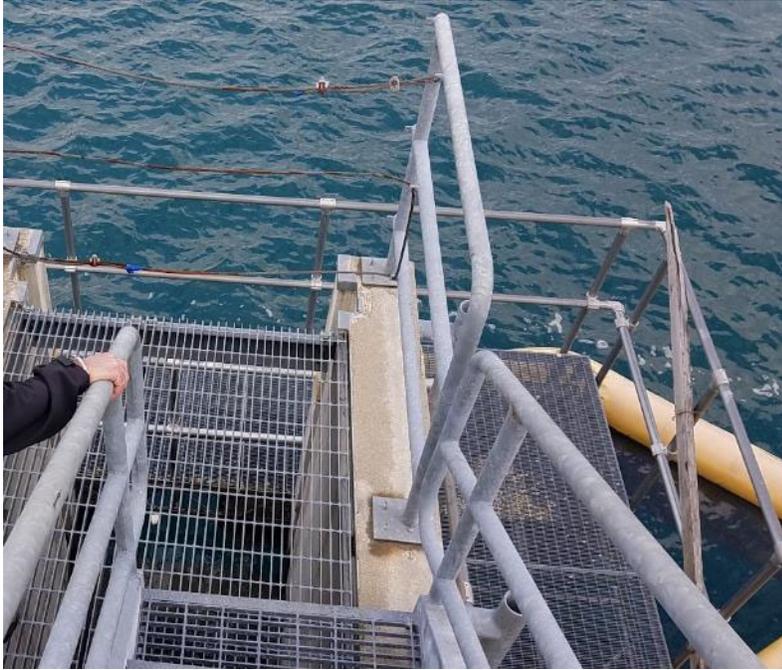
Photo No. 3	Date: 11/22/19

Direction Photo Taken: N/A		
Description: View of the primary spillway intake structure from above. Note metal bar grating is in good condition

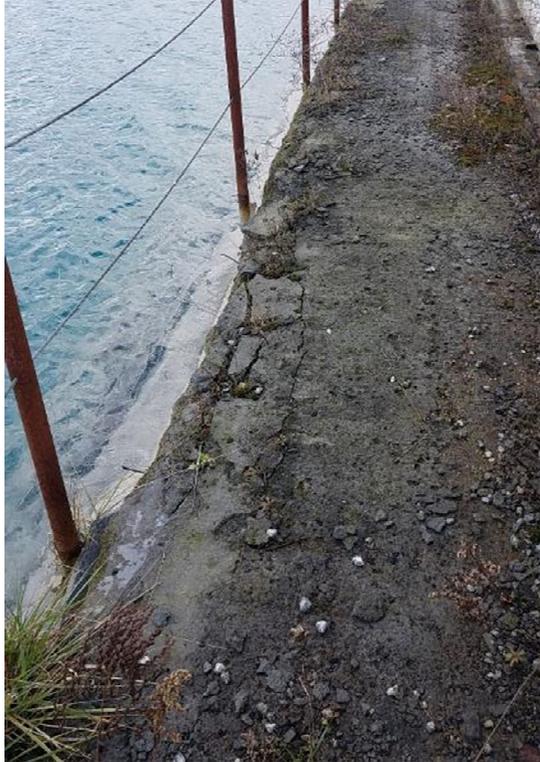
Photo No. 5	Date: 11/22/19

Direction Photo Taken: West		
Description: Upstream side of dam crest, looking east. Deterioration of roller-compacted concrete noted.

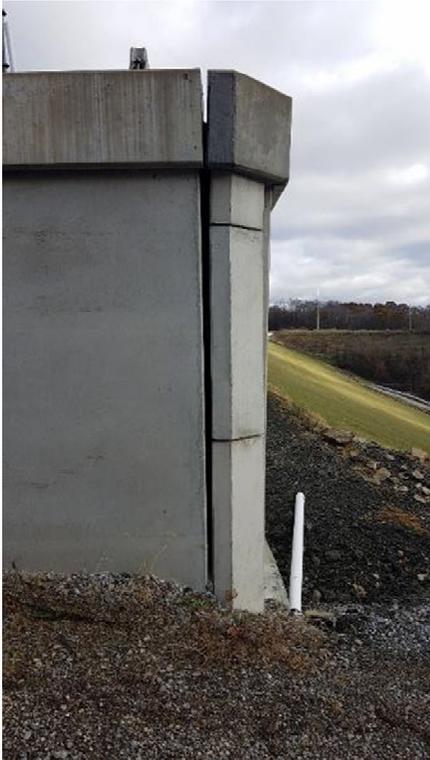
Photo No. 6	Date: 11/20/18

Direction Photo Taken: East		
Description: View of the downstream corner of the MSE Wall where the wall panel meets concrete coping. Note the separation at the corner piece.

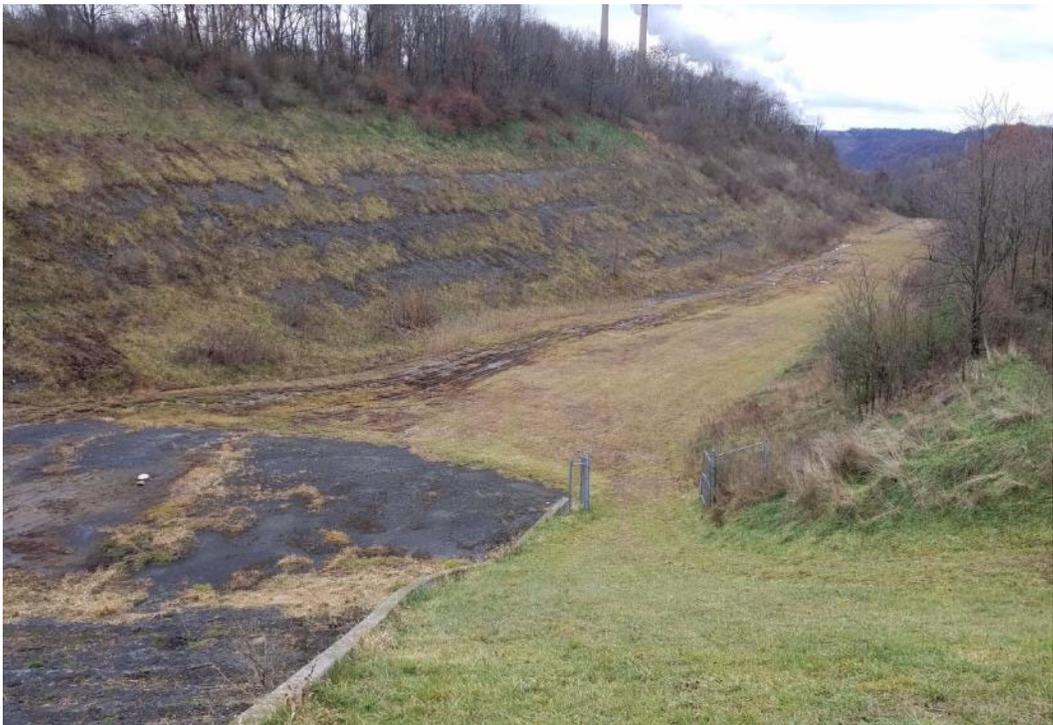
Photo No.: 10	Date: 11/22/19

Direction Photo Taken: South-Southeast		
Description: View of the emergency discharge channel. Vegetation is well maintained and the spillway is clear of obstructions.

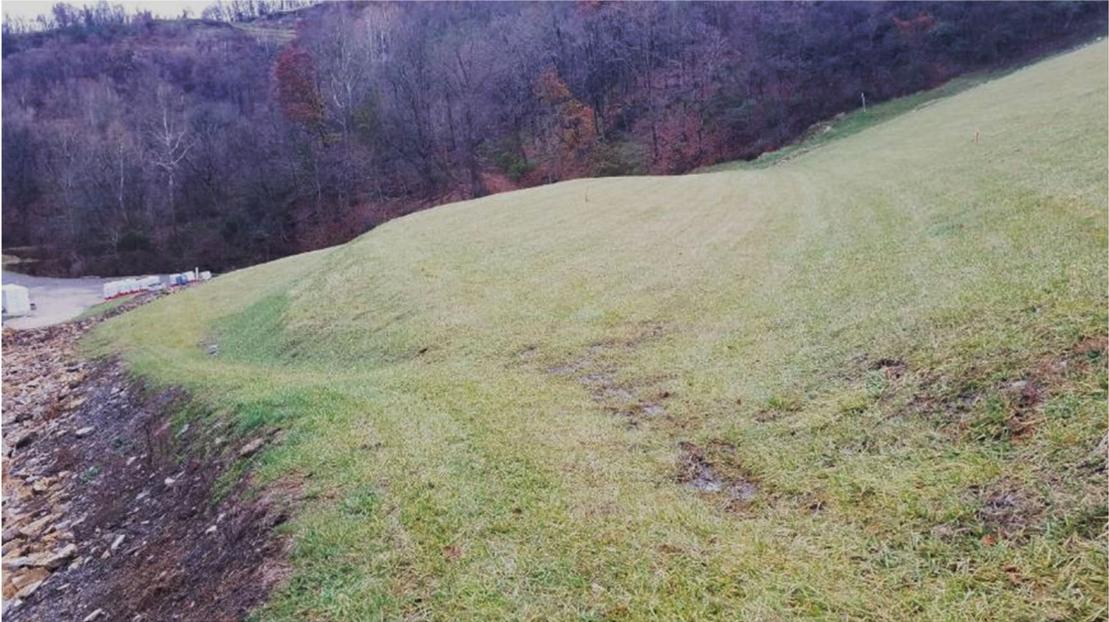
Photo No. 16	Date: 11/22/19

Direction Photo Taken: Southwest		
Description: View of the downstream slope lower berm bench area. Minor ponding at front of picture.

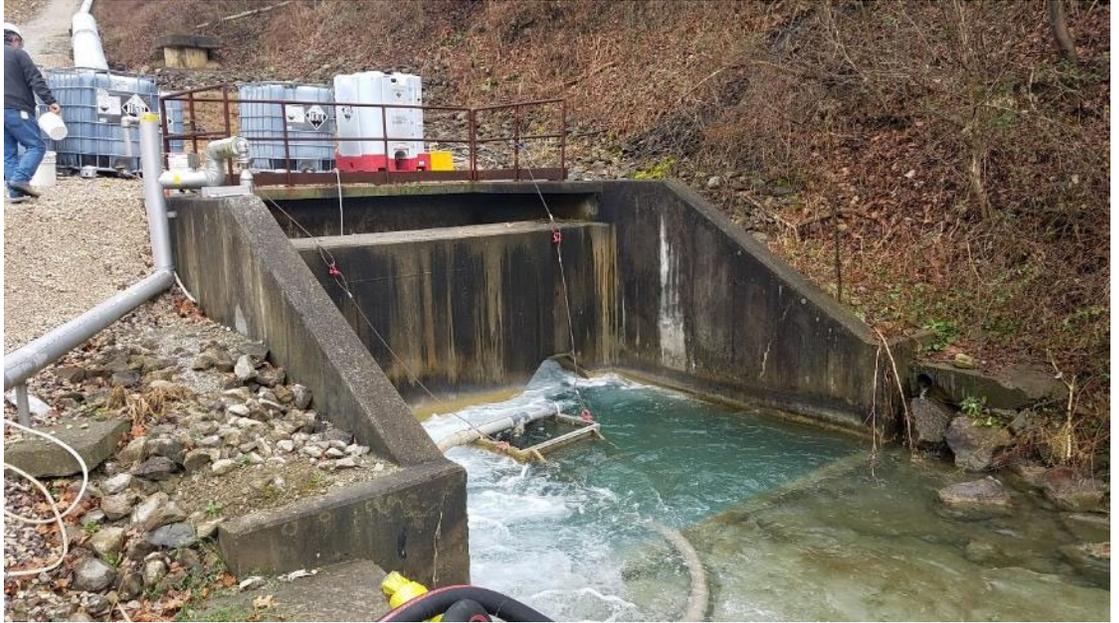
Photo No. 21	Date: 11/22/19
Direction Photo Taken: East-Northeast	
Description: View of the energy dissipater structure. Some minor hairline cracks and efflorescence noted in outflow channel wall.

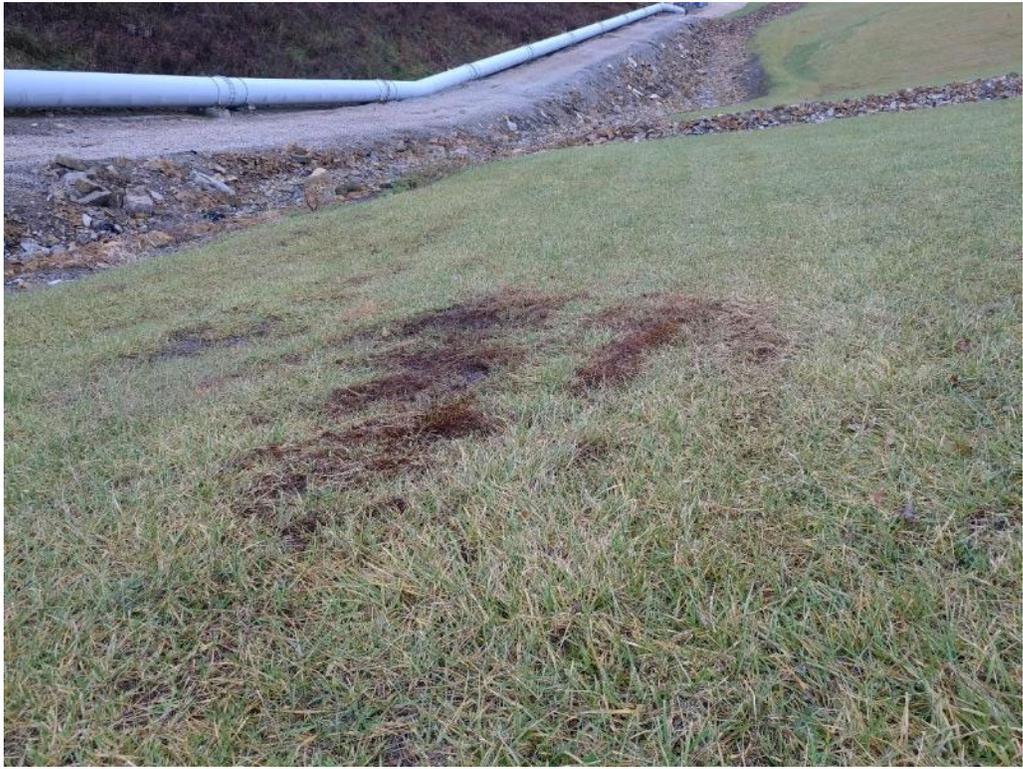
Photo No. 25	Date: 11/22/19
Direction Photo Taken: South	
Description: View of wetness and brown grass on face of dam. Location should continue to be monitored. Wetness may be attributed to rain event at time of inspection.

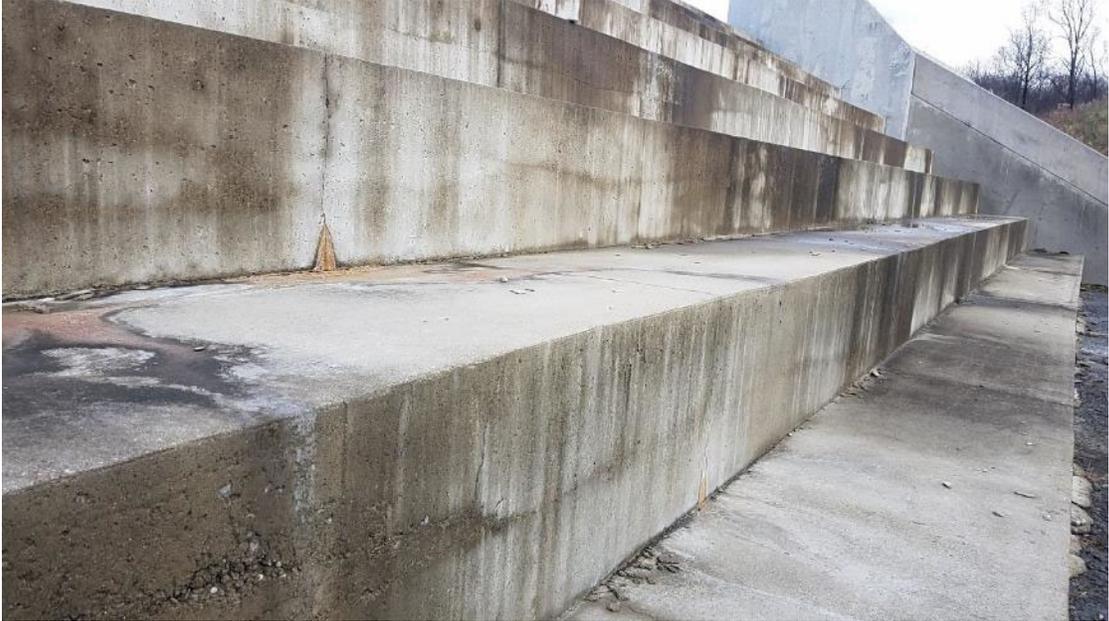
Photo No. 29	Date: 11/22/19

Direction Photo Taken: Northeast		
Description: View of the concrete portion of the Emergency Spillway after the newest raising. Several cracks 3/16" to 1/8" were noted with efflorescence in some of the cracks, indicating possible seepage through the water stops.

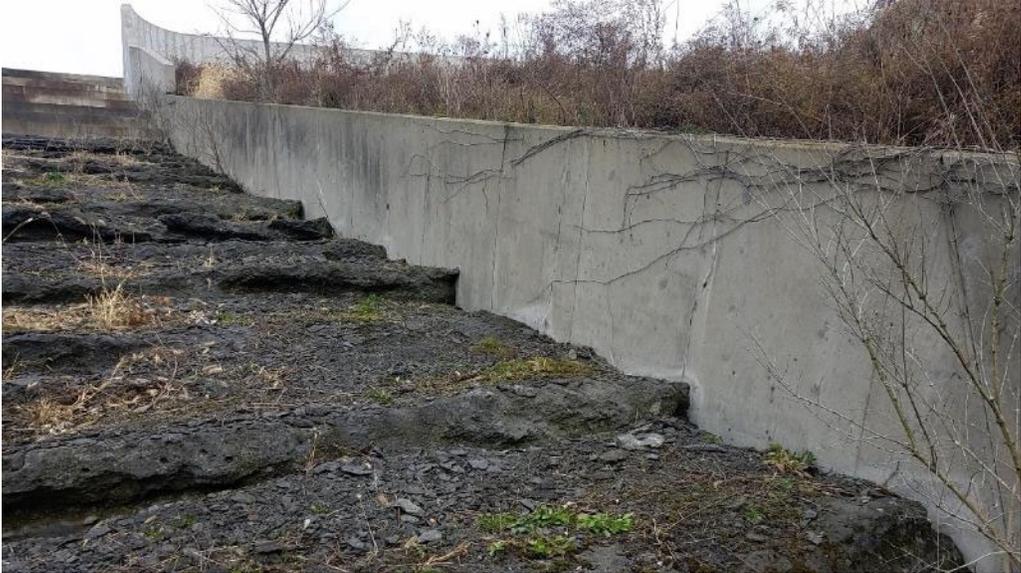
Photo No. 30	Date: 11/22/19

Direction Photo Taken: Northeast		
Description: Right concrete wall of emergency spillway – occasional cracking in concrete noted full width and depth of wall. Apparent movement of concrete walls not noted.

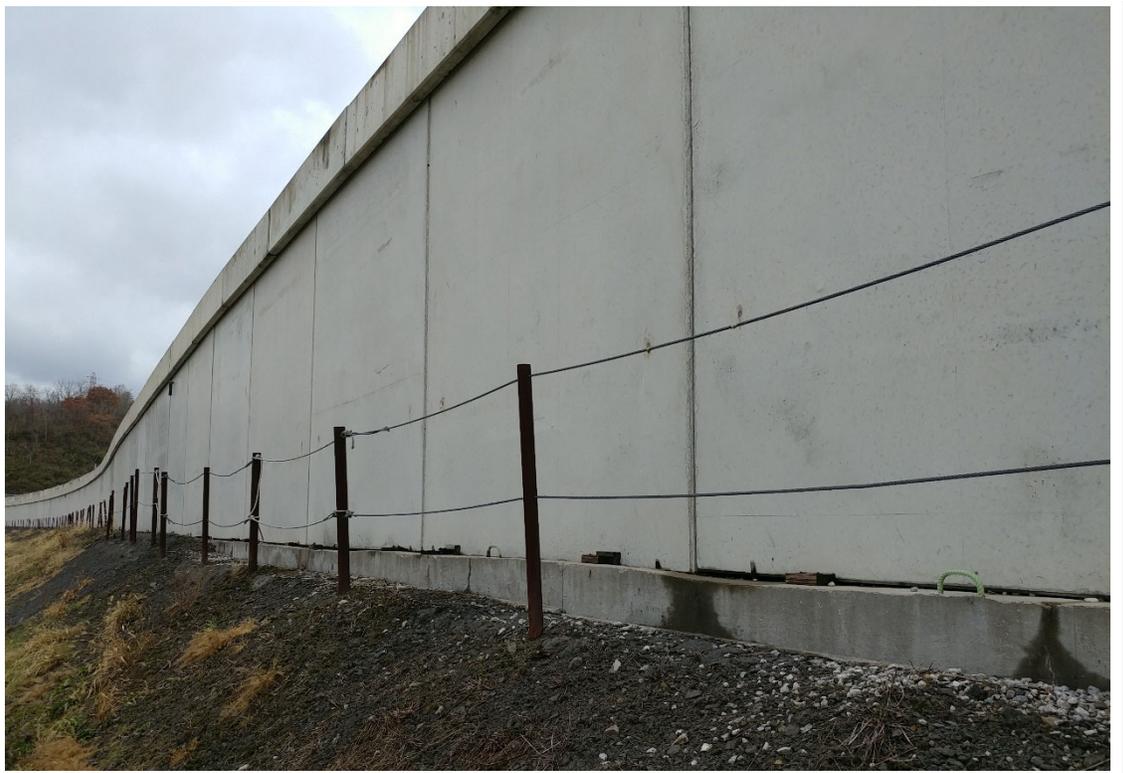
1. The main longitudinal MSE wall and return walls at both left and right ends of the dam were in good condition as shown in Photograph 7 and 31 of Appendix B and as indicated by the tiltmeter data in Figure 5o of Appendix E. There are no signs of differential settlement (no displaced panels, open joints, cracking, etc.) across the length of the wall. As noted in the 2018 inspection, there are relatively small separations at both the southwest and northeast corners of the wall, at the junction of the main longitudinal wall and the orthogonal return wall sections (see Photograph 6). The separations are most pronounced at coping beams at the top of the walls. These separations do not appear to have any adverse effect on serviceability, and it is noted that relative movement at MSE wall corners is a relatively common occurrence. The separations observed in 2019 do not appear to have worsened relative to previous inspections.

Photo No.: 31	Date: 11/22/19
Direction Photo Taken: Northwest	
Description: Typical condition of MSE Wall at crest of dam.

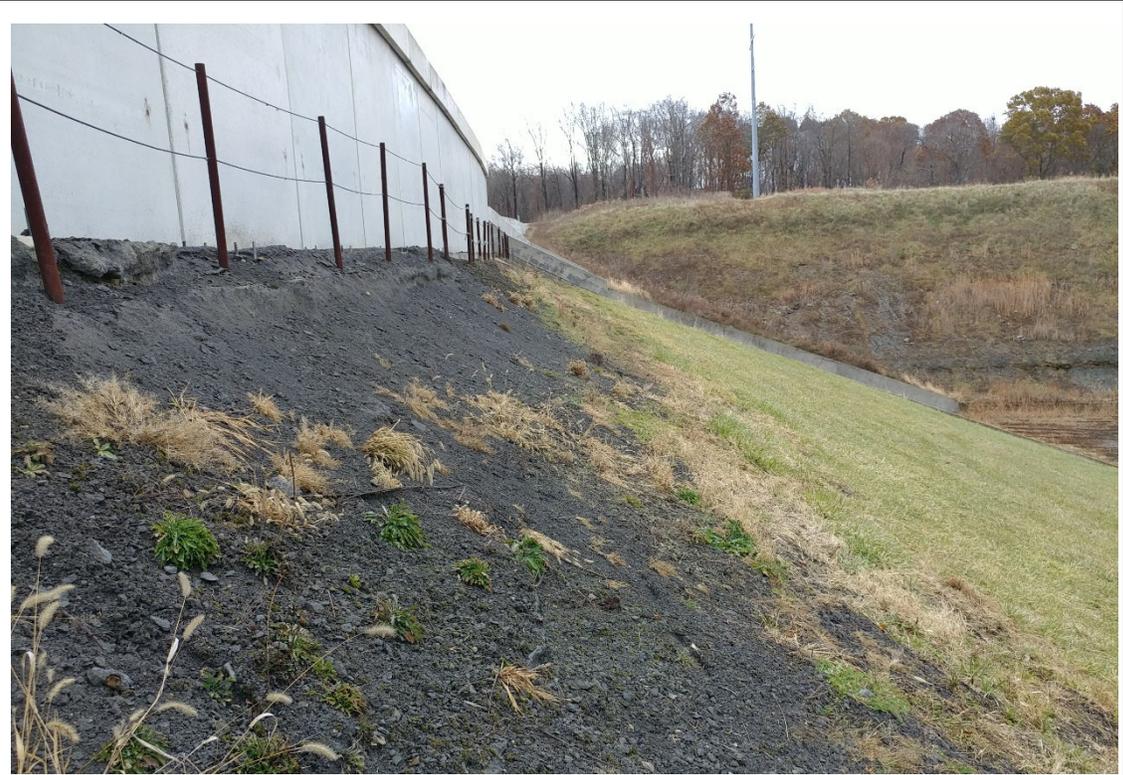
Photo No.: 32	Date: 11/22/19
Direction Photo Taken: East	
Description: RCC overlay at dam crest. The RCC is heavily weathered and in fair to poor condition

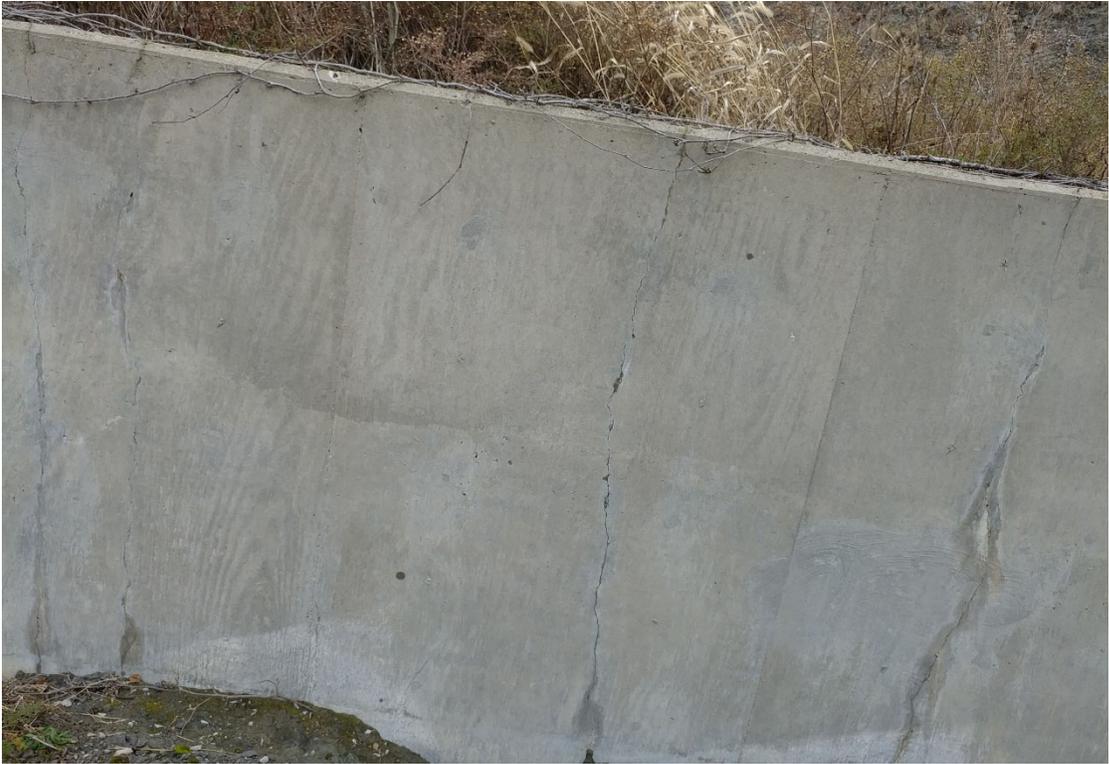
Photo No.: 33	Date: 11/22/19

Direction Photo Taken: East		
Description: Cracking in left (east) sidewall of emergency spillway.

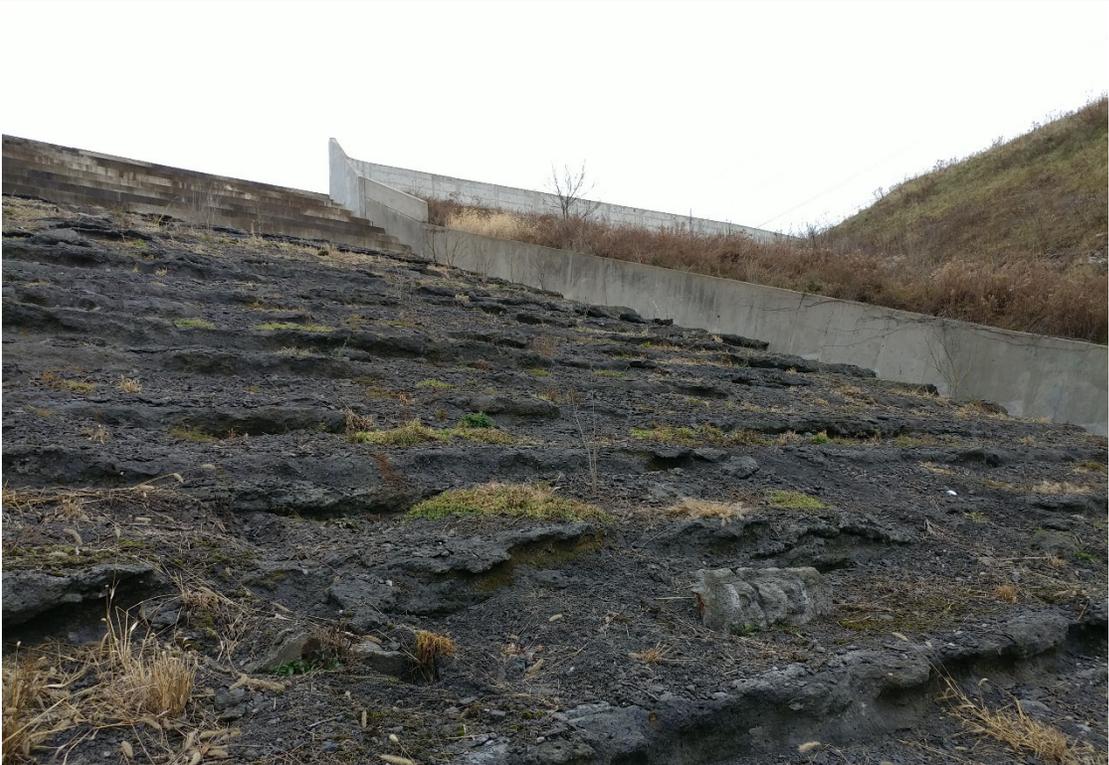
Photo No.: 34	Date: 11/22/19

Direction Photo Taken: Northeast		
Description: Typical condition of RCC steps on emergency spillway. Steps are highly to completely weathered.

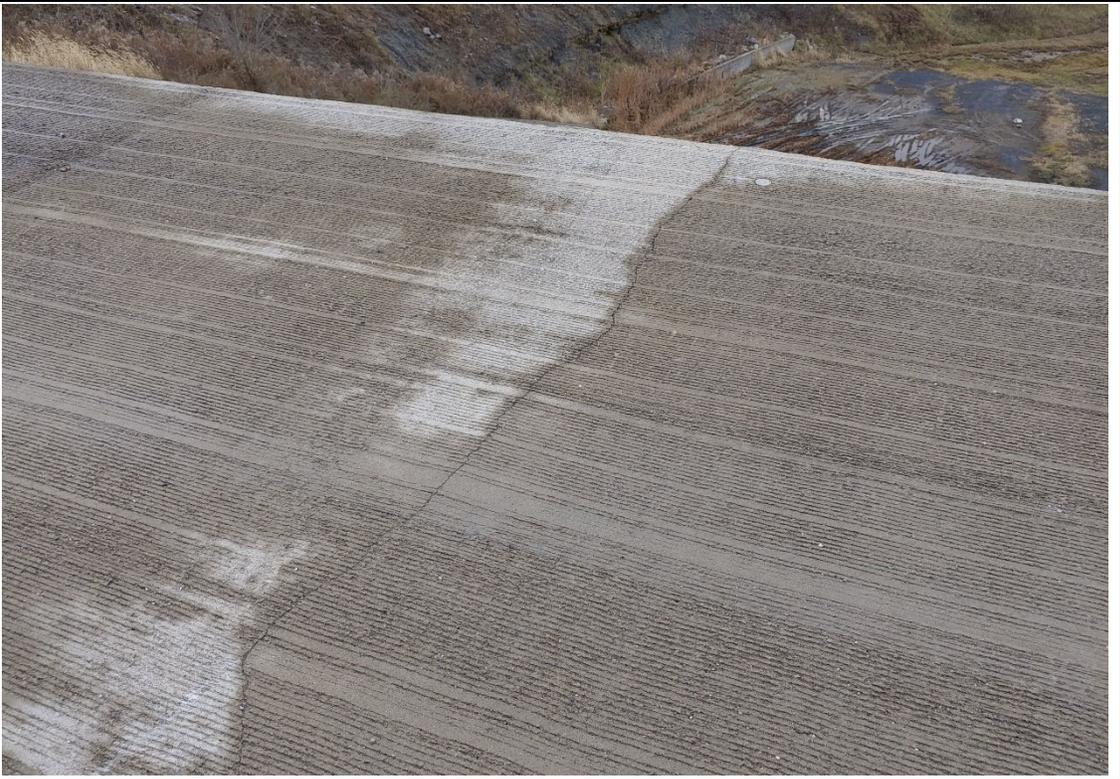
Photo No. 35	Date: 11/22/19

Direction Photo Taken: Northeast		
Description: Minor cracking in emergency spillway crest overflow slab.

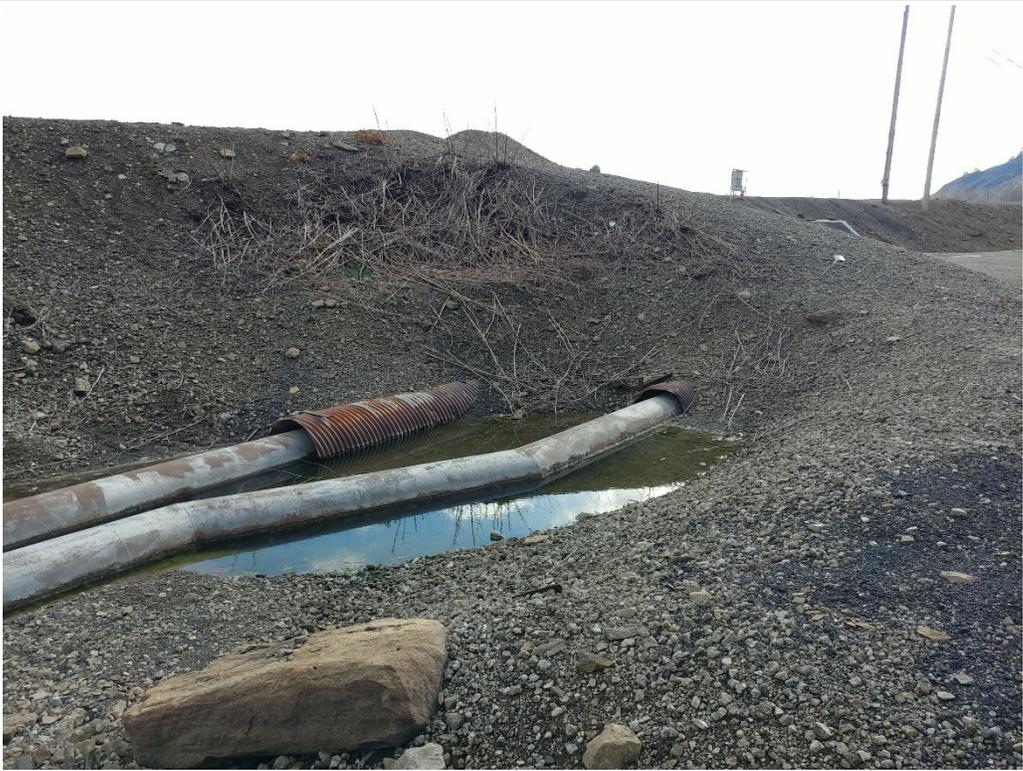
Photo No. 3	Date: 11/22/19

Direction Photo Taken: Southeast		
Description: View of the exterior slope along the toe of the embankment. Note ponded water near toe of slope. Water ponding likely due to combination of seepage and surface water.

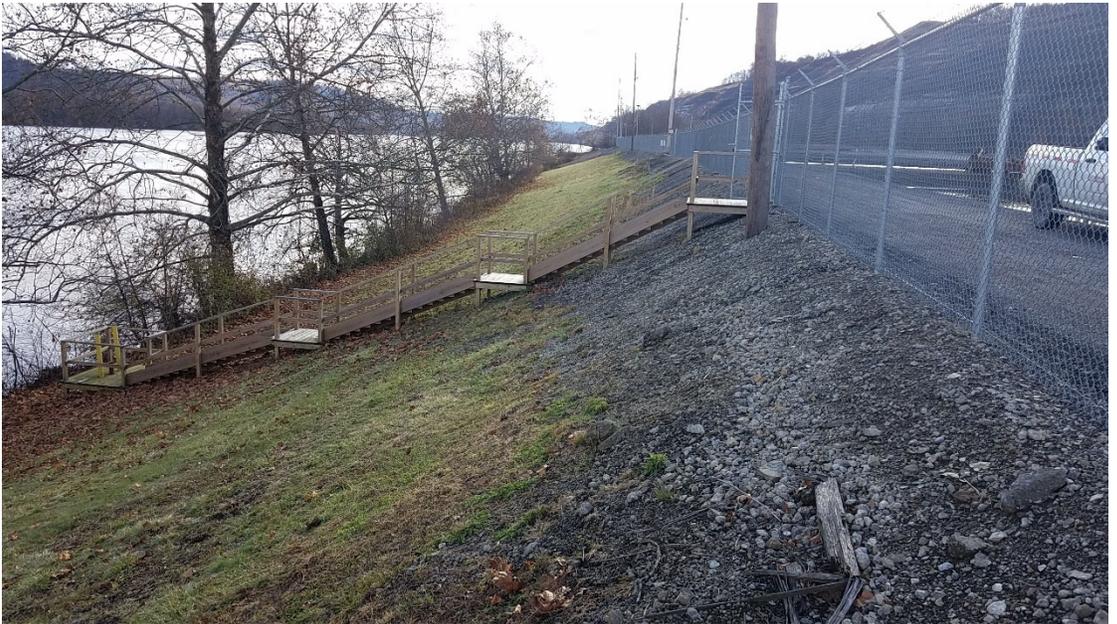
Photo No. 7	Date: 11/22/19
Direction Photo Taken: South	
Description: View of the exterior slope along the Ohio River and access stairs to the monitoring well. Trees at toe of natural river bank near waterline do not appear to be impacting the dam.

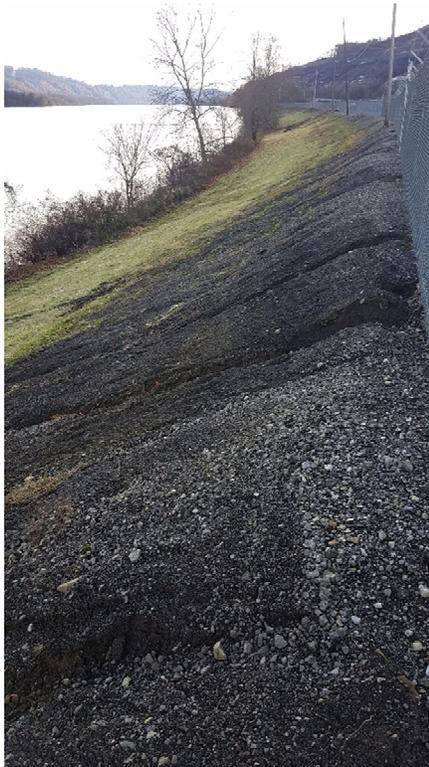
Photo No. 8	Date: 11/22/19
Direction Photo Taken: South	
Description: View of the exterior east embankment slope along the Ohio River. Several erosion rills noted along top of embankment.

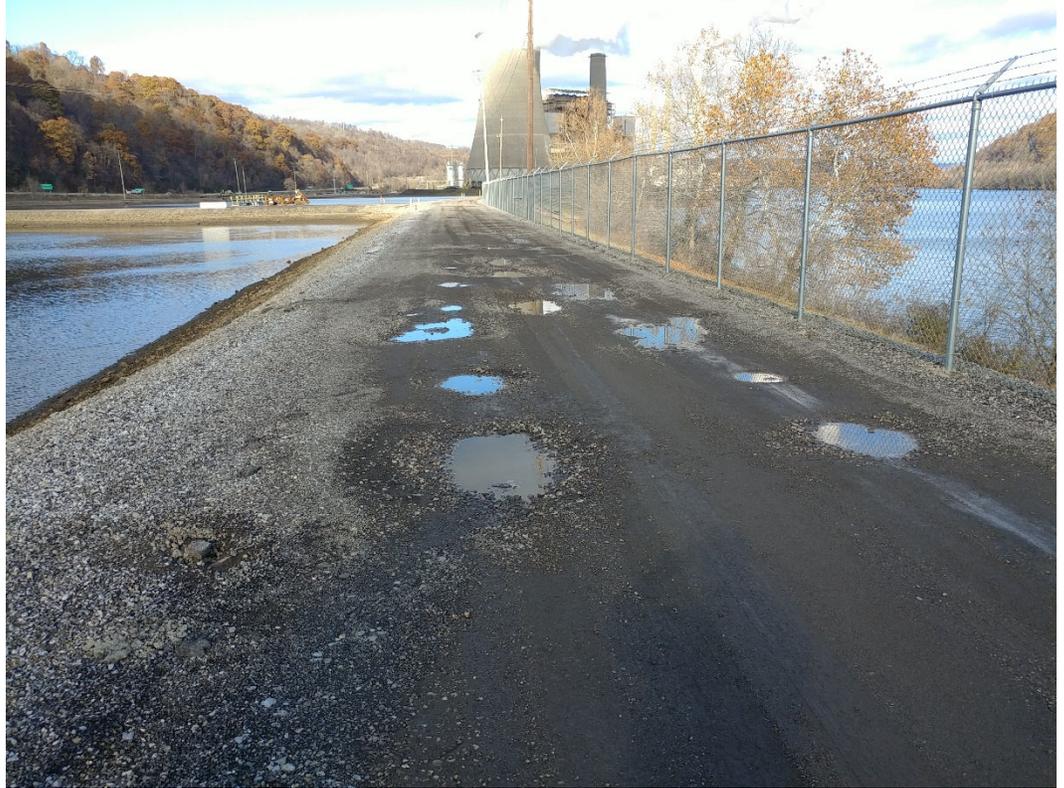
Photo No. 9	Date: 11/22/19
Direction Photo Taken: North	
Description: View of the crest area of the exterior slope along the Ohio River. Minor potholes were observed intermittently.

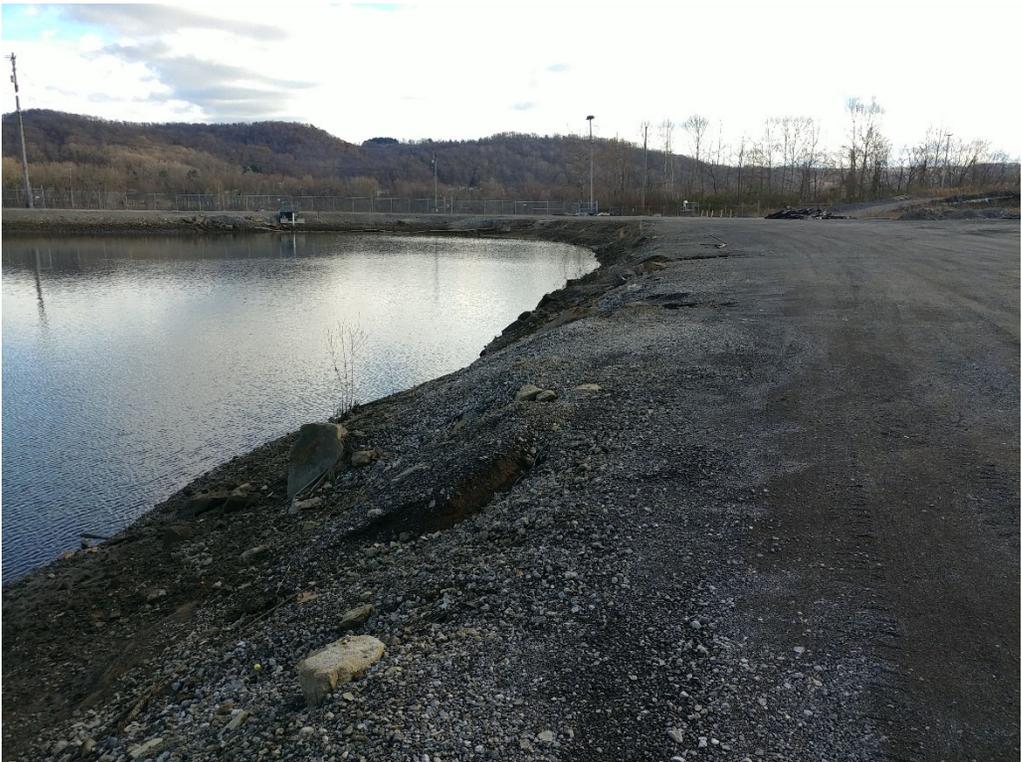
Photo No. 12	Date: 11/22/19

A photograph showing the interior slope of a pond. The foreground is a gravelly bank with some erosion channels. The water is calm and reflects the sky. In the background, there are trees and a fence line.
Direction Photo Taken: Southeast		
Description: View of the interior slope of the SW corner of the Bottom Ash Pond. Minor erosion channels along top of bank noted.

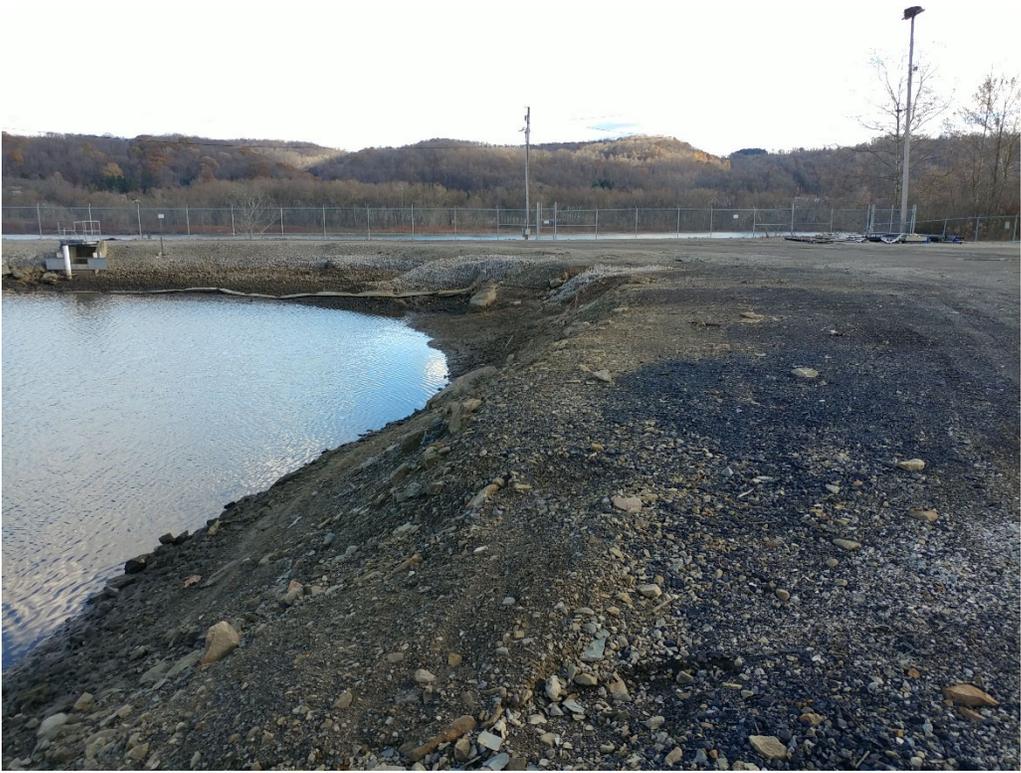
Photo No.: 13	Date: 11/22/19

Direction Photo Taken: East		
Description: View of the interior slope of the Bottom Ash Pond. Minor erosion channels along top of bank noted.

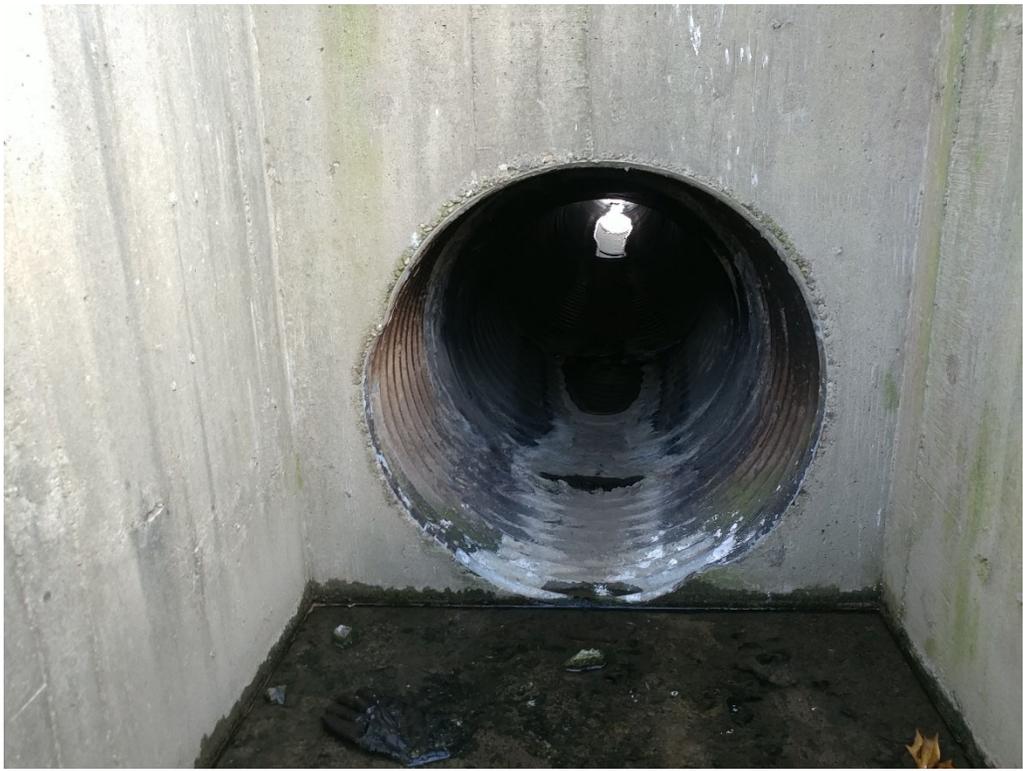
Photo No.: 15	Date: 11/22/19

Direction Photo Taken: East		
Description: View of interior of overflow sluiceway from overflow structure. Sluiceway appears to be generally clear of obstructions.
