2019 Annual Dam and Dike Inspection Report

Cardinal Plant Fly Ash Dams 1, 2 & Bottom Ash Complex

Project Number 60613809

January 2, 2020

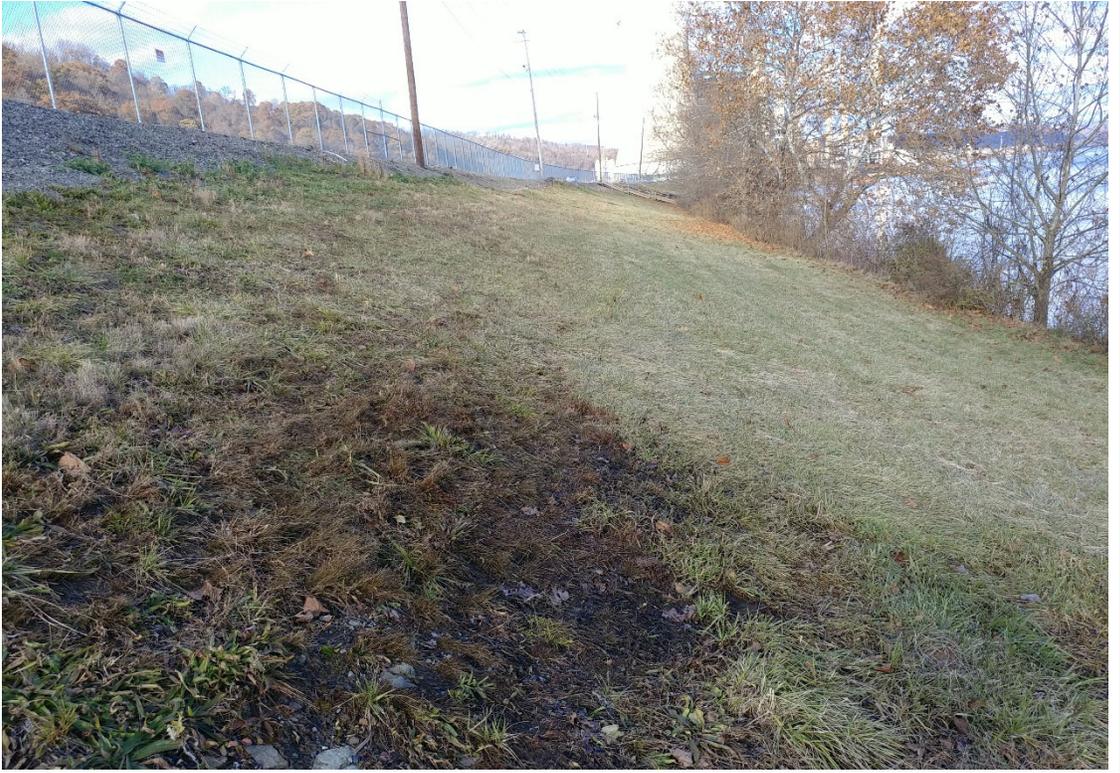
Photo No. 17	Date: 11/22/19

Direction Photo Taken: East		
Description: View of seepage on the face of the eastern dike slope.

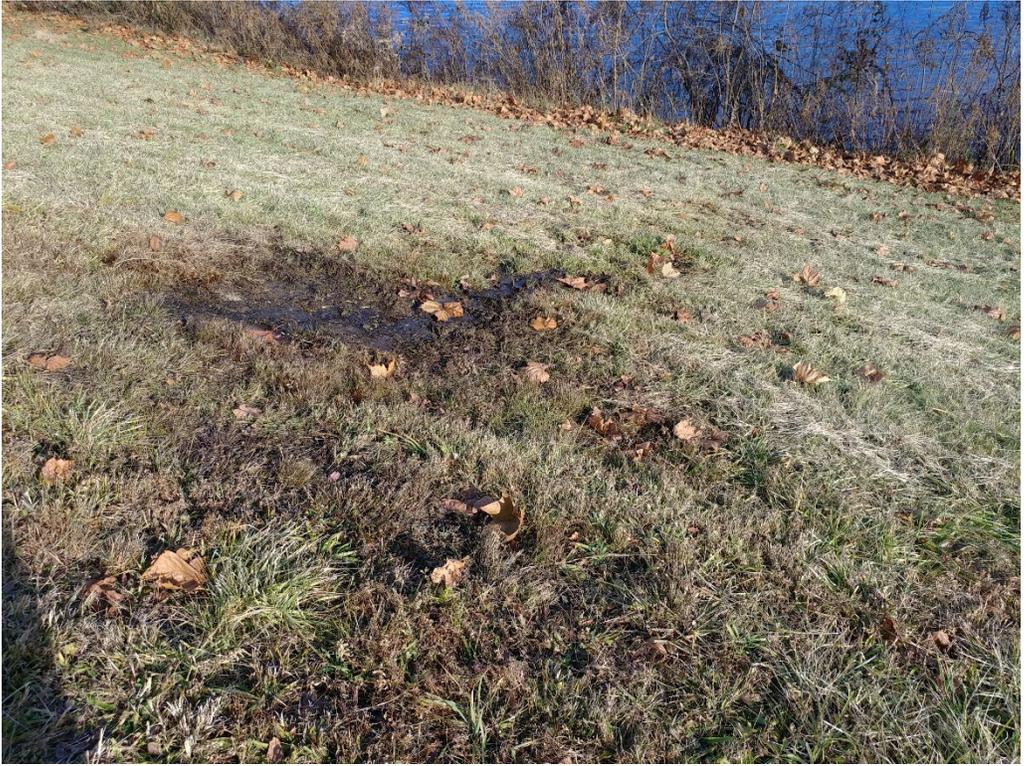
Photo No. 18	Date: 11/22/19

Direction Photo Taken: Northeast		
Description: View of seepage on the face of the eastern dike slope.

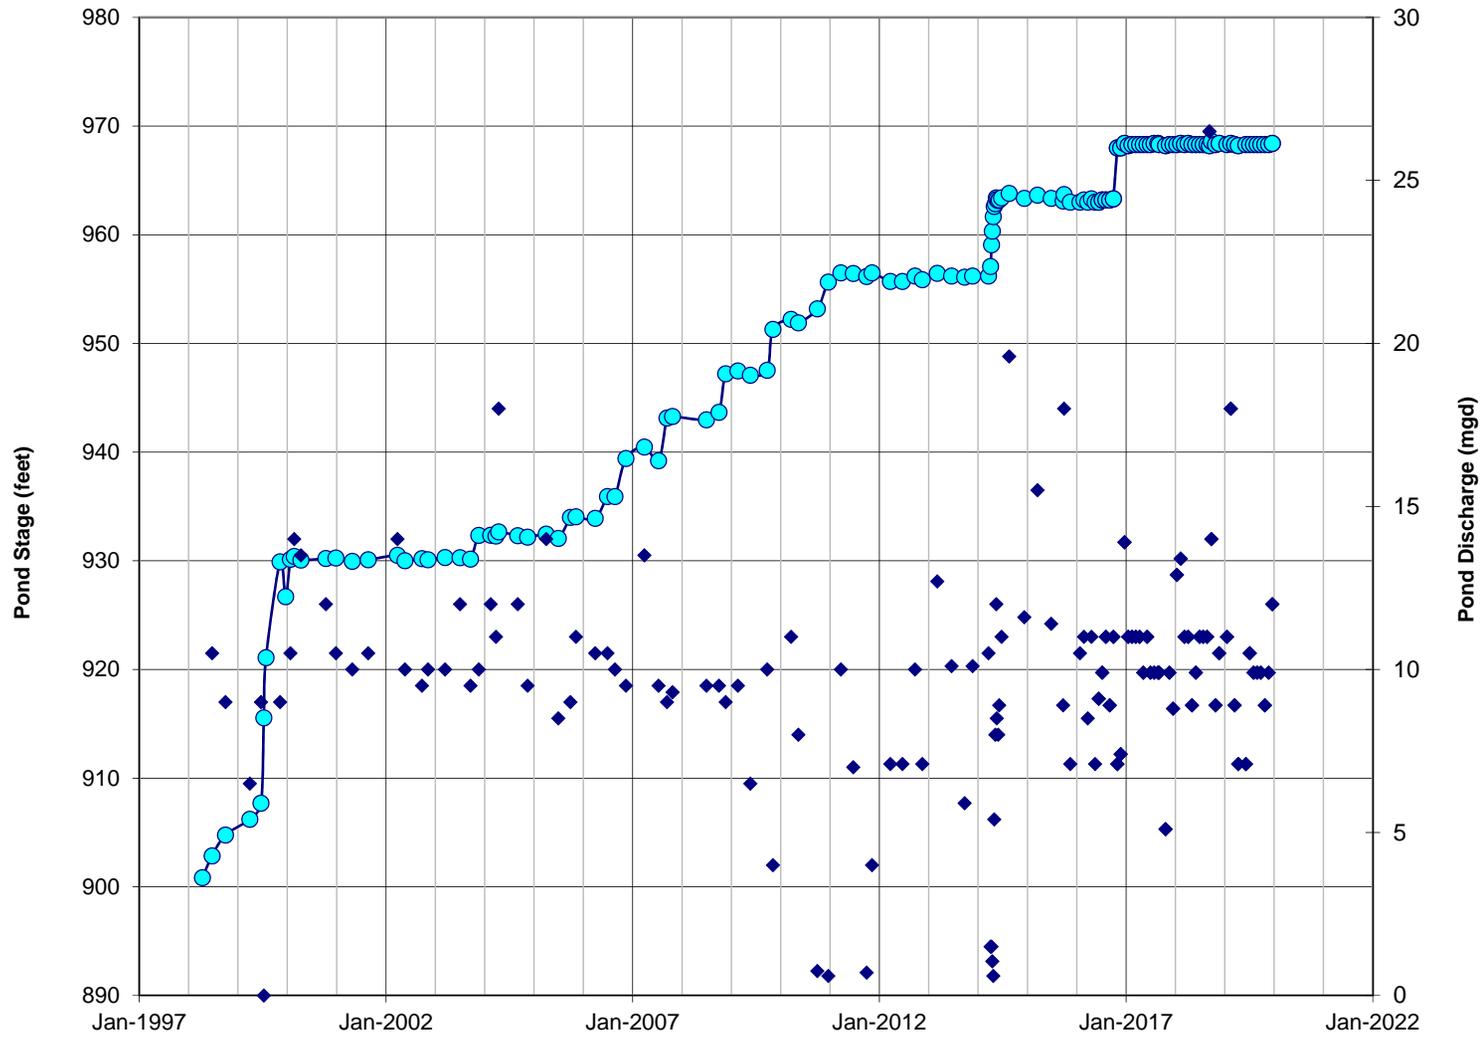
Figure 5b
Pool Stage versus Discharge
Cardinal FAD 2

The most recent flow volumes are presented in tables in Appendix F, along with the locations of the seepage drains in Figure 7. Figure 5b presents historical pond discharge at the Parshall Flume (Drain No. 14) versus the pond stage. Discharge rates in 2019 have generally been within the previously observed range.

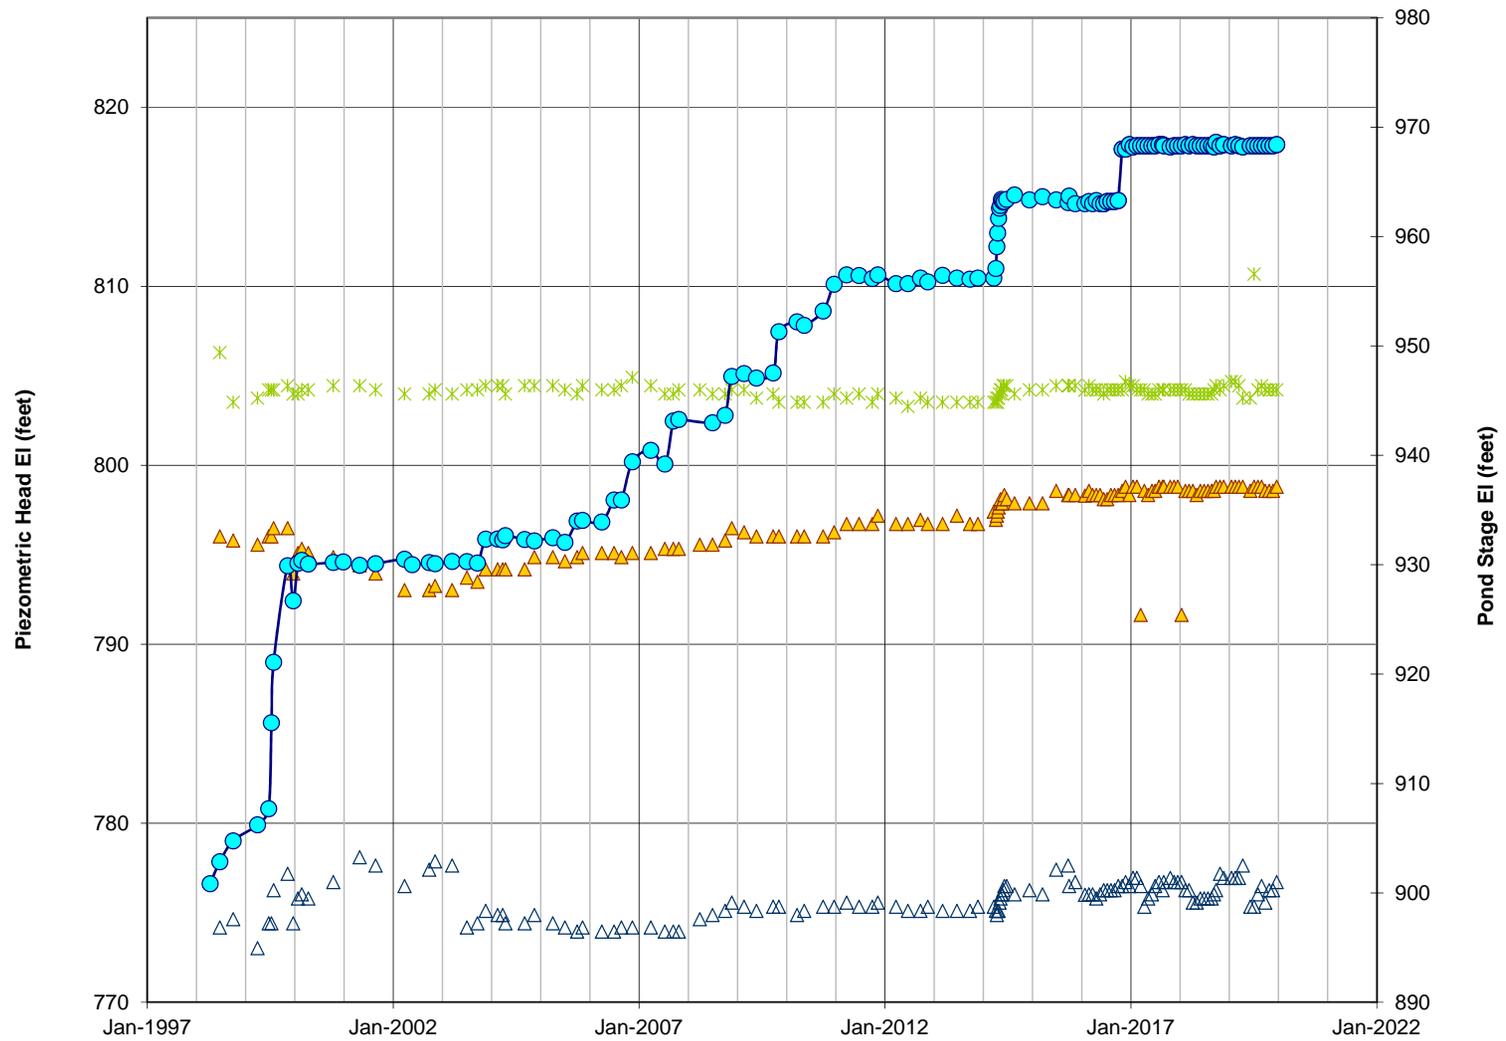
Figure 5c
Cardinal FAD 2
Right of Center
Foundation Piezometers

2. Water levels in the shallow (P-8A, P-11A), intermediate (P-8B, P-11B), and deep foundation (P-9, P-10) piezometers were consistent with historical readings (Figures 5c and 5d).
