2020 Annual Dam and Dike Inspection Report

Cardinal Plant
Fly Ash Dams 1, 2 & Bottom
Ash Complex

Cardinal Operating Company
306 County Rd. 7E
Brilliant, Ohio 43913

January 10, 2021

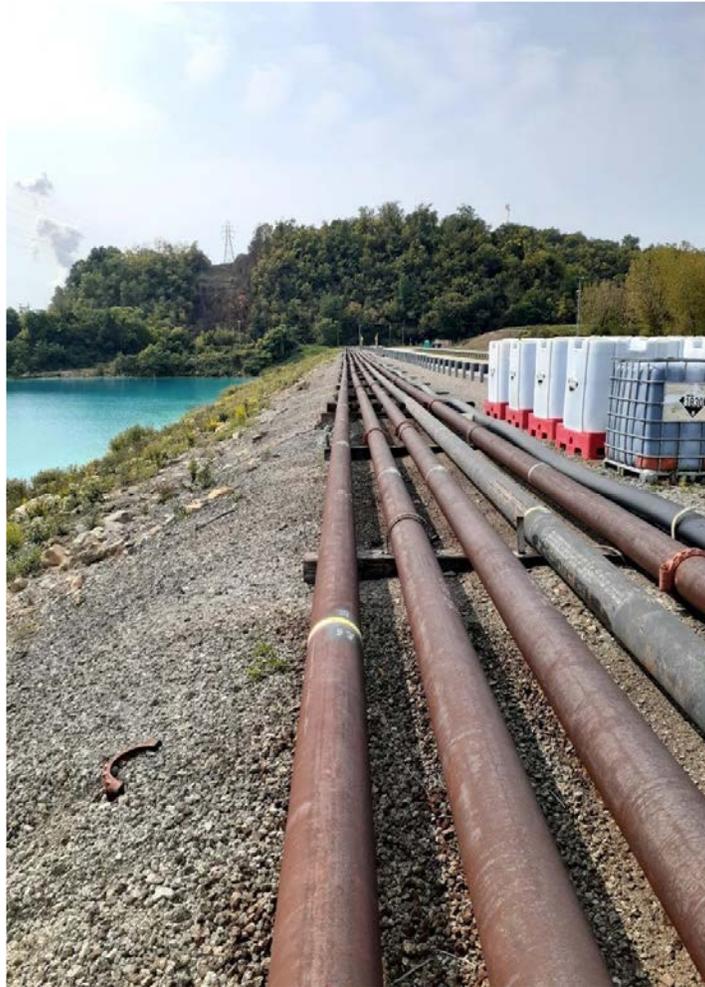
Photo No.1

1. The crest of the dam was in good condition, with no signs of significant erosion, rutting, or misalignment (Photo 1). The crest of the dam supports the plant's ash sluice lines along with

FAR 1 dam crest & fly ash sluice pipelines/landfill access road.

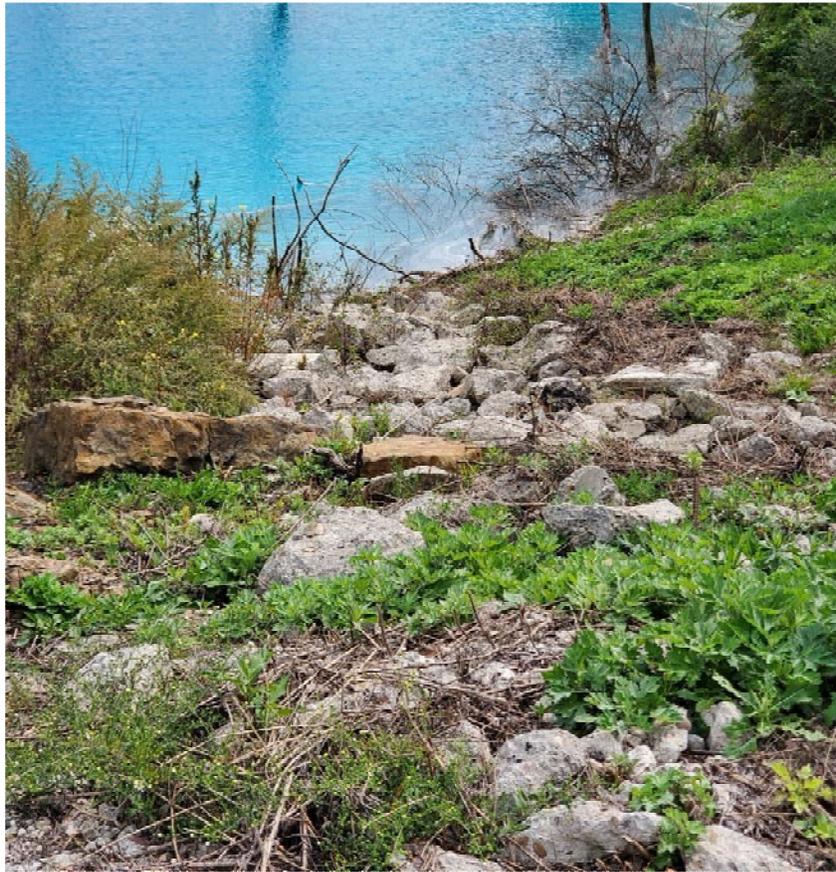
Photo No.3

2. No significant erosion was observed along the groin areas, areas of overgrown woody vegetation observed in 2019 have been cleared. The left groin shows no significant erosion or displacement of its rip rap (Photo 2). A close-up view of the rip rap shows that it is in good condition with no significant weathering (Photo 3).

Close up view showing the good condition of the rip rap placed with the groin ditch but weedy vegetation is encroaching into the ditch and left abutment

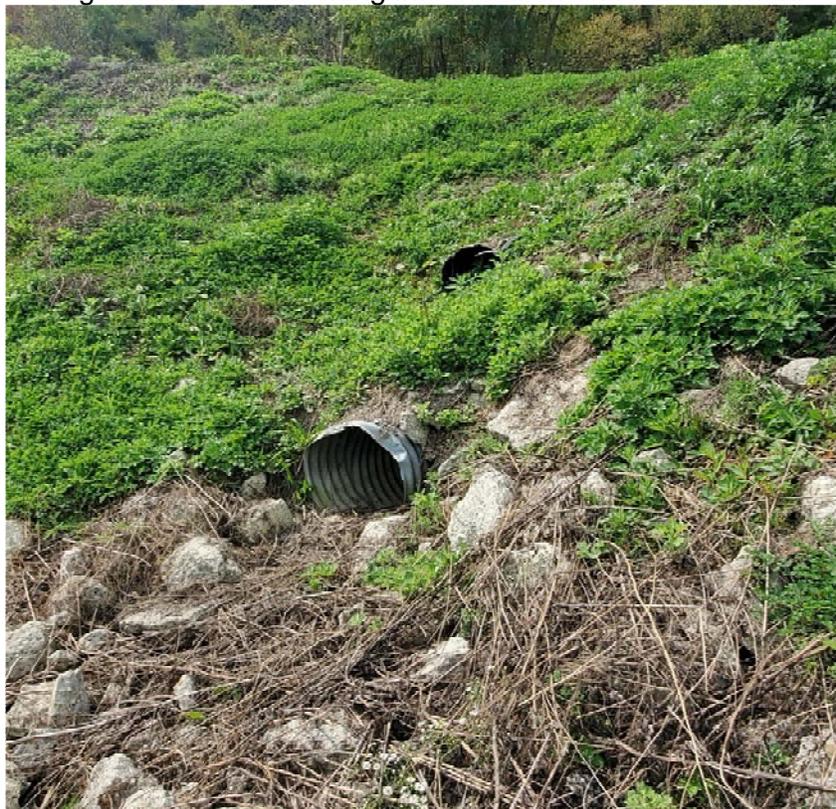
Photo No.4

3. A surface water drainpipe discharges near the crest of the right abutment (Photograph No. 4). The flow line is well protected with large riprap and no signs of erosion or deterioration has been noted.

Typical view showing the right groin ditch and alignment of road culvert.

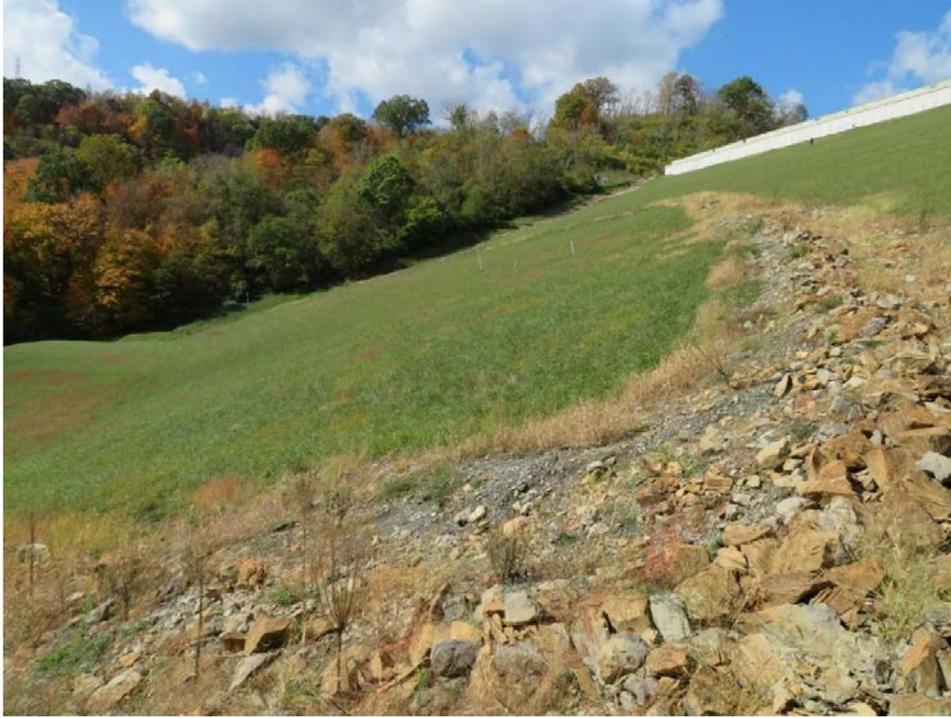
Photo No.3

Close up view of storm water diversion berm and downstream slope showing good vegetative grass cover.

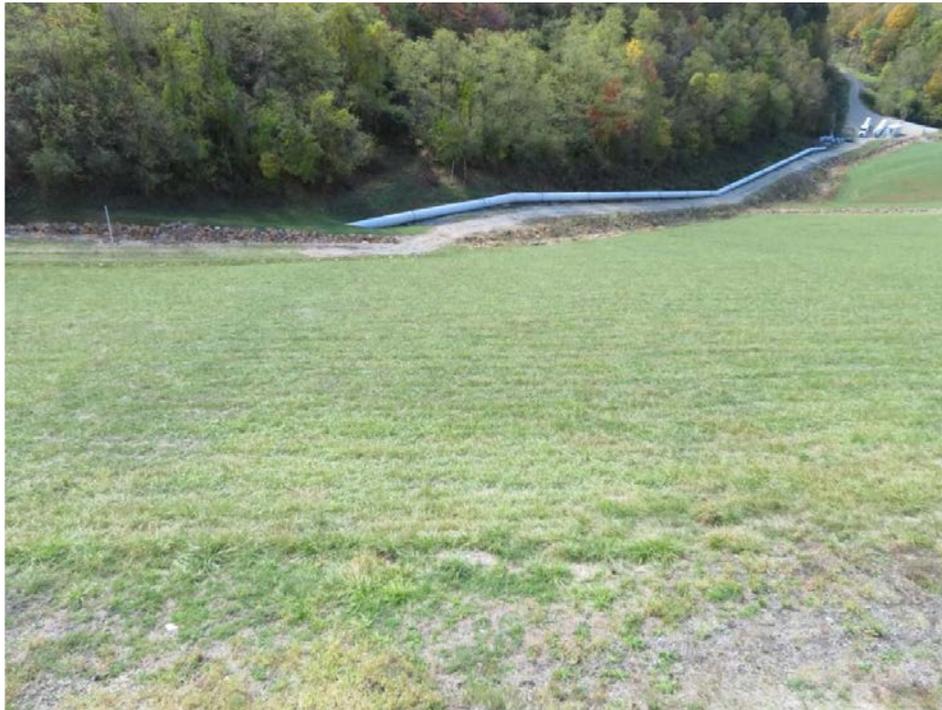
Photo No.4

Typical view of the left groin ditch and FAR 2 discharge pipe.

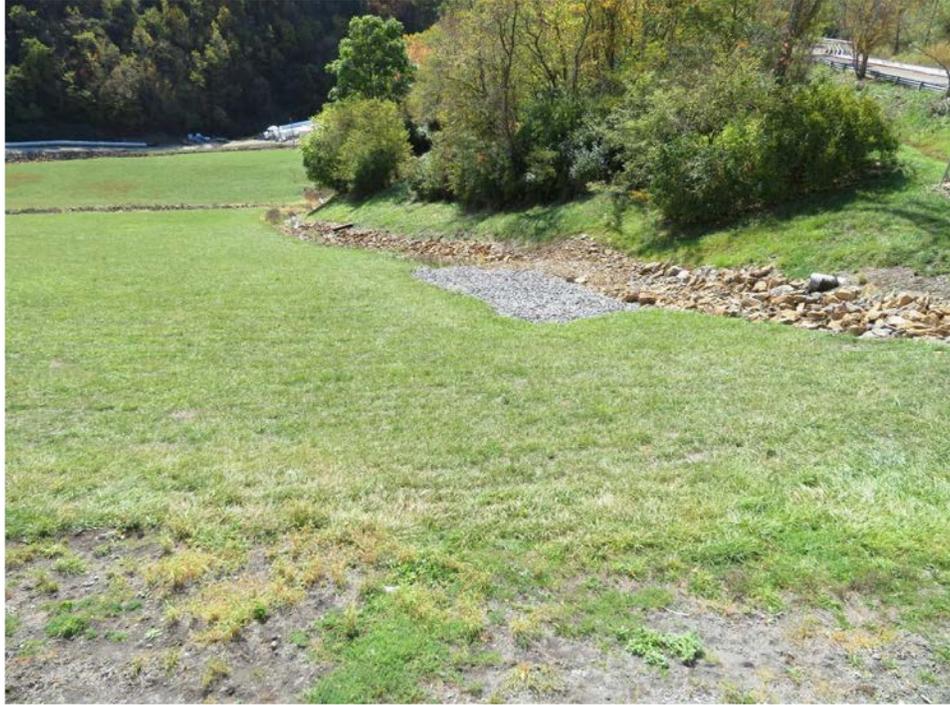
Photo No.5

Typical view of the right groin ditch and inverted filter drainage blanket installed to control seepage on the face of the dam.

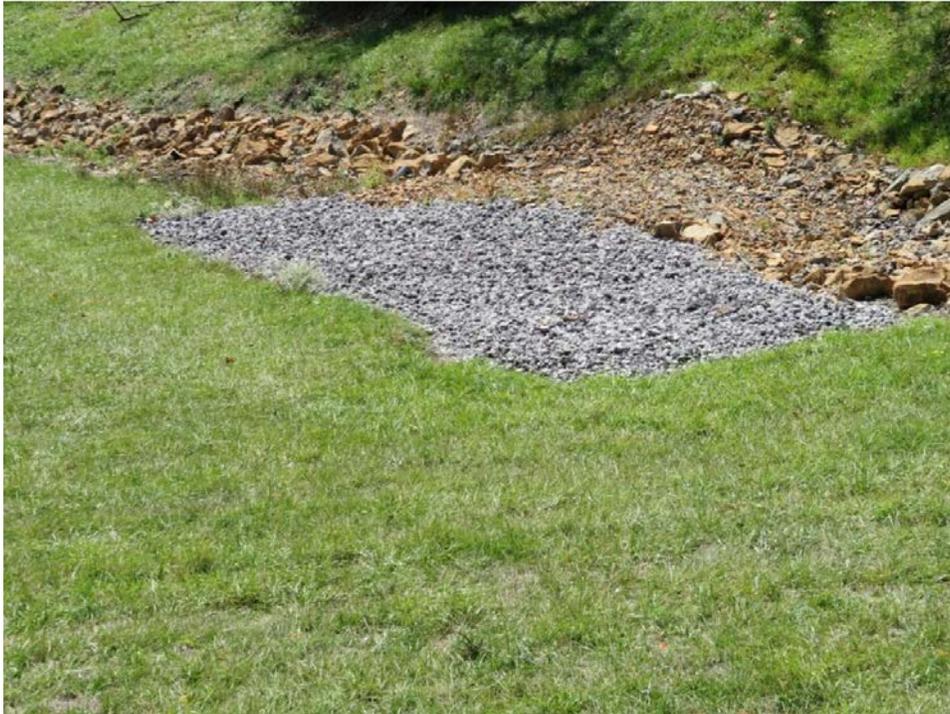
Photo No.6

Close up view of drainage blanket adjacent to the right groin ditch.

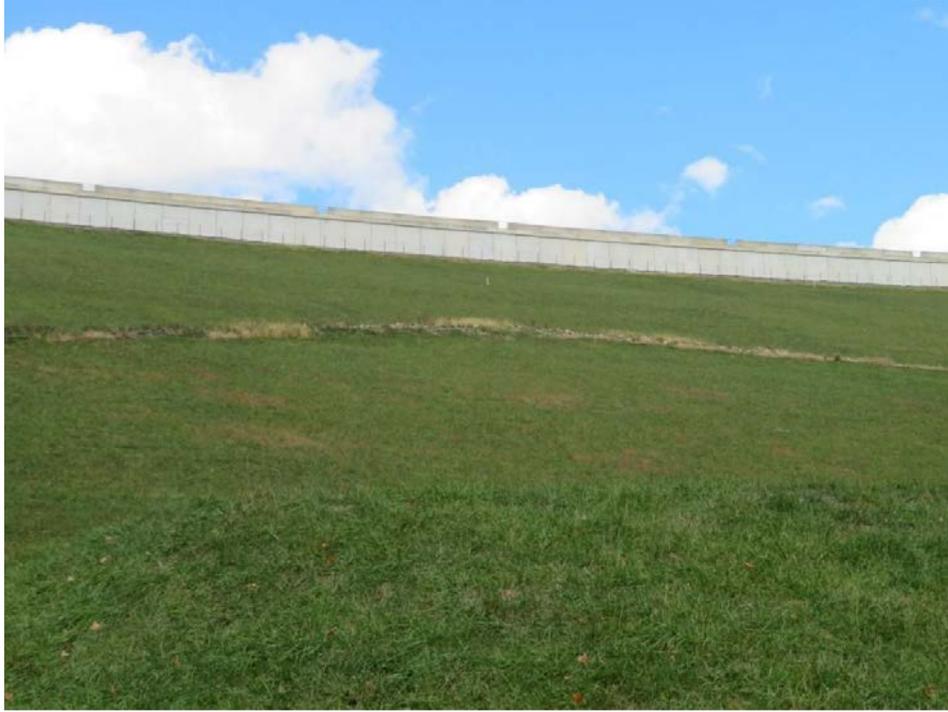
Photo No.7

Typical view looking upslope from the bench to the top of the dam along the right groin ditch.

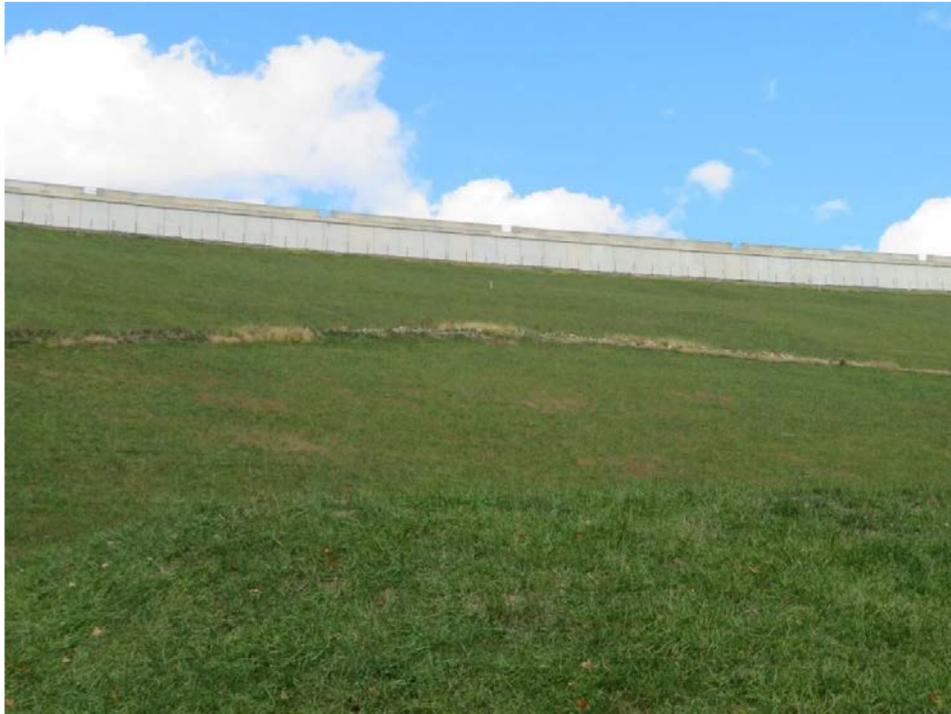
Photo No.8

View looking upslope from the toe of the dam showing a uniform slope, no significant erosion, bulges, slumps, or other signs of mass movement.

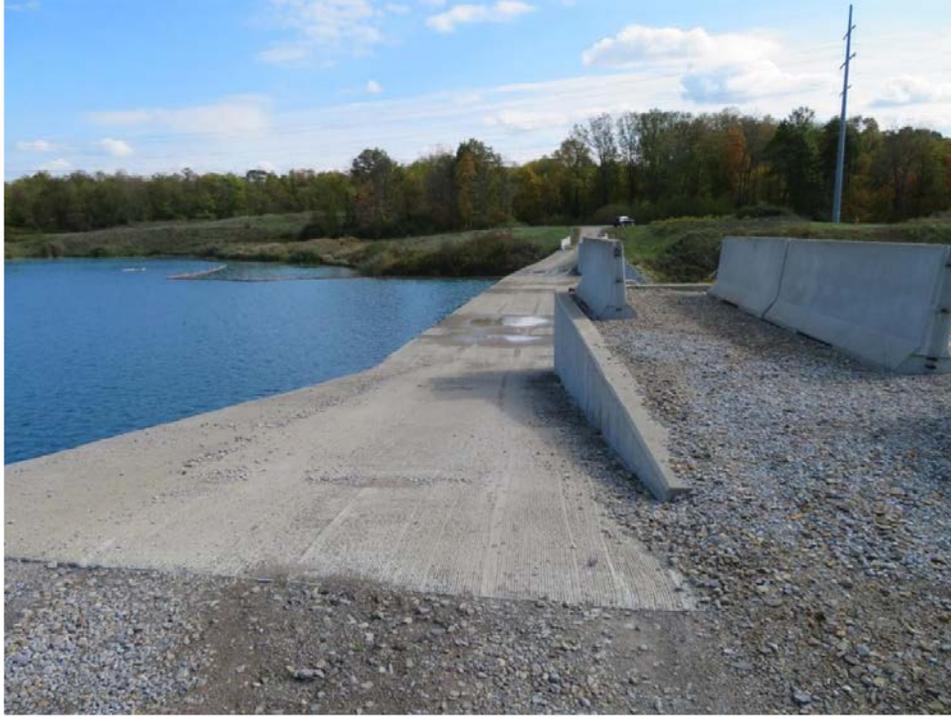
Photo No.9

View looking along the top of the emergency spillway showing unobstructed conditions.

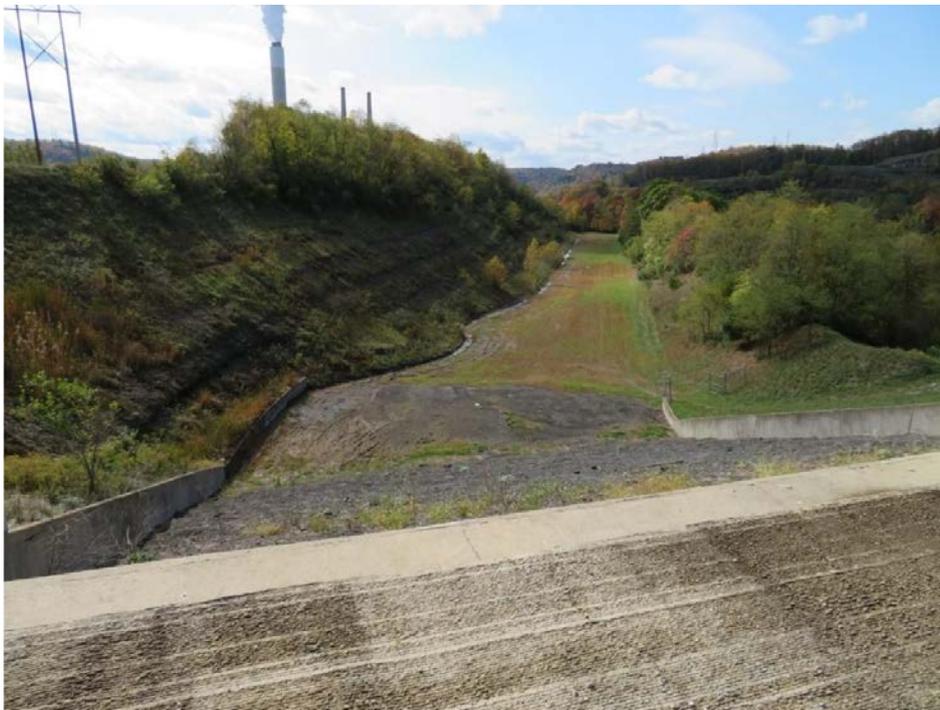
Photo No.10

View of emergency spillway channel showing good conditions.

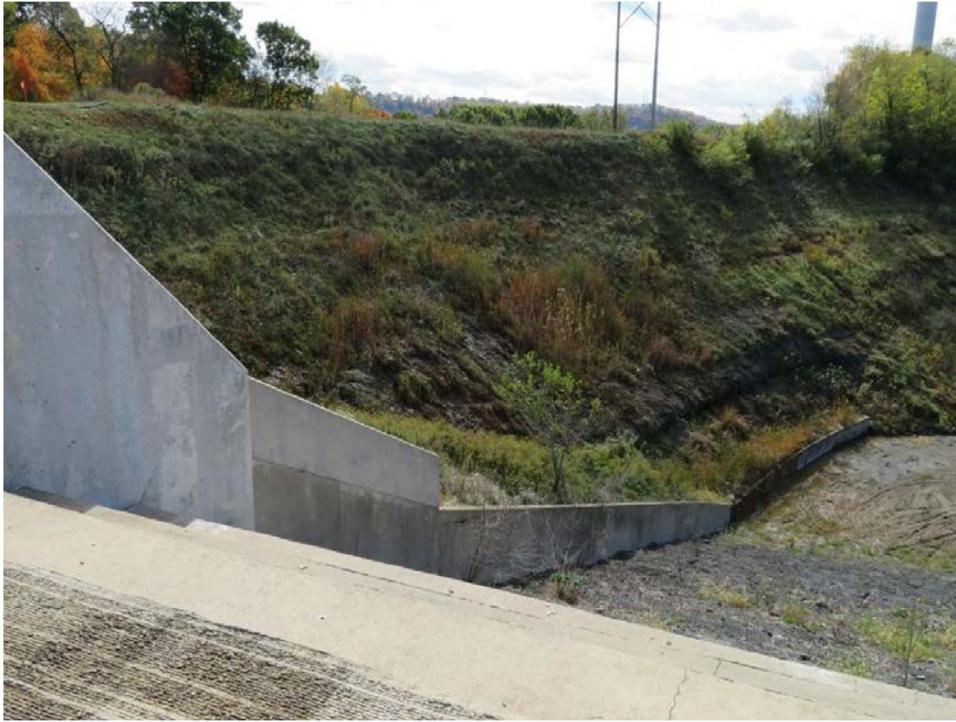
Photo No. 11

3. The emergency spillway has a plain concrete overflow section at the crest that transitions along the downstream slope to the RCC steps between the concrete retaining walls. The concrete steps appeared to be in good condition while the spillway's 2-ft high RCC steps continue to weather (Photo 11). The concrete sidewalls of the spillway are in fair condition.

View of emergency spillway channel. Seepage is collected from the left hillside and conveyed towards the end of the channel to be discharged through Drain No. 12.

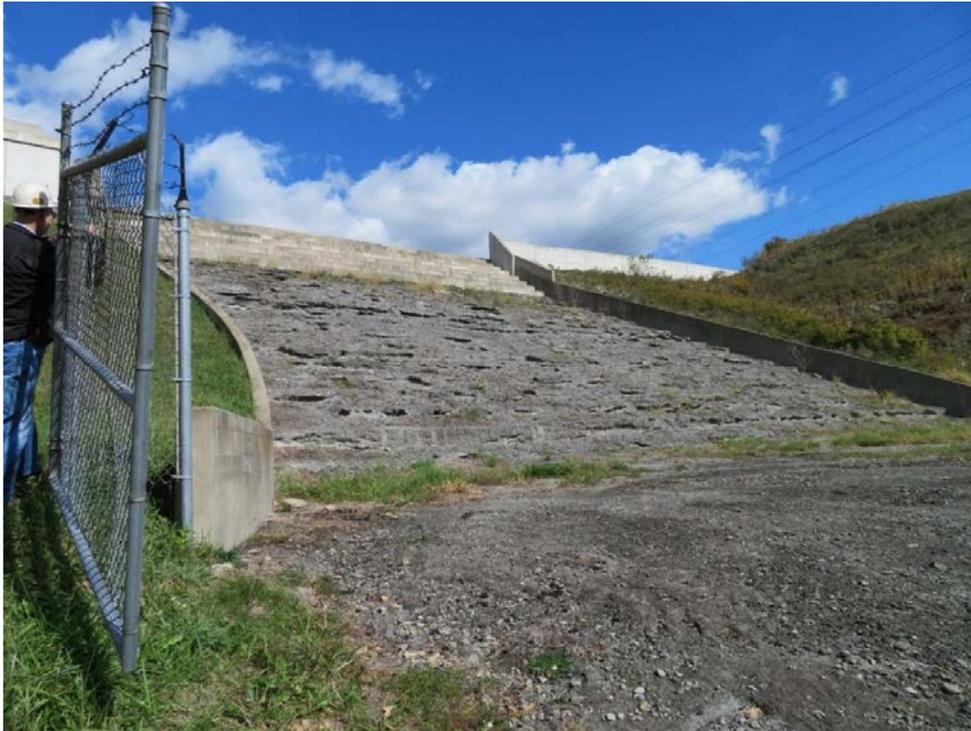
Photo No.12

View of the upper part of the spillway showing the Stage 3 massive concrete steps overlying the Stage 2 RCC (roller compacted concrete) and the right retaining wall.

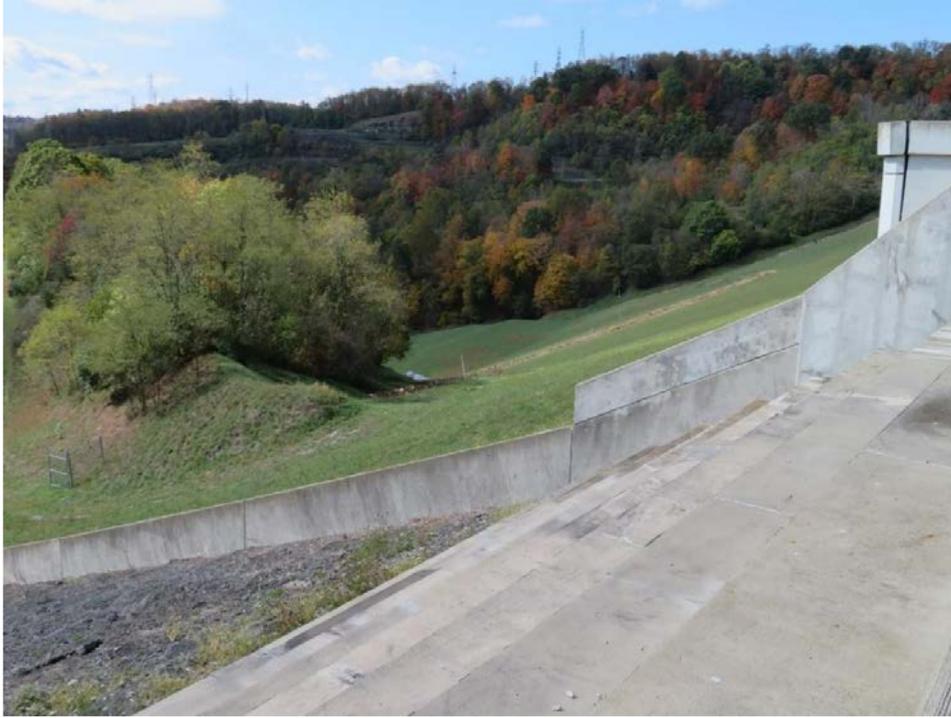
Photo No.13

View of the right retaining wall and the terminal end point of the Stage 3 MSE wall showing separation at the corner post.

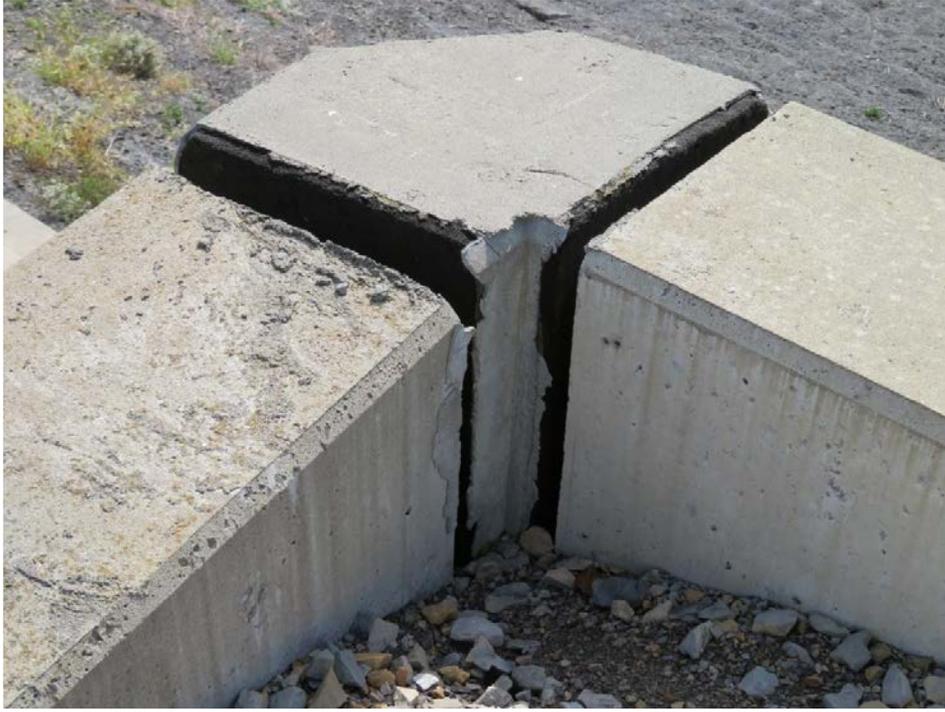
Photo No.15
View looking at the top of the MSE wall corner post.

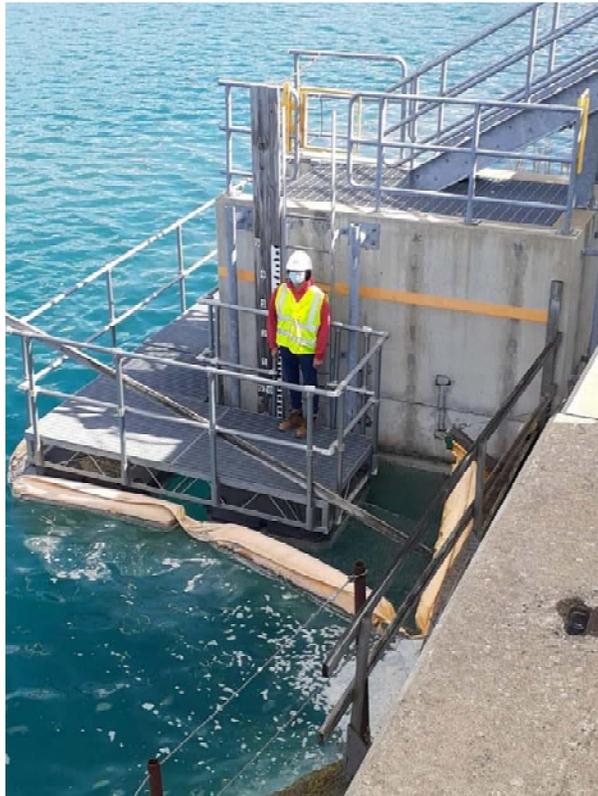
Photo No.16
Typical view of decant structure showing good conditions.

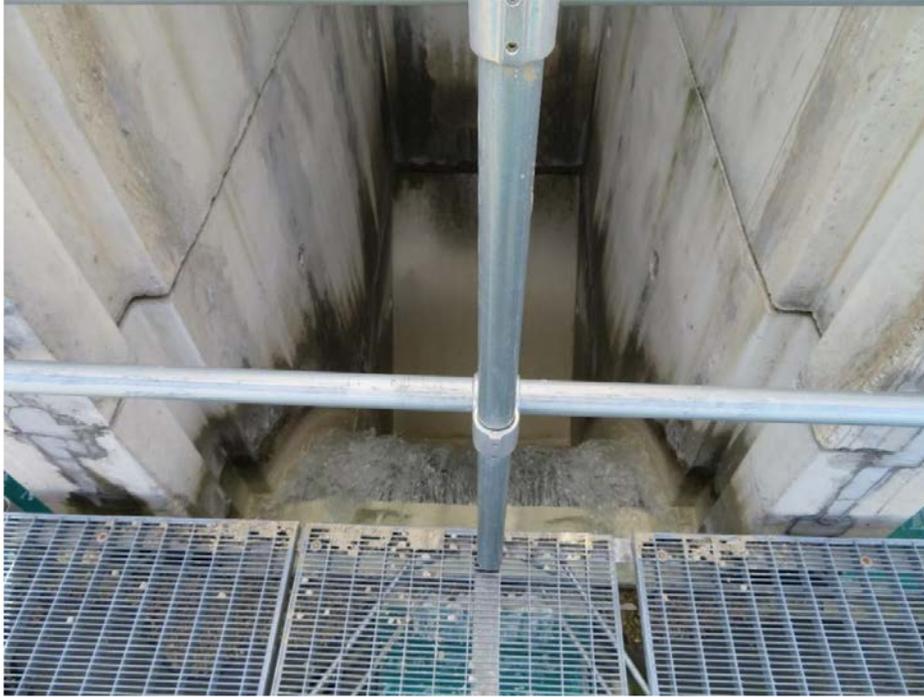
Photo No.17

View of pond effluent being discharged into the decant structure.

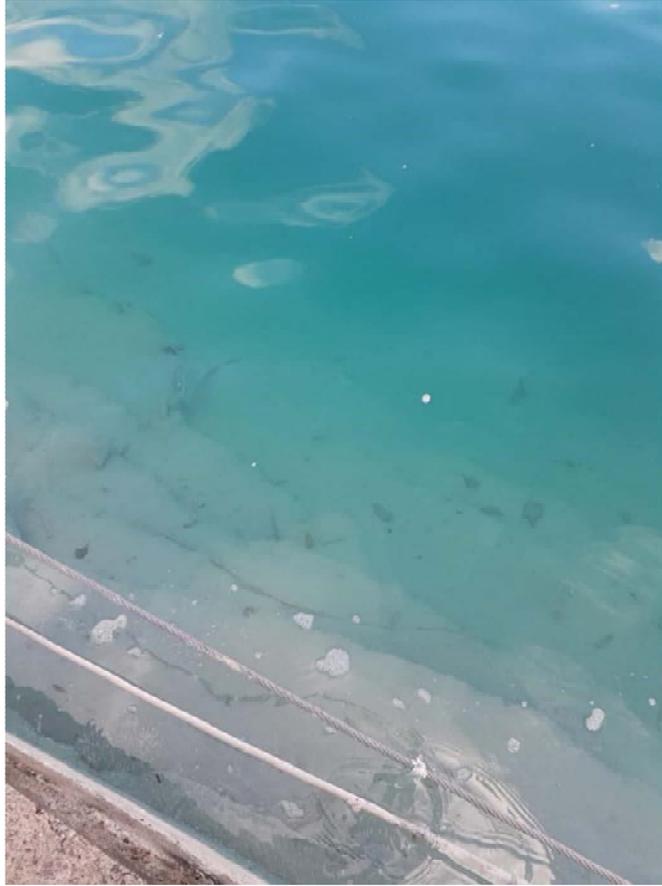
Photo No.19

View of the inundated RCC showing satisfactory conditions. No slumping or wave cut erosion was observed and water clarity was very good.

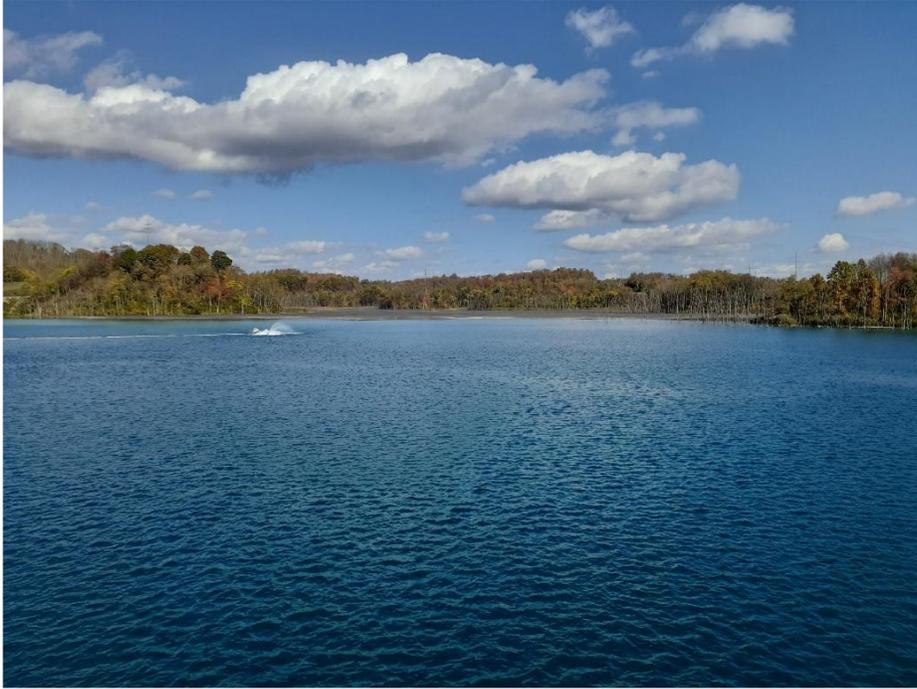
4. The principal spillway structure appeared to be in good condition, with no obstructions at the stop-log structure and no signs of instability on the riser or staircase. There was no visual evidence of significant differential movement of the structure/skimmer chute or steps. The principal spillway access walkway, stairways, staff gauge, and other metal structures were in good condition (Photos 16 to 18). The inundated RCC wall appeared to be in good condition and did not show any wave cut erosion. The pond water clarity allowed observation of the inundated RCC to an approximate depth of 12 to 14 and was observed to be stable with no scour erosion, slumping or wave cut erosion (Photo 19). Photo 20 provides a view of the FAR 2 pool at the time of the inspection.

Photo No.20
View of the FAR 2 pond viewed from the decant structure.

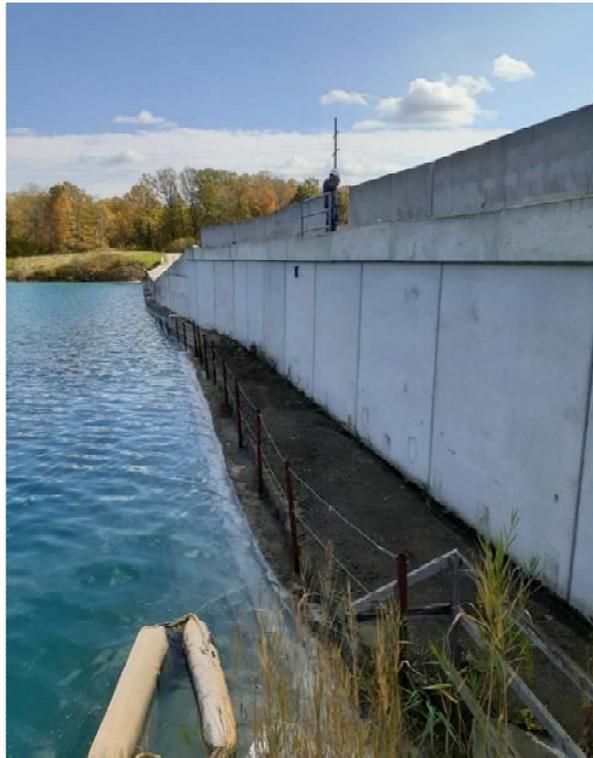
Photo No.21
View of the upstream MSE wall showing good conditions towards the emergency spillway.

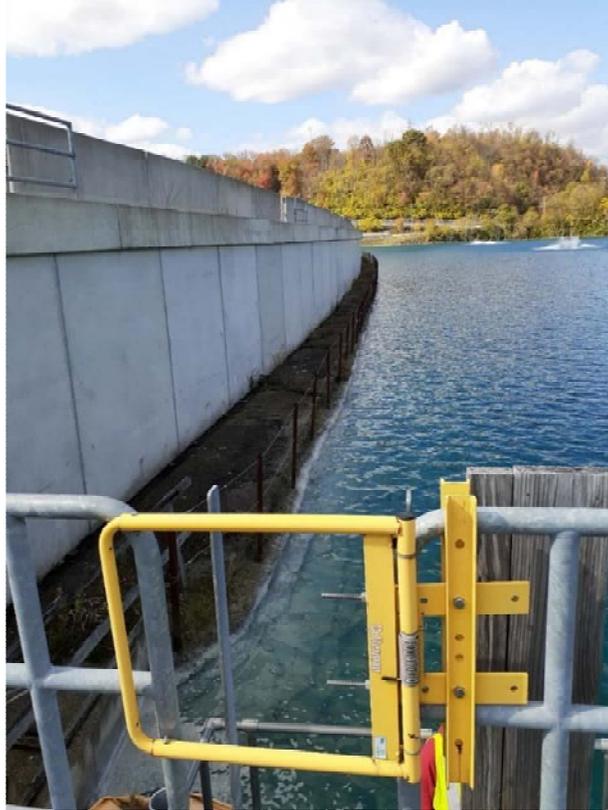
Photo No.22

View of the upstream MSE wall showing good conditions towards the right abutment.

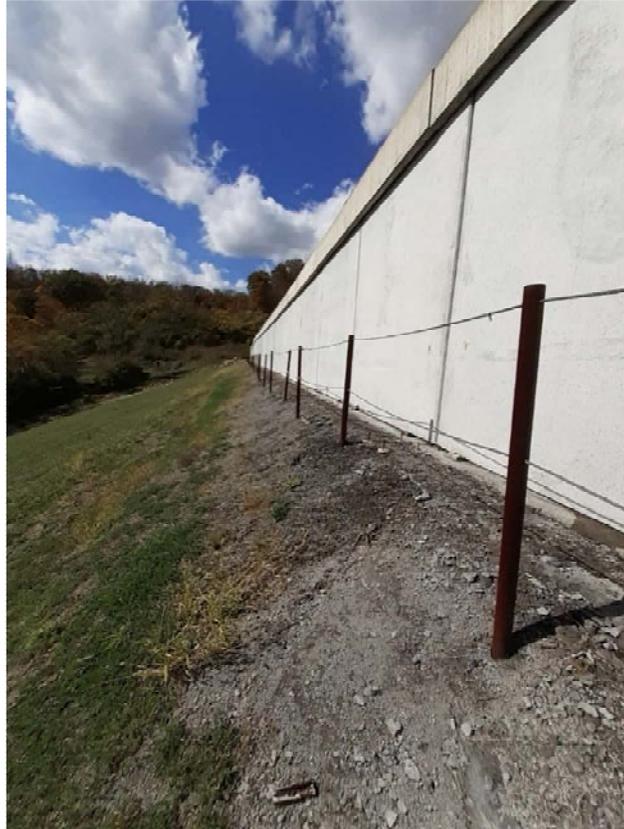
Photo No.23

View of the MSE wall on the downstream side of the wall showing good conditions looking towards the right abutment.

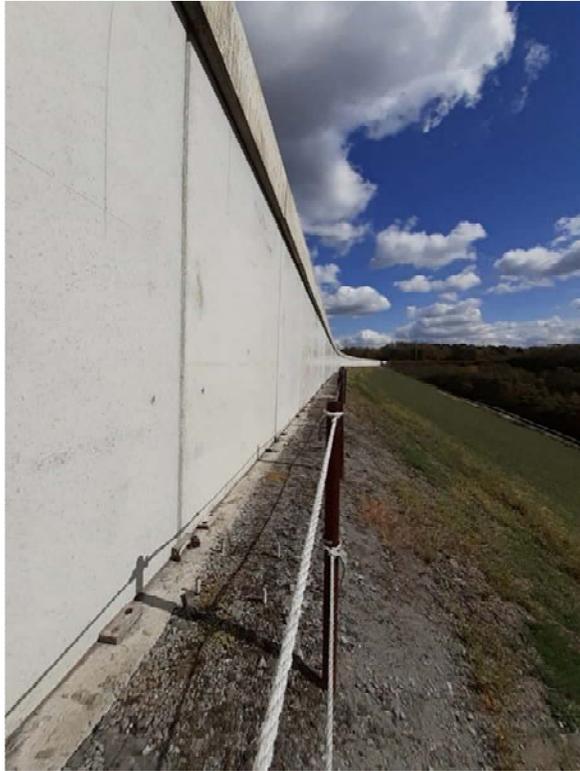
Photo No.24

View of the MSE wall on the downstream side of the wall showing good conditions looking towards the left abutment.

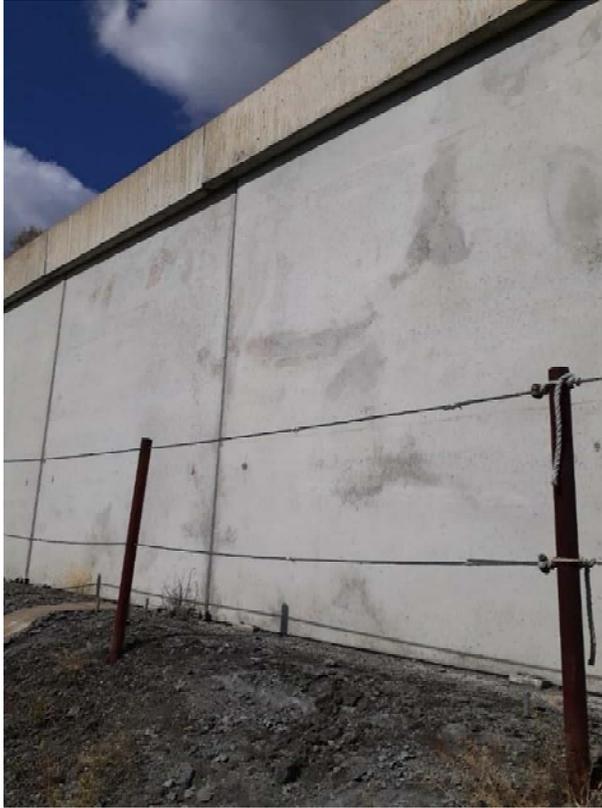
Photo No.25

2. Photos 25 and 26 provide a close-up view of the MSE wall showing good conditions and unobstructed drains at the base of the wall.

Close up view of the MSE wall on the downstream side of the wall showing good conditions (no cracking, spalling or misalignment).

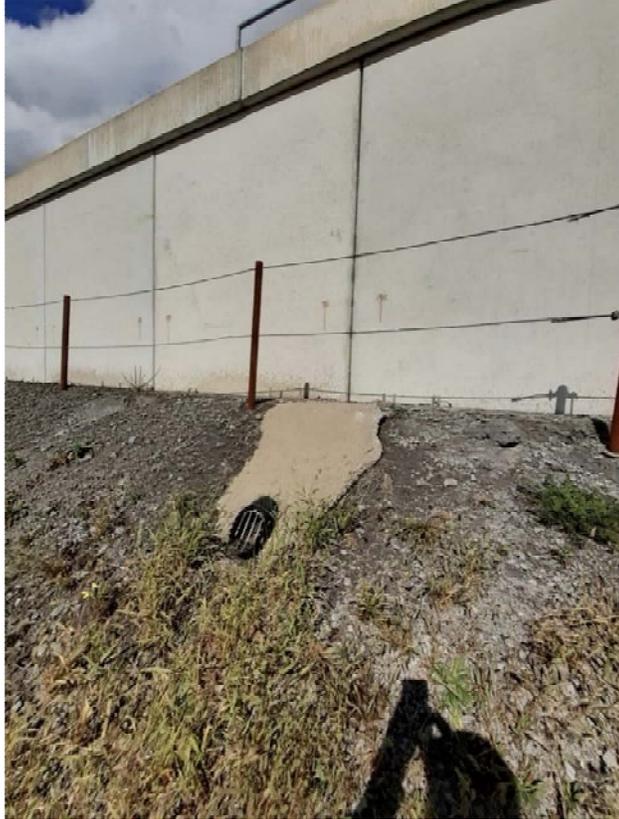
Photo No.26

Close up view of the drainage outlet showing the animal guard and no erosion was observed.

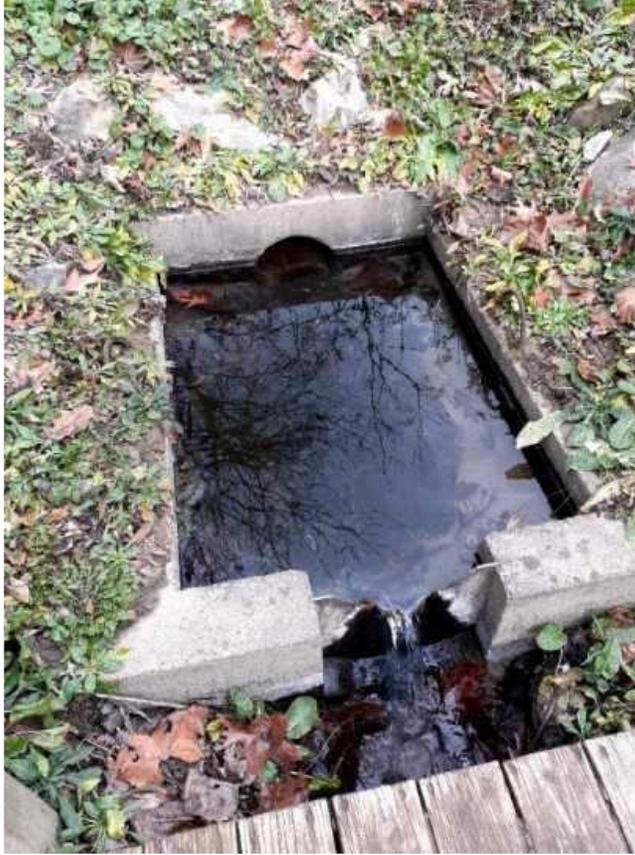
Photo No.27

1. Drain No 1, the chimney/toe drain, was observed to be in fair condition due to the pool behind the V-notched weir having significant algae growth within the pool (Photo 27). The discharge was observed to be visually clear.

View of drain # 1 of the chimney/toe drain system with a measured discharge approximately 23 gpm.

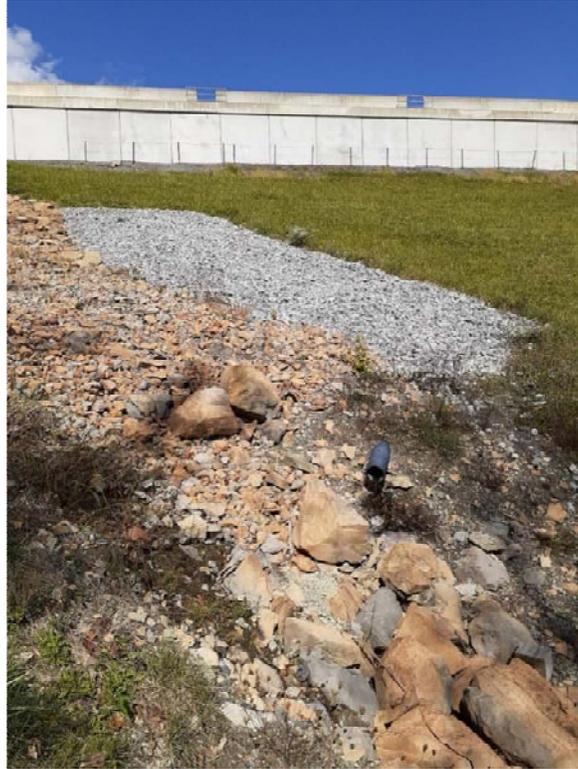
Photo No.32

View of "new" drain collecting seepage from the drainage blanket discharging into the right groin ditch. The discharge was observed to be steady at approximately 4 gpm and was visually clear.

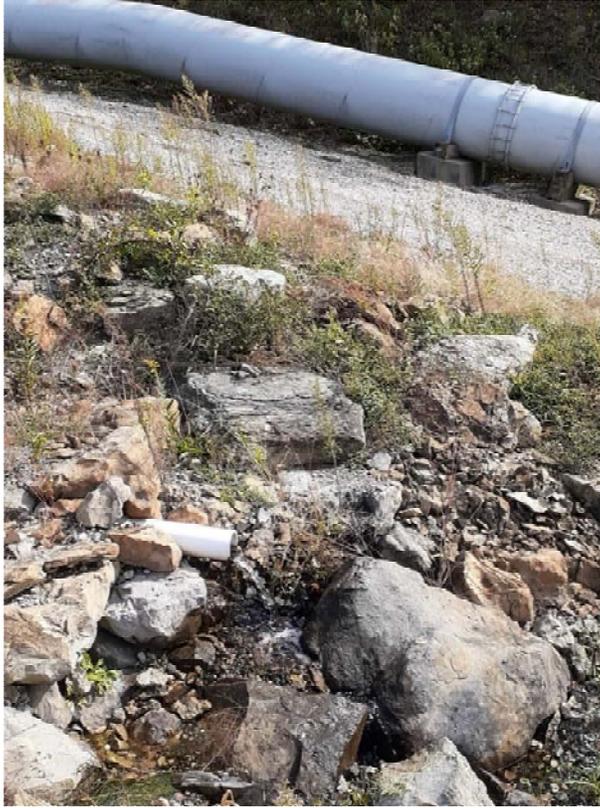
Photo No.33

View of drain # 8 discharging approximately 5 gpm into the left groin ditch. The discharge was visually clear.

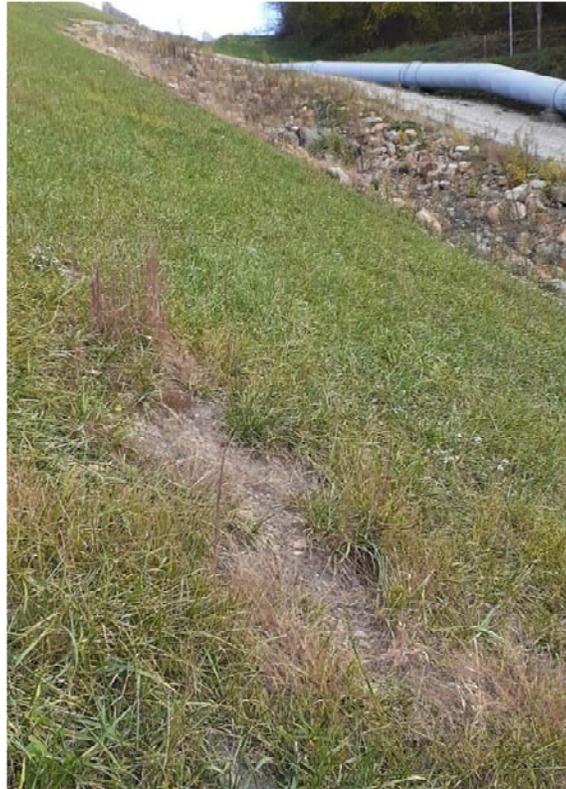
Photo No.34

View of an ephemeral wet weather spring/ bare ground during dry conditions.

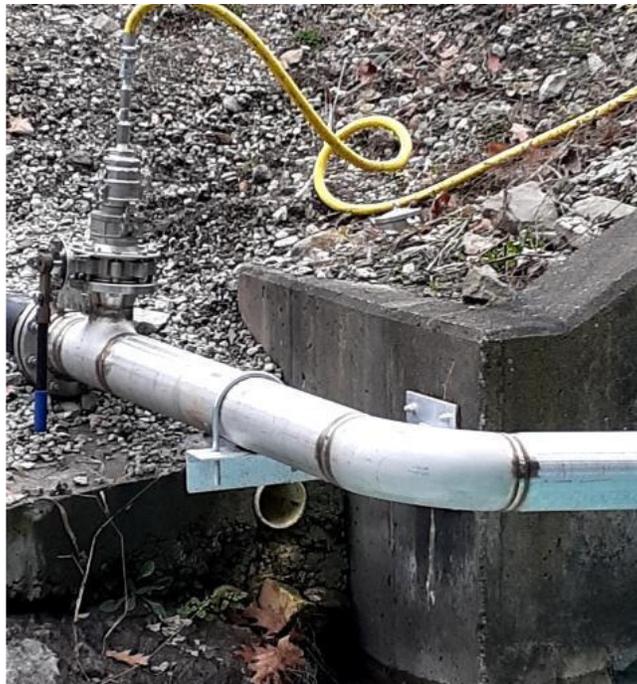
Photo No.35

View of drain # 5 located along the right side of the dissipator structure showing a negligible discharge.

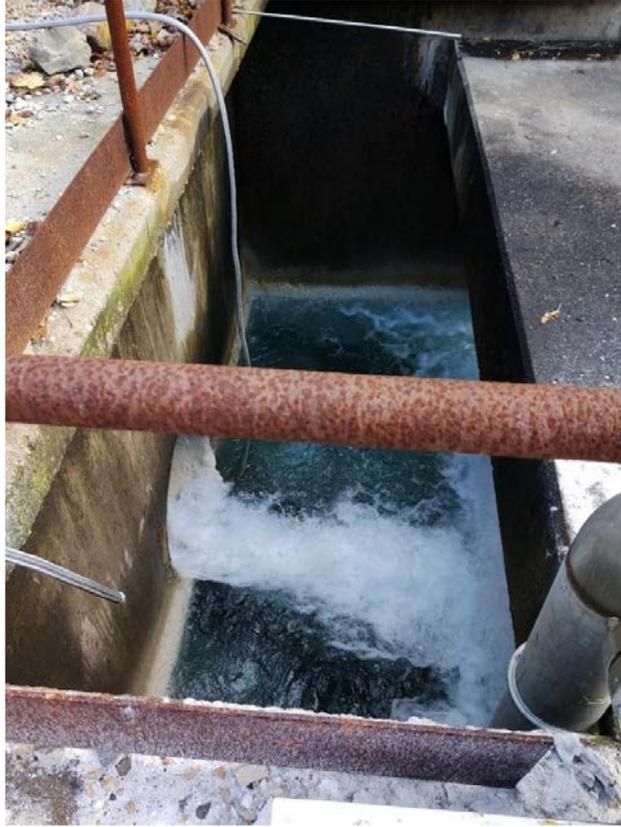
Photo No.38

View of the energy dissipator structures upper chamber showing good conditions.

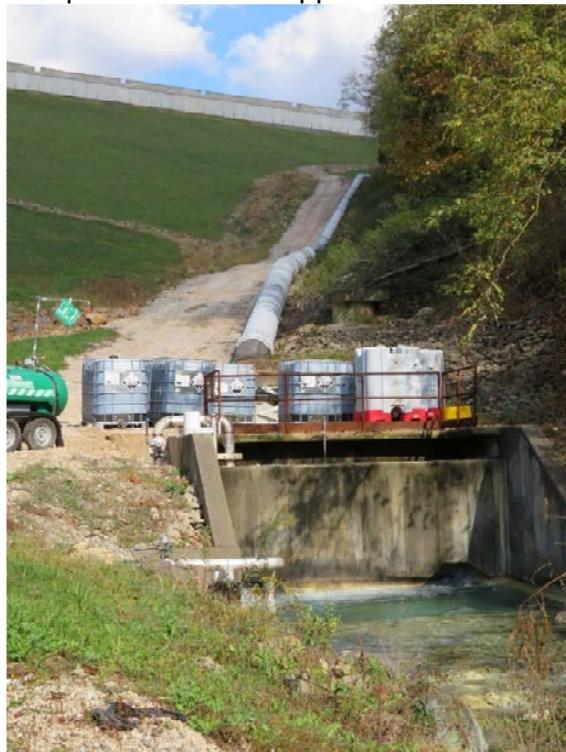
Photo No.39

View of Energy dissipator discharging into the main channel.

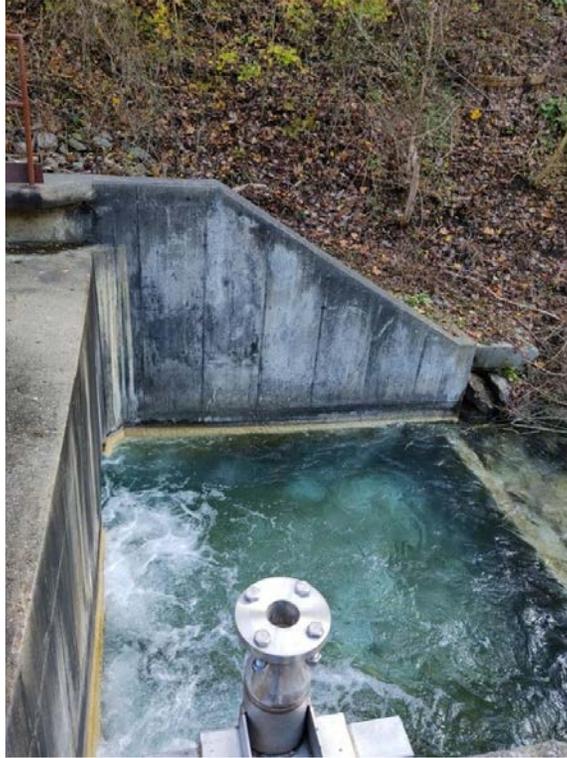
Photo No.40

View of the energy dissipator structures lower chamber showing good conditions.

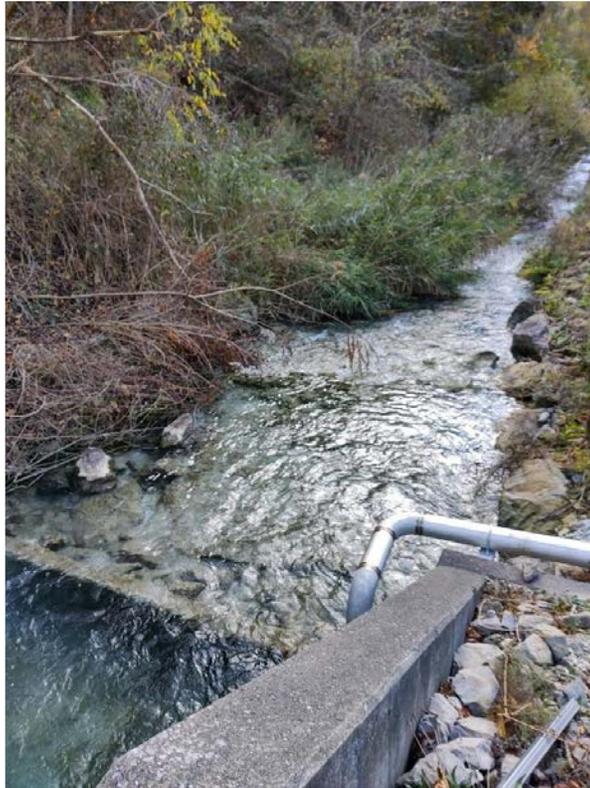
Photo No.41

View of main channel showing flow towards the concrete flume.

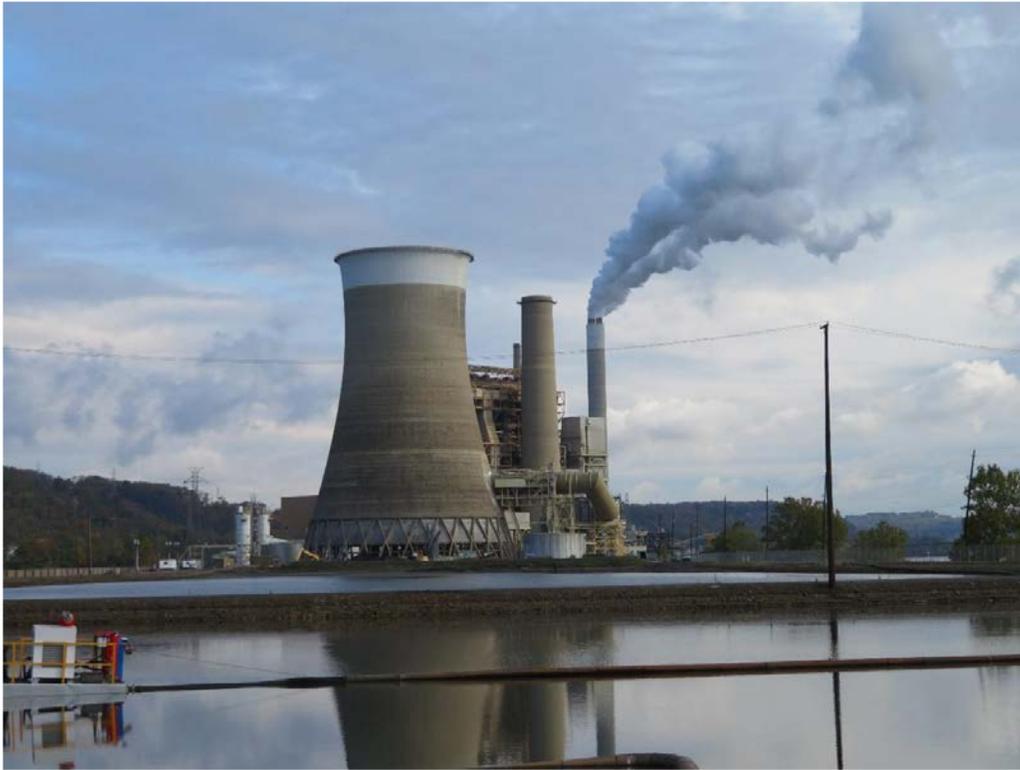
Photo No.1
Typical view of bottom ash pond complex.

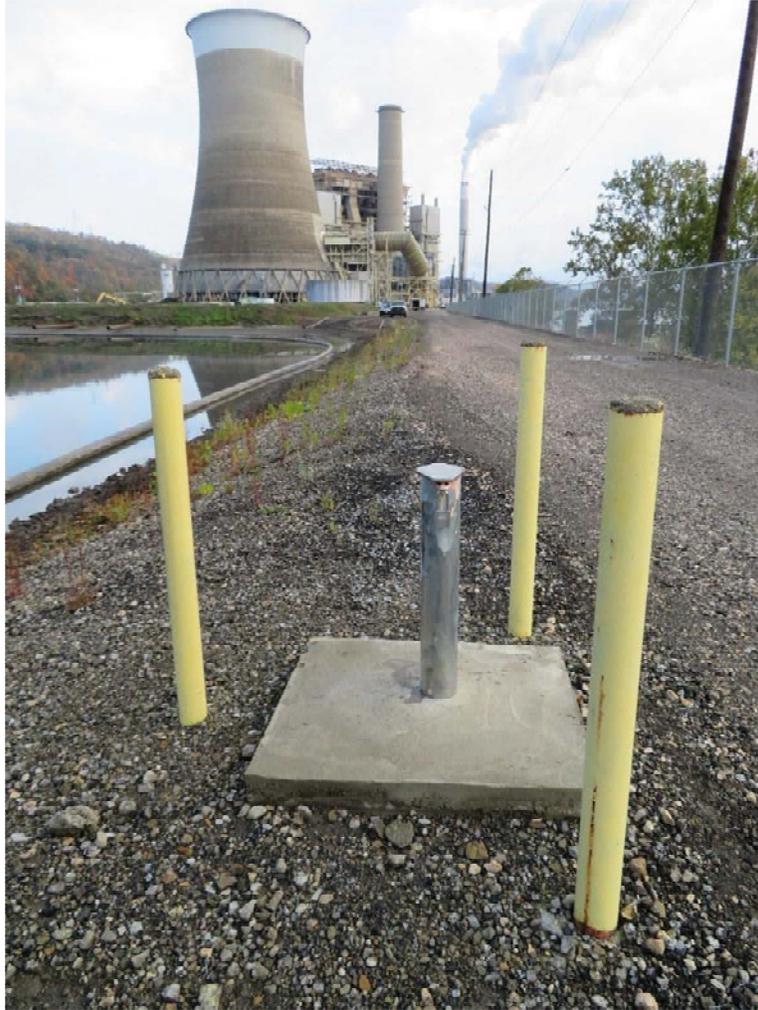
Photo No.2

Typical view of interior slopes and crest. Excellent condition of protective casing for piezometer/
concrete pad and protective bollards.
