2020 Annual Dam and Dike Inspection Report

Cardinal Plant
Fly Ash Dams 1, 2 & Bottom
Ash Complex

Cardinal Operating Company
306 County Rd. 7E
Brilliant, Ohio 43913

January 10, 2021

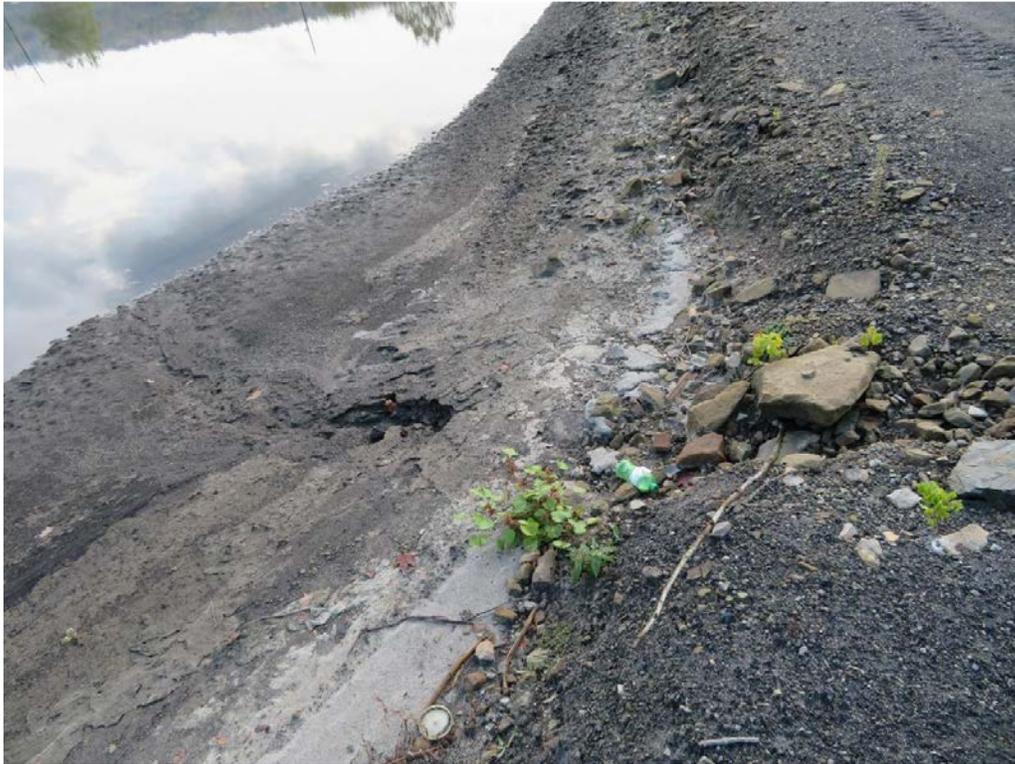
Photo No.3

Minor erosion along splitter dike with emergent discharge along the toe of the slope into the bottom ash pond.

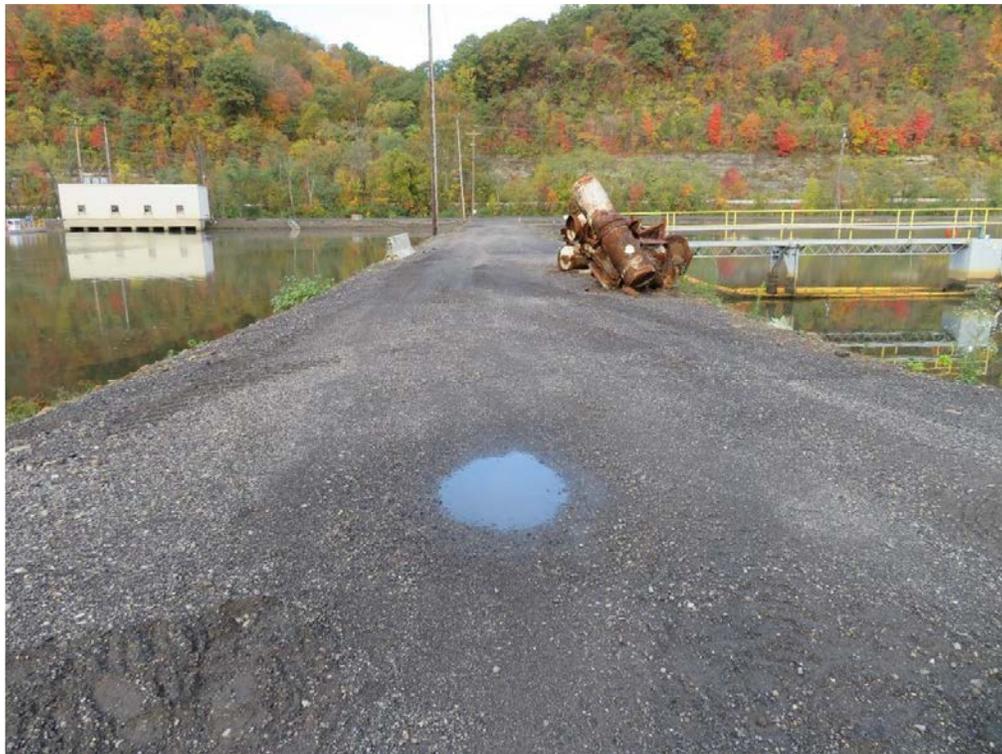
Photo No.4

Typical view of splitter dike crest and new decant structure. Former structure on the dike is scheduled to be removed.

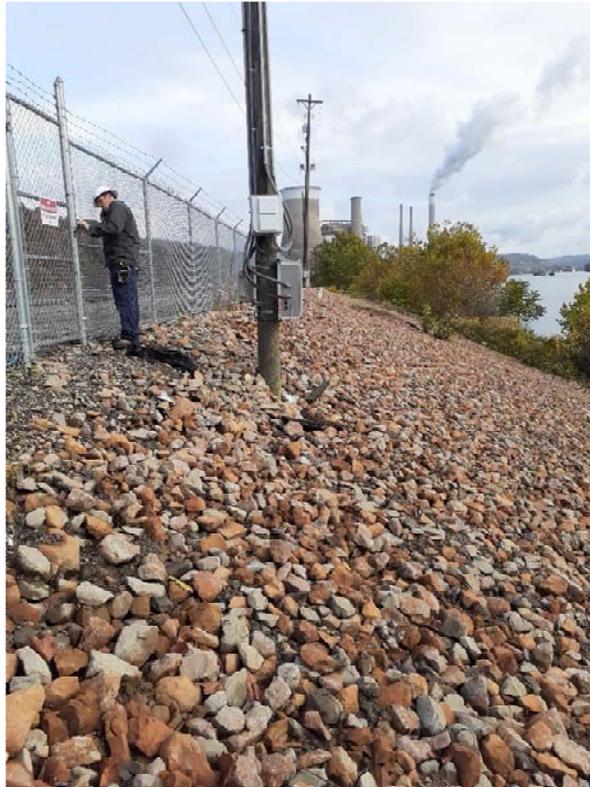
Photo No.12

View of exterior slope covered with rip rap showing good conditions (i.e. uniform slope, no erosion or bare ground exposed)

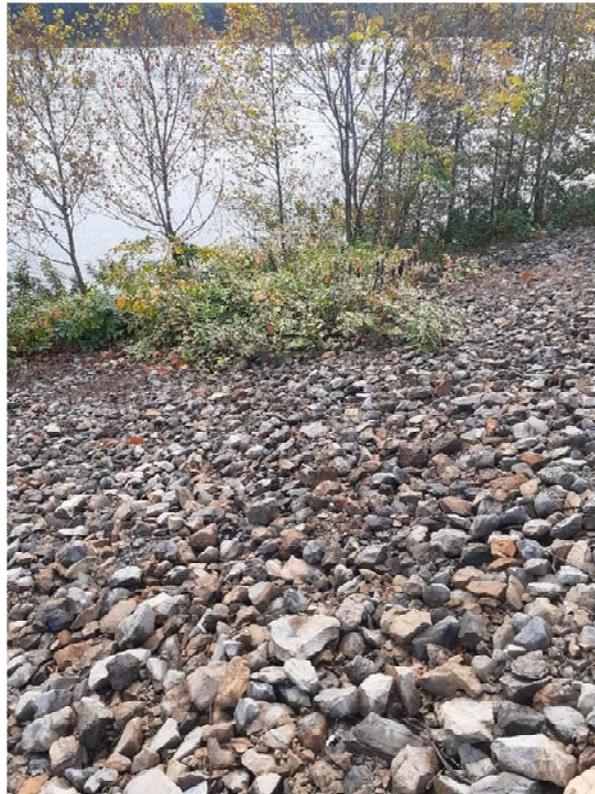
Photo No.13

Minor vegetative growth encroaching into the rip rap along the toe of the slope.

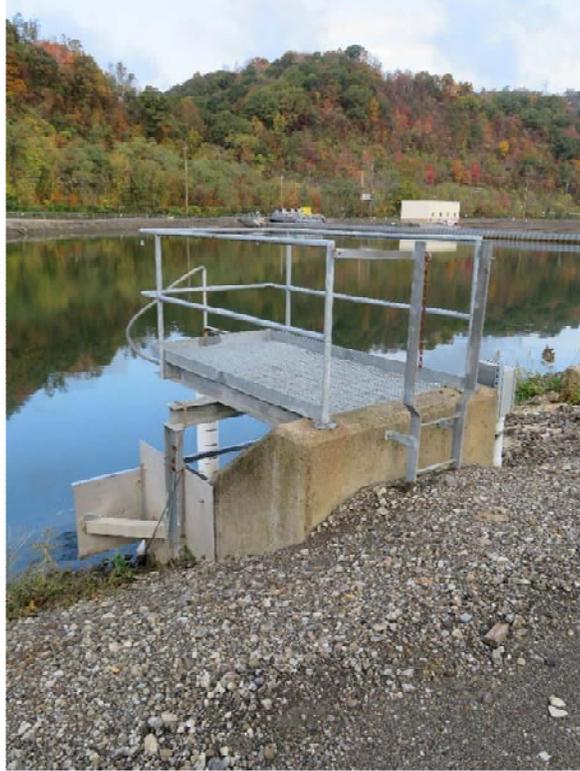
Photo No.14

Typical view of outfall structure (#01B00009023) showing good conditions.

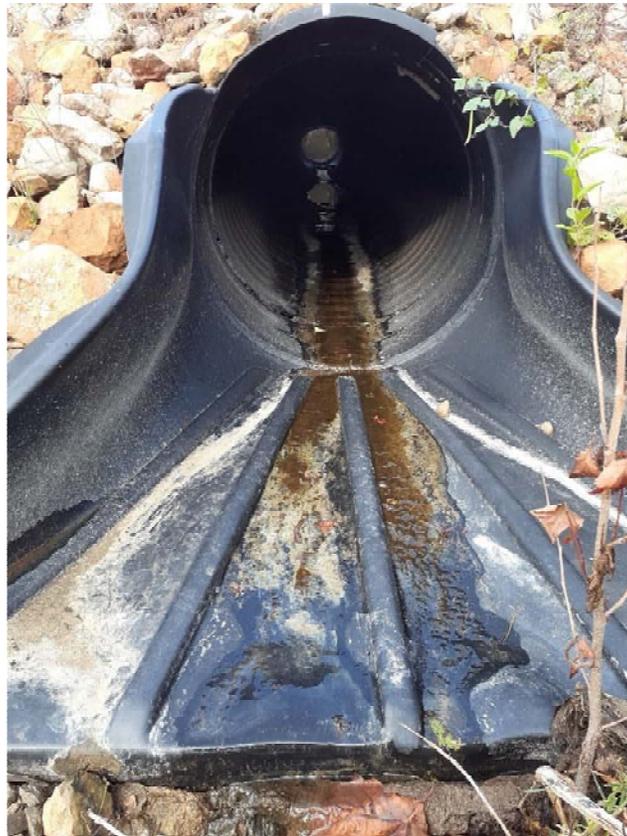
Photo No.15

View of discharge pipe and splash apron.

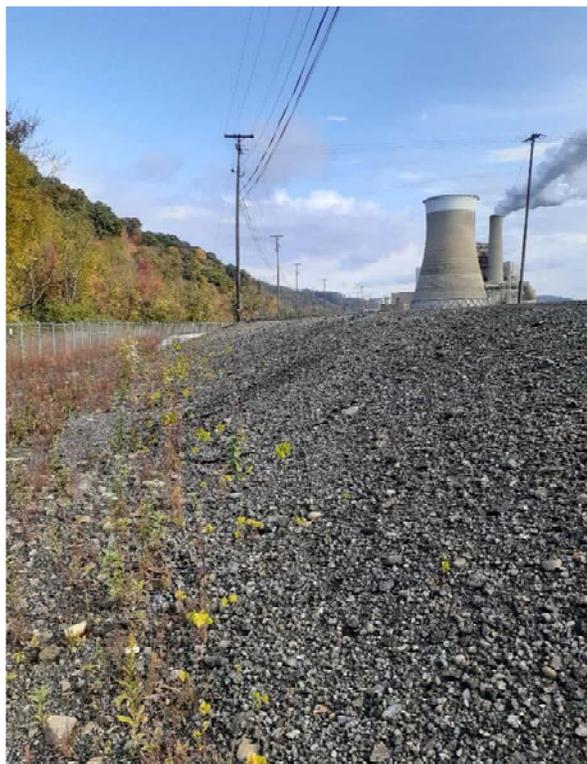
Photo No.17

Exterior embankment along the recirculation pond showing stable uniform slope conditions with no erosion or slumping.

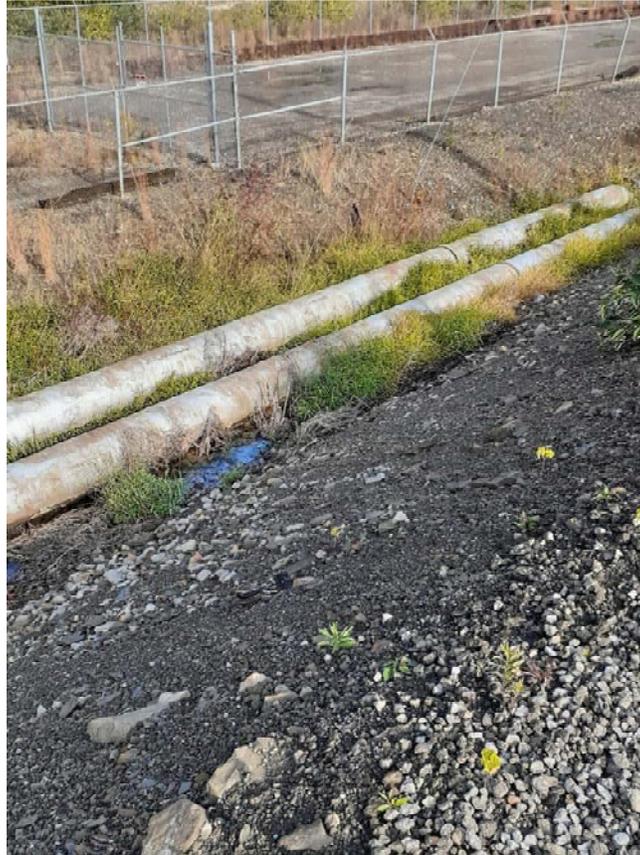
Photo No.18

The bottom ash pond has two persistent wet areas/springs that have been observed for the last several years on the exterior embankment along the Ohio River. It is recommended that this area continue to be monitored to determine if the proposed retrofit liner can mitigate this seepage.

Emergent spring along the toe of the exterior slope. No noticeable change in from previous reports in regard to the spring location or discharge.

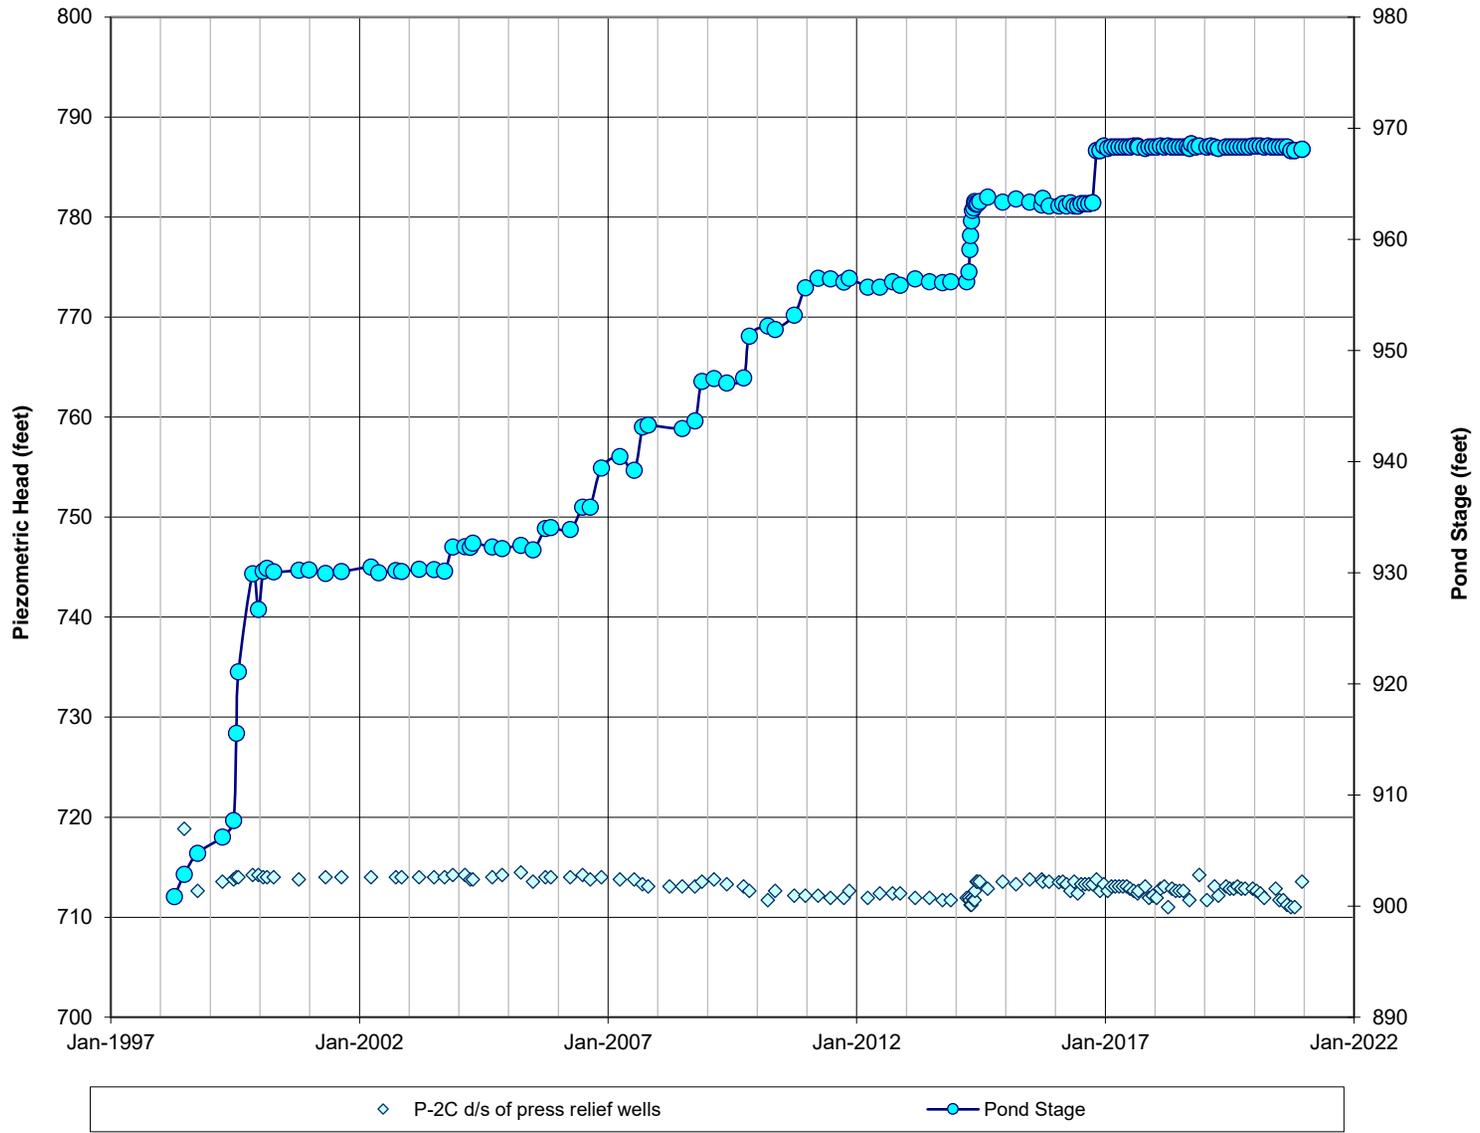
Figure 5k
Cardinal FAD 2
Centerline of Dam
Foundation Piezometers

5. Piezometer P-2C, installed within the foundations of the dam shows no increase corresponding to raising the pond stage (Figure 5k).
6. Two standpipe type piezometers were installed in 2004 into the right bedrock abutment to monitor seepage (FA-7 & FA-8). Both piezometers are installed into the Morgantown Sandstone member, a well fractured and jointed, medium to coarse grained sandstone.
