# Five-Year Periodic Safety Factor Assessment

Fly Ash Reservoir II  
Brilliant, Ohio

October 2021

**Fly Ash Reservoir II Dam  
Initial Safety Factor Assessment**

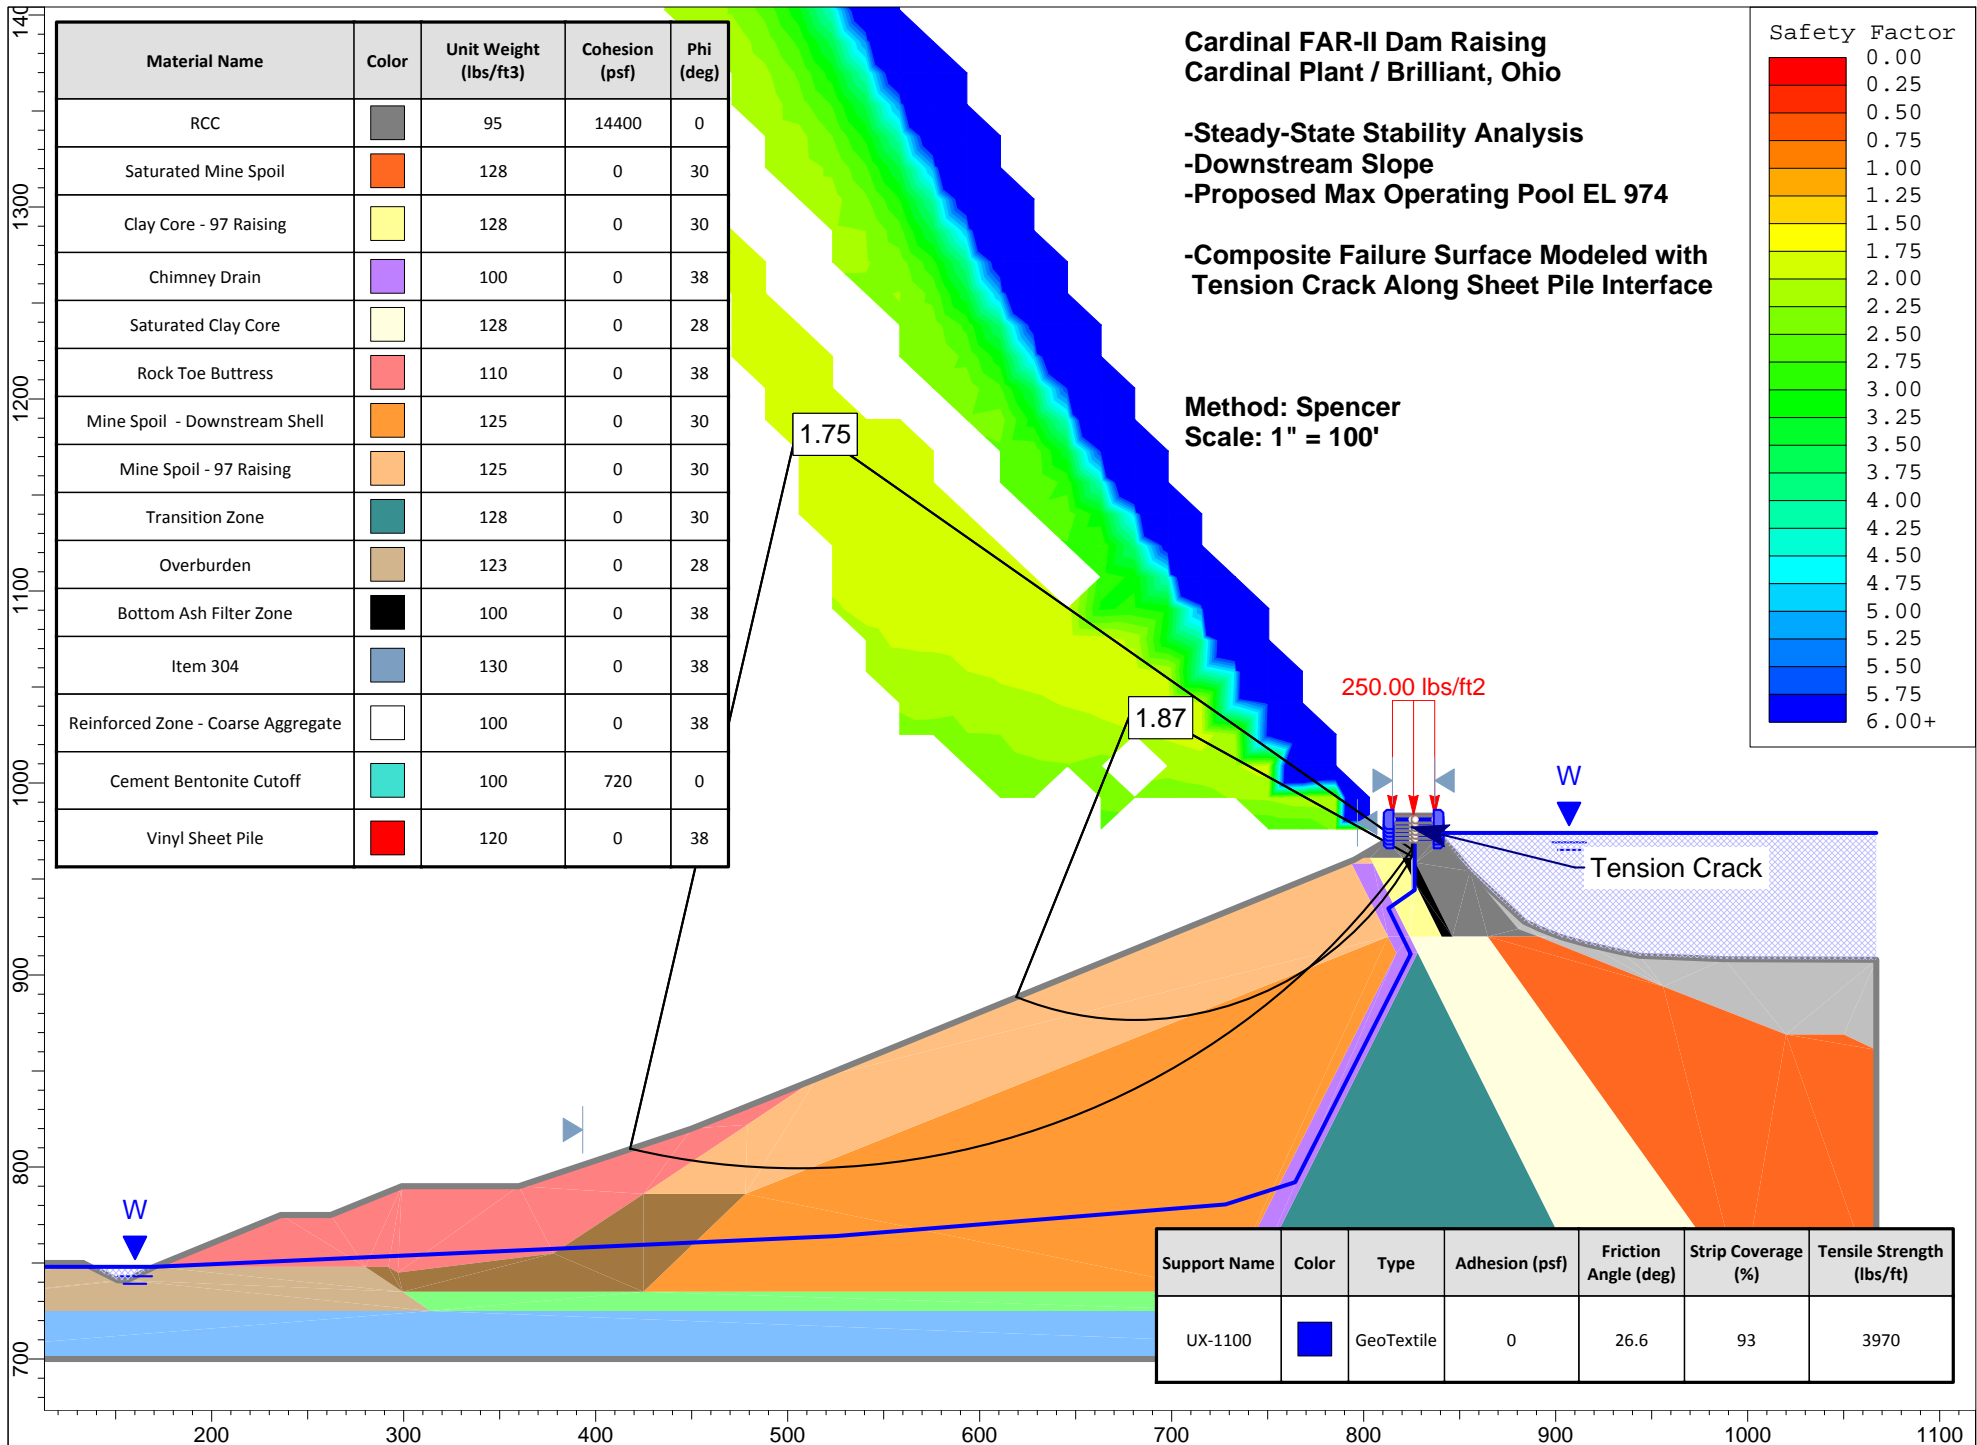
**Cardinal FAR-II Dam Raising  
Cardinal Plant / Brilliant, Ohio**

**-Steady-State Stability Analysis  
-Downstream Slope  
-Proposed Max Operating Pool EL 974**

**-Composite Failure Surface Modeled with  
Tension Crack Along Sheet Pile Interface**

**Method: Spencer  
Scale: 1" = 100'**

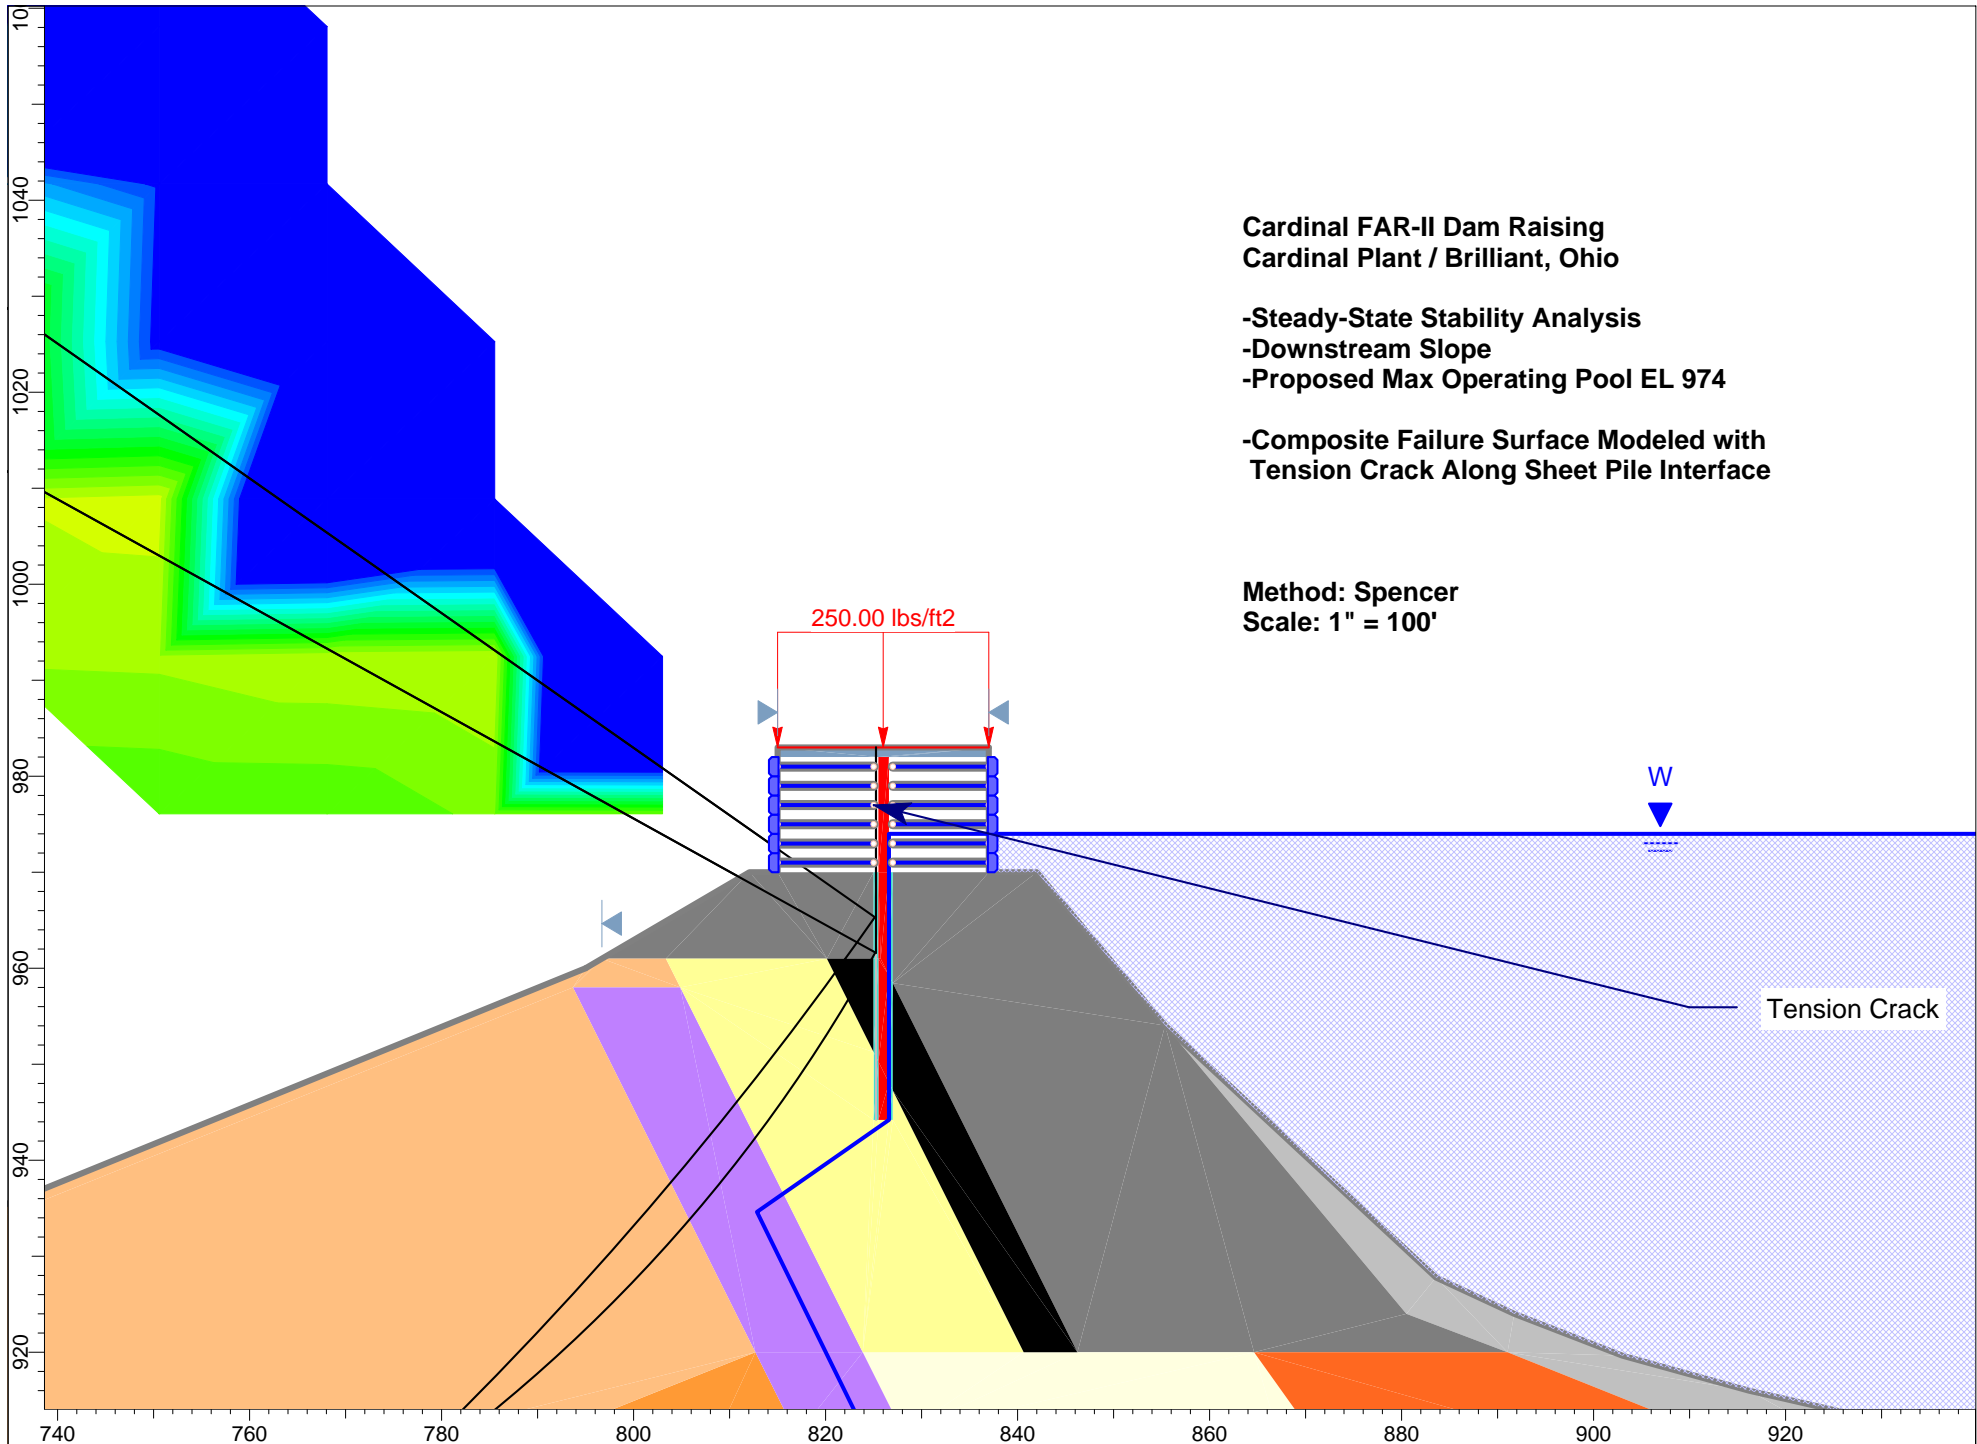
**Cardinal FAR-II Dam Raising  
Cardinal Plant / Brilliant, Ohio**

- Steady-State Stability Analysis
- Downstream Slope
- Proposed Max Operating Pool EL 974

**-Composite Failure Surface Modeled with  
Tension Crack Along Sheet Pile Interface**

**Method: Spencer  
Scale: 1" = 100'**
