2020 Annual Landfill Inspection Report

Cardinal Plant 2020 CCR Landfill Inspection Report

Cardinal Operating Company
306 County Rd. 7E
Brilliant, Ohio 43913

January 10, 2021

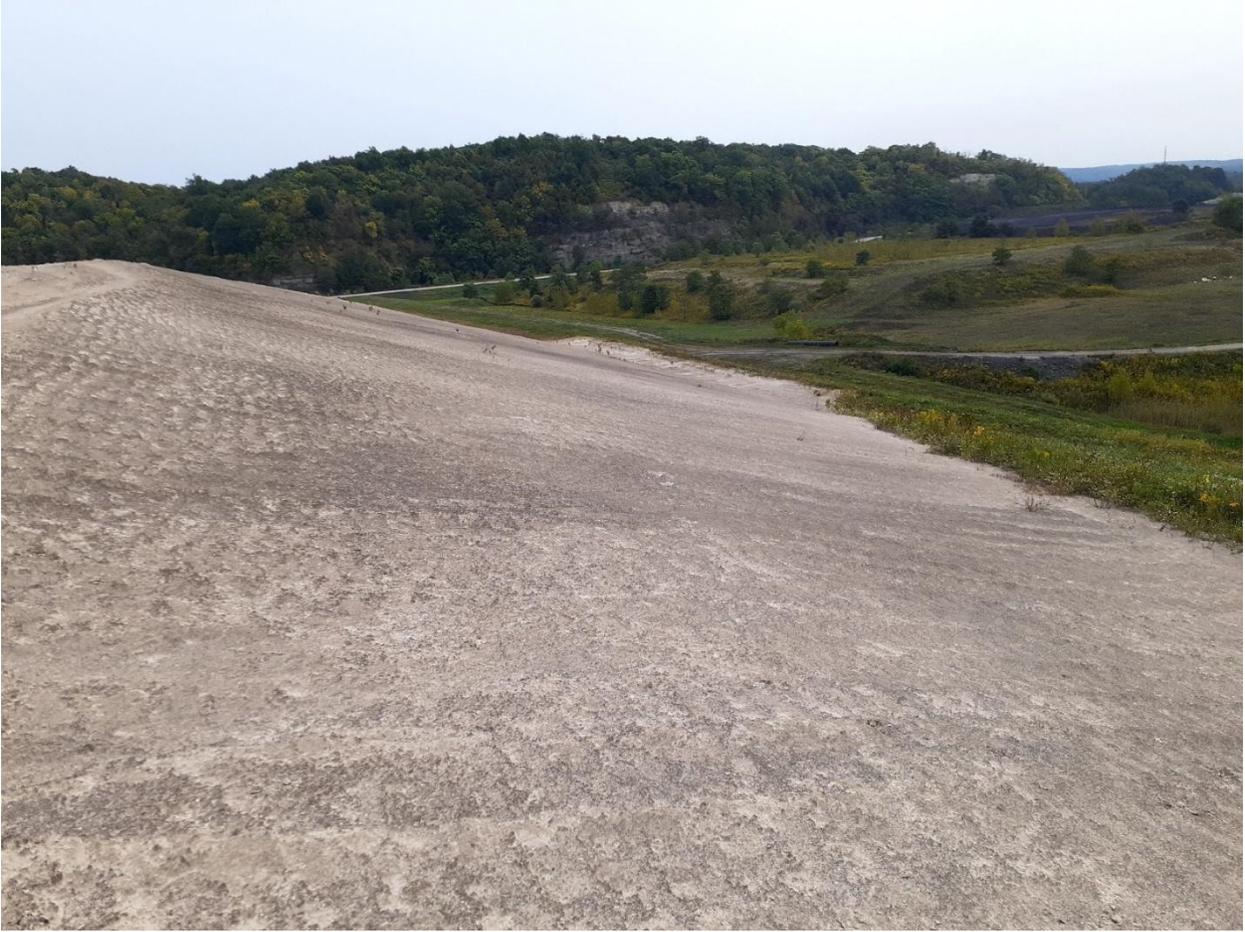
Photo 1

Areas where no activity was taking place were observed to be in excellent condition and were protected using a polymeric dust suppressant which had been sprayed on the surface (Photo 1). No fugitive dust was observed on the date of the inspection at any location. The temporary slopes within the active waste placement areas were also observed to be in excellent condition exhibiting uniform slopes, no erosion, slumping or other signs of instability or displacement.

Cell 1 FGD Gypsum slope showing excellent conditions (i.e. no erosion, slumping or bulges).

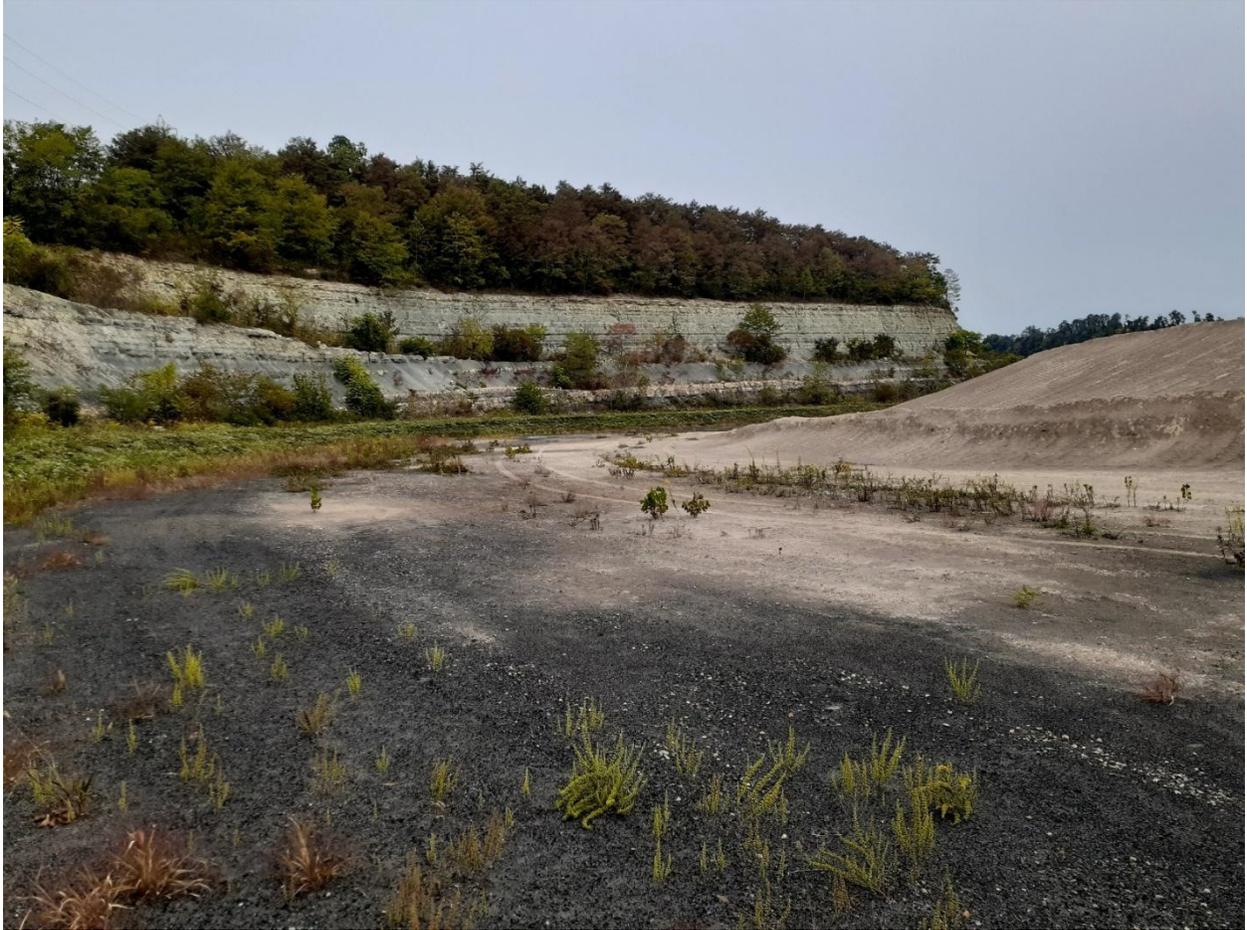
Photo 2

The bedrock highwall located along the western perimeter of Cell 1 appeared to be stable with no significant rock overhangs, rockfall or other signs of instability. The bedrock highwall is composed of alternating sequences of thin to thick bedded limestone interbedded with shale and siltstone reaching a height of 60 ft. No ponded water or uncontrolled seepage flows were observed at the base of the highwall, suggesting that the seepage collection system is functioning as intended. (Photo 2).

Cell 1 highwall slope showing stable conditions.

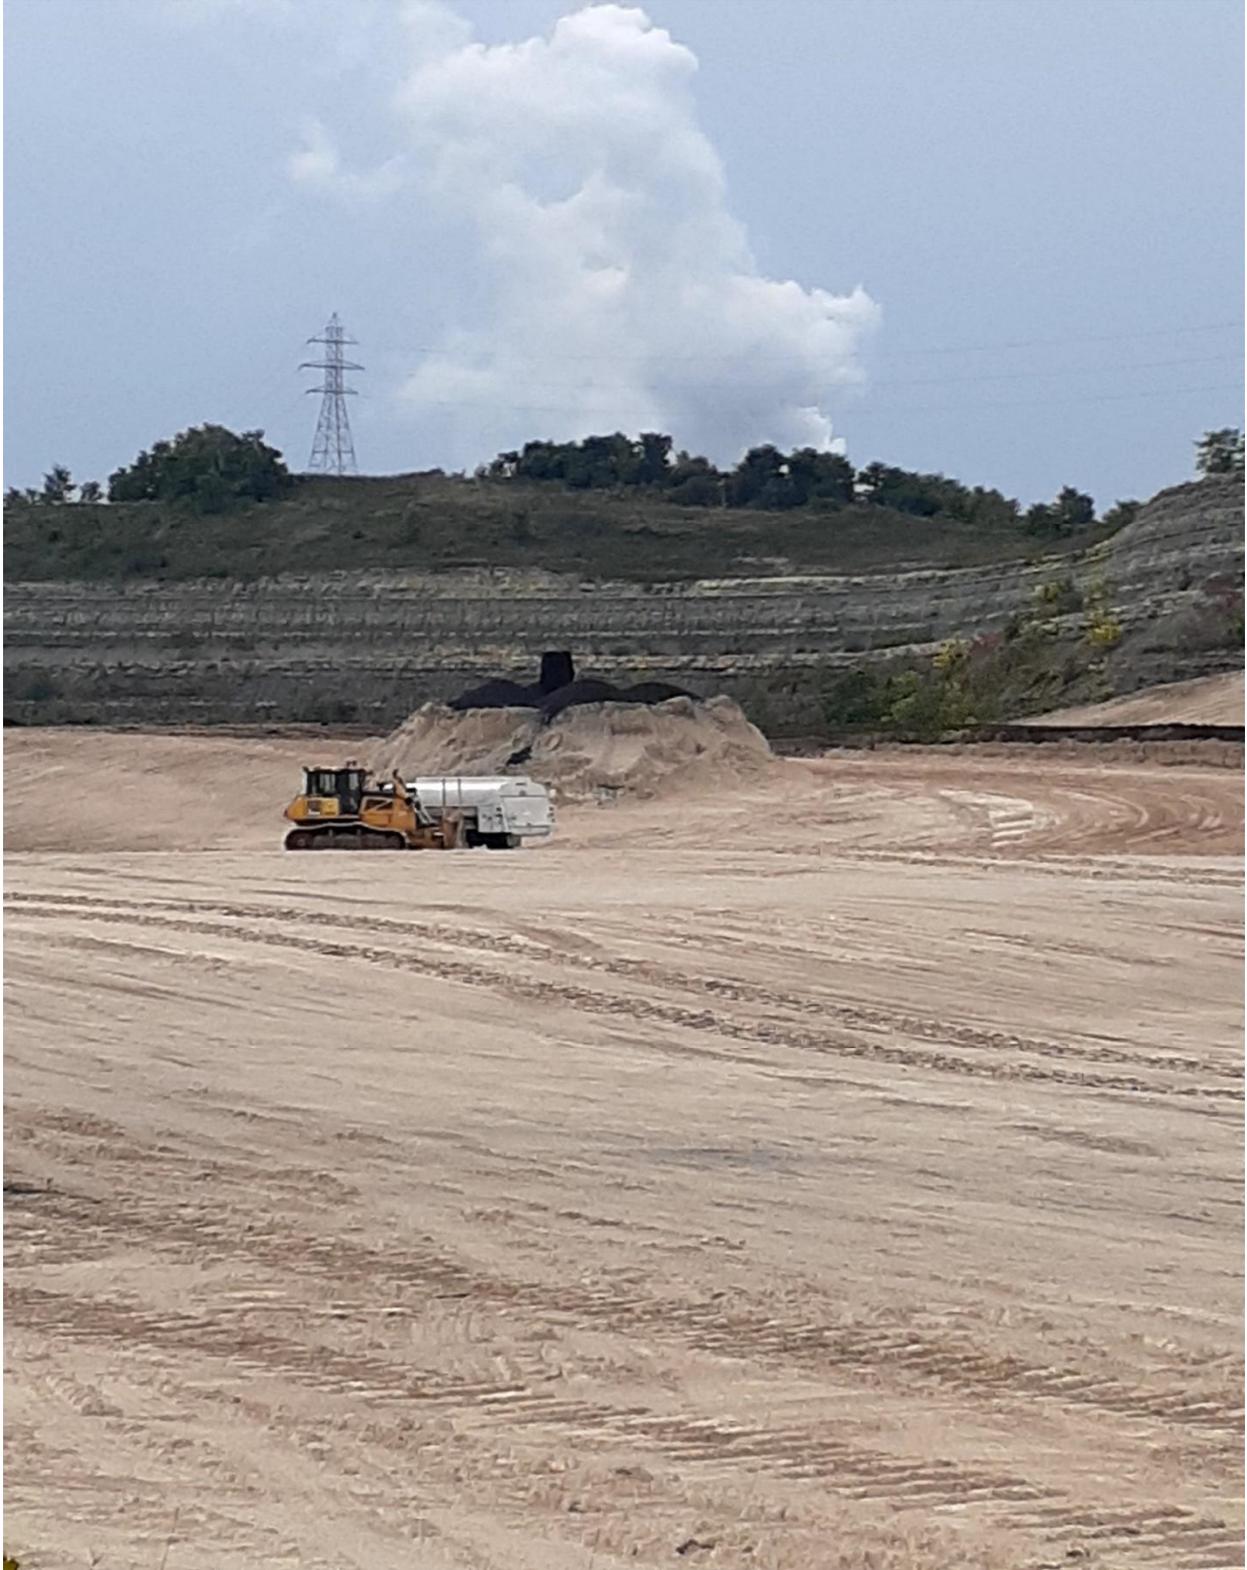
Photo 3

The active fill areas within Cell 3 were observed to be well maintained and in excellent condition. A majority of the gypsum in Cell 3 footprint has been actively reclaimed for beneficial utilization. The excavated area did not have any significant ponded water or erosion within the cell and appeared to be well graded to promote drainage to the LCS's risers (also referred to as chimney drains). The riser structures (exposed on account of the excavation activities) were surrounded and protected by a layer of CCR to prevent impact from heavy equipment (Photo 3).

Cell 3 FGD Gypsum landfill showing the active fill area.

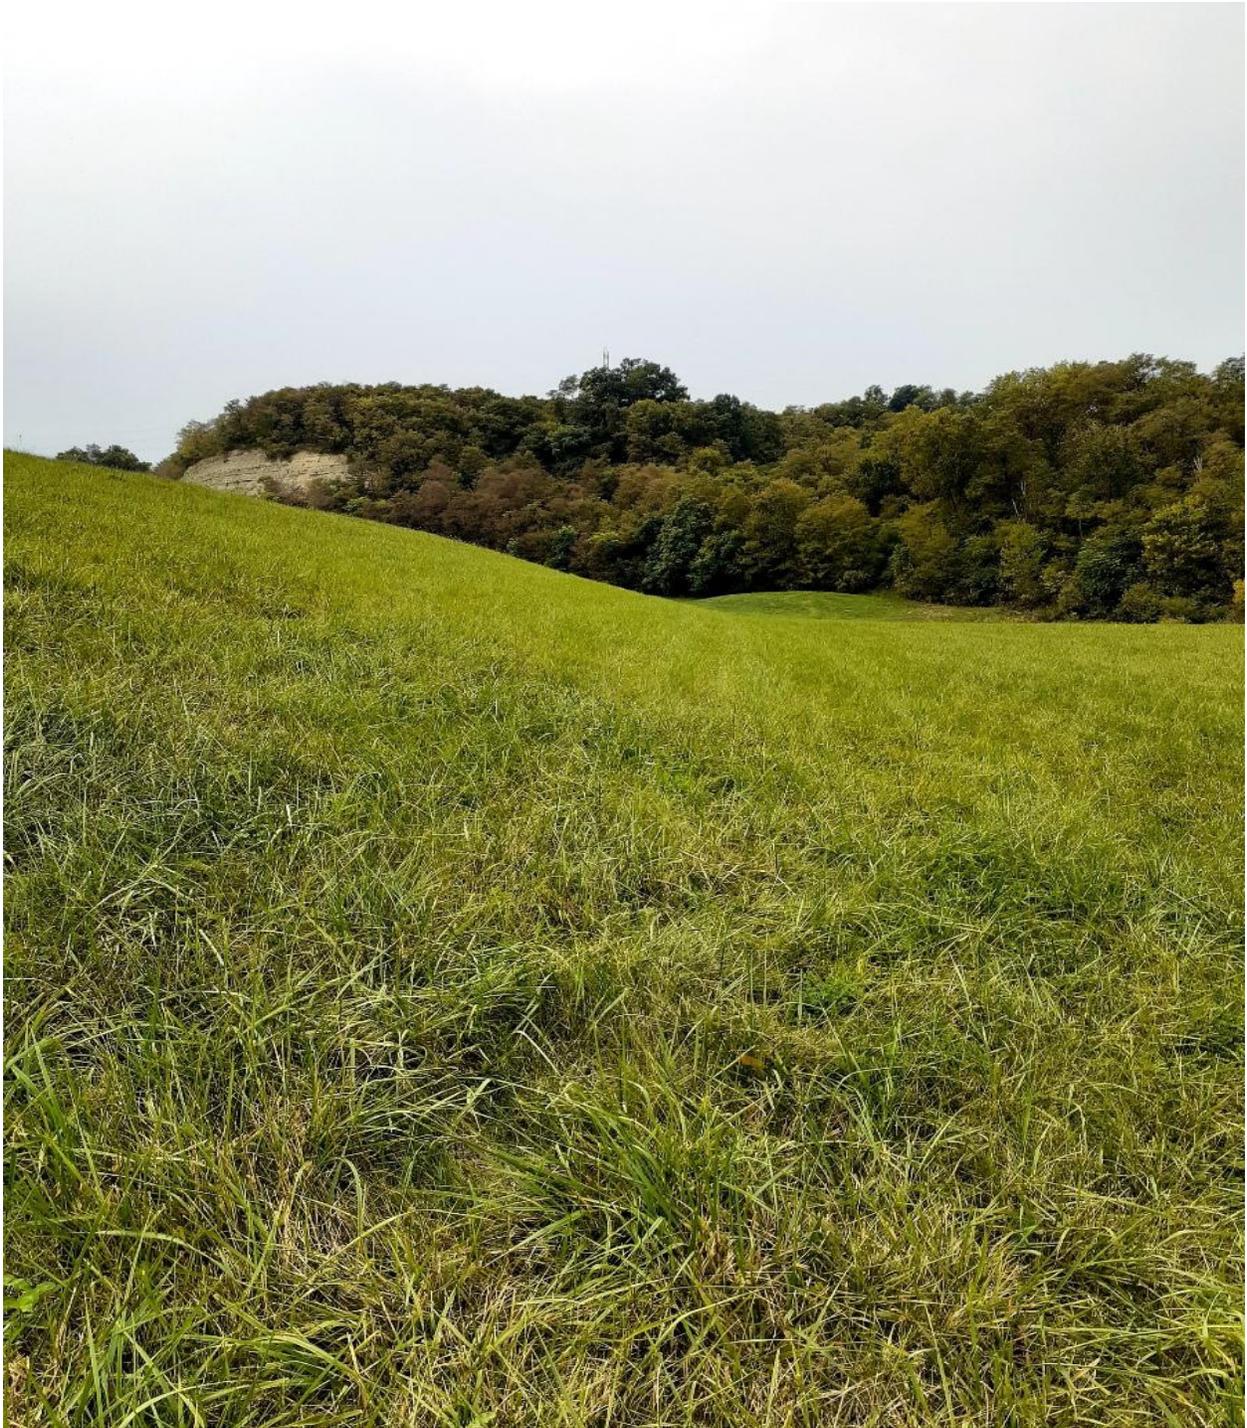
Photo 4

All areas with protective vegetative cover established such as the closed portion of the landfill and berms had a healthy grass stand of vegetation that was mowed and well maintained. The northern closed area was in excellent condition. No erosion or animal burrows were observed, and the slopes were uniform (i.e. no slumping or bulging) and appeared to be well drained. No standing water was observed or soft/wet areas on the surface. (Photos 4 and 5).

Cell 3 FGD Gypsum landfill showing the closed and permanent cover cap area.

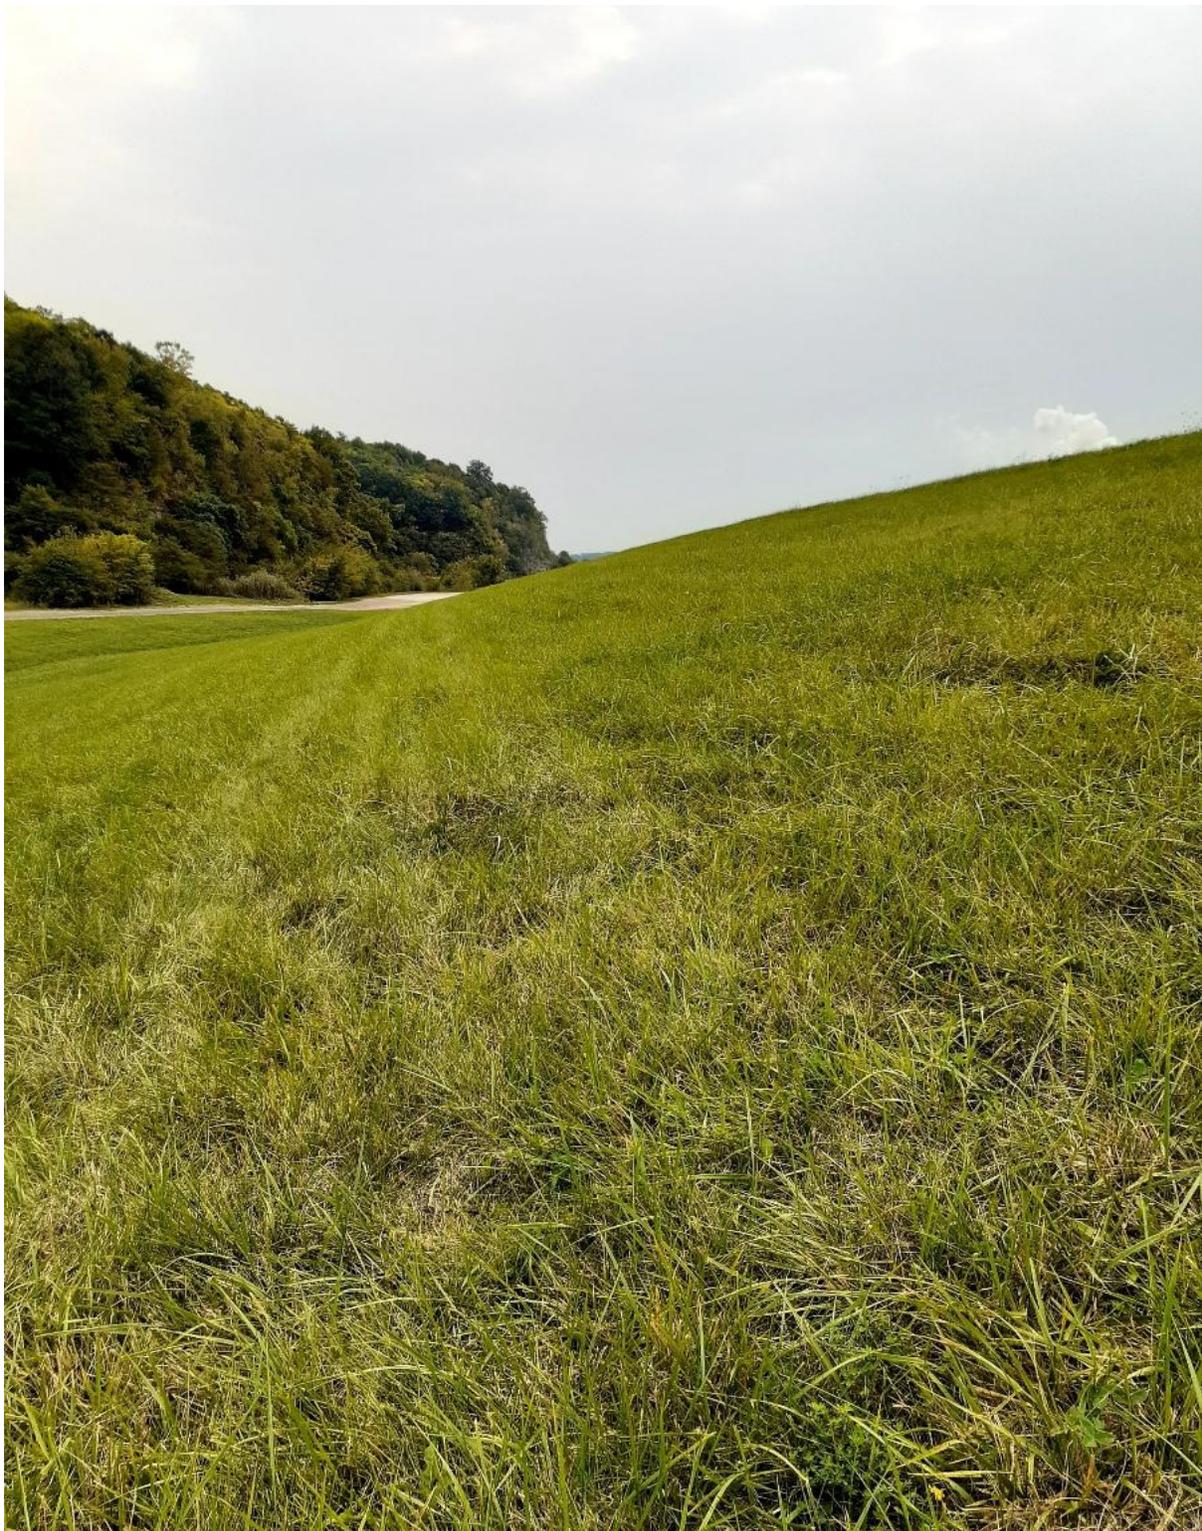
Photo 5

Cell 3 FGD Gypsum landfill showing a well established vegetative cover over the closed and permanent cover cap area.

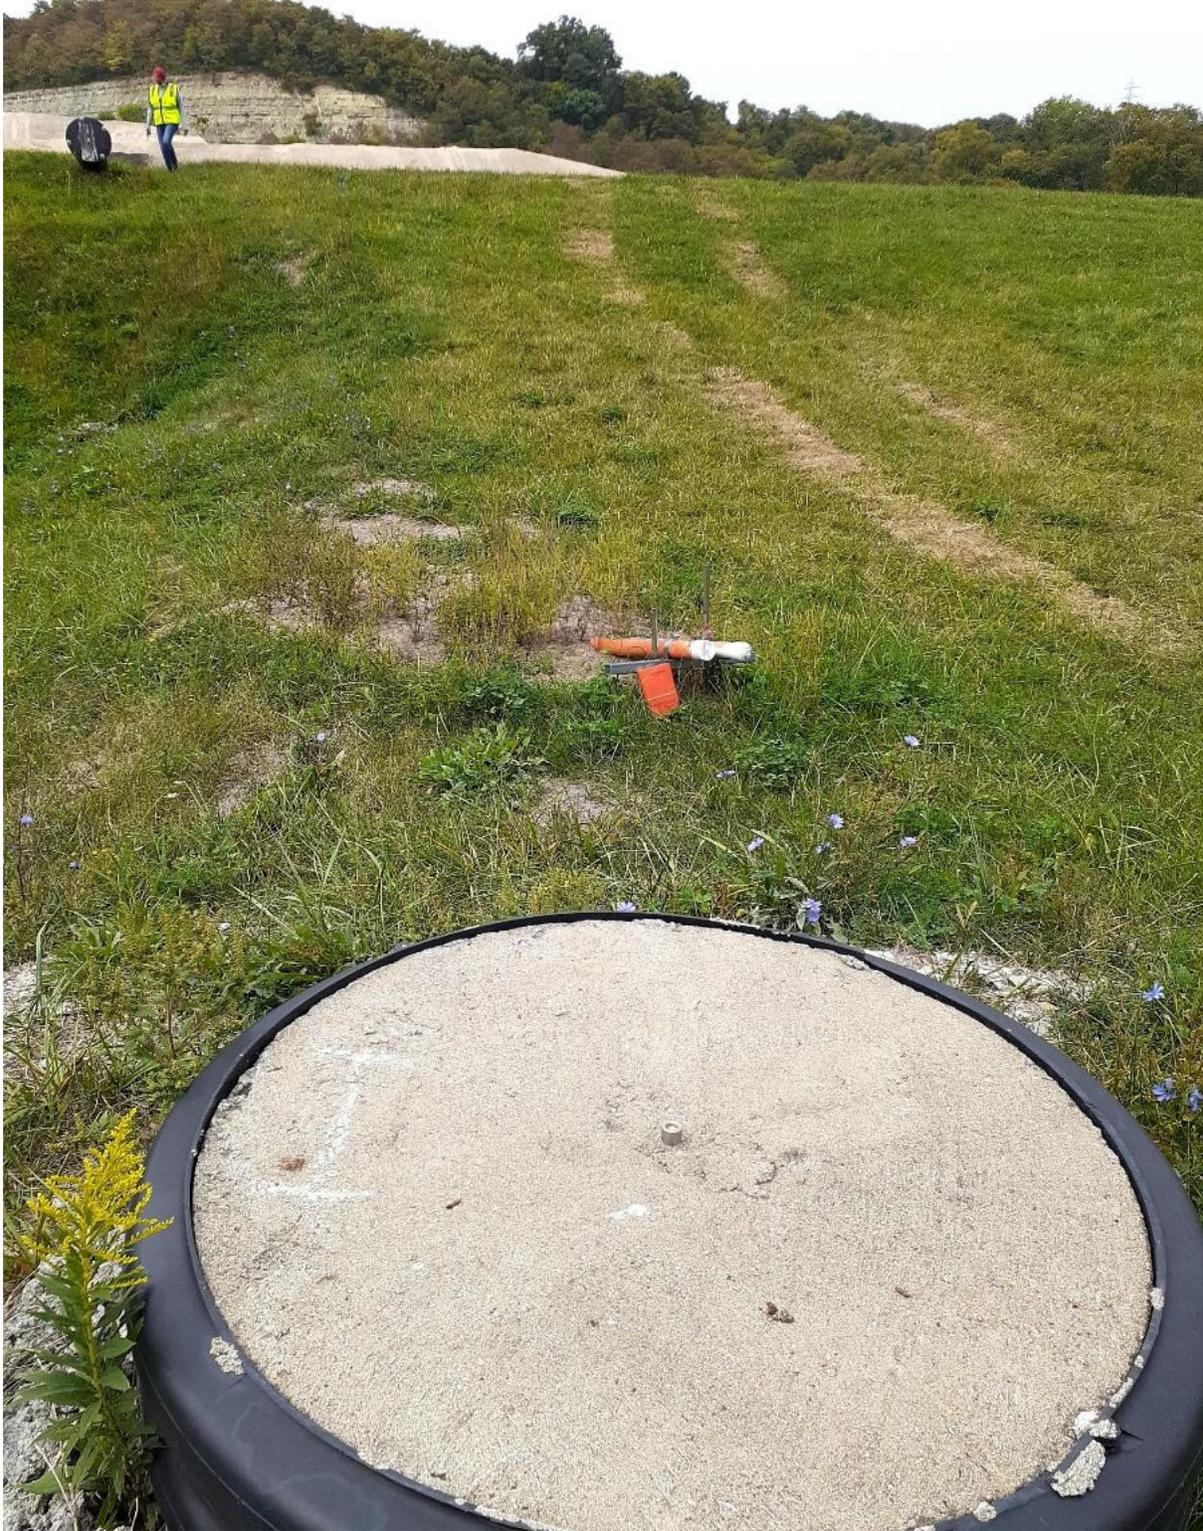
The pedestal for settlement profiler No.1 is depicted in Photo 6 showing typical conditions. Photo 7 depicts settlement profiler No.2 which also shows good conditions along with the LCS manhole showing excellent conditions (i.e. no cracking, spalling or exposed rebar). Photo 8 shows the excellent conditions of the manhole interior. The landfill's leachate was observed to be freely flowing into the manhole.

Settlement pedestal for the Landfill's No. 1 settlement profiler.

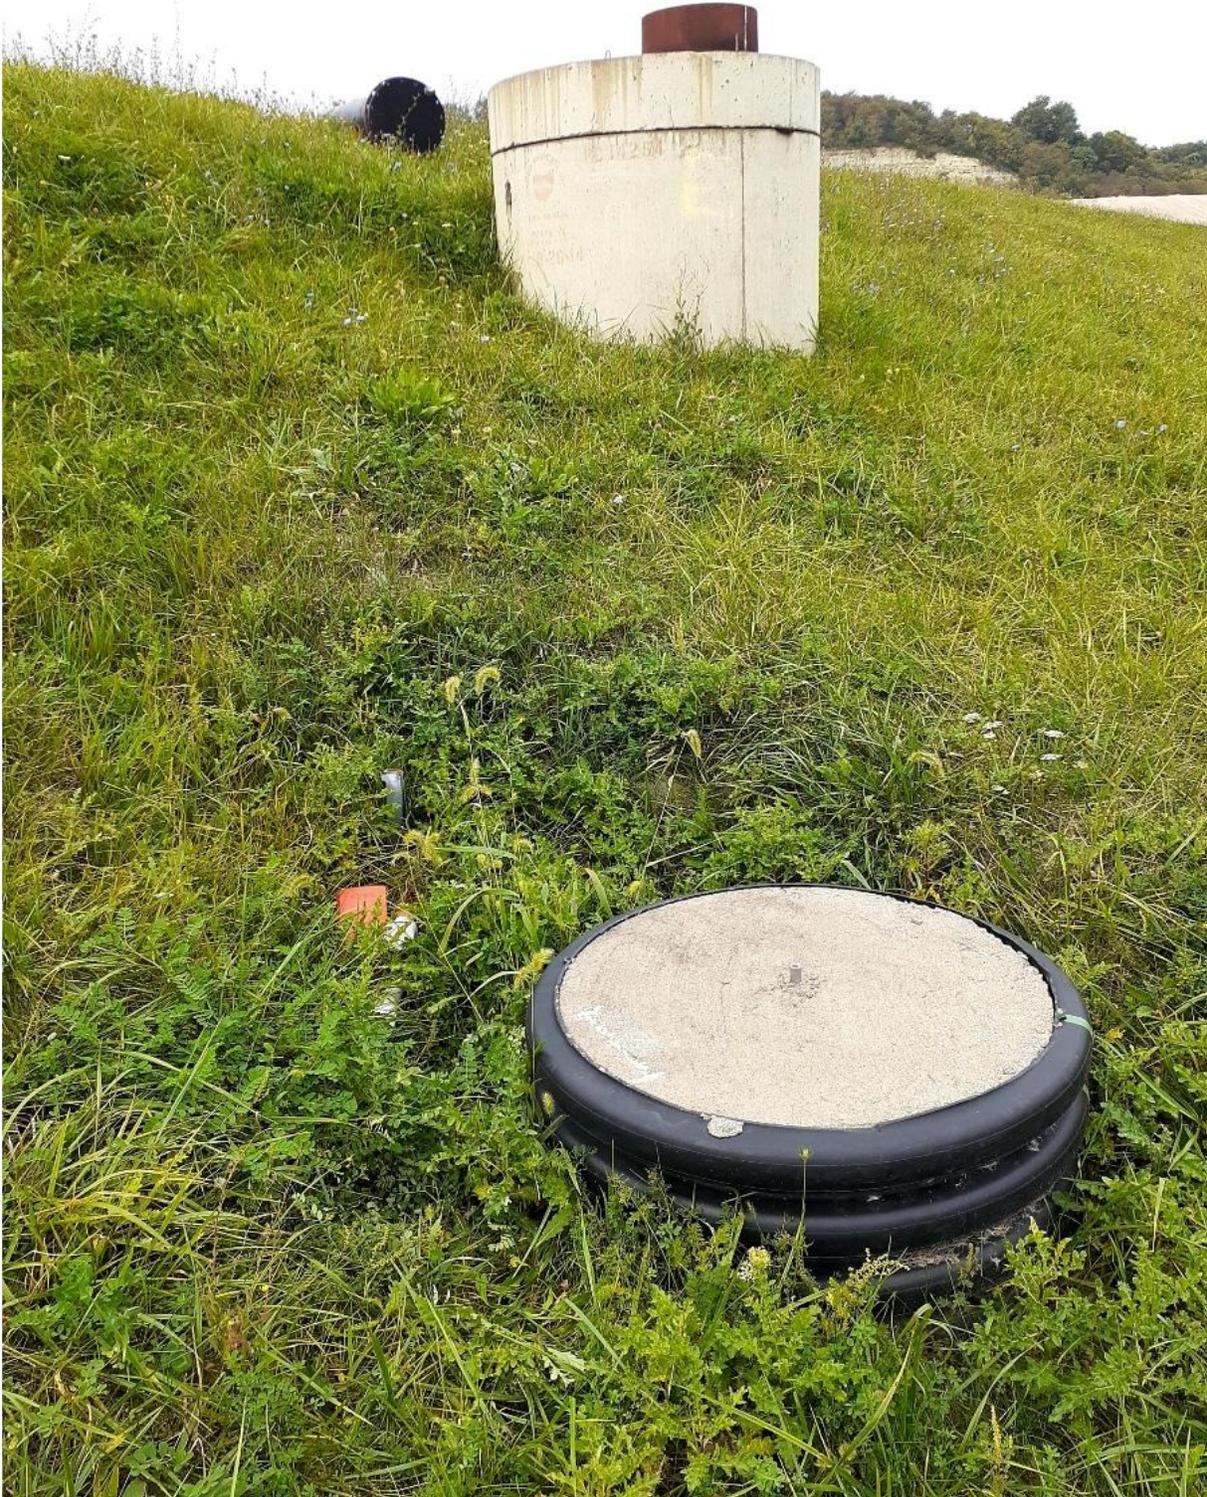
Photo 7

Settlement pedestal for the Landfill's No. 2 settlement profiler with the leachate collection system manhole.

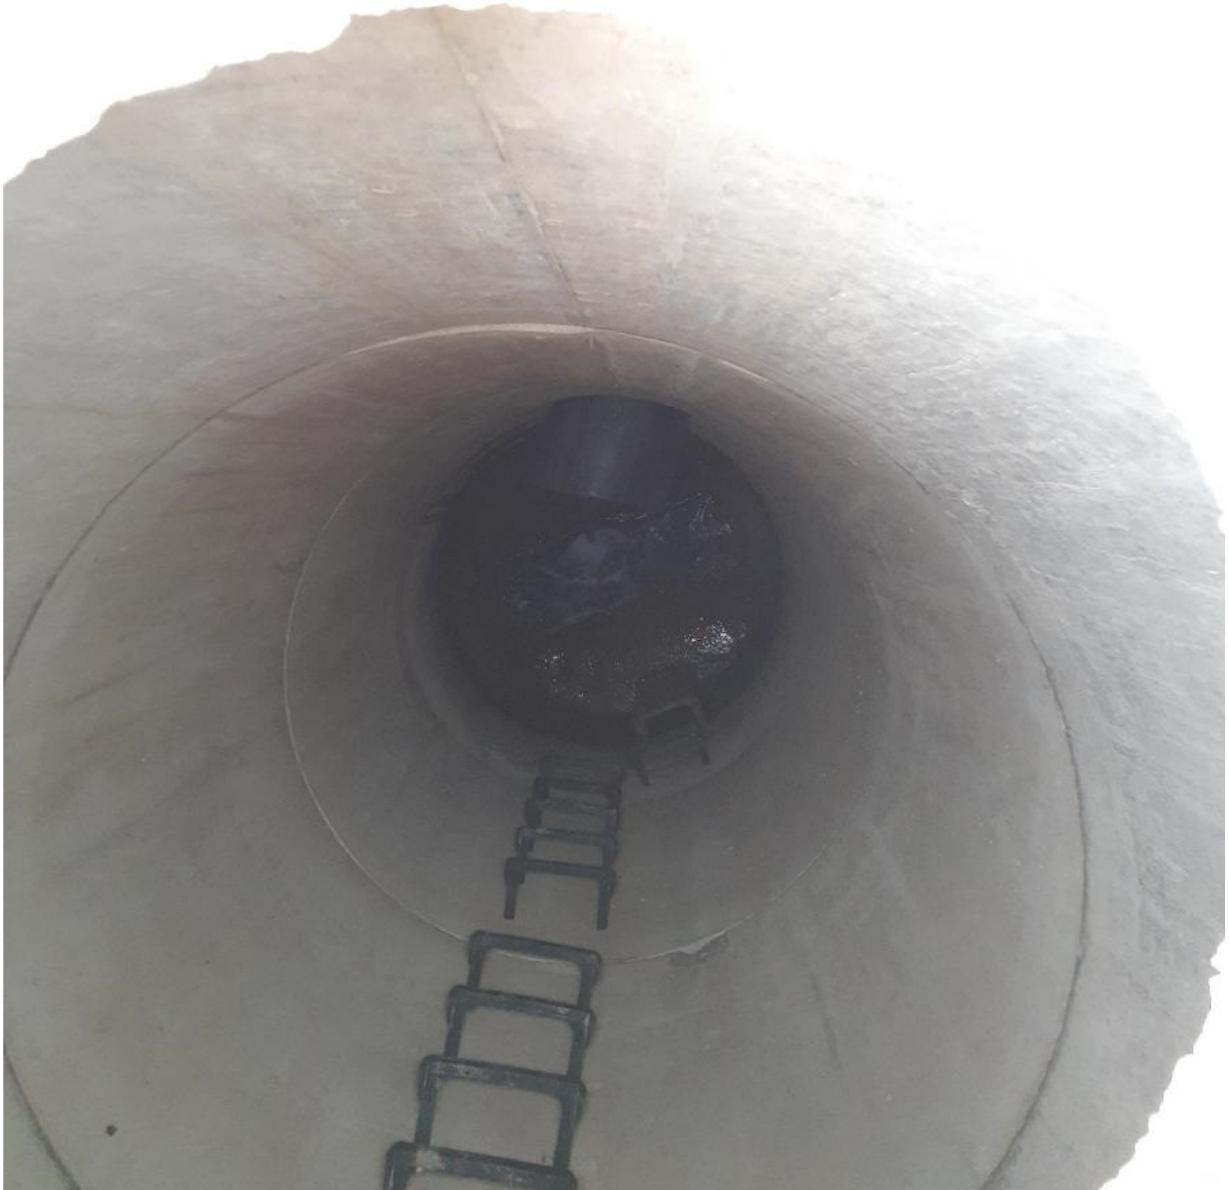
Photo 8

Interior view of manhole showing leachate flowing freely into the manhole.

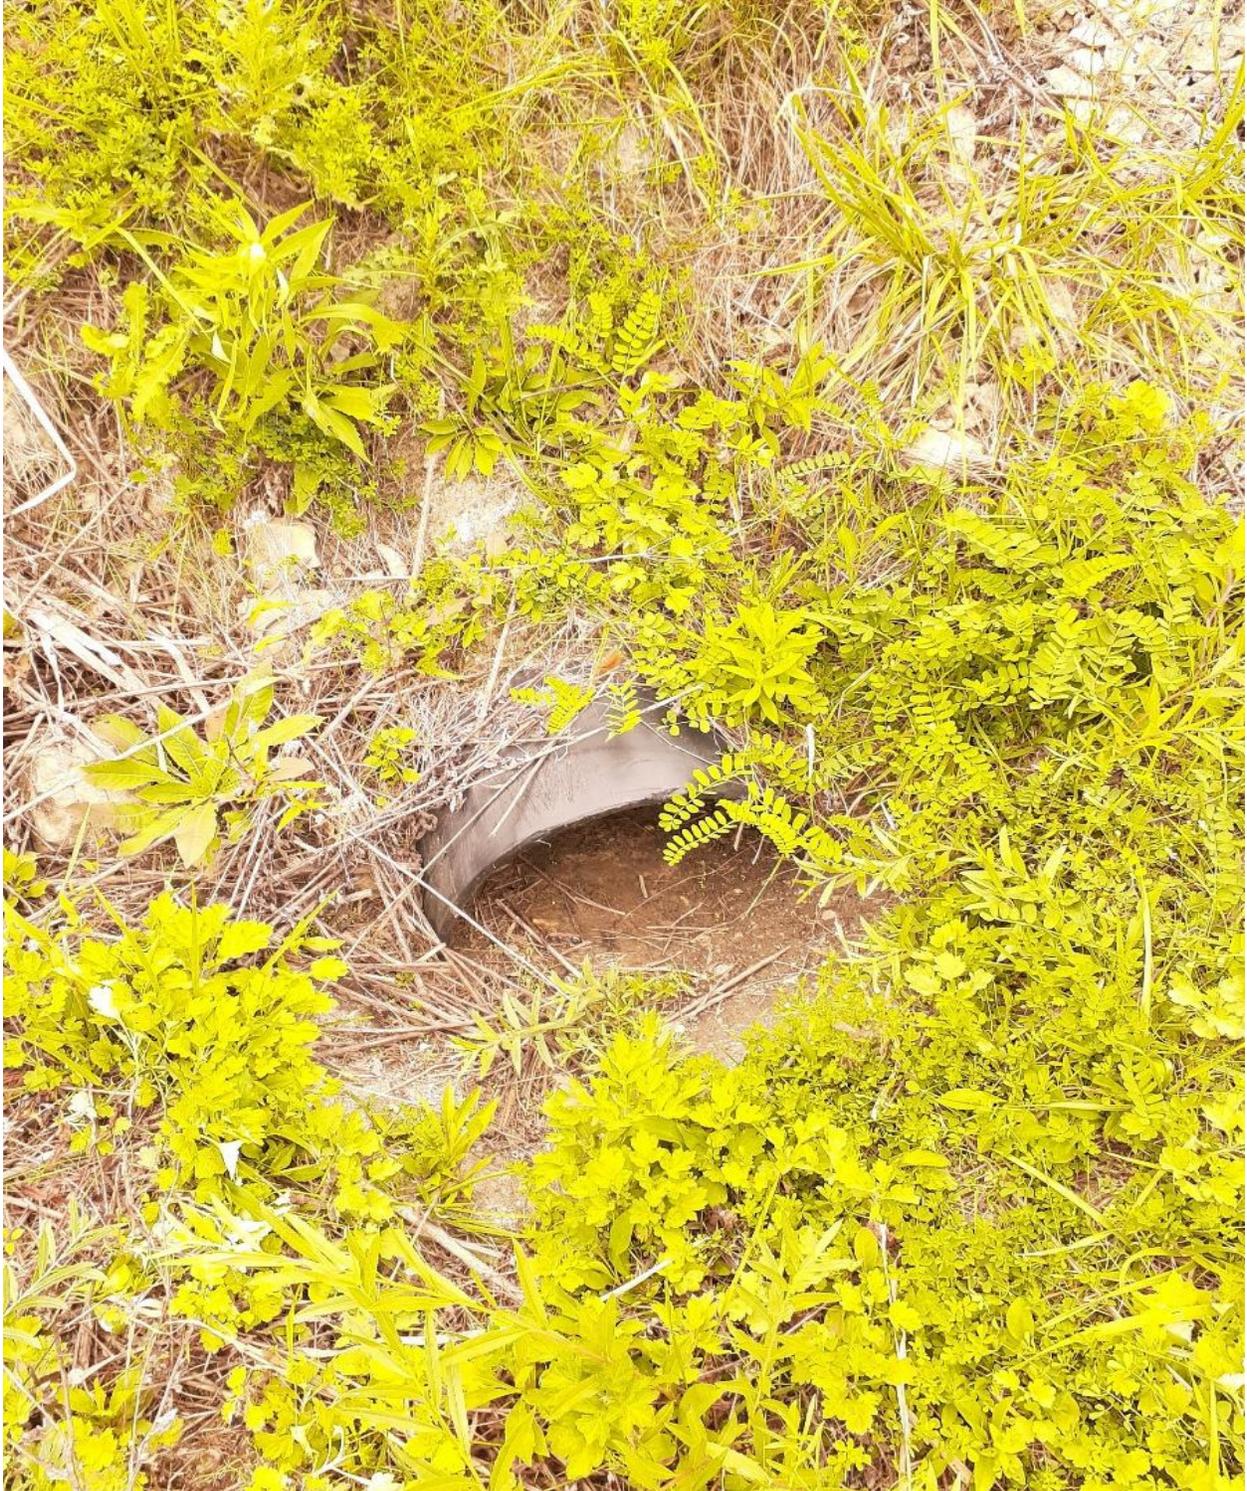
Photo 9

The access road into Cell 3 is in good condition and crosses the perimeter ditch that collects non-contact storm water. A HDPE 16 " culvert was observed to be in fair condition and is partially blocked by the accumulation of sediment (Photo 9).

Minor sediment build up in 16 in the HDPE culvert at the access road leading into the landfill.

1. Continue to monitor the leachate collection system and spring drain collection system for unobstructed flow. Clean out the ditch to the FAR 2 pond to facilitate unobstructed flow from the SDL.
2. Continue all current maintenance and fill placement practices.

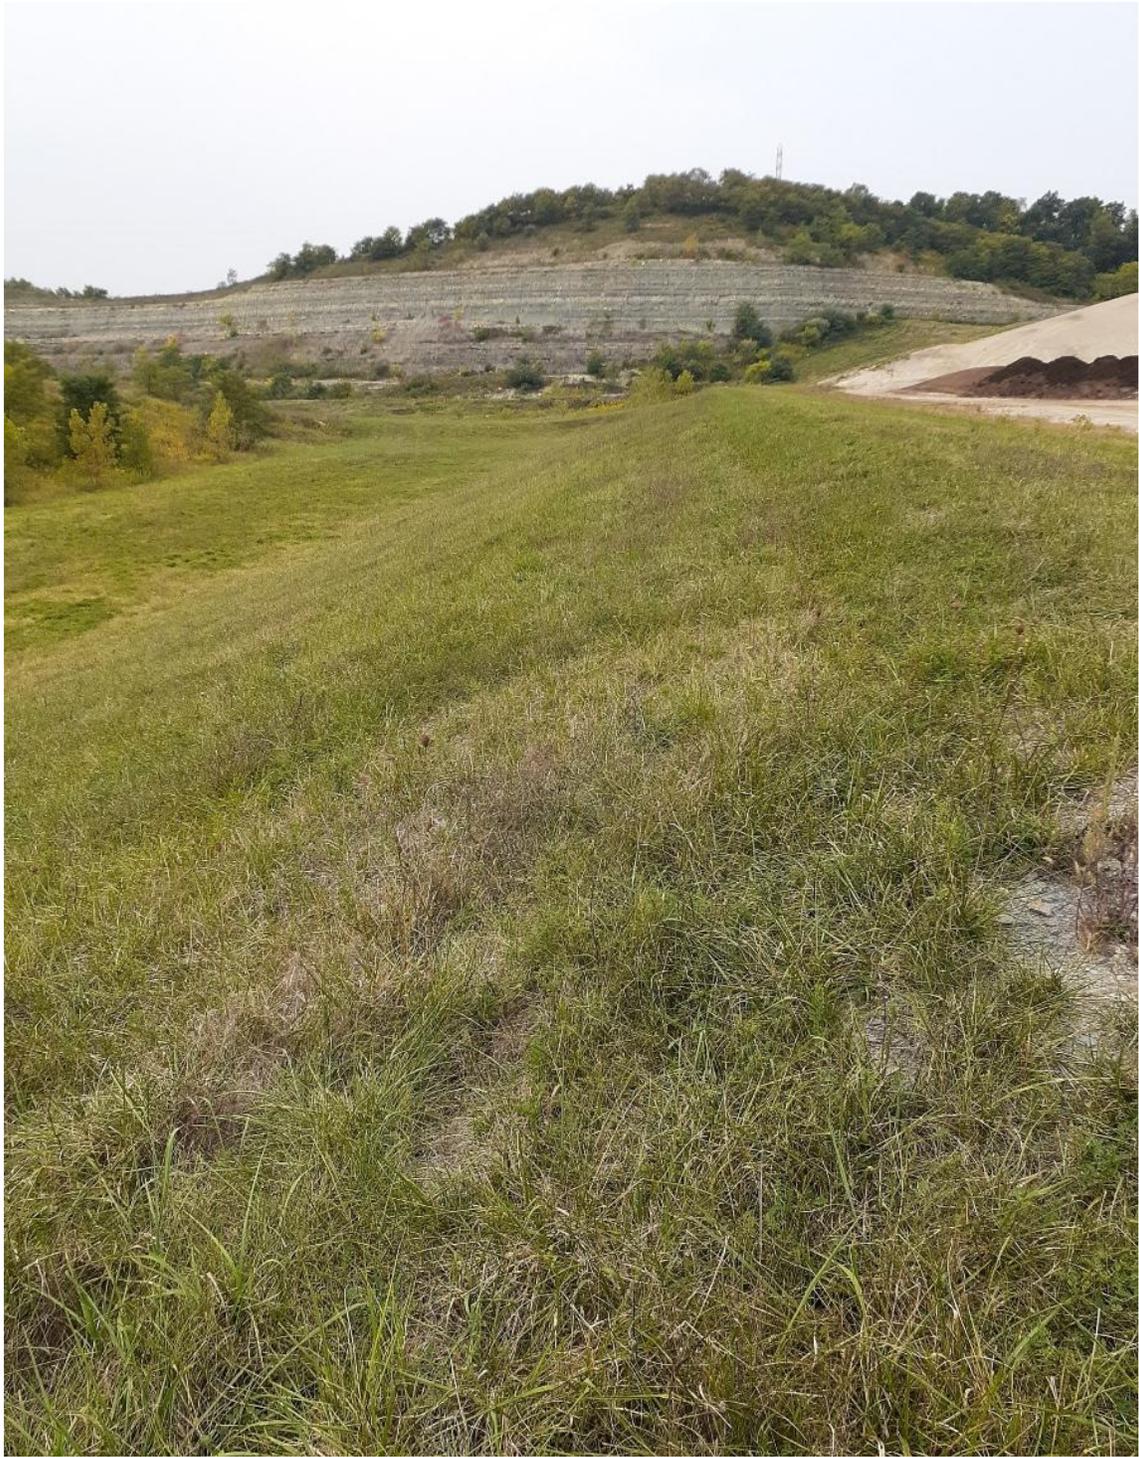
The exposed gypsum slope depicted in Photo 10 also shows excellent conditions and has been treated with a dust suppression polymer that also protects the slope from erosion. The dark colored fill depicted in Photo 10 is the wastewater treatment plant solids being placed in Cell 3.

Interim berm for Cells 1 and 3 showing excellent vegetative cover on lower portions of the slope. The upper portion of the slope showing exposed FGD Gypsum is also in excellent condition and has been treated with a dust suppressant polymer. The dark colored fill is calcium chloride waste that is also generated from the plant's SO₂ scrubbing operation.

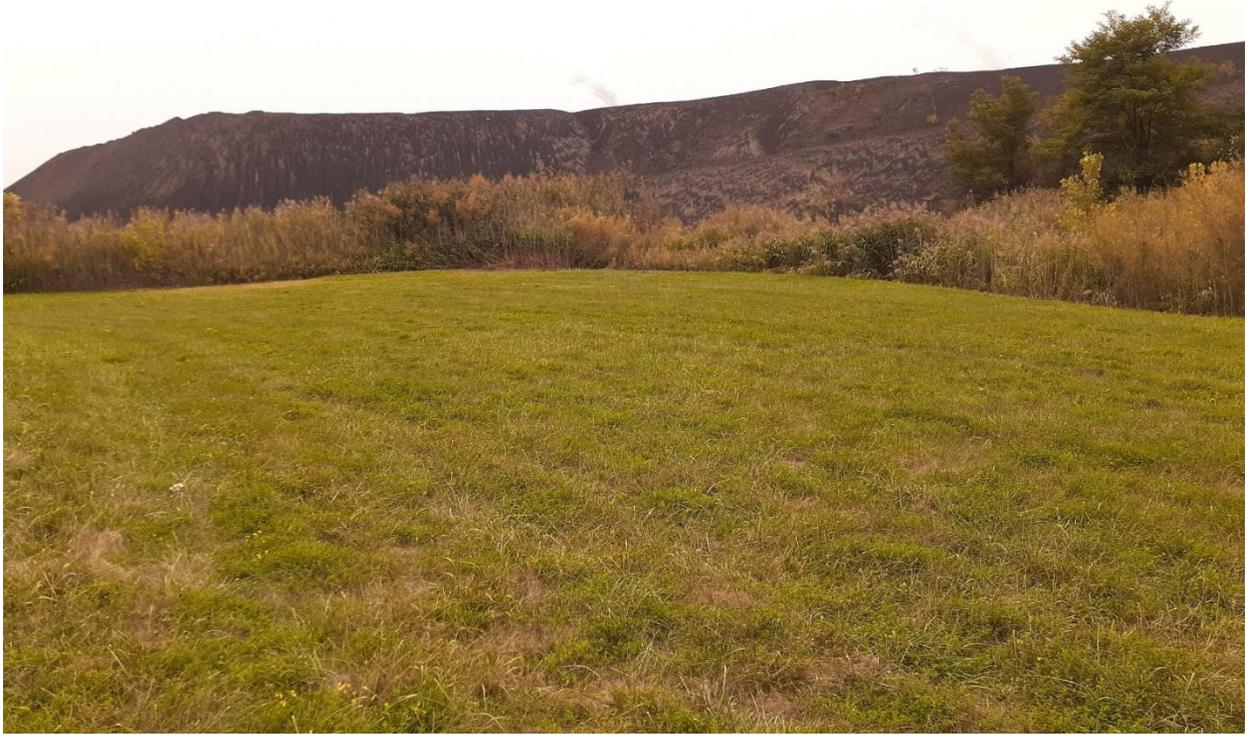
Photo 11 shows typical conditions of various stockpiles located within the undeveloped cells of the landfill. This is to control/reduce future settlement of the cells when they are constructed. The stockpiles are well graded to promote drainage.

Typical view of stockpile fill materials that will be used in future expansions of the landfill.

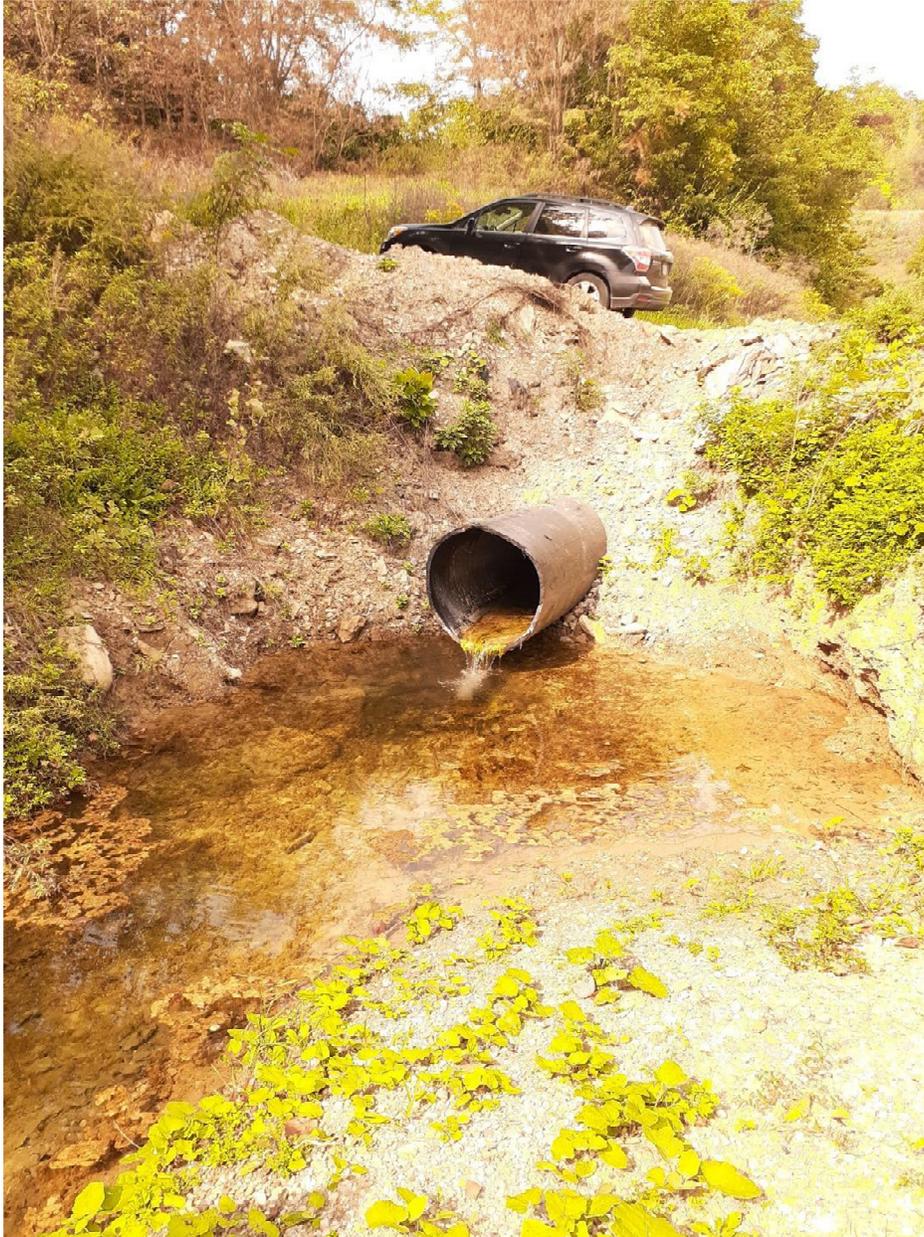
Photo 12

The landfill's LCS terminal point for the transmission pipe was observed to be in excellent condition which was discharging the leachate effluent freely and was observed to be visually clear prior to flowing into the FAR II pond (Photo 12).

Typical view of leachate discharge from the leachate transmission pipe flowing freely and was observed to be visually clear.
