# 2021 Annual Landfill Inspection Report

Cardinal Plant

2021 CCR Landfill Inspection Report

January 6, 2022

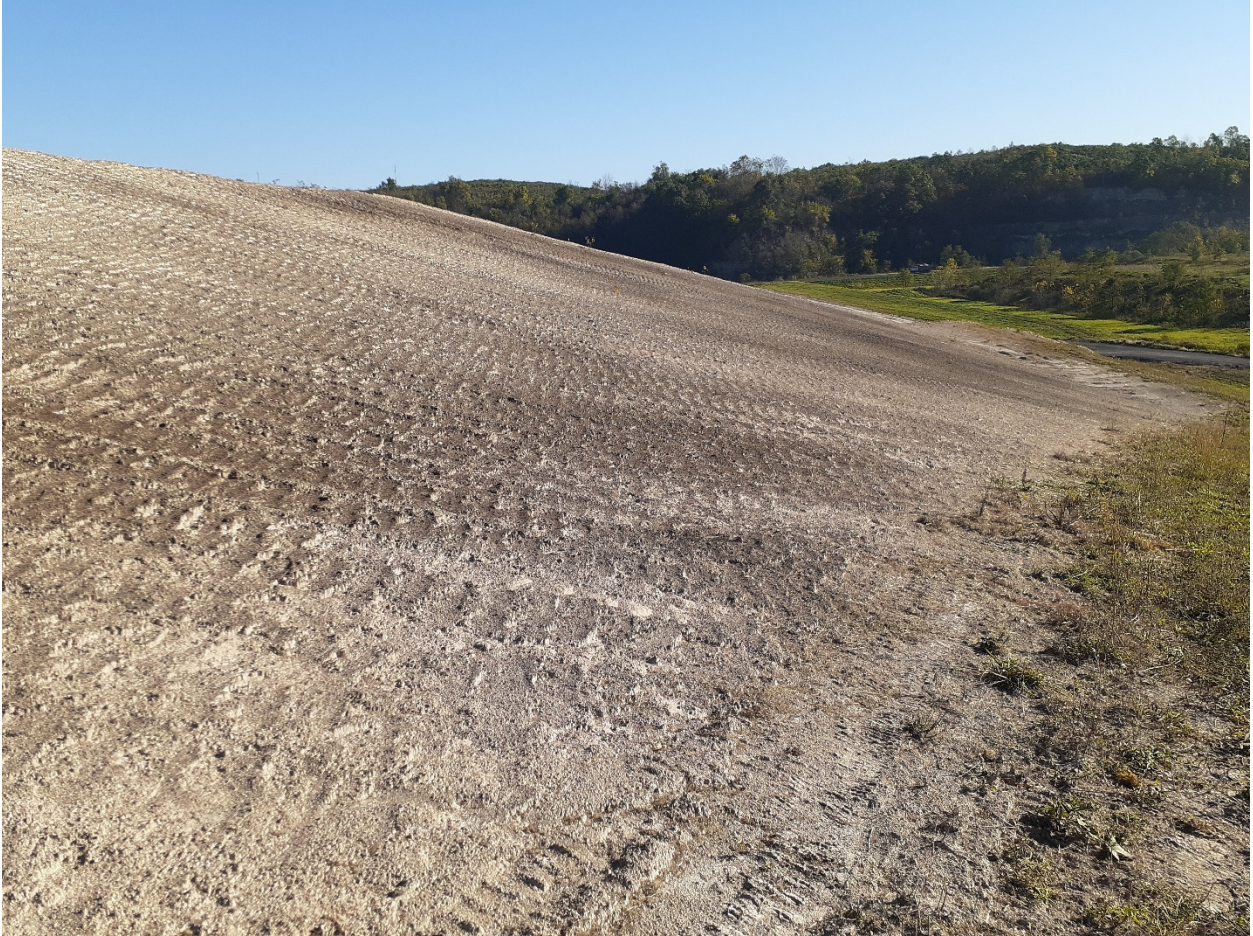
Photo 1

Areas where no activity was taking place were observed to be in excellent condition and were protected using a polymeric dust suppressant which had been sprayed on the surface (Photo 1). No fugitive dust was observed on the date of the inspection at any location. The temporary slopes within the active waste placement areas were also observed to be in excellent condition exhibiting uniform slopes, no erosion, slumping or other signs of instability or displacement.

Cell 1 FGD Gypsum slope showing excellent conditions (i.e. no erosion, slumping or bulges).

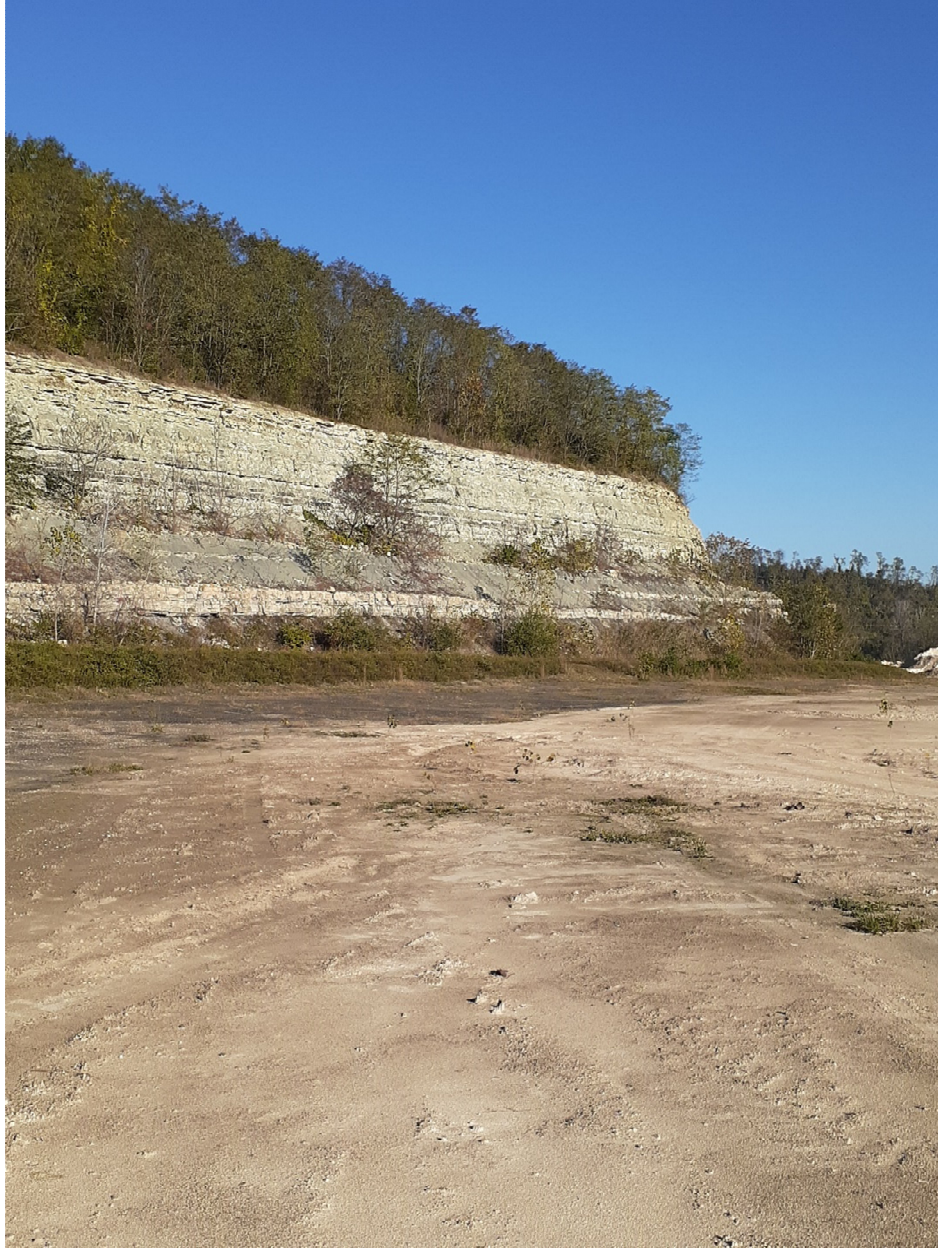
Photo 2

The bedrock highwall located along the western perimeter of Cell 1 appeared to be stable with no significant rock overhangs, rockfall or other signs of instability. The bedrock highwall is composed of alternating sequences of thin to thick bedded limestone interbedded with shale and siltstone reaching a height of 60 ft. No ponded water or uncontrolled seepage flows were observed at the base of the highwall, suggesting that the seepage collection system is functioning as intended. (Photo 2).

Cell 1 highwall slope showing stable conditions.

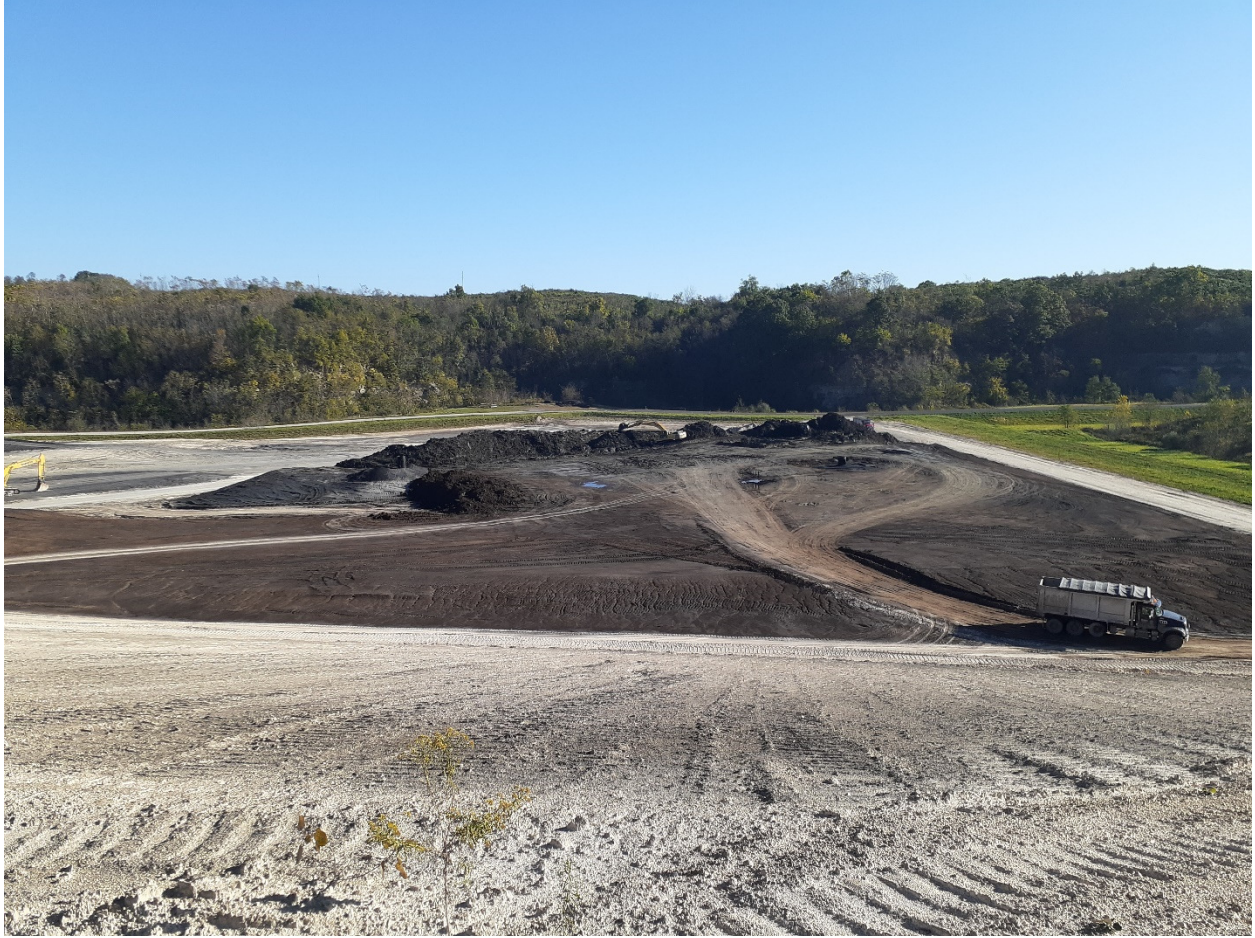
Photo 3

The active fill areas within Cell 3 were observed to be well maintained and in excellent condition. Cell 3 did not exhibit any ponded water or erosion within the cell and appeared to be well graded to promote drainage to the LCS's risers (also referred to as chimney drains). The riser structures (exposed on account of the excavation activities) were surrounded and protected by a layer of CCR to prevent impact from heavy equipment. Dry fly ash is actively being landfilled in Cell 3 (Photo 3).

Dry fly ash being place in Cell 3.

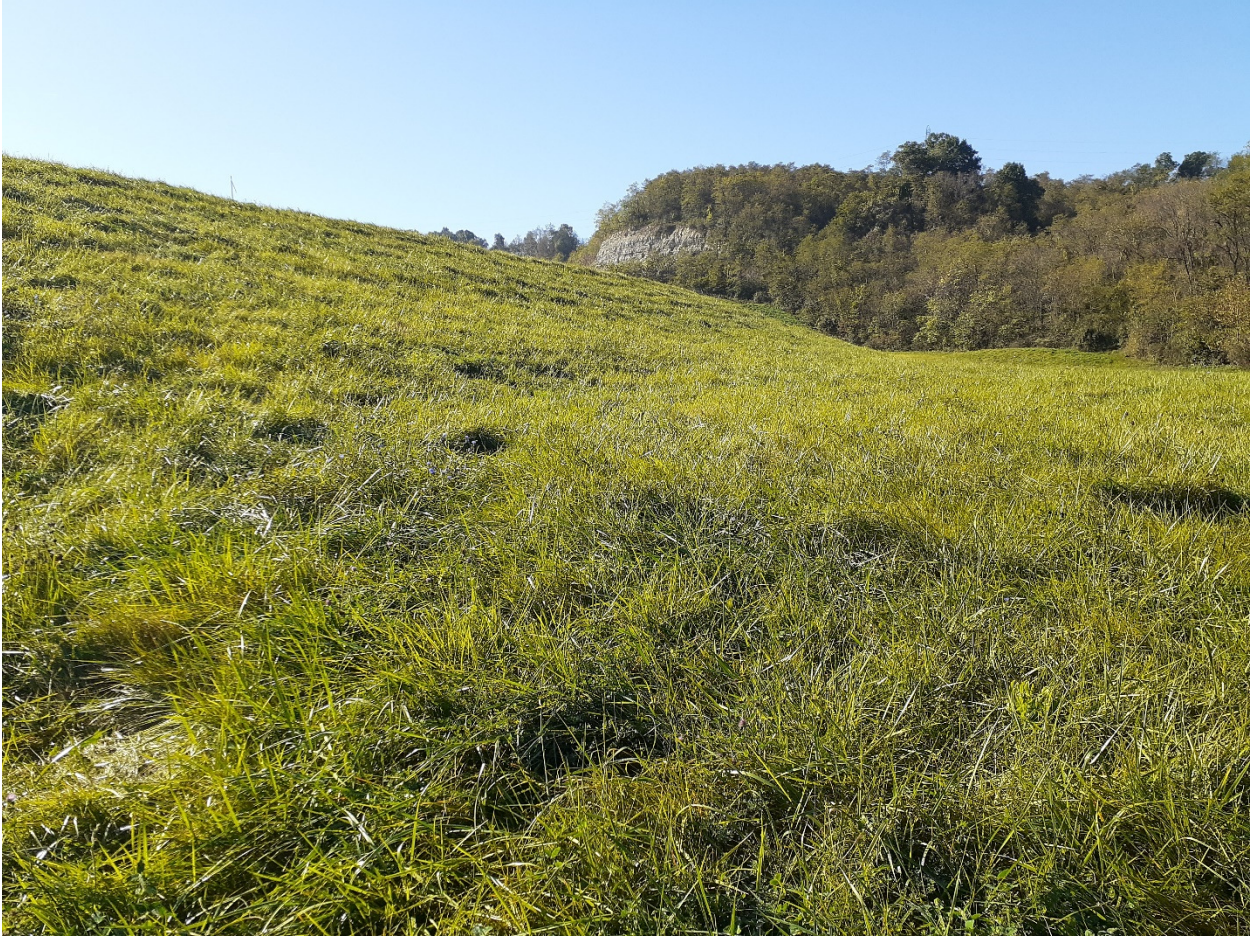
Photo 4

All areas with protective vegetative cover established such as the closed portion of the landfill and berms had a healthy grass stand but did exceed 12 inches in most areas. The northern closed area was in excellent condition. No erosion or animal burrows were observed, and the slopes were uniform (i.e. no slumping or bulging) and appeared to be well drained. No standing water was observed or soft/wet areas on the surface. (Photos 4 and 5).

Cell 3 FGD Gypsum landfill showing the closed and permanent cover cap area.

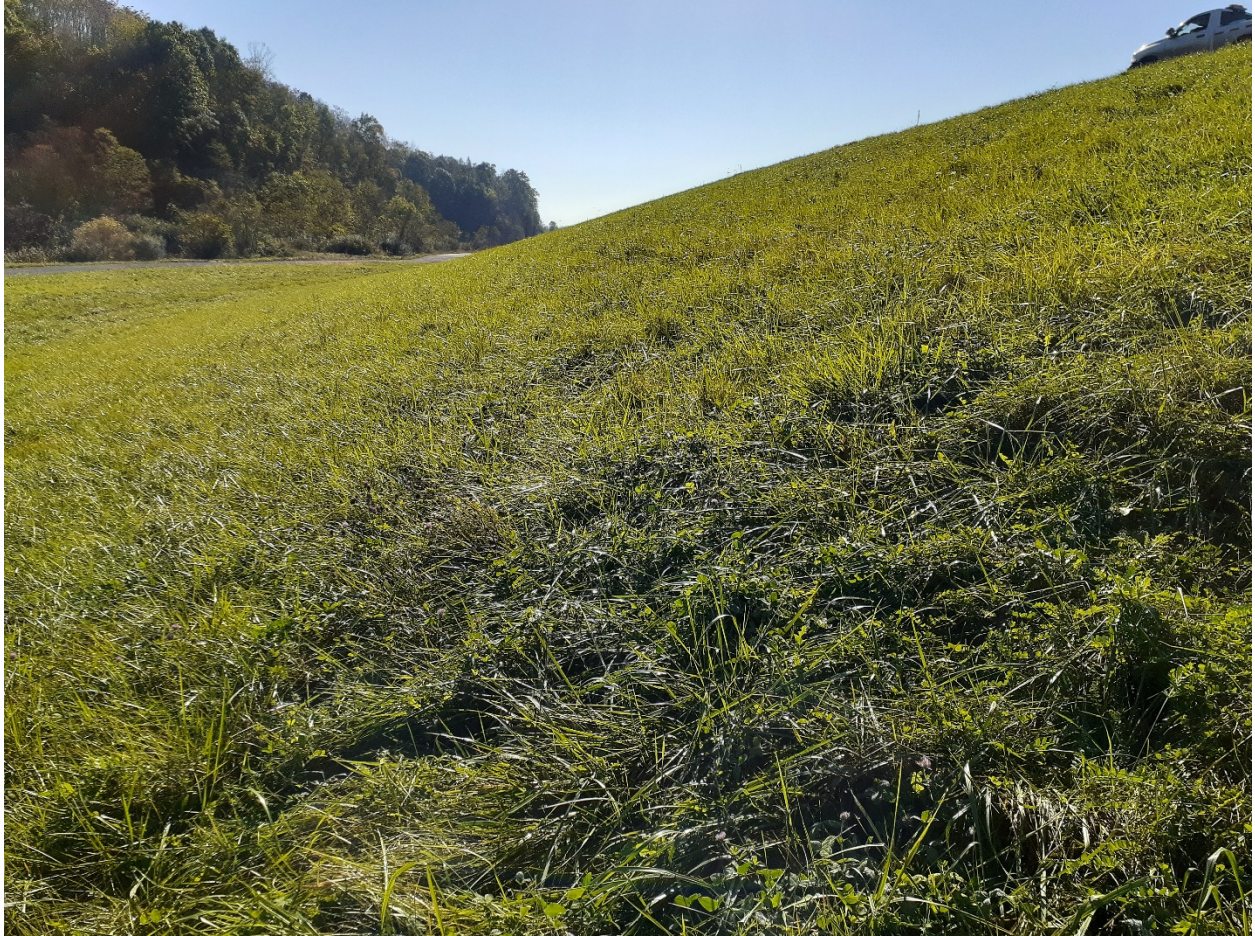
Photo 5

Cell 3 FGD Gypsum landfill showing a well-established vegetative cover over the closed and permanent cover cap area.

1. Continue current maintenance practices including but not limited to continuing to maintain the vegetative cover height at 6 inches or less and continue the 7-day inspections of the area.

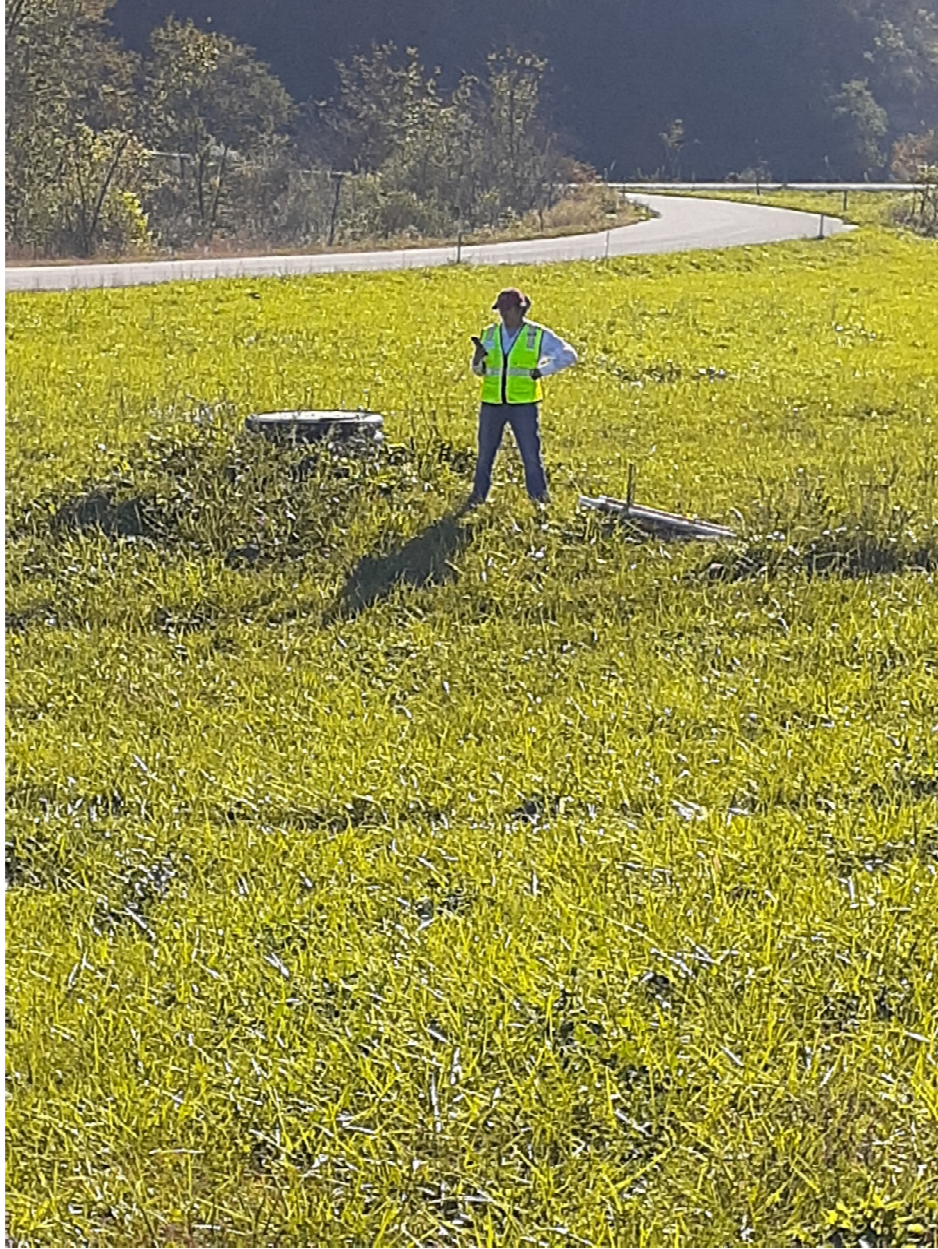
The pedestal for settlement profiler No.1 is depicted in Photo 6 showing typical conditions. Photo 7 depicts settlement profiler No.2 which also shows good conditions along with the LCS manhole showing excellent

Settlement pedestal for the Landfill's No. 1 settlement profiler.

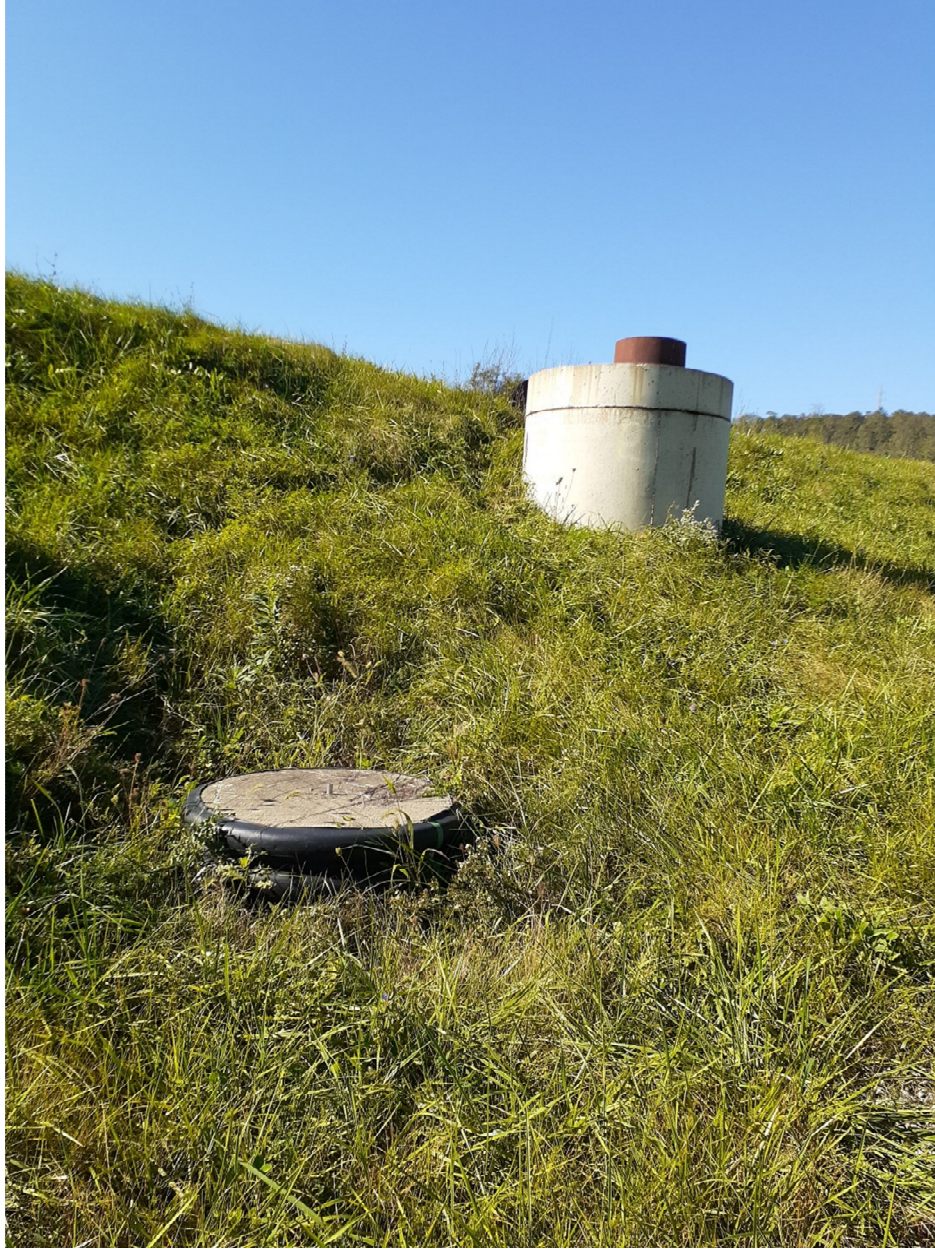
Photo 7

conditions (i.e. no cracking, spalling or exposed rebar). Photo 8 shows the excellent conditions of the manhole interior. The landfill's leachate was observed to be freely flowing into the manhole.

Settlement pedestal for the Landfill's No. 2 settlement profiler with the leachate collection system manhole.

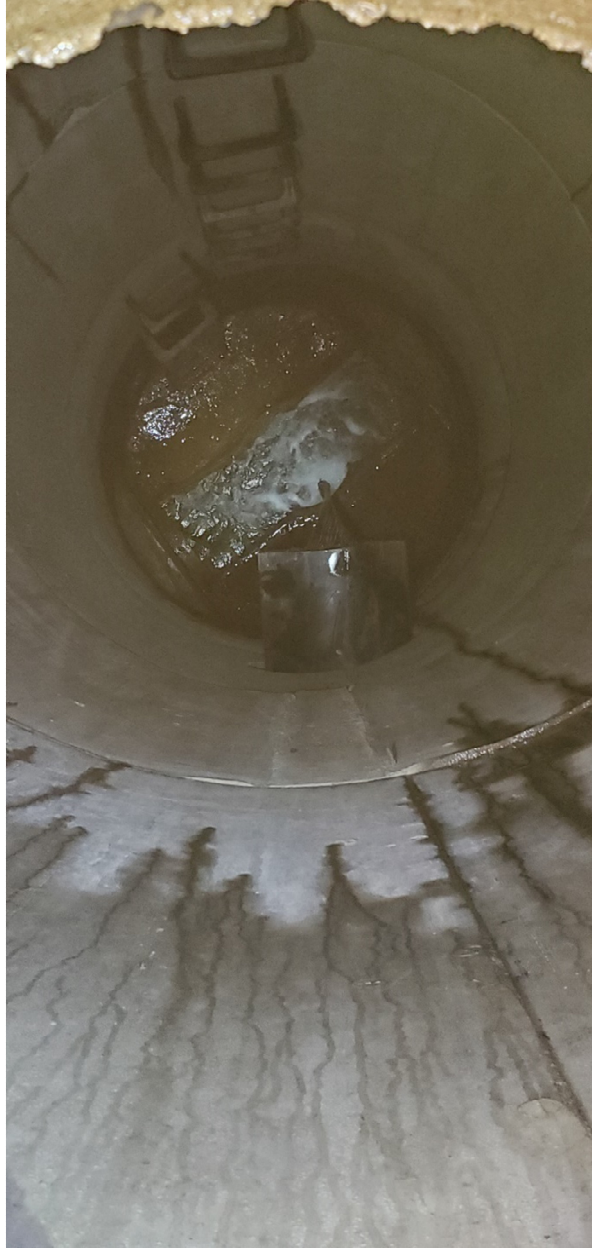
Photo 8

Interior view of manhole showing leachate flowing freely into the manhole.

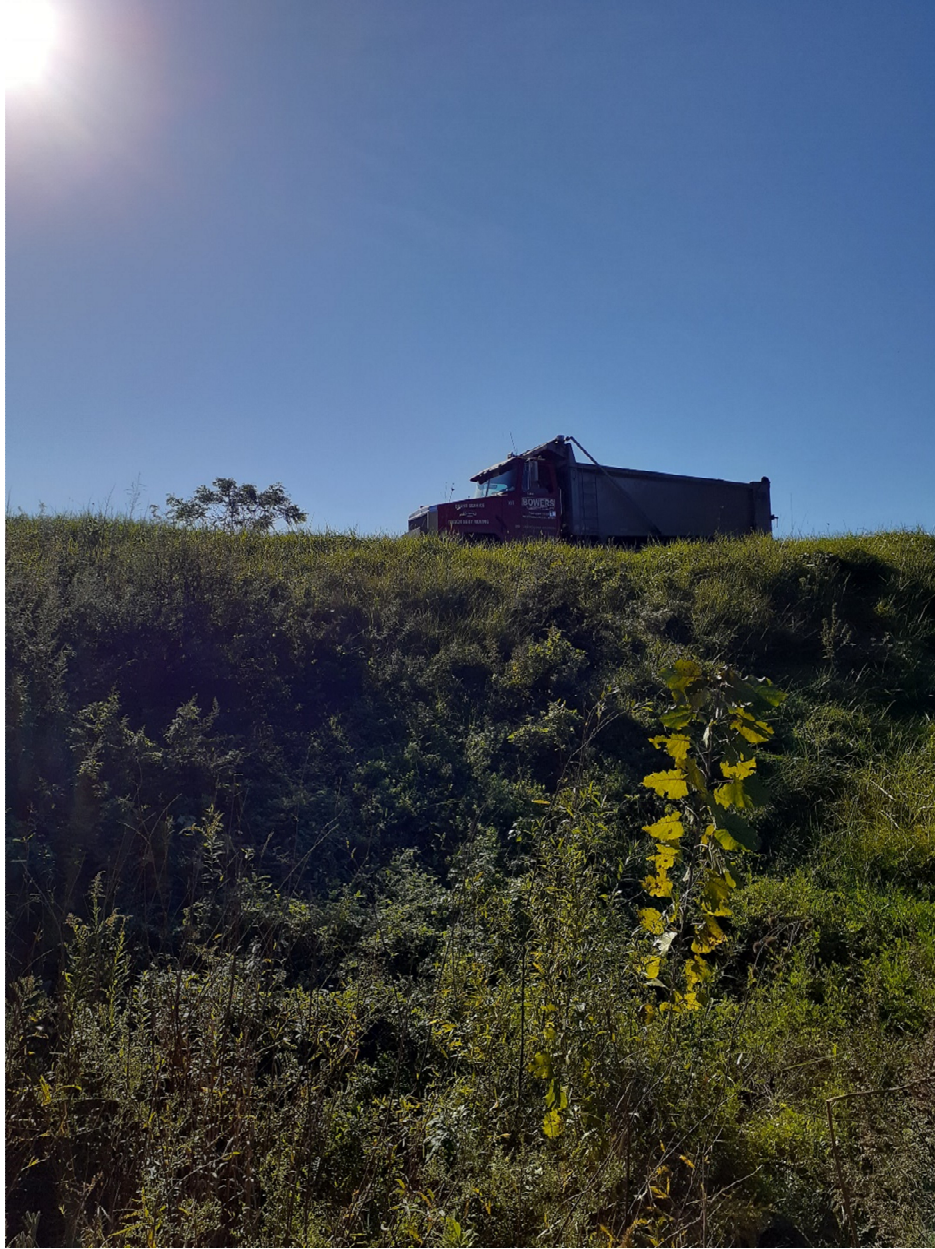
Photo 9

The access road into Cell 3 is in good condition and crosses the perimeter ditch that collects non-contact storm water. A HDPE 16 " culvert was not observed due to excessive vegetative (Photo 9).

Excessive vegetative growth has obscured the 16 inch HDPE culvert at the access road leading into the landfill.

1. Continue to mow all vegetated berms on a regular basis to prevent the growth of excess woody plants and brush.
2. Continue to complete regular maintenance of minor erosion rills and use the polymer as needed for erosion control and fugitive dust control.
3. Continue to complete weekly inspections and submit inspection reports to the operating record.

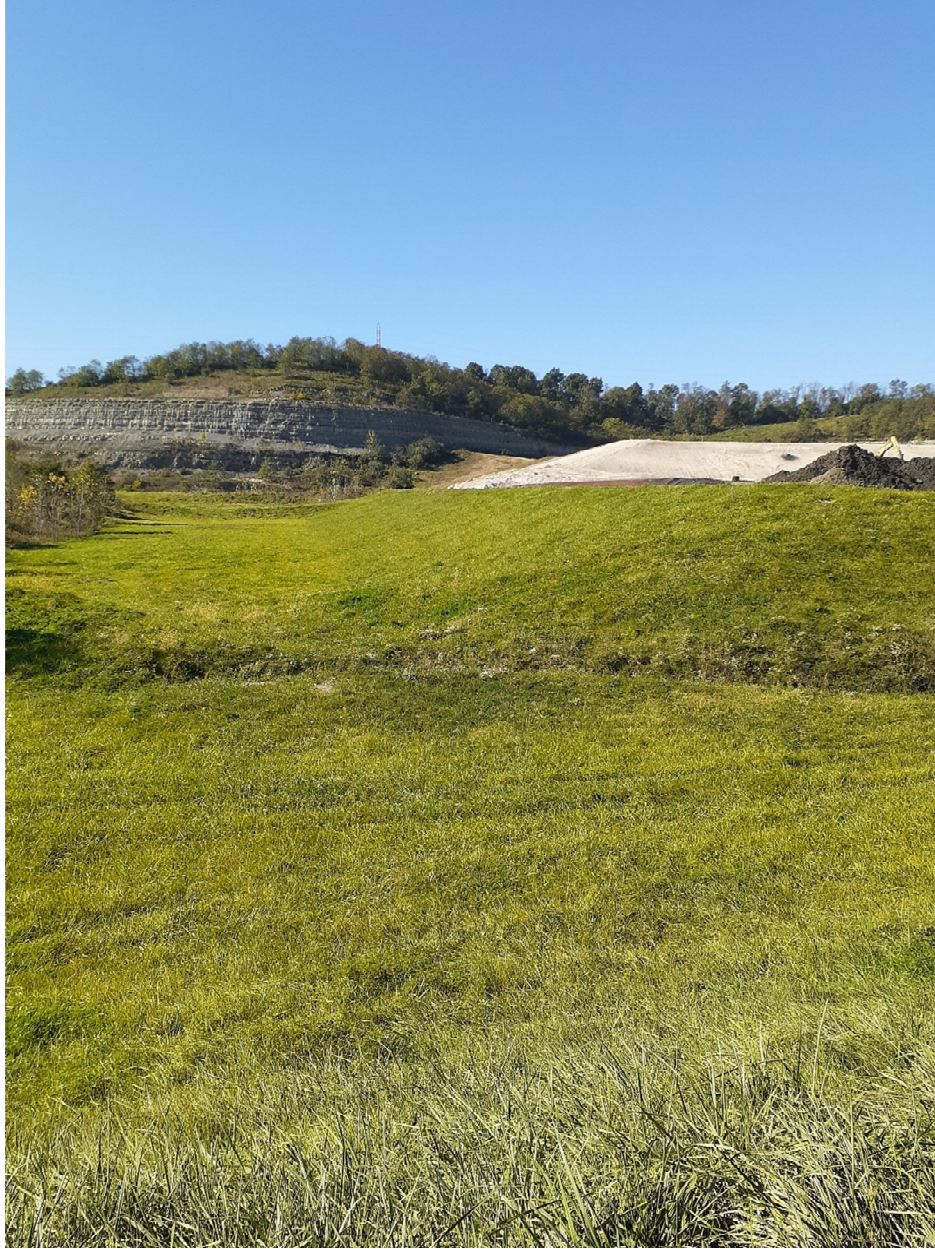
The exposed gypsum slope depicted in Photo 10 also shows excellent conditions and has been treated with a dust suppression polymer that also protects the slope from erosion. The dark colored fill depicted in Photo 10 is the wastewater treatment plant solids being placed in Cell 3.

Interim berm for Cells1 and 3 showing excellent vegetative cover on lower portions of the slope. The upper portion of the slope showing exposed FGD Gypsum is also in excellent condition and has been treated with a dust suppressant polymer. The dark colored fill is calcium chloride waste that is also generated from the plant's SO<sub>2</sub> scrubbing operation and conditioned fly ash.

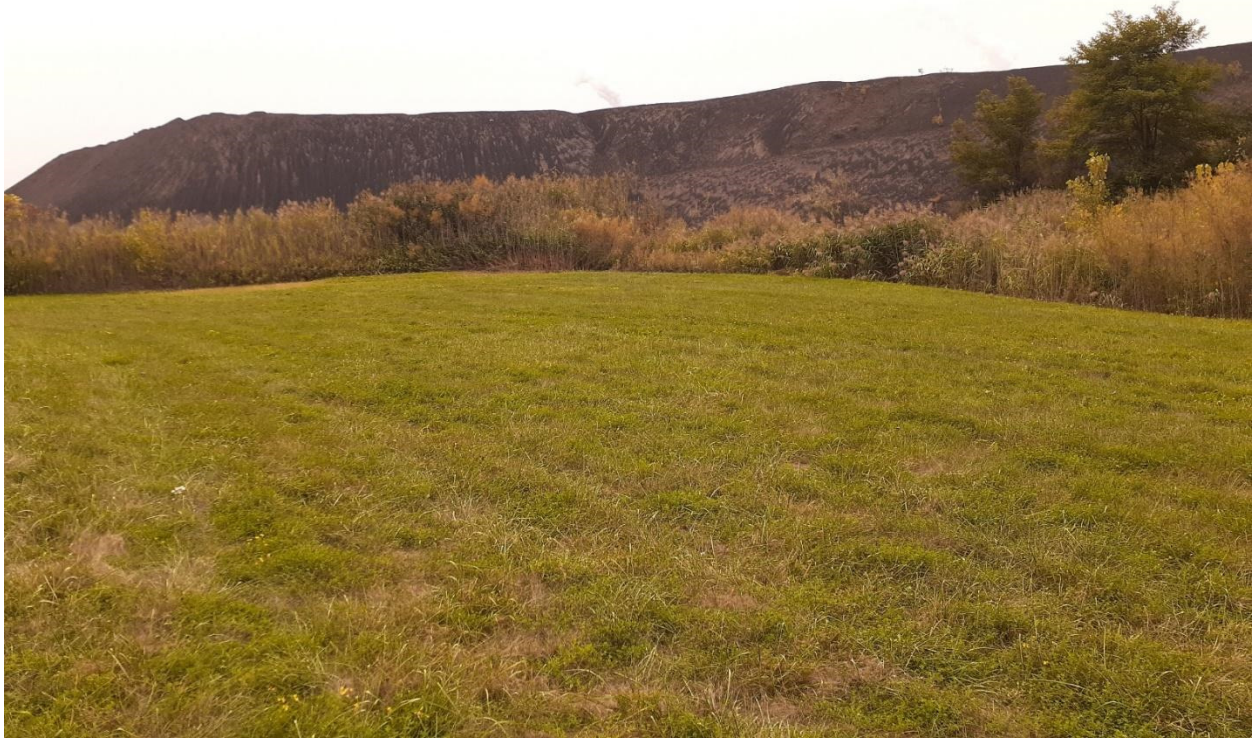
Photo 11 shows typical conditions of various stockpiles located within the undeveloped cells of the landfill. This is to control/reduce future settlement of the cells when they are constructed. The stockpiles are well graded to promote drainage.

Typical view of stockpile fill materials that will be used in future expansions of the landfill.

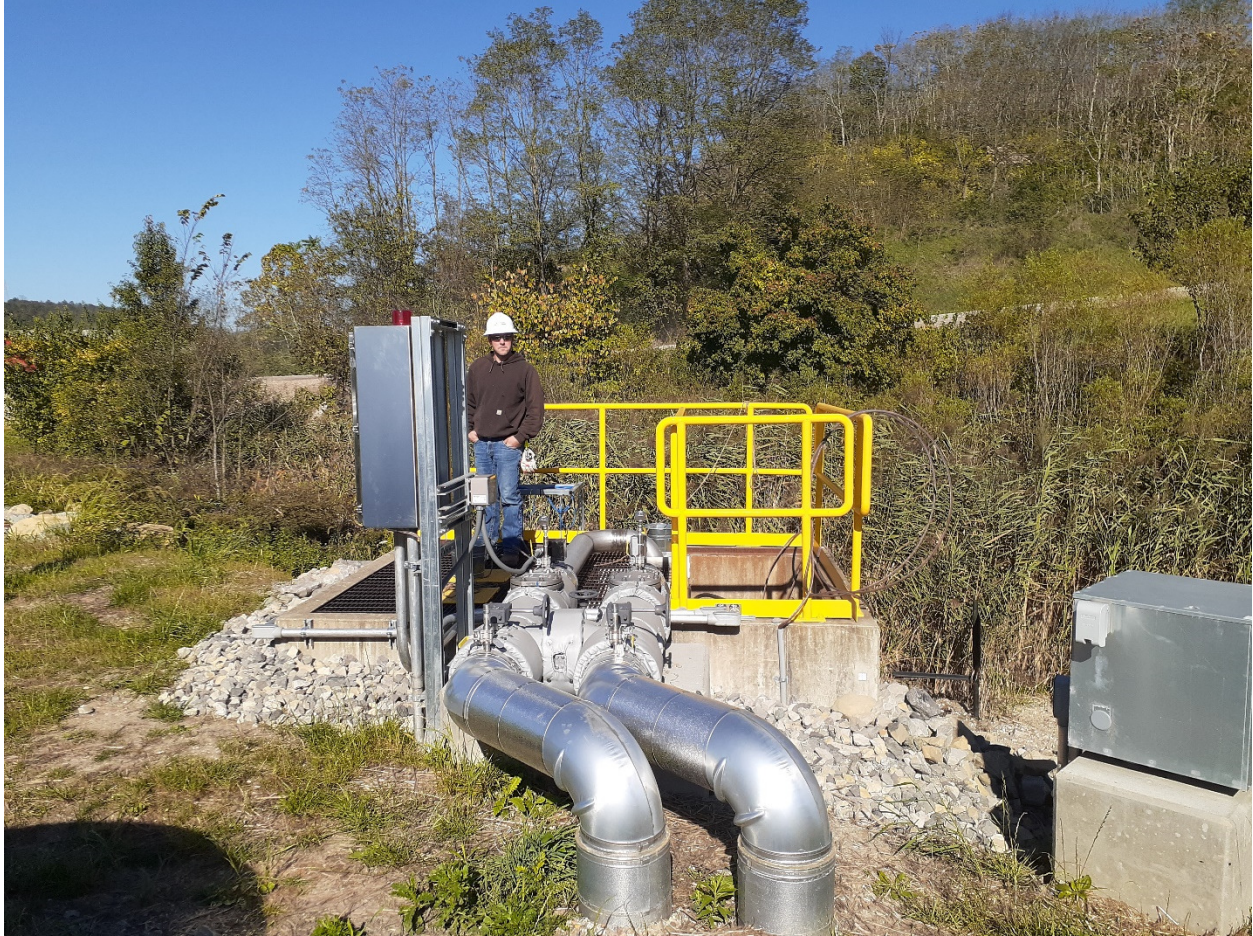
Photo 12

The junction structures for the leachate collection system and spring drain/SDL were observed to be in good condition and were freely flowing into the concrete sump on the date of the inspection (Photo 12).

Typical view of the concrete leachate sump structure allowing discharge from the leachate transmission pipe to flow freely into the sump. The effluent was observed to be visually clear.

1. Continue to monitor the leachate collection system and spring drain collection system for unobstructed flow.
2. Continue all current maintenance and fill placement practices.

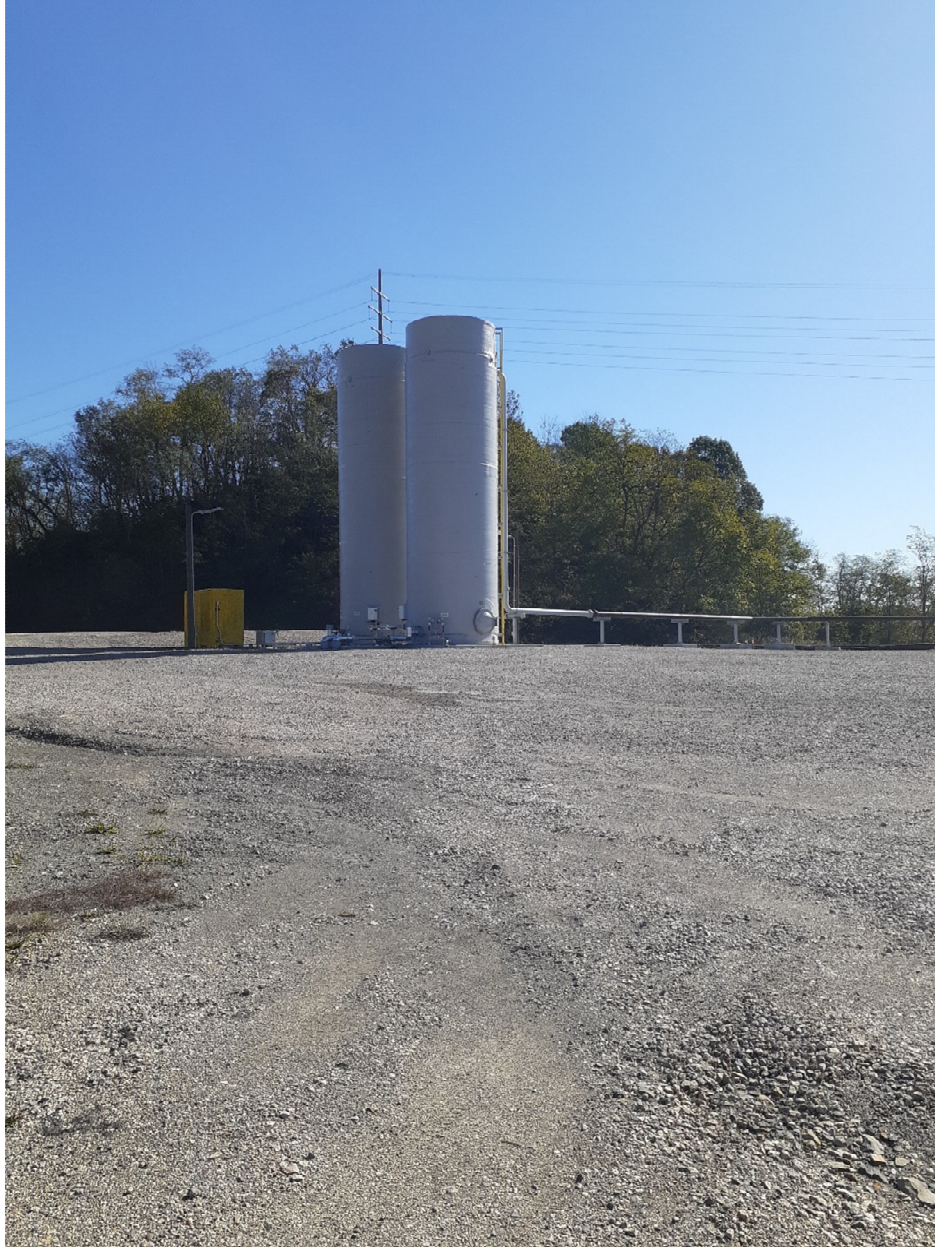
Photo 13

The leachate effluent is then discharged to pretreatment settling tanks in which temperature and effluent levels are monitored (Photos 13 and 14).

Typical view of the pretreatment settling tanks to manage the landfill leachate since the FAR II impoundment has initiated closure.

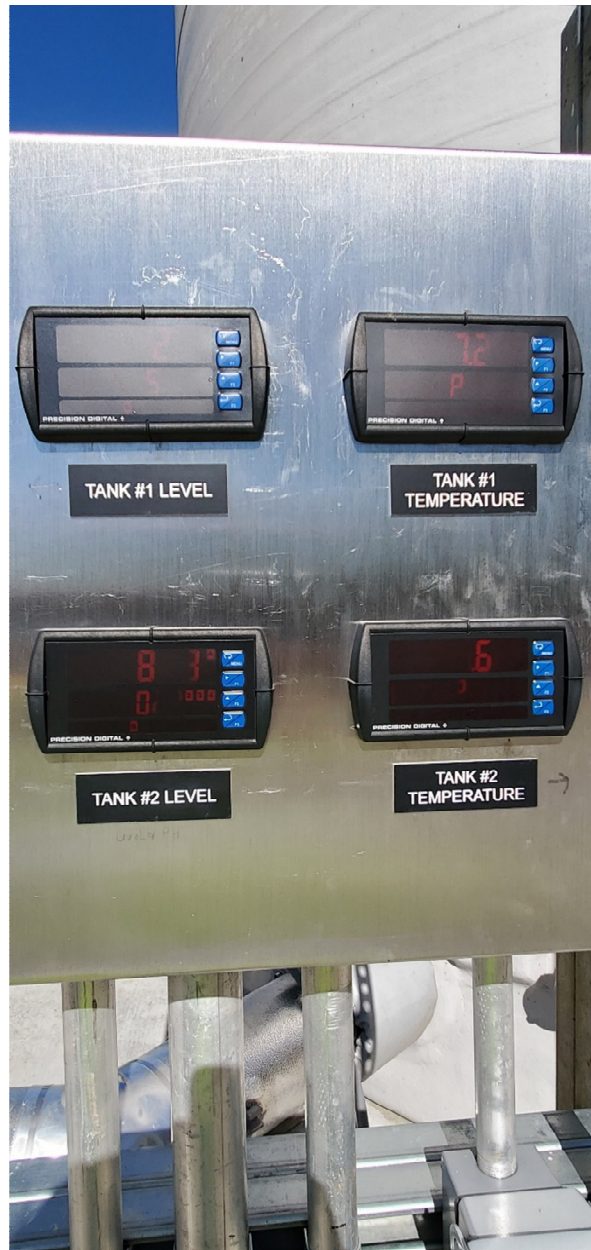
Photo 14

Typical view of the instrument panel for the pretreatment settling tanks indicating tank effluent levels and temperature for each tank.
