# 2023 Annual Landfill Inspection Report

Cardinal Plant

## 2023 CCR Landfill Inspection Report

January, 2024

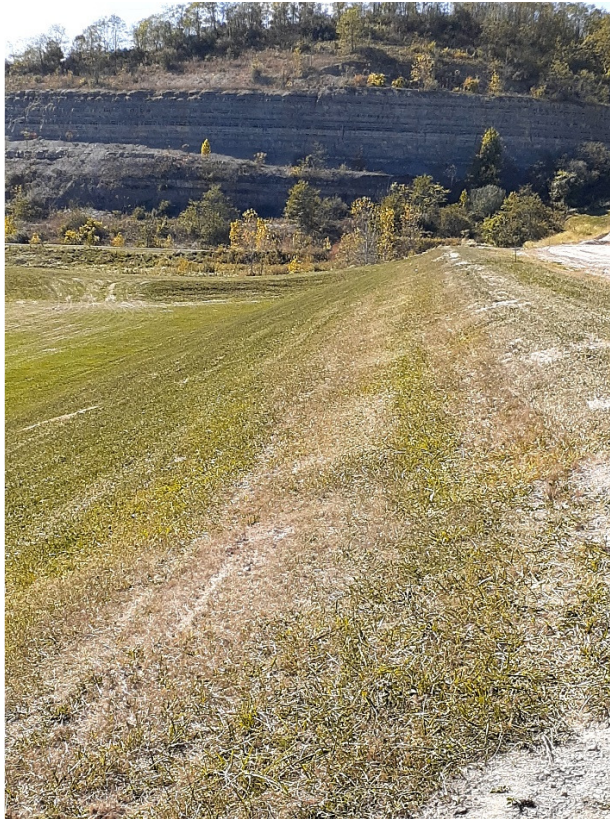
Photo 1

The interim berm between Cell 3 and the landfill's undeveloped cells was observed to be in good condition with the slope terminating at a crest which forms a temporary ditch along the perimeter of the cell to convey contact storm water to the LCS. The interim slope is constructed with a temporary cover soil in which an established vegetation was observed to be in good condition. The slope appeared to be uniform and free of displacement or other signs of instability (Photo 1). The stockpiles within the future undeveloped landfill

Typical view of intermediate slope between Cells 1& 3 and remaining undeveloped cells.

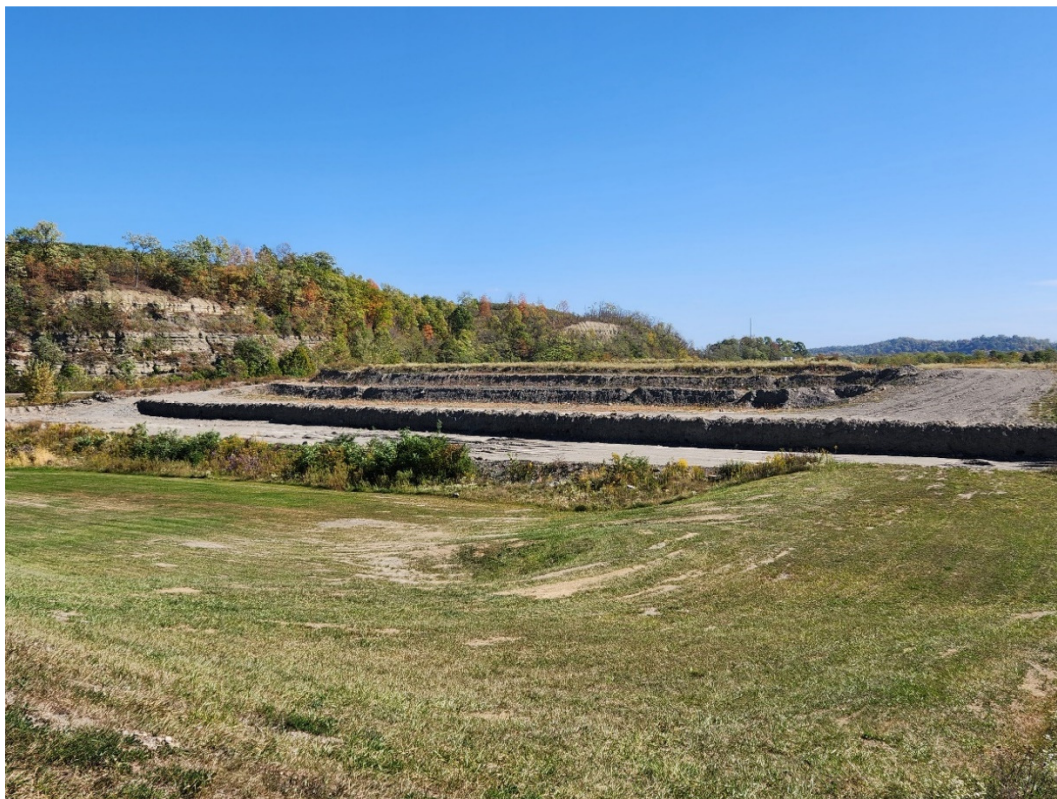
Photo 2

cells shows an orderly excavation of these fill materials (Photo 2). The stockpiles are well graded to promote drainage.

Typical view of remaining undeveloped cells and stockpiles.

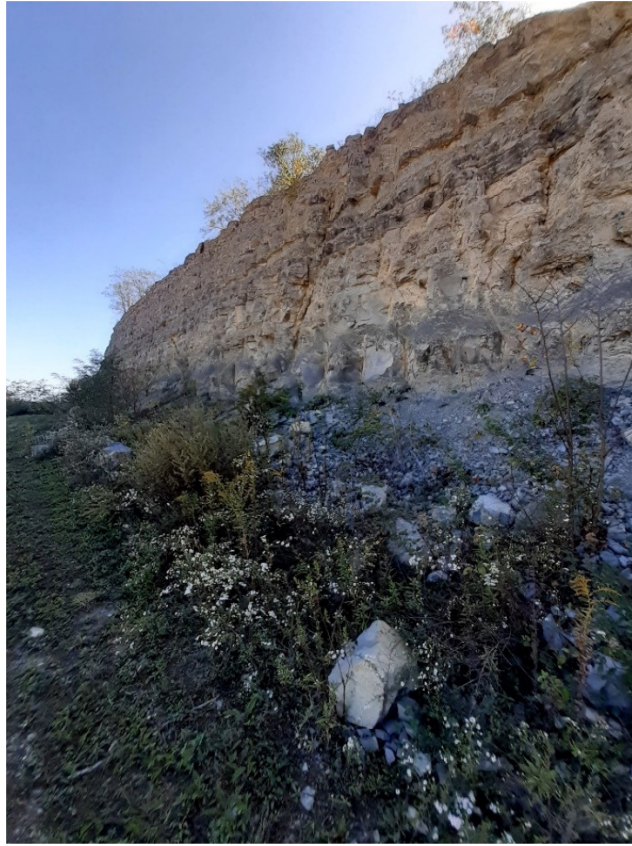
The bedrock highwall located along the western perimeter of Cell 1 appeared to be stable with no significant rock overhangs, rockfall or other signs of instability (Photo 3). The bedrock highwall is composed of alternating sequences of thin to thick bedded limestone interbedded with shale and siltstone reaching a height of 60 ft. No ponded water or uncontrolled seepage flows were observed at the base of the highwall, suggesting that the seepage collection system is functioning as intended.

Photo 3  
Close up of the highwall seen in Photo No.1.

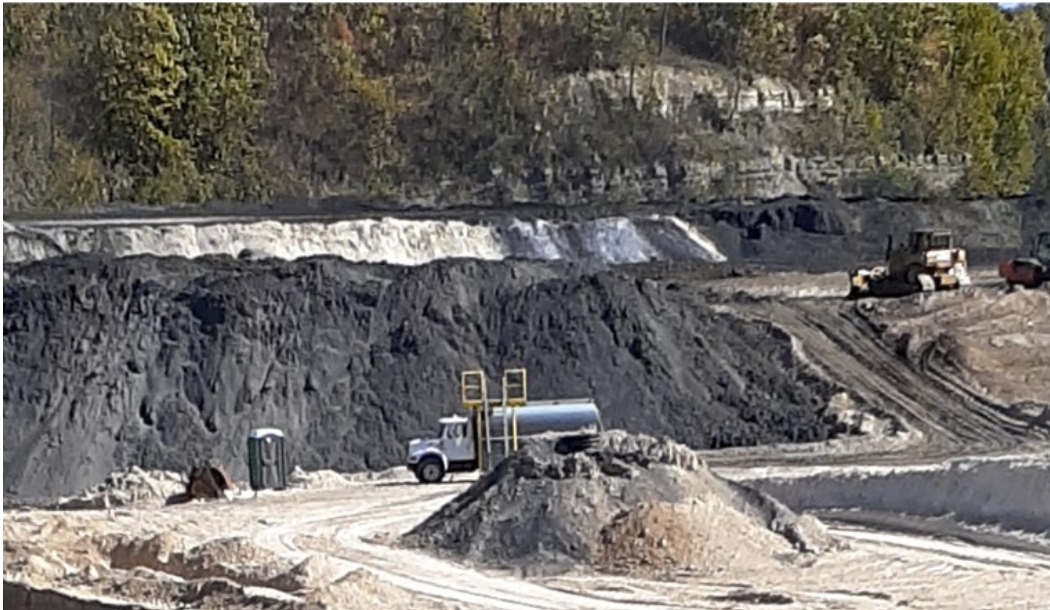
Photo 4  
Typical view of leachate collection system riser pipe having a protective barrier surrounding the riser.

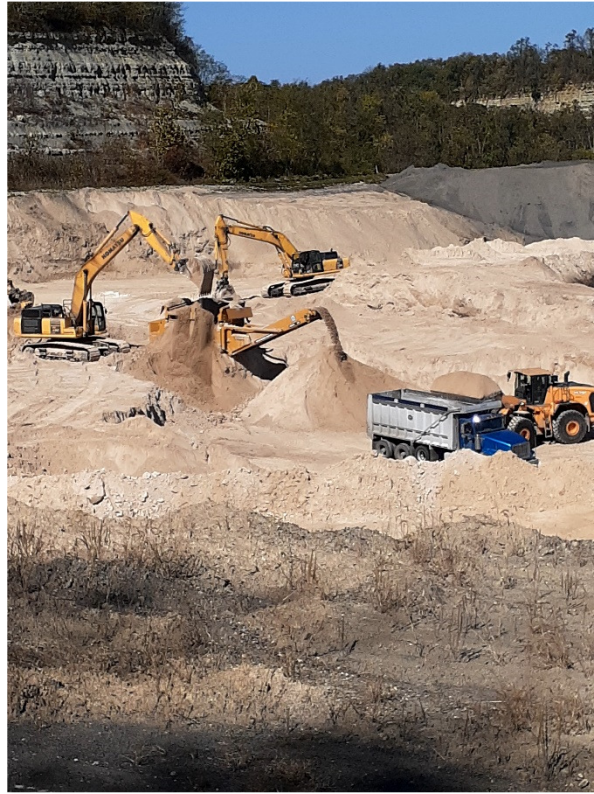
Photo 5

The active fill areas within Cells 1 and 3 were observed to be well maintained and in excellent condition. Cell 1 did not exhibit any ponded water or erosion within the cell and appeared to be well graded to promote drainage to the LCS's risers (also referred to as chimney drains). The riser structures (exposed on account of the excavation activities) were surrounded and protected by a layer of CCR to prevent impact from heavy equipment (Photo 4). FGD gypsum is actively being excavated from Cell 1 for beneficial utilization (Photo 5). Dry fly ash is actively being landfilled in Cell 3.

Typical view showing the reclamation of FGD gypsum for beneficial reutilization.

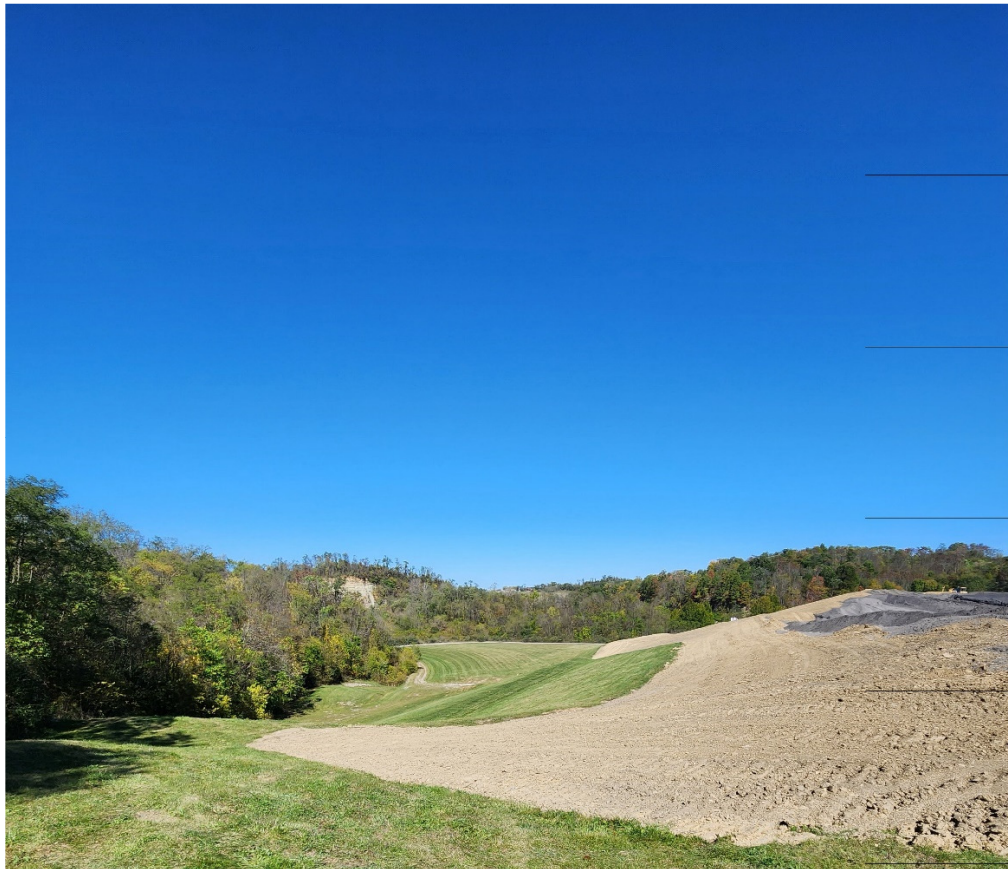
Photo 6

A protective vegetative cover is well established in Cell 1 in the closed portion of the landfill showing a healthy grass stand, approximately 6 inches in height. The northern closed area was in excellent condition. No erosion or animal burrows were observed, and the slopes were uniform (i.e., no slumping or bulging) and appeared to be well drained. The area also showed the recent placement of intermediate clay cover up to the active fill area (Photo 6).

Typical view of the permanent cover cap showing a well-maintained vegetative cover and placement of intermediate cover.

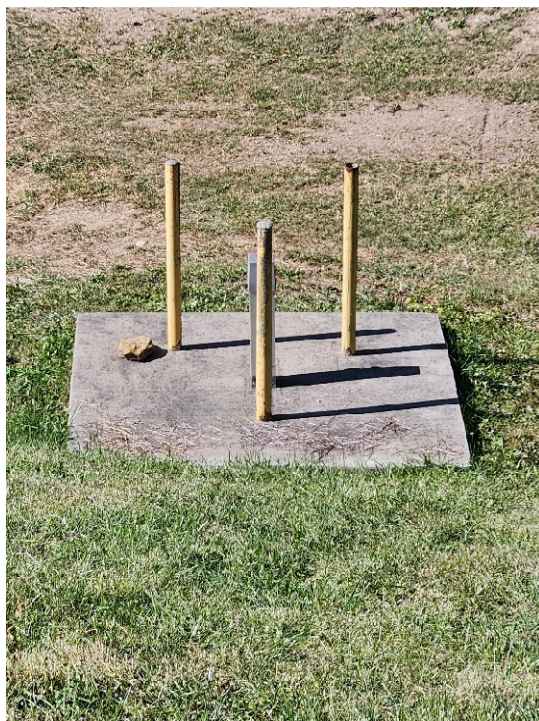
Photo 7

A monitoring well located at the toe of the slope in Cell 1 was observed to be in excellent condition. The concrete well pad was not cracked or undermined, protective bollards were adequately spaced, and the casing protector was locked (Photo 7).

Typical view of the landfill's monitoring well showing very good conditions (i.e. concrete pad, protective bollards, and locked casing protector).

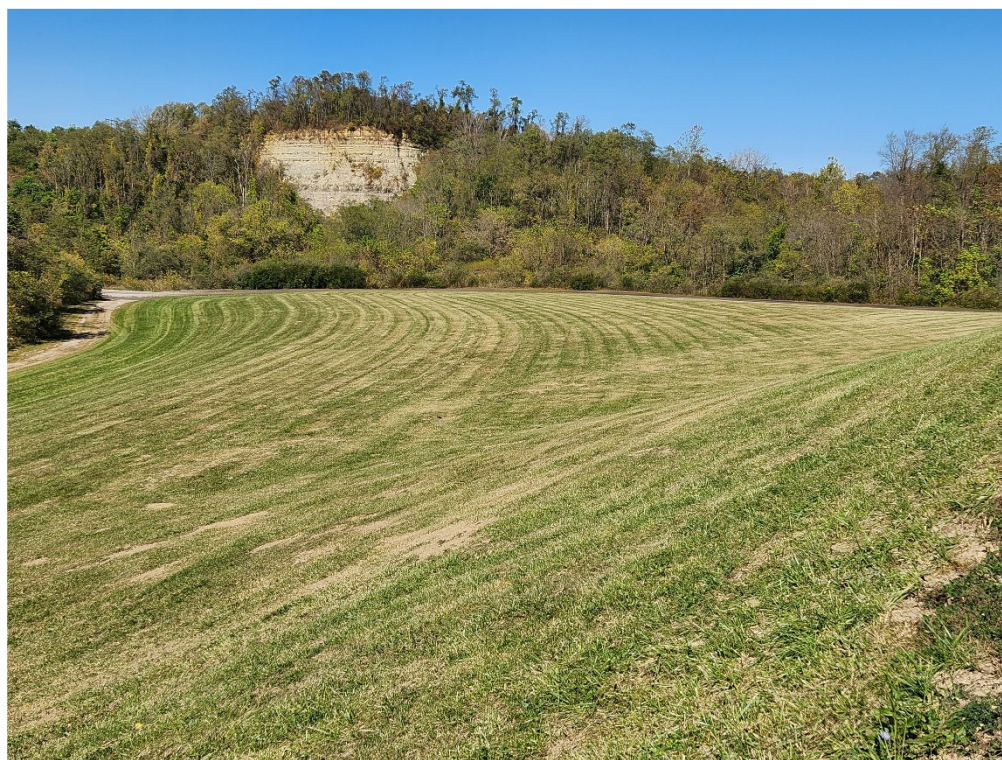
Photo 8

View of Cell 3 exterior slope showing excellent condition, uniform slopes with a healthy vegetative grass cover.

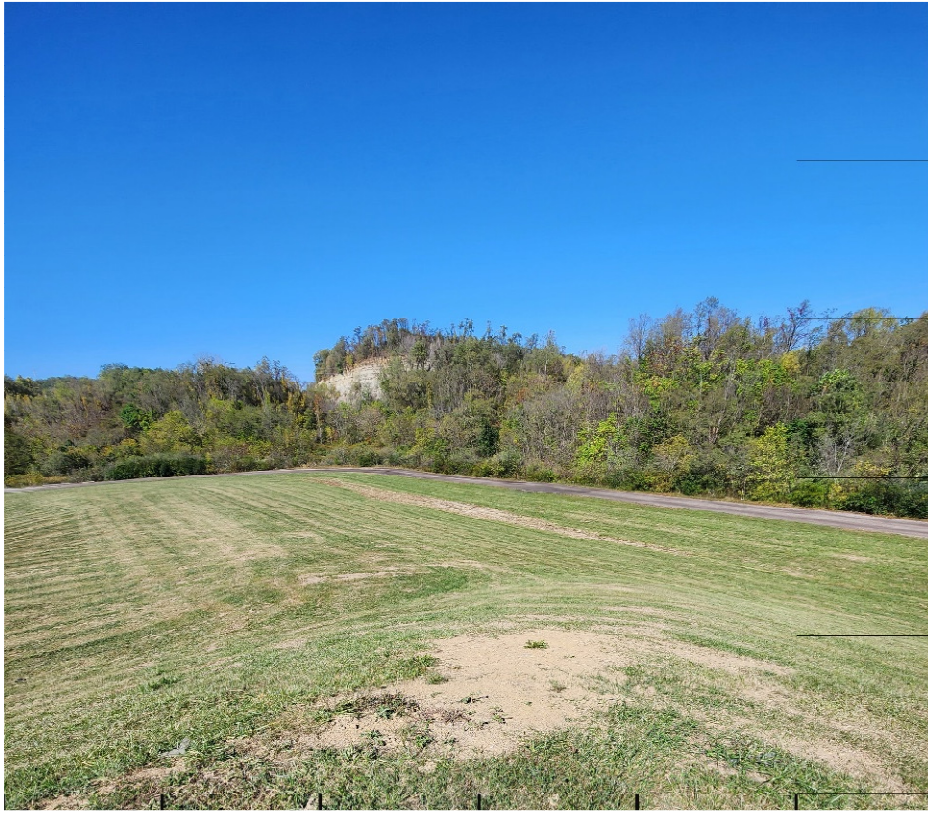
Photo 9

View of a minor bare soil area due to mowing operations.

1. Continue to mow all vegetated berms on a regular basis to prevent the growth of excess woody plants and brush.
2. Continue to reseed minor barren soil areas as needed to prevent erosion of the cover cap.
3. Continue to complete regular maintenance of minor erosion rills and use the polymer as needed for erosion control and fugitive dust control.
4. Continue to complete weekly inspections and submit inspection reports to the operating record.

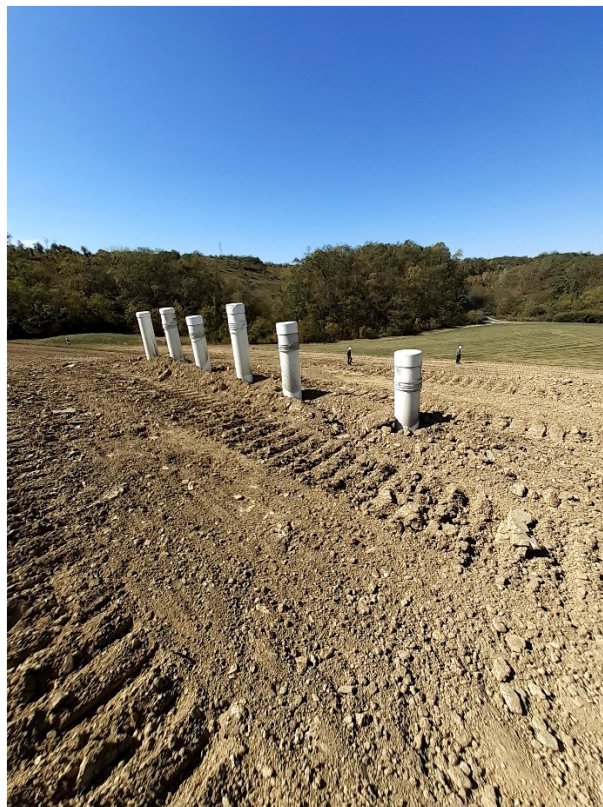
Photo 10

All areas in Cell 3 with protective vegetative cover established such as the closed portion of the landfill and berms had a healthy grass stand but did exceed 6 inches in height. No erosion, animal burrows, slumping or other signs of slope instability were observed (Photo 8). A minor barren soil was observed due to mowing operations at the apex of the (Photo 9). The intermediate clay cover was also being placed in Cell 3 inclusive of the area where 6 monitoring wells are located (Photo 10).

View of the landfill's monitoring wells and recent placement of intermediate cover.

1. Continue current maintenance practices including but not limited to continuing to maintain the vegetative cover height at 6 inches or less and continue the 7-day inspections of the area.
2. Protective bollards should be placed around the 6 monitoring wells located in Cell 3 to prevent mowing operations from damaging these wells.

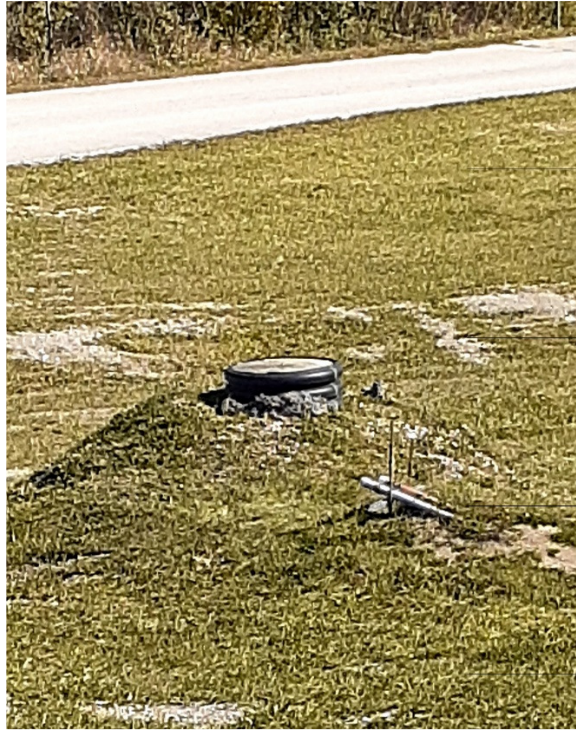
Photo 11

The pedestal for settlement profiler No. 1 and associated piping was observed to be in excellent condition (Photo 11). Settlement profiler No. 2 shows excellent conditions (Photo 12). The adjacent LCS manhole also shows excellent conditions (i.e., no cracking, concrete spalling, or exposed rebar on the outer surface).

Typical view of the settlement profiler No. 1 concrete pedestal and associated piping showing good conditions.

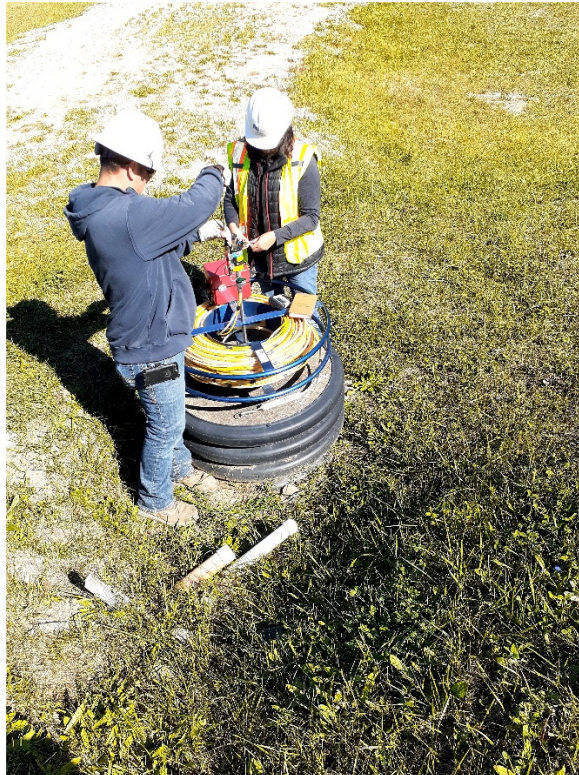
Photo 12

Typical view of the settlement profiler No. 2 concrete pedestal and associated piping showing good conditions.

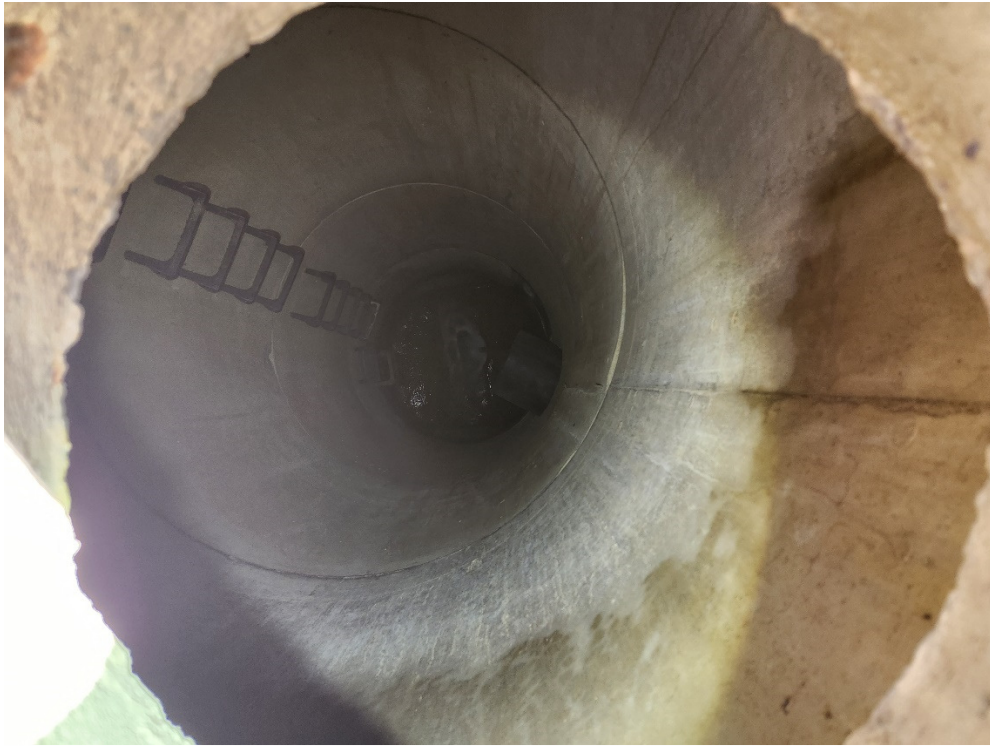
Photo 13 shows the excellent condition of the manhole's interior. The landfill's leachate was observed to be flowing freely into the manhole.

Typical view showing excellent conditions of the manhole's interior for the leachate collection pipe. No spalling, cracking or noticeable deterioration of the concrete was observed. Leachate was flowing freely along the base of the manhole.

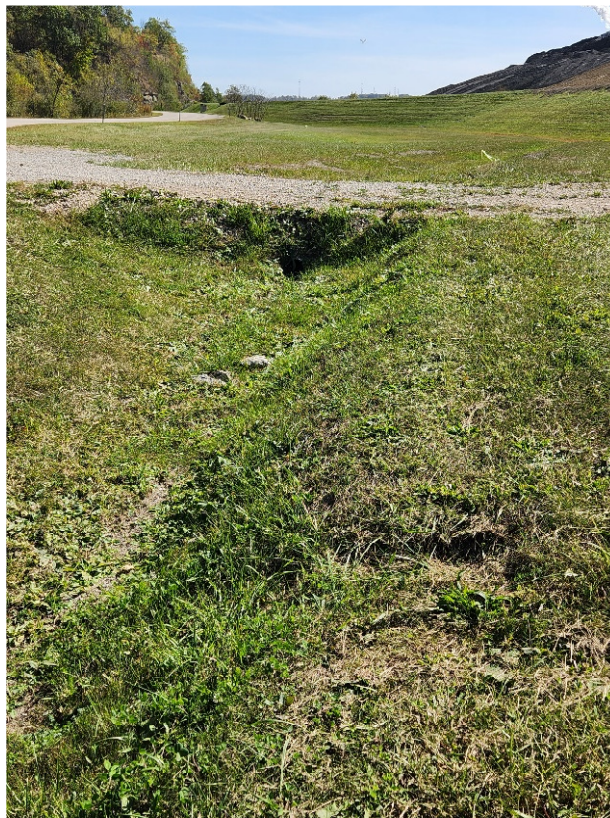
Photo 14

There is a significant improvement in drainage along the toe of Cell 3, no standing water was observed, and culverts were unobstructed.

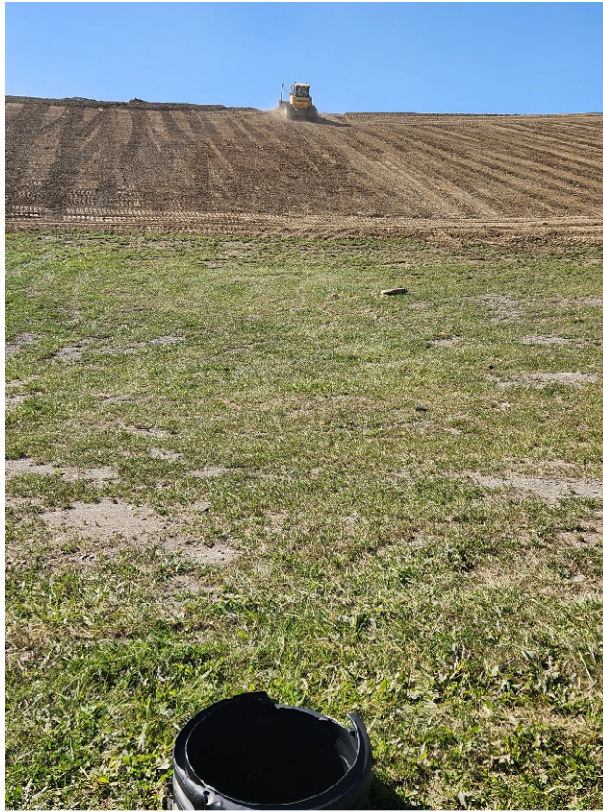
Photo 15

View of Cell 3 exterior slope showing excellent conditions with active placement of intermediate soil cover creating uniform slopes with the established permanent cover cap.

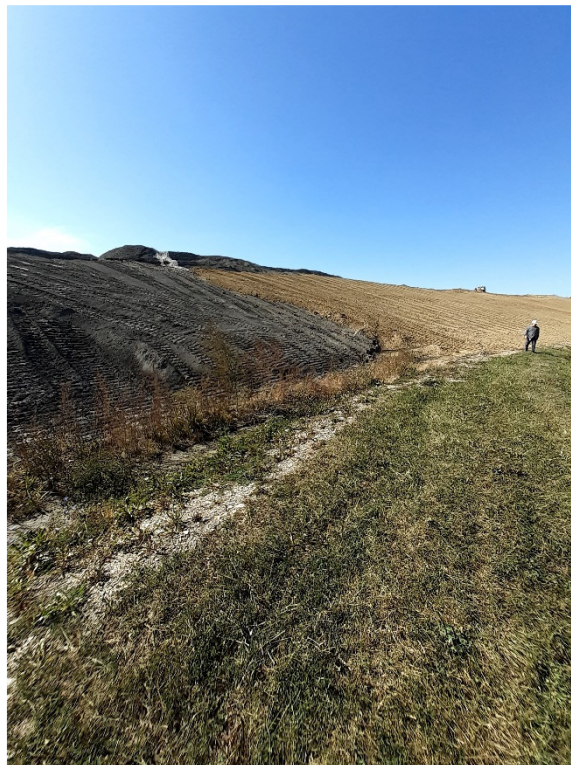
Photo 16

View of Cell 3 exterior slope showing excellent conditions with active placement of intermediate soil cover creating uniform slopes. Foreground shows perimeter ditch that will convey contact water to the landfill's LCS.

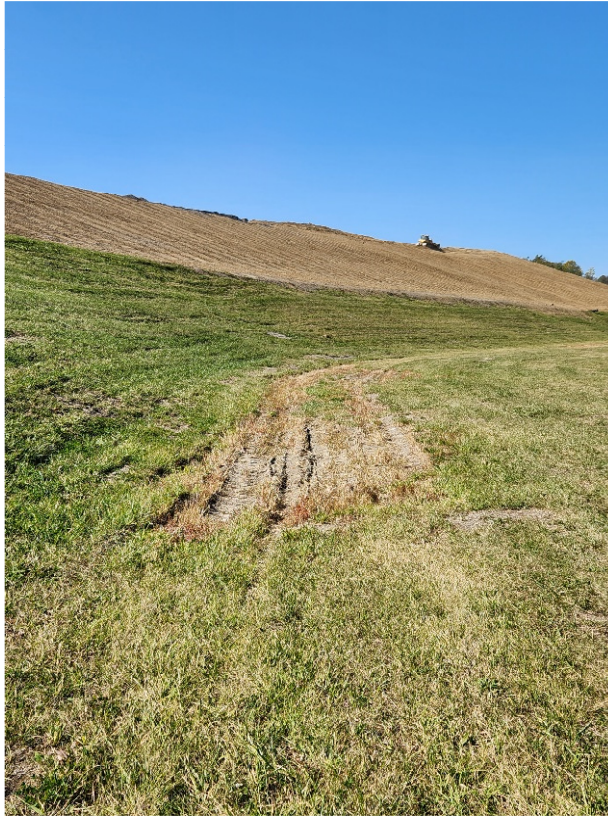
Photo 17

Drainage along the toe of the slope has been significantly improved from last year's inspection. No standing water was observed or soft/wet areas on the surface (Photo 14). The intermediate clay cover was actively being placed (Photo 15). The perimeter ditch to collect contact water from exposed CCR slopes was well maintained (Photo 16). Minor rutting and bare soil were observed along the toe of Cell 3 (Photo 17).

View of Cell 3 along the toe of the permanent slope showing minor rutting and bare soil.

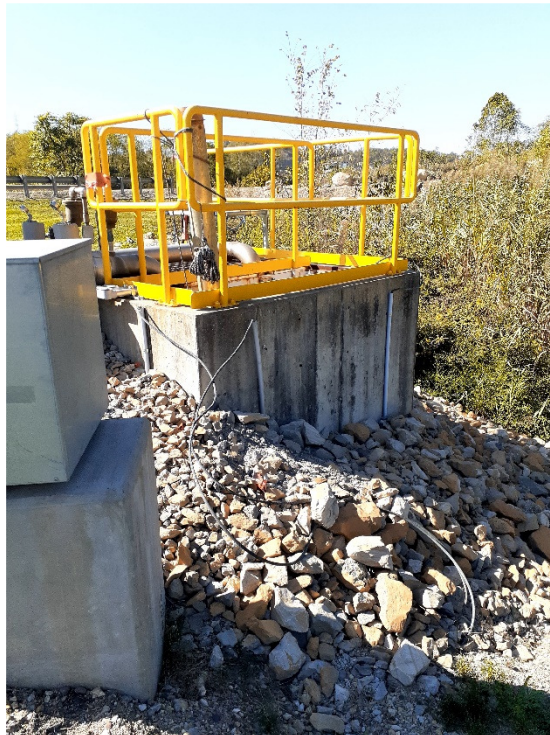
Photo 18

The leachate collection sump structure was observed to be in good condition and with leachate flowing freely into the concrete sump on the date of the inspection (Photos 18 and 19).

Typical view of the LCS sump structure showing good conditions.

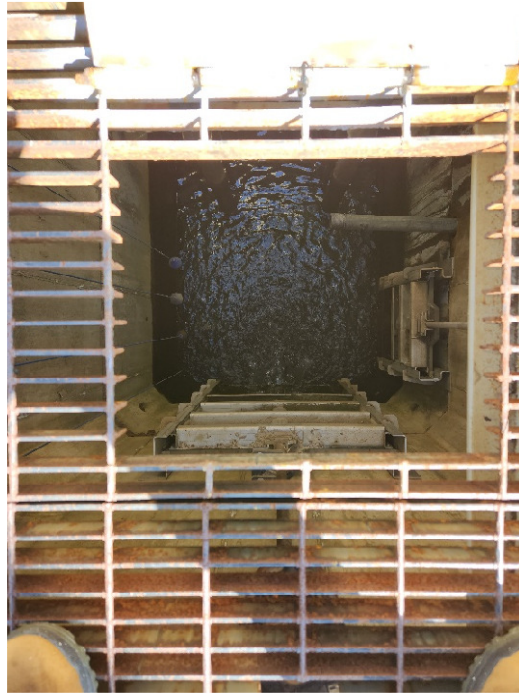
Photo 19

Typical view of the LCS sump structure showing interior conditions of the sump structure. Leachate from the LCS was flowing freely into the sump.

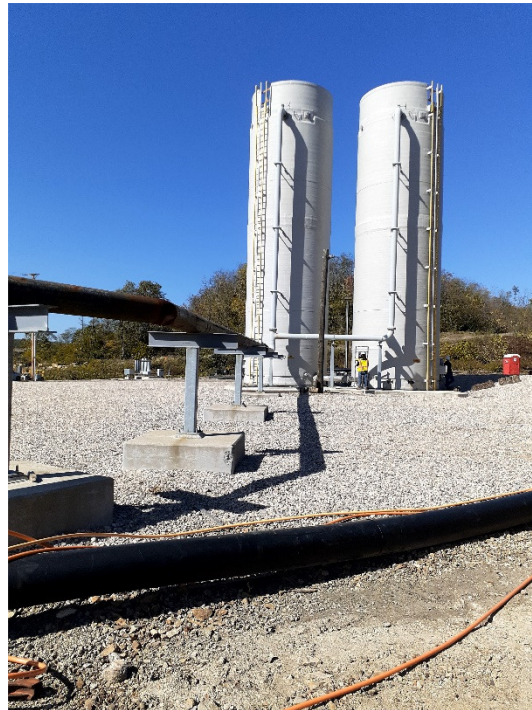
Photo 20

The leachate effluent is then discharged to pretreatment settling tanks in which temperature and effluent levels are monitored with subsequent discharge through a NPDES permitted outfall (Photo 20).

Typical view of the LCS tank showing good conditions.
