2024 Annual Landfill Inspection Report

**Cardinal Operating Plant
Brilliant, OH**

January 6, 2025

Cardinal CCR Landfill

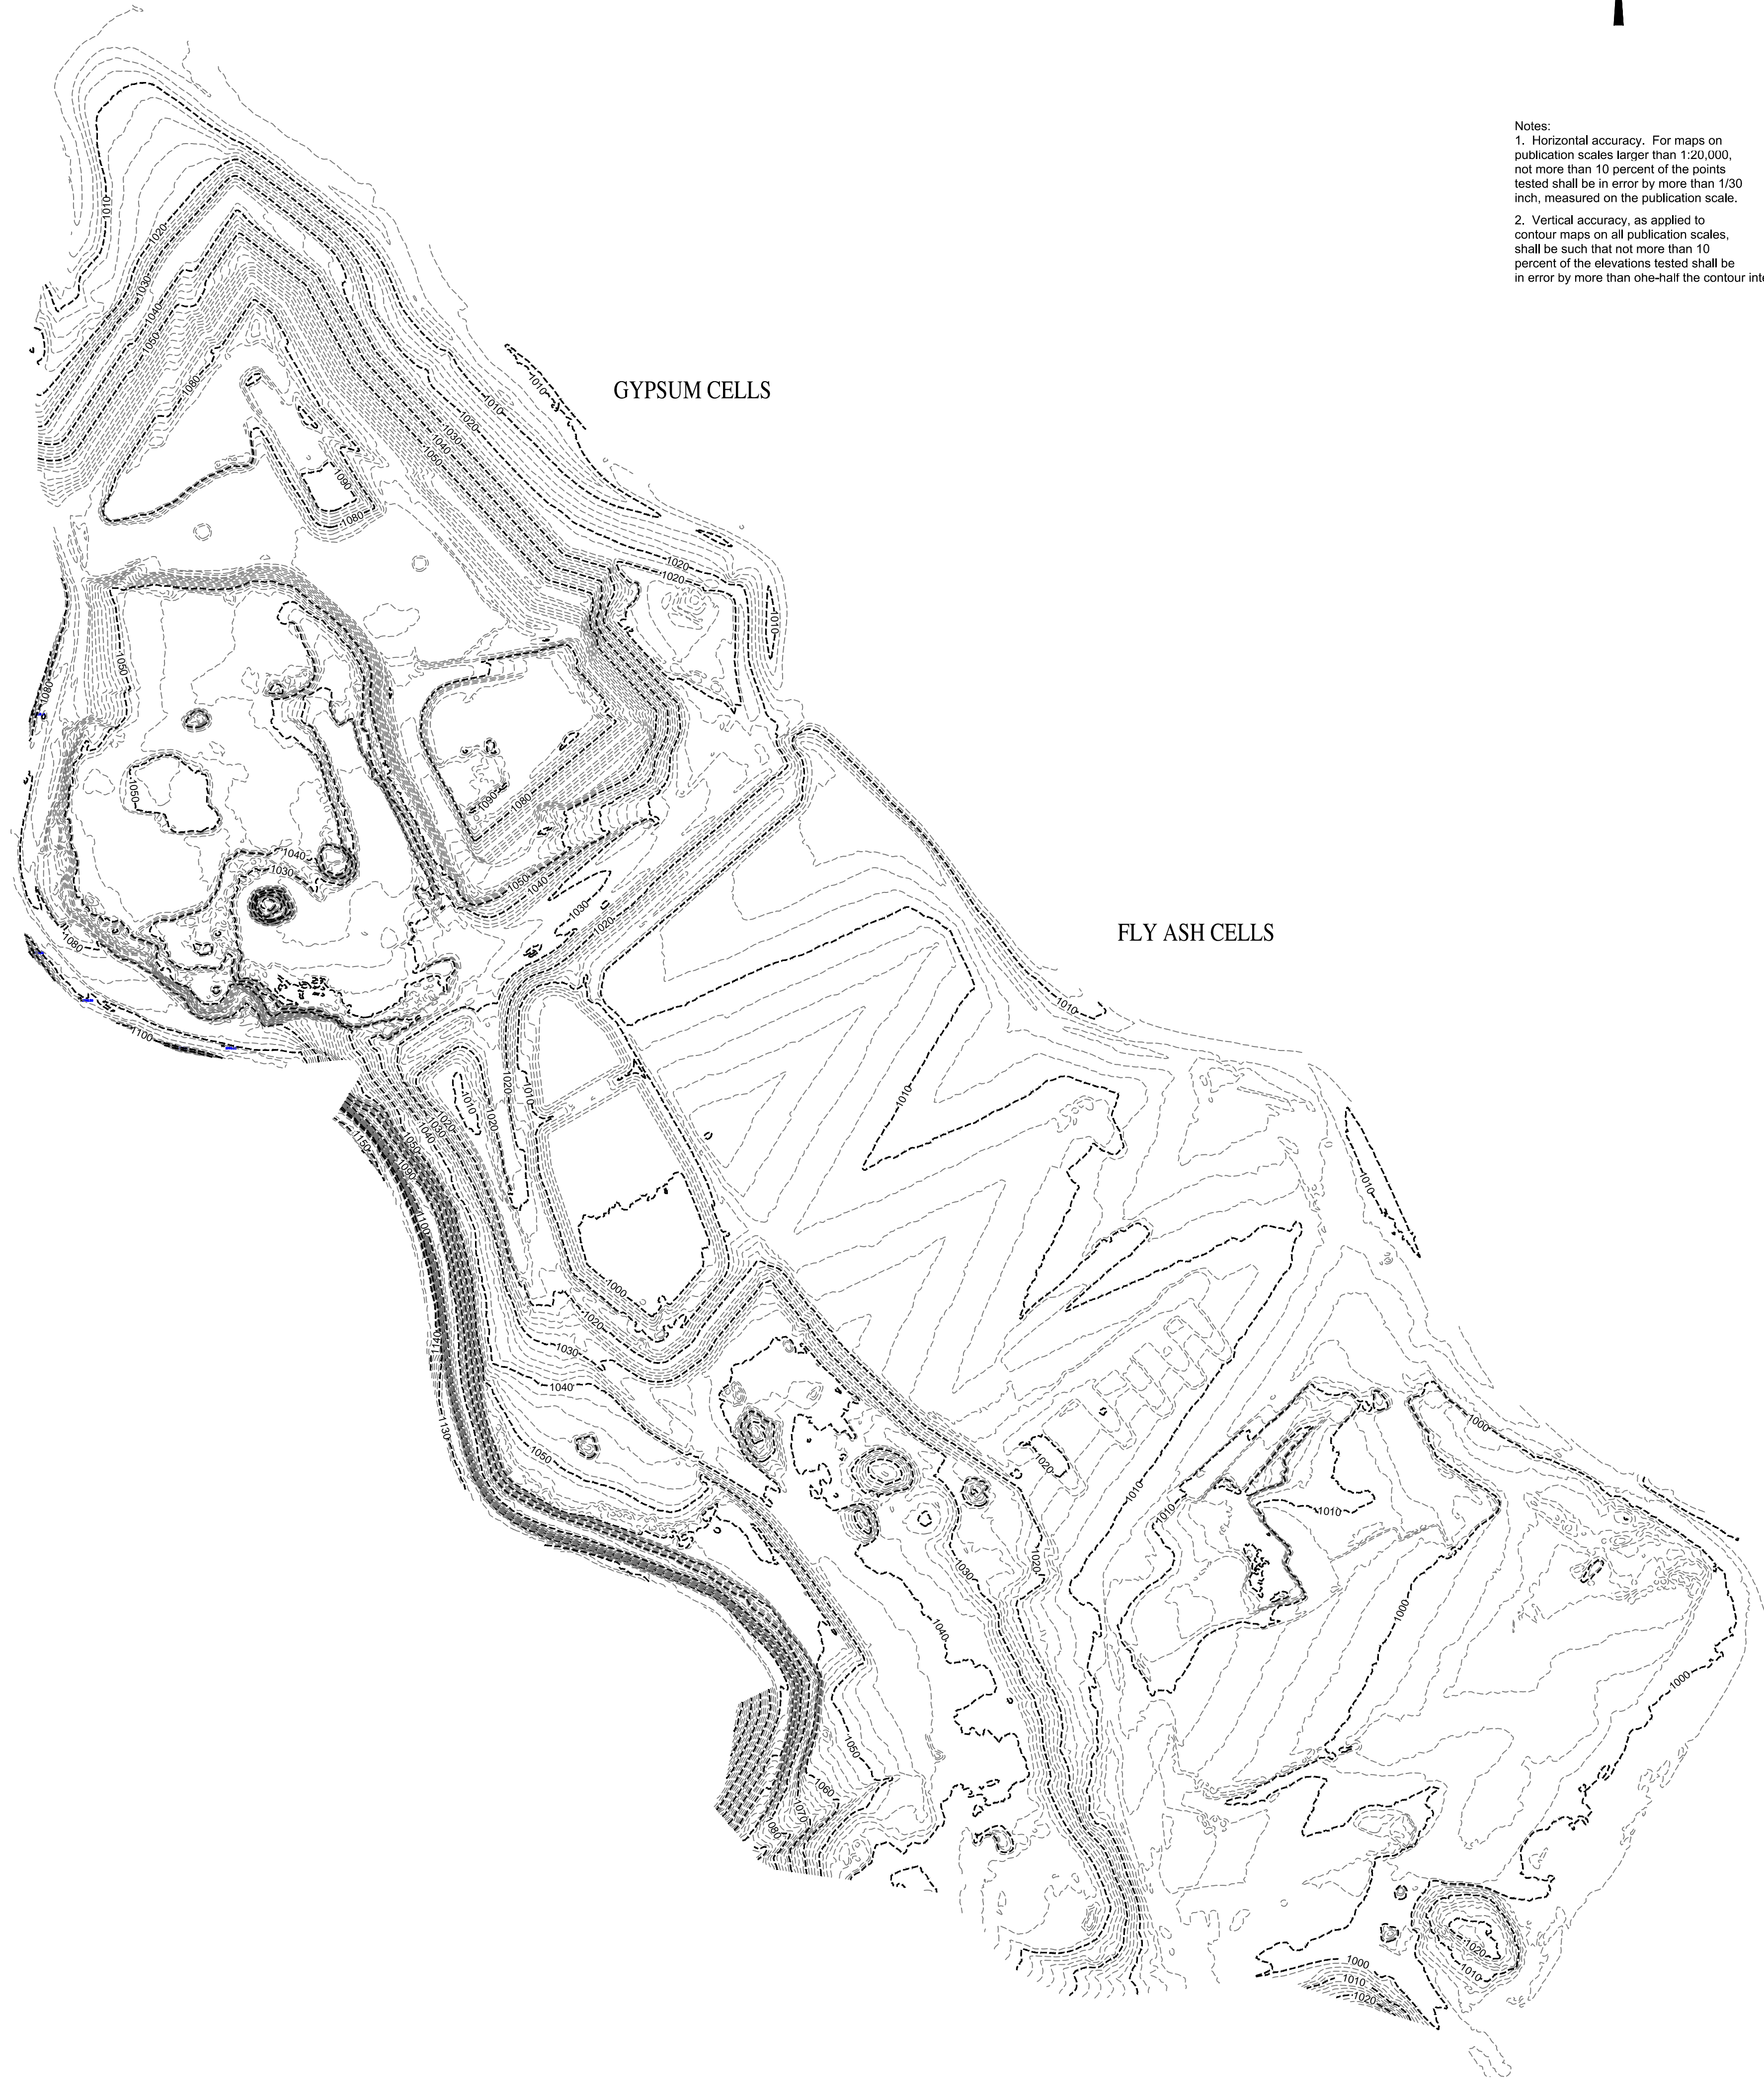
FIGURE 1

This report contains the observations from the inspection, conclusions, and maintenance recommendations for the landfill. The inspection was performed on October 21, 2024 by Mr. Shawn McGee, P.E., TRC's Geotechnical Engineering Practice Leader, and accompanied with Mr. Nicholas Kasper C.P.G. of Buckeye Power and Mr. Zach Miller of the Cardinal Operating Company. As part of the annual landfill inspection, a field topographic survey was performed by Jack A. Hamilton & Assoc., Inc. on October 21, 2024 (see Figure 1).

The overall current condition of the site is shown in plan view as Figure 1. The site inspection began in the southwest corner of the landfill's Cell 1 area progressing along the highwall. The inspection then observed the condition of the active fill areas of both cells progressing to the closed and capped portions/perimeter berms of the landfill. As previously noted, Cells 2, 4, 5, and 6 have not been constructed but have been used to stockpile fill materials for future construction activities. Construction of a storm water pond is currently in progress in portions of Cell 2. This pond will be used to manage storm water runoff (contact water) from the landfill and surrounding areas. Results of the visual inspection performed on October 21, 2024, are summarized below.
