2025 Annual Landfill Inspection Report

**Cardinal Operating Plant
Brilliant, OH**

January 8, 2026

Cardinal CCR Landfill

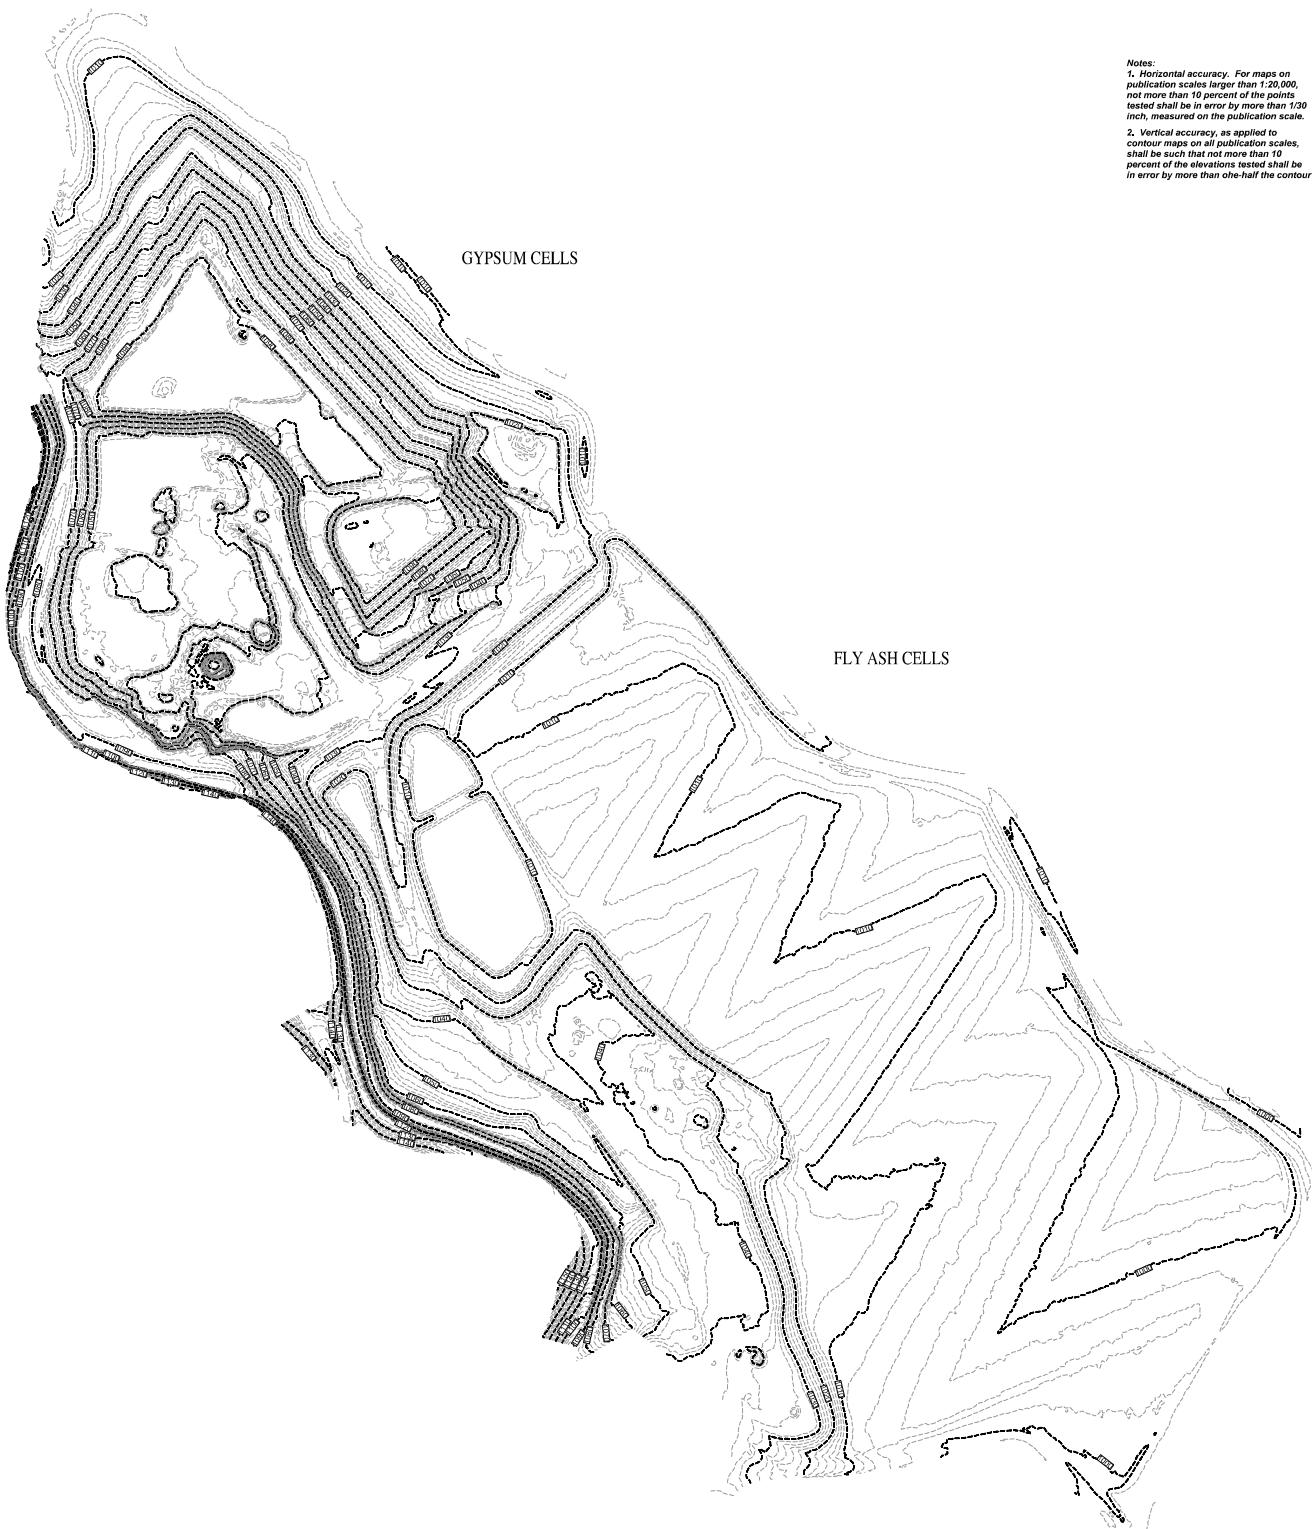
FIGURE 1

The overall current condition of the site is shown in plan view as Figure 1. The site inspection began in the southwest corner of the landfill's Cell 1 area progressing along the highwall. The inspection then observed the condition of the active fill areas of both cells progressing to the closed and capped portions/perimeter berms of the landfill. As previously noted, Cells 2, 4, 5, and 6 are in pre-construction condition. Construction of a storm water pond was recently completed in portions of Cell 2. This pond will be used to manage storm water runoff (contact water) from the landfill and surrounding areas, and is expected to be in operation in 2026. Results of the visual inspection performed on November 4, 2025, are summarized below.

Figure 1: Annual Landfill Topography Survey (prepared by Jack A. Hamilton & Associates, Inc. map dated 11/04/2025)
