2022 Annual Landfill Inspection Report

Cardinal Plant 2022 CCR Landfill Inspection Report

Cardinal Operating Company 306 County Rd. 7E Brilliant, Ohio 43913

January, 2023

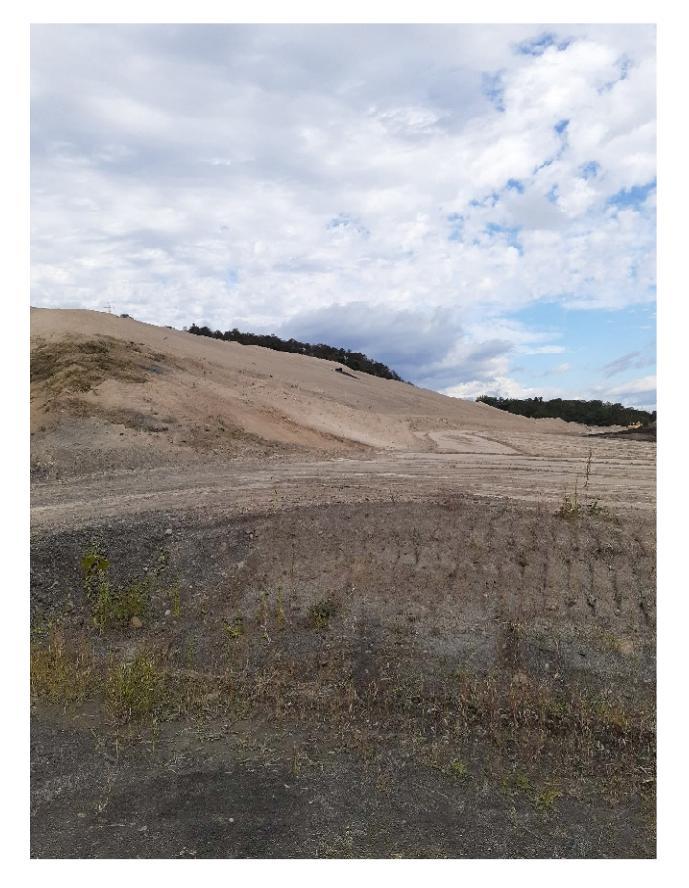
Areas where no activity was taking place were observed to be in excellent condition and were protected using a polymeric dust suppressant which had been sprayed on the surface (Photo 1). No fugitive dust was observed on the date of the inspection at any location. The temporary slopes within the active waste placement areas were also observed to be in excellent condition exhibiting uniform slopes, no erosion, slumping or other signs of instability or displacement.

Photo 1 Typical view of a slope protected with a dust suppressant.

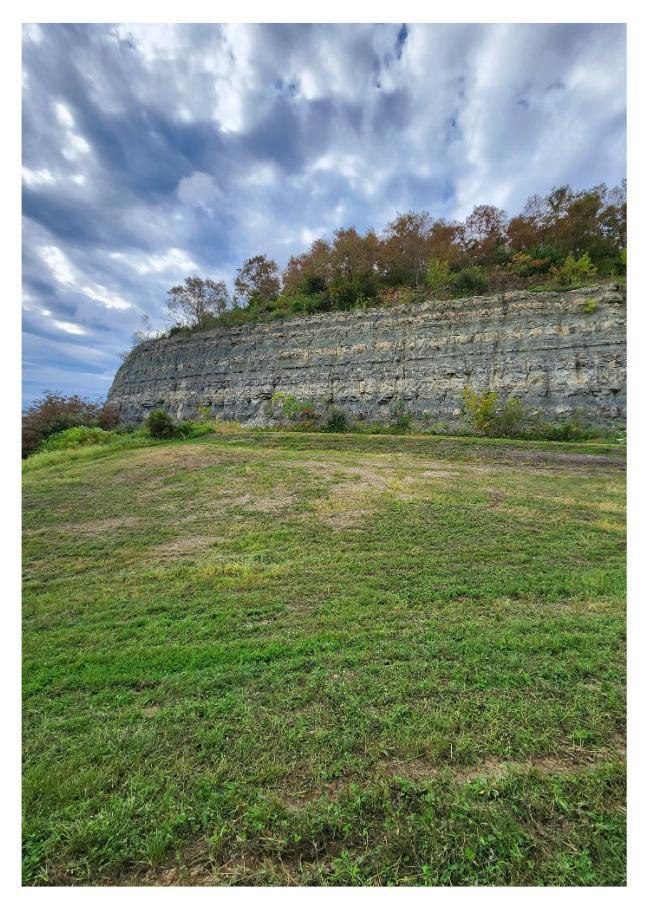
The bedrock highwall located along the western perimeter of Cell 1 appeared to be stable with no significant rock overhangs, rockfall or other signs of instability. The bedrock highwall is composed of alternating sequences of thin to thick bedded limestone interbedded with shale and siltstone reaching a height of 60 ft. No ponded water or uncontrolled seepage flows were observed at the base of the highwall, suggesting that the seepage collection system is functioning as intended. (Photo 2).

Photo 2 Typical view showing good conditions along the length and height of the highwall.

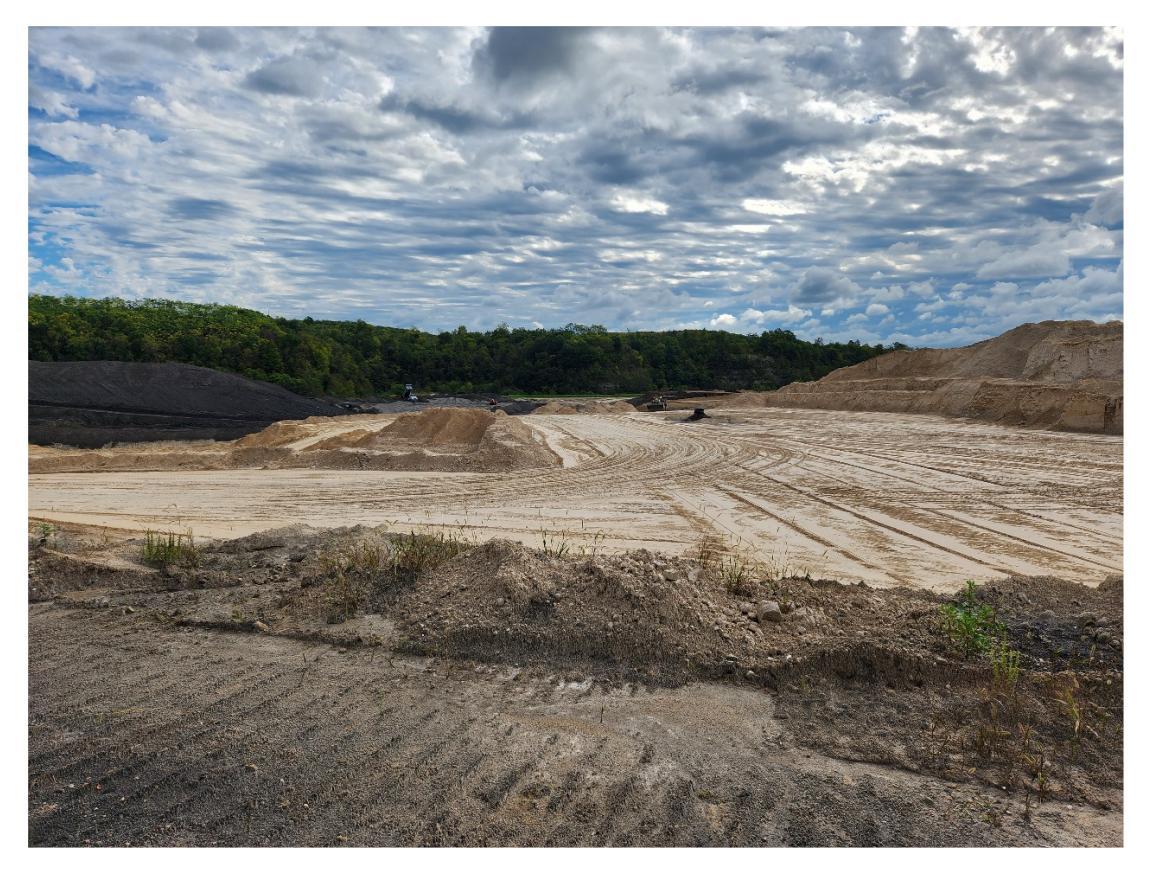
Photo 3 View of Cell 1 showing excellent conditions of the FGD

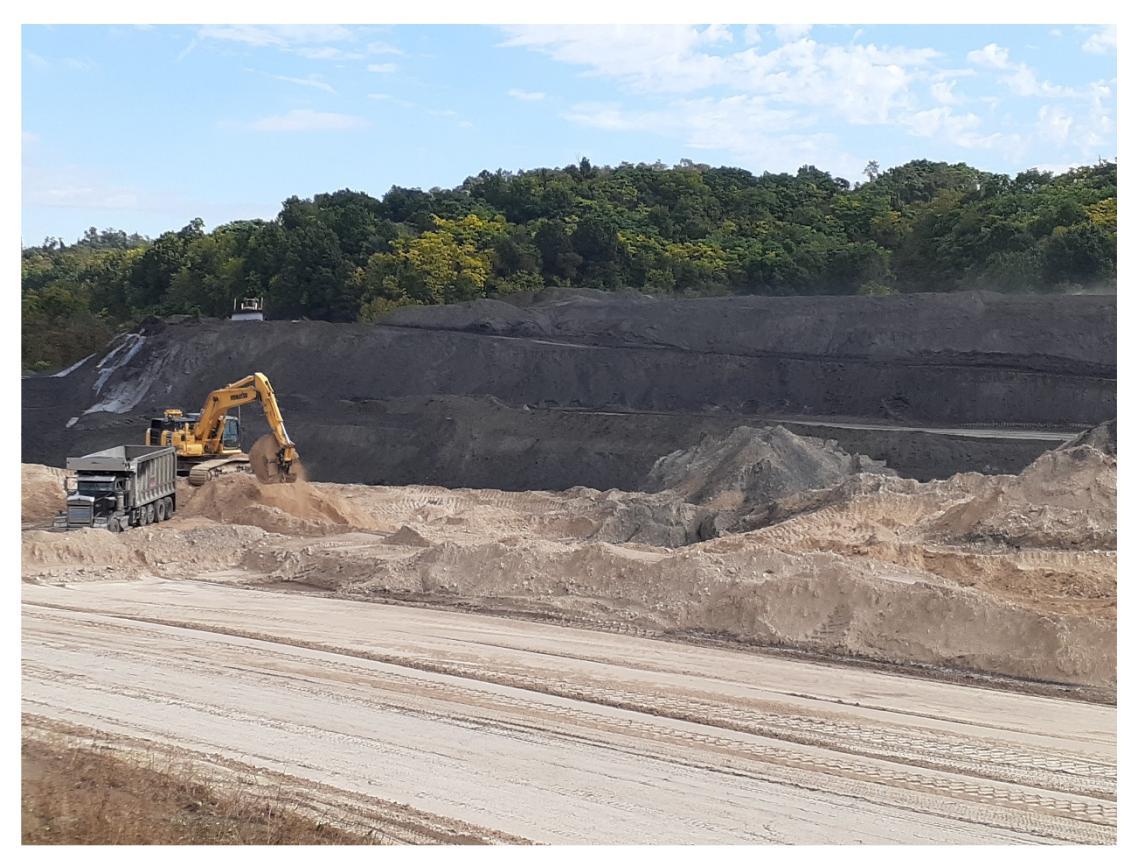
The active fill areas within Cells 1 and 3 were observed to be well maintained and in excellent condition. Cell 1 did not exhibit any ponded water or erosion within the cell and appeared to be well graded to promote drainage to the LCS's risers (also referred to as chimney drains). The riser structures (exposed on account of the excavation activities) were surrounded and protected by a layer of CCR to prevent impact from heavy equipment (Photo 3). FGD gypsum is actively being excavated from Cell 1 for beneficial utilization (Photo 4). Dry fly ash is actively being landfilled in Cell 3.

Photo 4 Typical view showing the reclamation of FGD gypsum for beneficial reutilization.

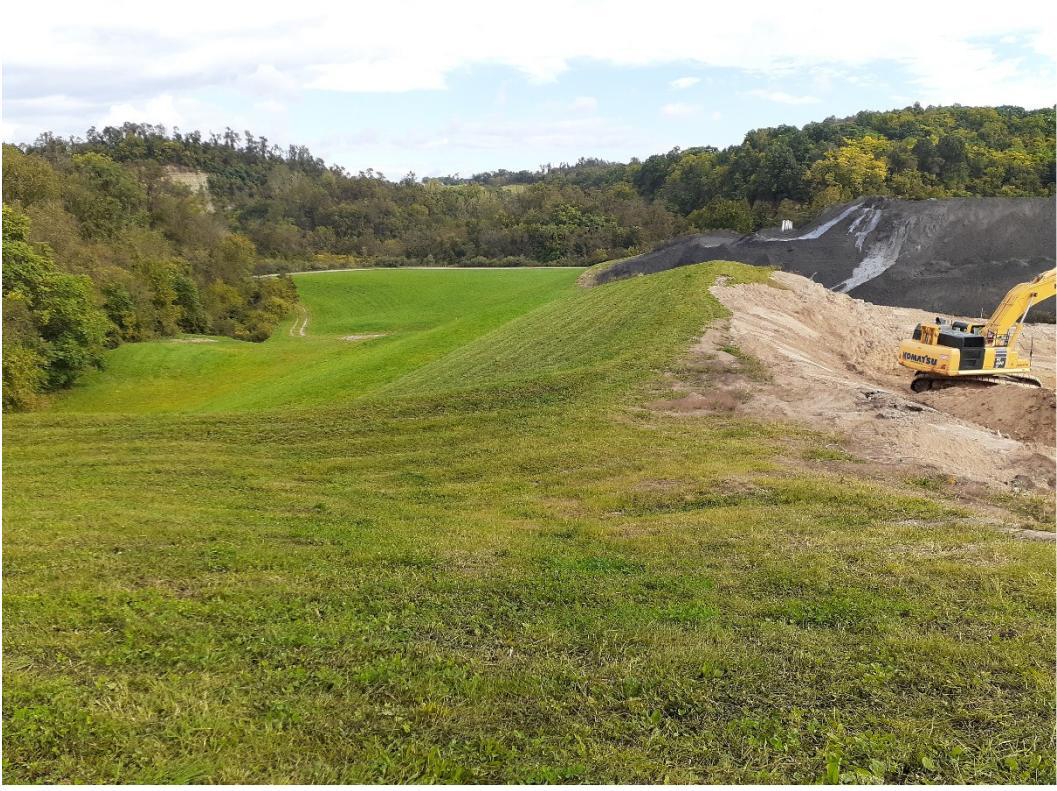
Typical view of Cell 1 looking eastward showing excellent conditions. No erosion, animal borrows, slumping or other signs of slope instability were observed.

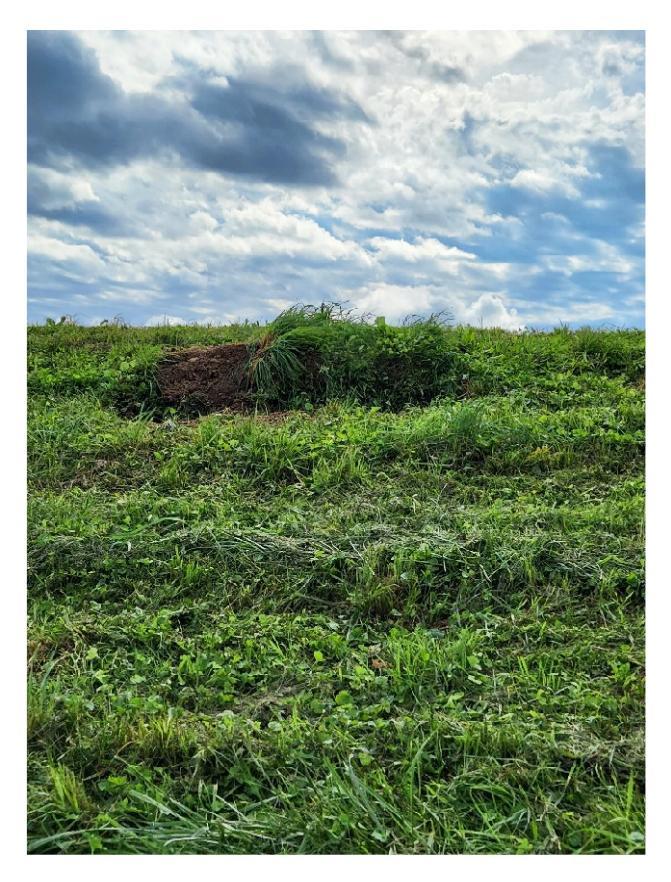
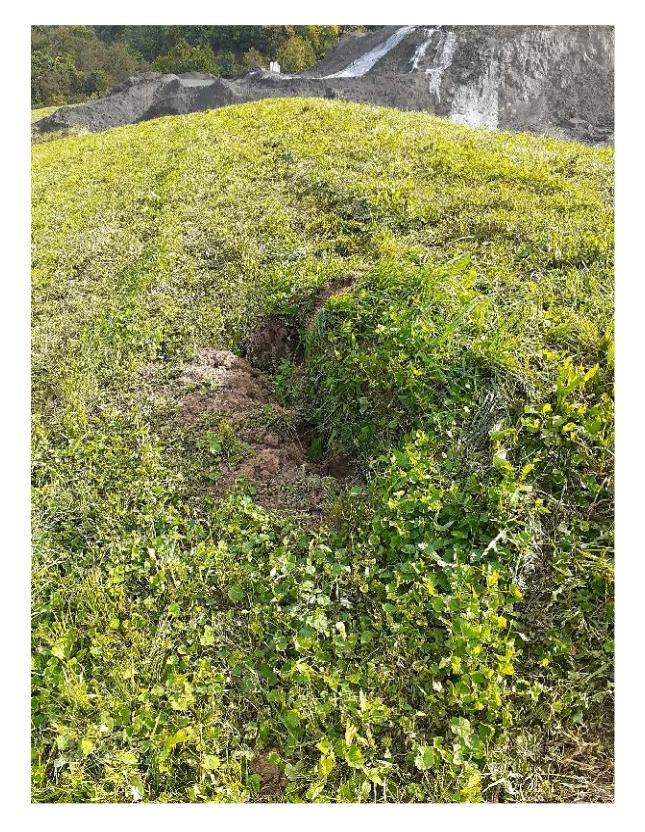
All areas in Cell 1 with protective vegetative cover established such as the closed portion of the landfill and berms had a healthy grass stand but did exceed 12 inches in most areas. The northern closed area was in excellent condition. No erosion or animal burrows were observed, and the slopes were uniform (i.e., no slumping or bulging) and appeared to be well drained. No standing water was observed or soft/wet areas on the surface (Photo 5). There was a minor disturbance of the soil cap near the crest in Cell 1 where a backhoe operator created an unintentional excavation of the soil cap. The depth of the excavation was

measured to be 2.3 ft deep and approximately 4.5 ft long (Photos 6 and 7). Cardinal reported repair of the unintentional excavation and soil cap in October 2022.

Photo 6 View of a divot created by a backhoe operator error

The depth of the divot was measured to be 2.3 ft which was brought to the attention of the landfill supervisor.

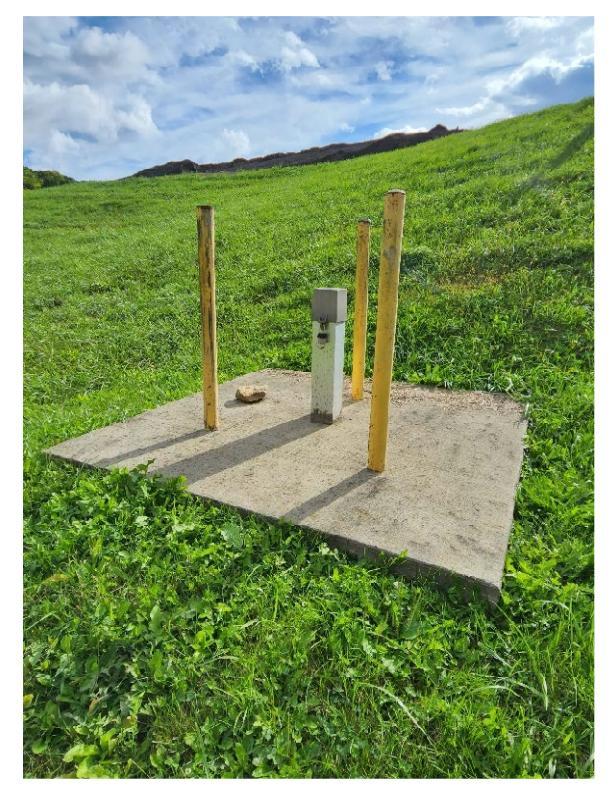
Photo 8

A monitoring well located at the toe of the slope in Cell 1 was observed to be in excellent condition. The concrete well pad was not cracked or undermined, protective bollards were adequately spaced, and the casing protector was locked (Photo 8).

Typical view showing excellent conditions for a monitoring well located near the toe of Cell 1. No deterioration of the concrete pad was observed. Protective bollards and a locked casing protector were also observed to be in excellent conditions.

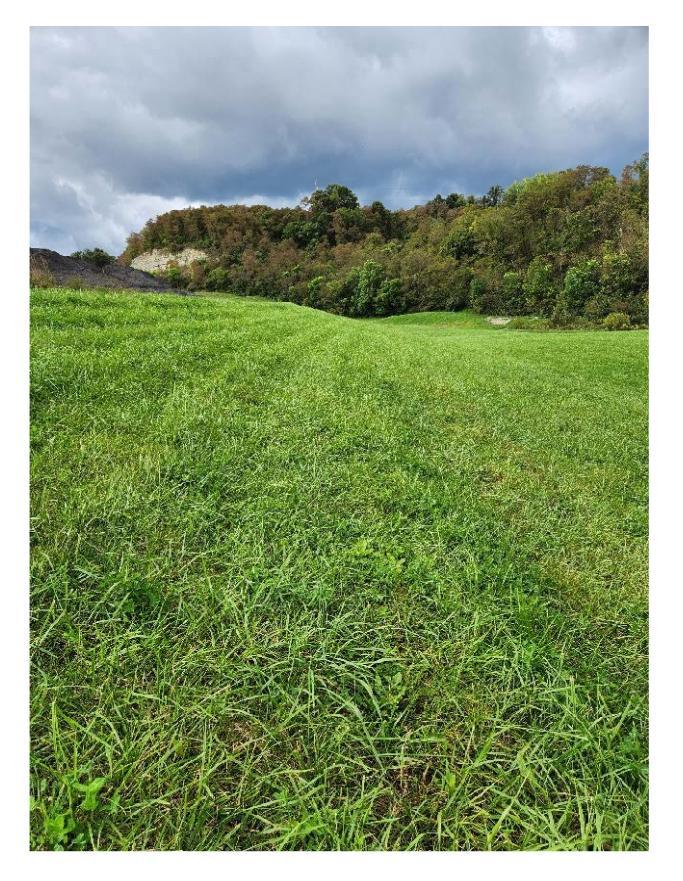
All areas in Cell 3 with protective vegetative cover established such as the closed portion of the landfill and berms had a healthy grass stand but did exceed 12 inches in most areas. No erosion, animal burrows, slumping or other signs of slope instability were observed (Photo 9).

Typical view of Cell 3 looking westward showing excellent conditions. No erosion, animal borrows, slumping or other signs of slope instability were observed.

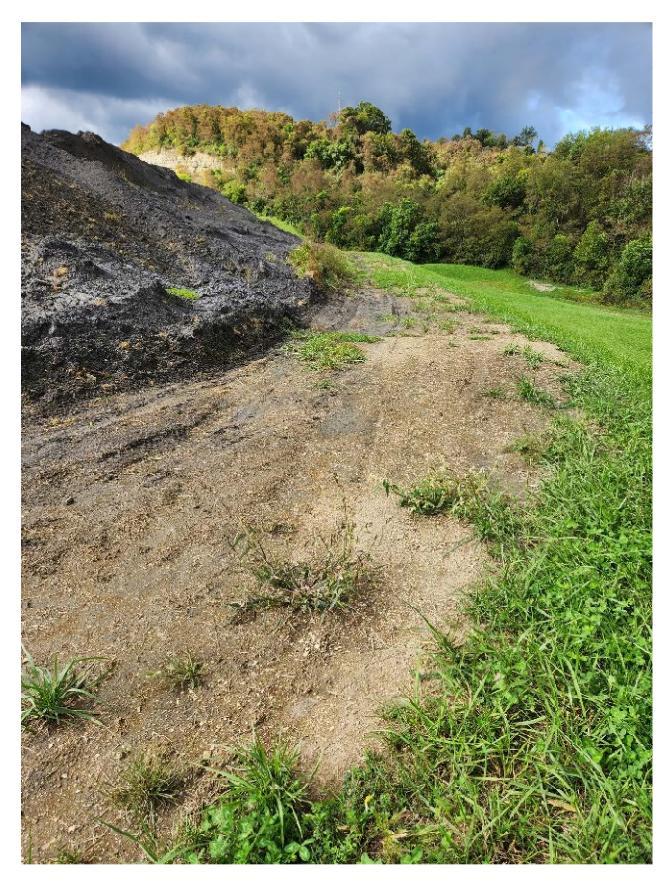
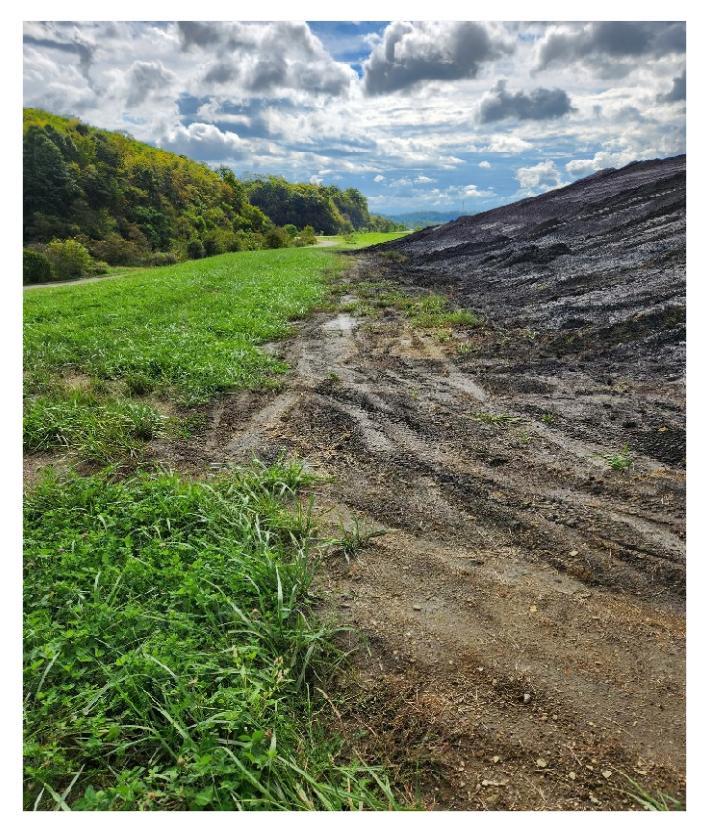
In Cell 3, the perimeter ditch was observed vary from poor to good conditions. Poor conditions were observed along the northern most end of Cell 3 between the active fill and the soil cover cap (Photos 10 and 11). The perimeter ditch within this area did not have well defined slopes used to contain runoff from the active fill area. Ponded water within the ditch was observed in the vicinity of the former access road into Cell 3 (Photos 12 and 13). The remainder of the ditch along Cell 3 was observed to be in good condition showing well defined channel slopes with good alignment, unobstructed flow and no scouring or erosion along the toe of the active fill area (Photo 14). Cardinal reported repair of the Cell 3 perimeter ditch by adding clay and regrading the berm in October 2022.

Photo 10 View of perimeter ditch in Cell 3 between the active fill slope and the cover cap showing poor conditions.

Southward looking view of the perimeter ditch in Cell 3 between the active fill slope and the cover cap showing poor conditions.

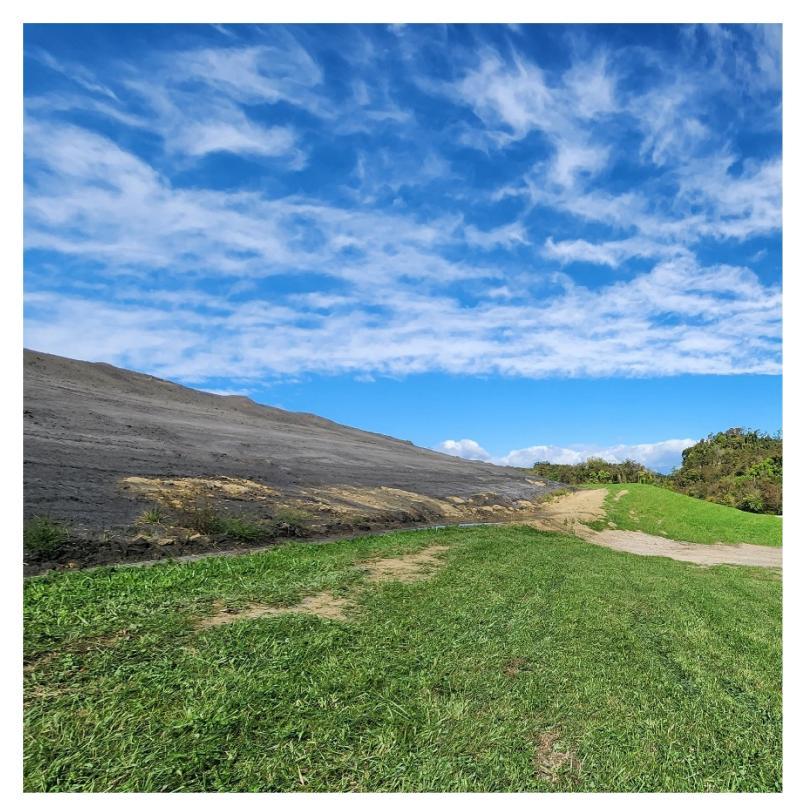
Photo 12

View of perimeter ditch in the area of the former access road into Cell 3. The area needs to be filled and the ditch needs to be reestablished to provide positive drainage in the area.

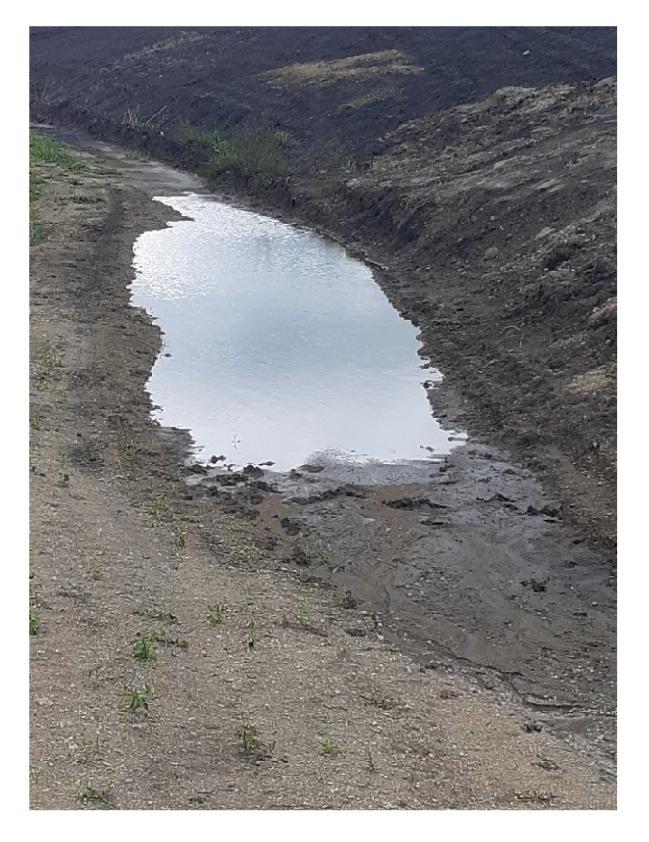
Ponding along the perimeter ditch in Cell 3 between the active fill slope and the cover cap in the area shown in Photo 12

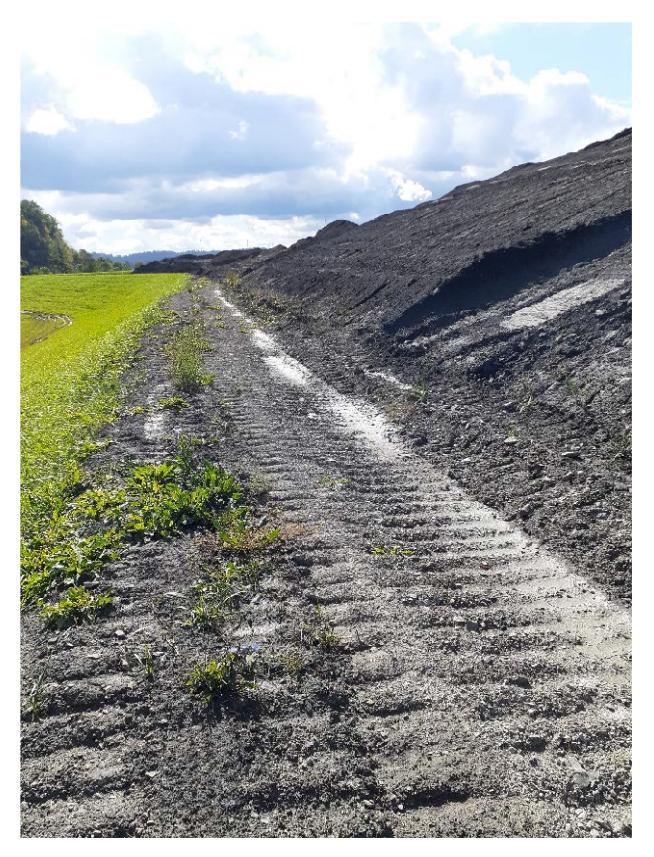
Photo 14

View of the perimeter ditch along Cell 3 showing satisfactory conditions in alignment, unobstructive flow and no erosion or ponding of water.

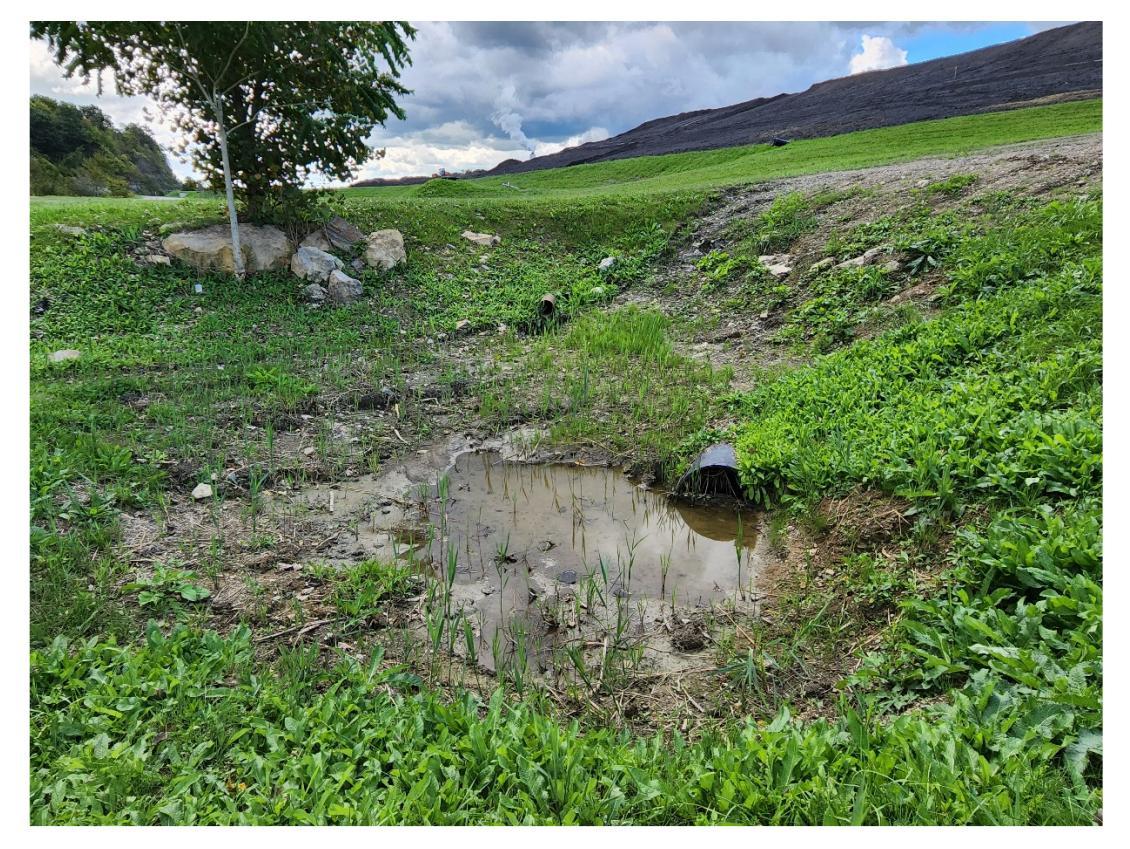
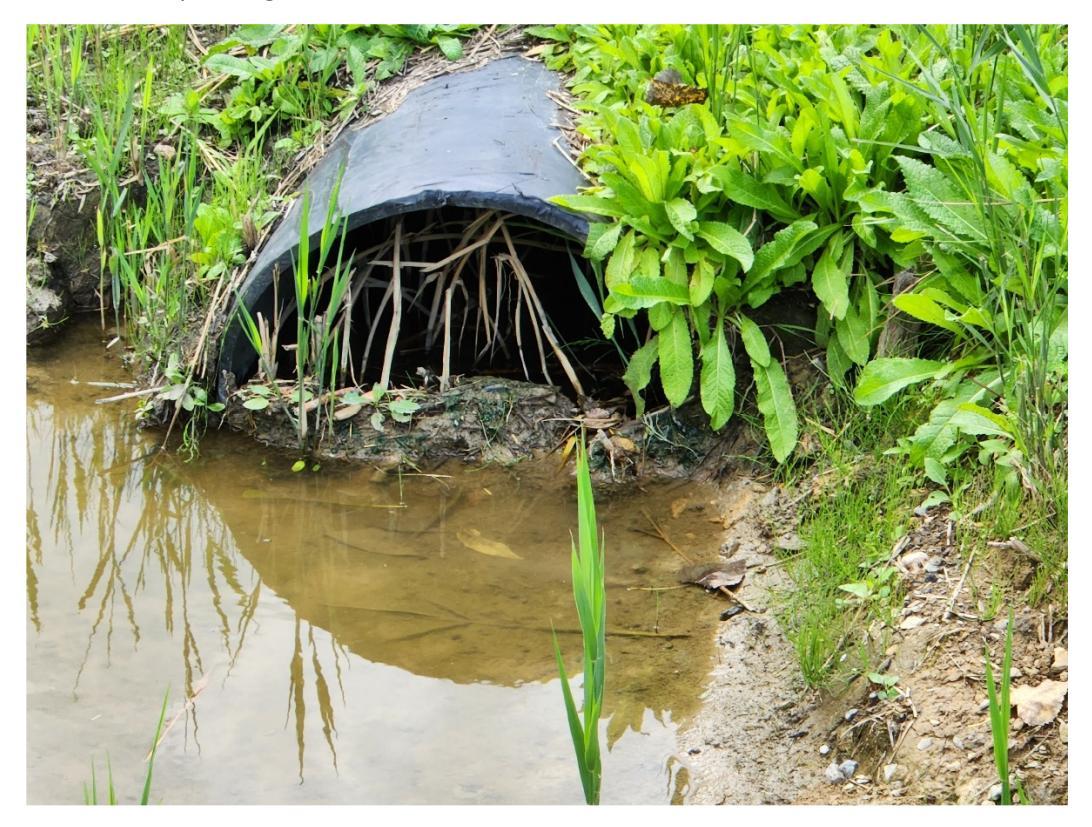
Minor ponding of water was observed at the upstream end of culverts at the former access road and current access road into Cell 3. There is sediment deposition along with a vegetative mat that is partially blocking drainage at both culverts (Photos 15 to 18). Cardinal reported clean-out of the culverts in December 2022.

Photo 15 Minor ponding in front of the culvert for the former access road into Cell 3.

Photo 16 Close up view of the culvert shown in Photo 15 showing sediment deposition and vegetative mat buildup at the upstream end of the culvert.

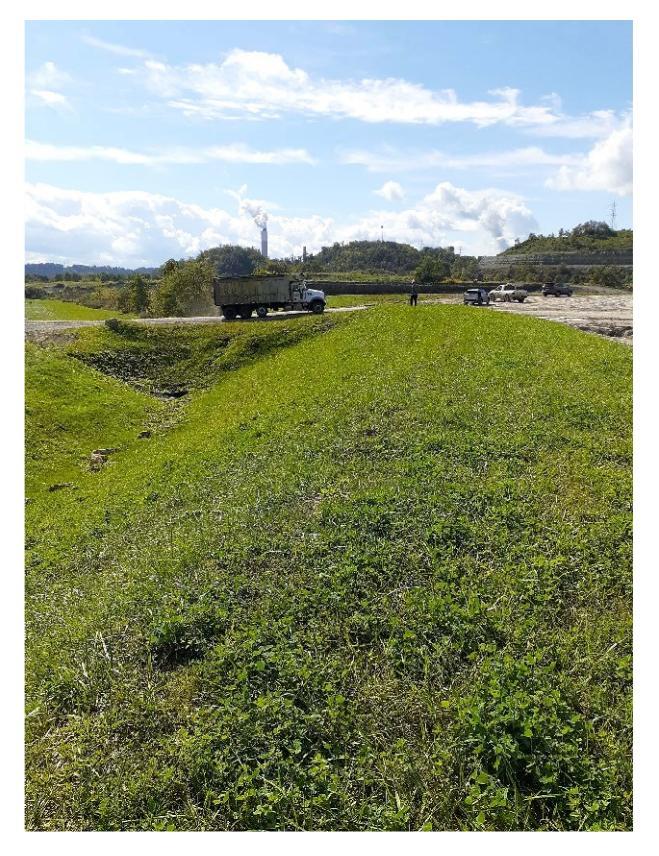
Typical view of access road into Cell 3 showing excellent vegetative growth along the slopes and the centerline of the drainage ditch at the toe of the slope

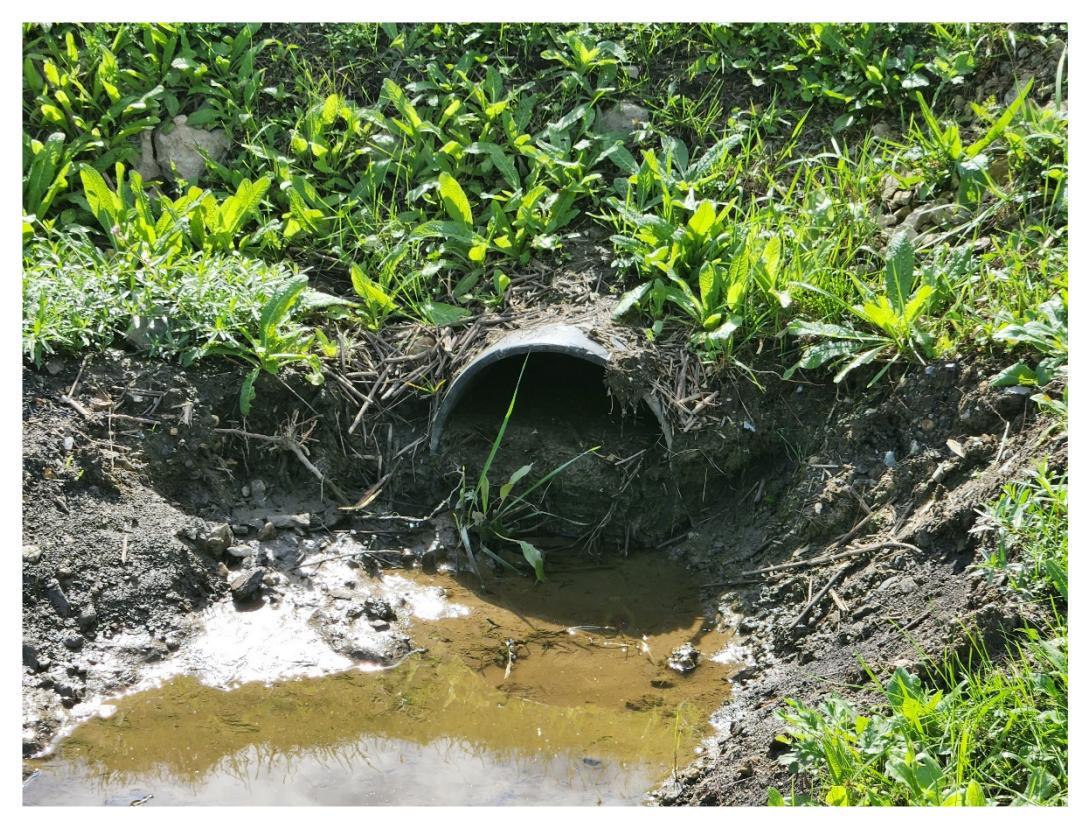
Photo 18

Close up view of the culvert shown in Photo 17 showing sediment deposition and vegetative mat buildup at the upstream end of the culvert beneath the current access road into Cell 3.

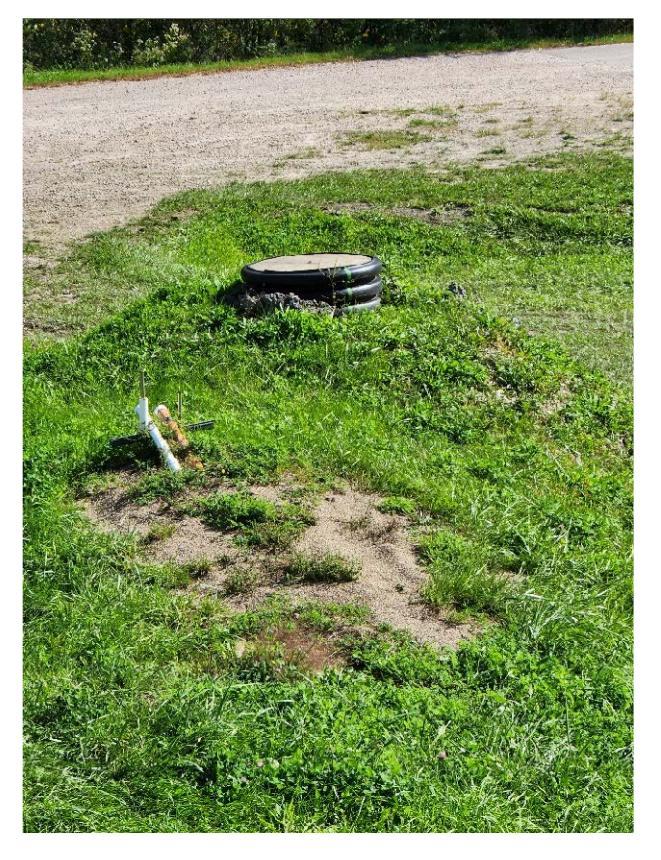
The pedestal for settlement profiler No.1 and associated piping was observed to be in excellent condition (Photo 19). Settlement profiler No. 2 also shows excellent conditions along with the LCS manhole (i.e., no cracking, concrete spalling or exposed rebar) (Photo 20). Photo 21 shows the excellent condition of the manhole's interior. The landfill's leachate was observed to be flowing freely into the manhole.

Typical view of the settlement profiler No. 1 concrete pedestal and associated piping showing good conditions.

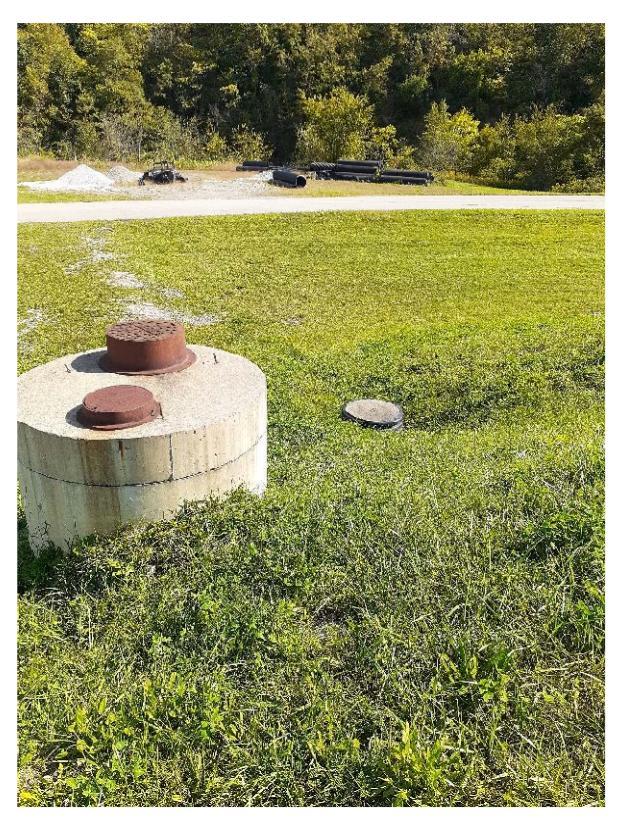
Photo 20

Typical view showing excellent conditions of the settlement profiler No. 2 concrete pedestal and the manhole for the leachate collection pipe. Vegetation is well established and is being maintained to allow access to both the manhole and settlement profiler.

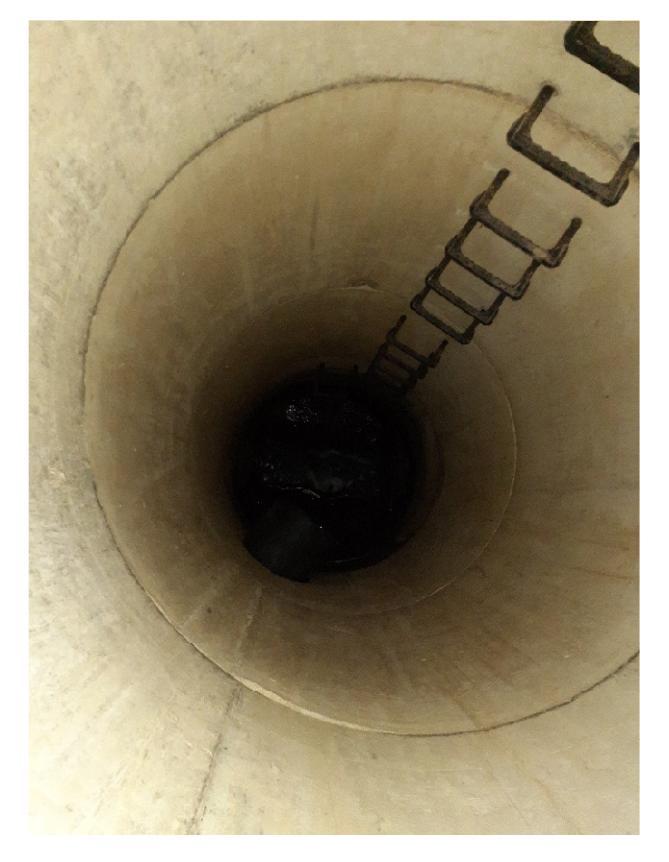
Typical view showing excellent conditions of the manhole's interior for the leachate collection pipe. No spalling, cracking or noticeable deterioration of the concrete was observed. Leachate was flowing freely along the base of the manhole.

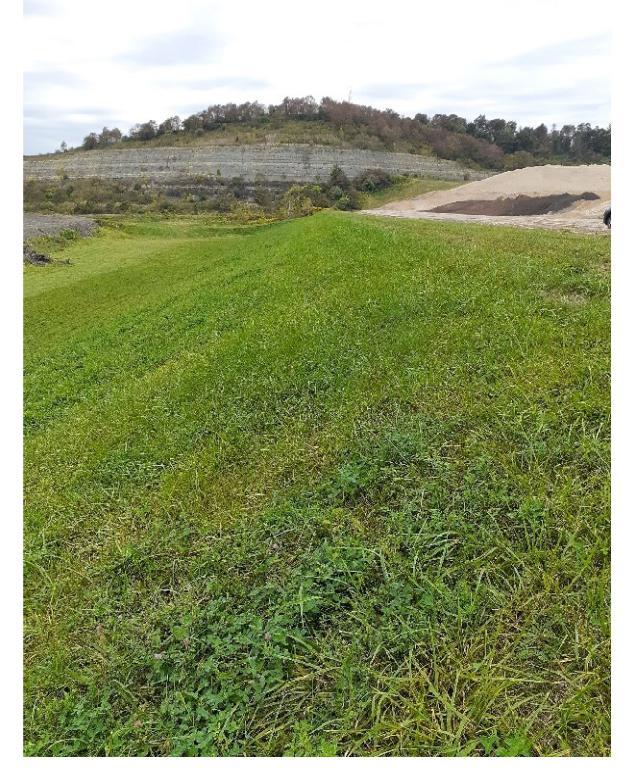
Photo 22

Typical view showing excellent conditions of the interim slope between Cells 1 and 3 and future cell. The slope is uniform with no erosion or slumping and has an excellent vegetative cover.

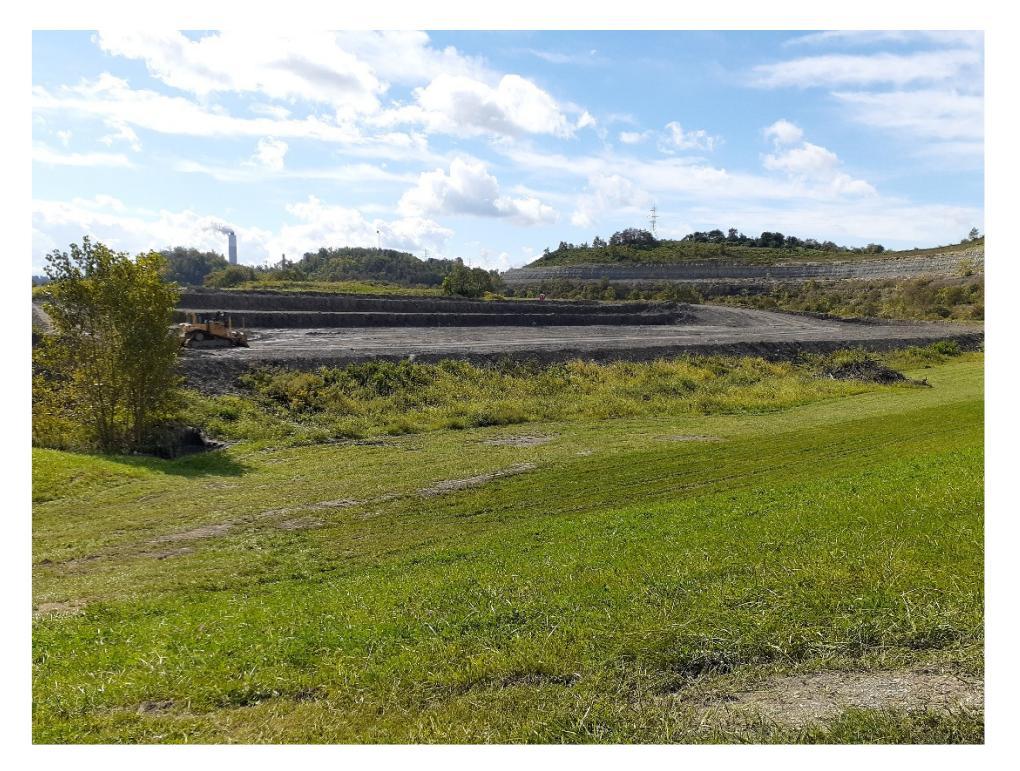
The interim berm between Cell 3 and the landfill's undeveloped cells was observed to be in good condition with the slope terminating at a crest which forms a temporary ditch along the perimeter of the cell to convey contact storm water to the LCS. The interim slope is constructed with a temporary cover soil in which an established vegetation was observed to be in good condition. The slope appeared to be uniform and free of displacement or other signs of instability (Photo 22). The stockpiles within the future undeveloped landfill cells shows an orderly excavation of these fill materials (Photo 23). The stockpiles are well graded to promote drainage.

Typical view of showing the orderly excavation of stockpiles within located within the landfill's future cells.

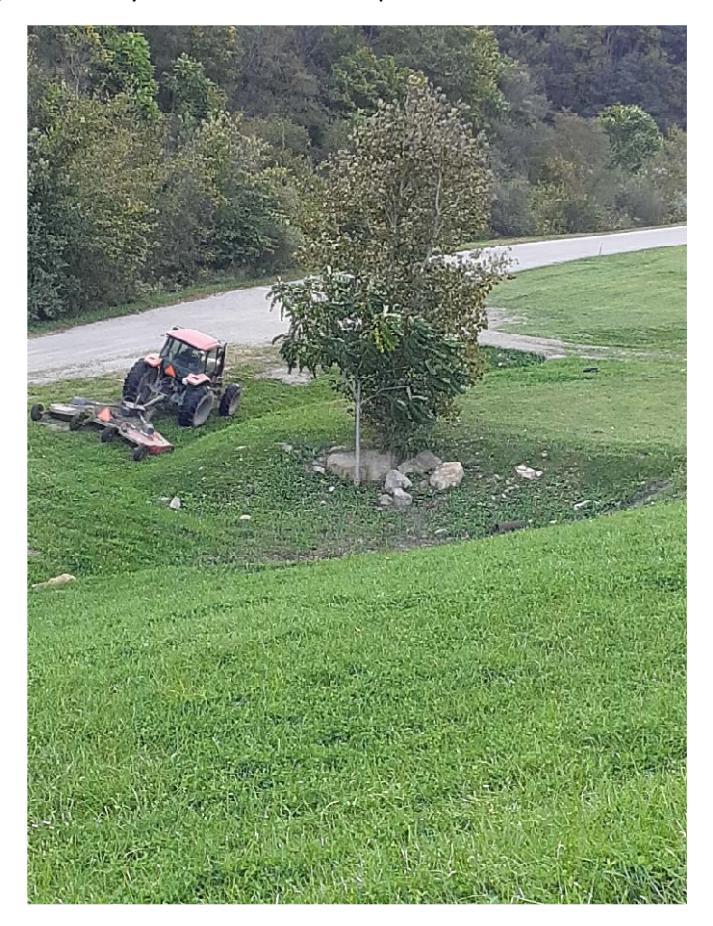
Photo 24

Typical view of the tractor and pull behind mower being used to control vegetation on grassed covered slopes. In general, the mowing operation has provided very good control in keeping a healthy grass covered soil cap on permanently closed areas and interim slopes.

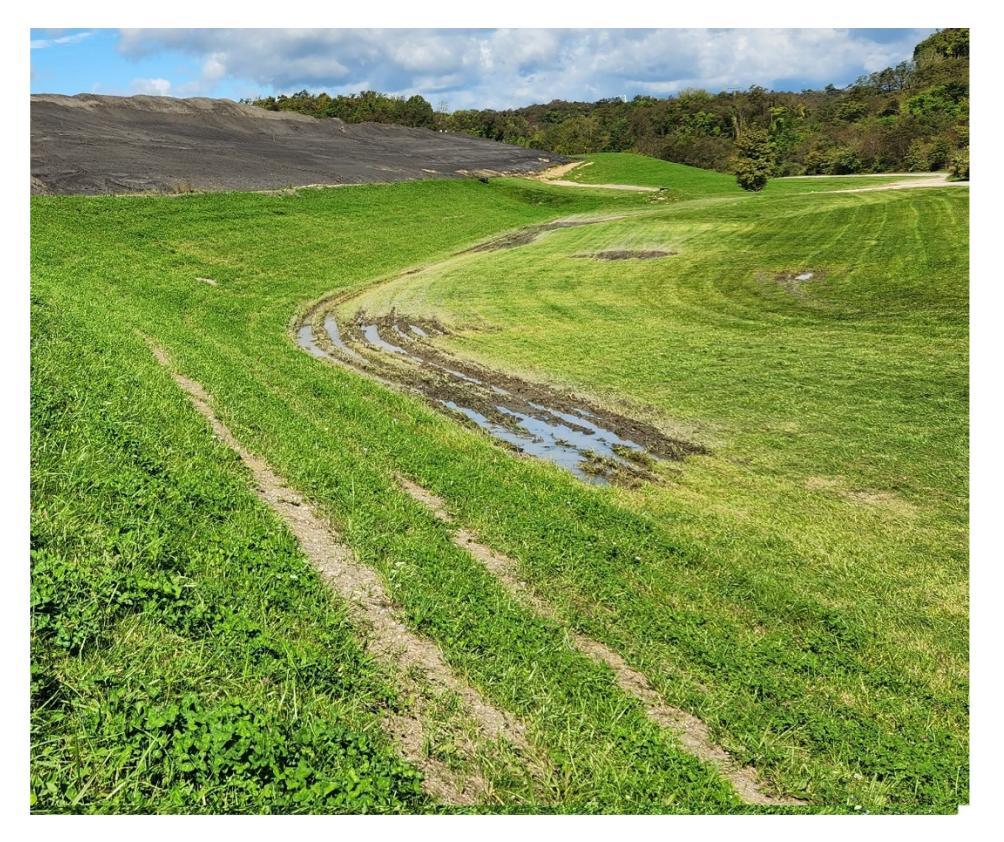
The mowing operation was on going at the time of the inspection using a tractor with a pull behind mower (Photo 24). Mowing operations were observed to occur in three large areas where rutting and water ponding has resulted (Photo 25). These areas will require a minor amount of regrading to reestablish the swale and reseeding (Photos 26 and 27).

Mowing operations need to be curtailed along flat lying areas (grassed covered swales) adjacent to the toe of Cell 3. Three large areas of rutting and water ponding were observed and will require regrading to reestablish drainage and seeding.

- 1. Continue current maintenance practices including but not limited to continuing to maintain the vegetative cover height at 6 inches or less and continue the 7-day inspections of the area.
- 2. Equipment operators need to be trained to prevent rutting with subsequent ponding of water from mowing operations.

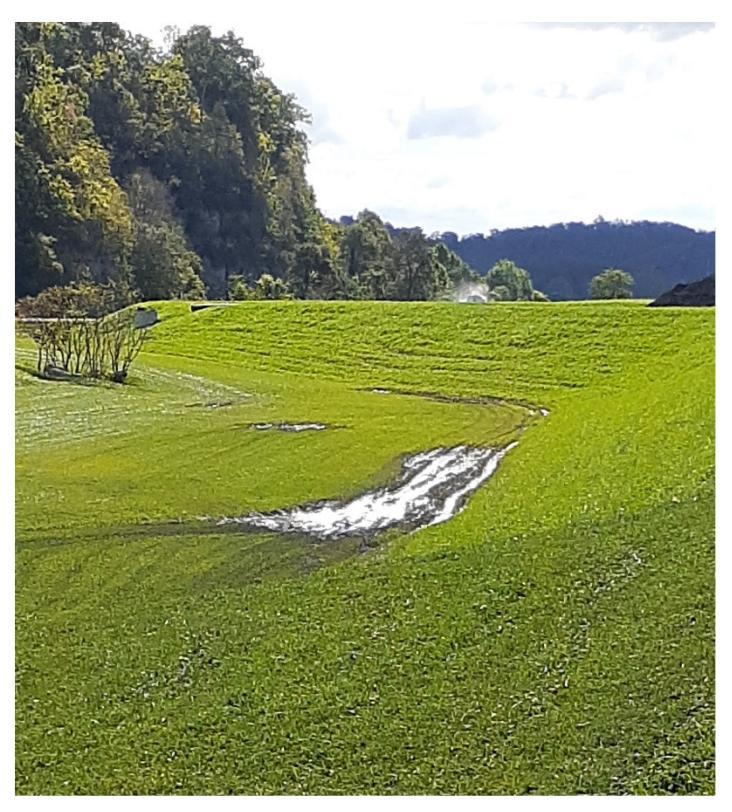
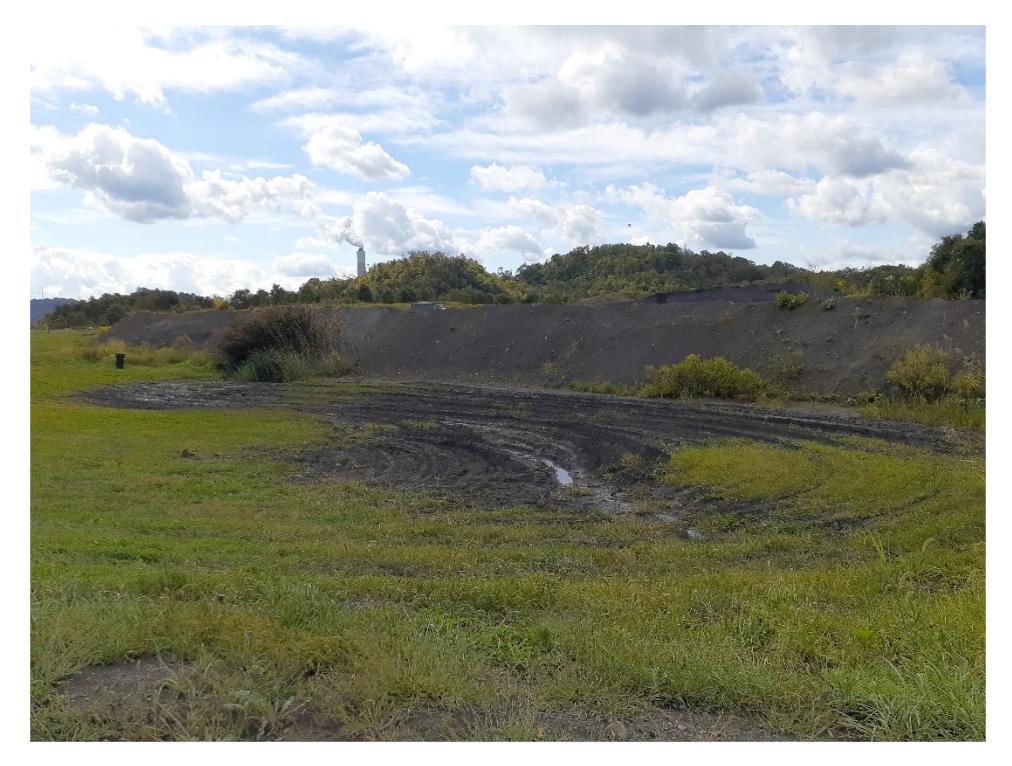
Photo 26 Close up view of rutting and subsequent ponding of water along the toe of Cell 3.

Photo 27 Damage to soil grassed areas due to mowing along stockpiled areas.

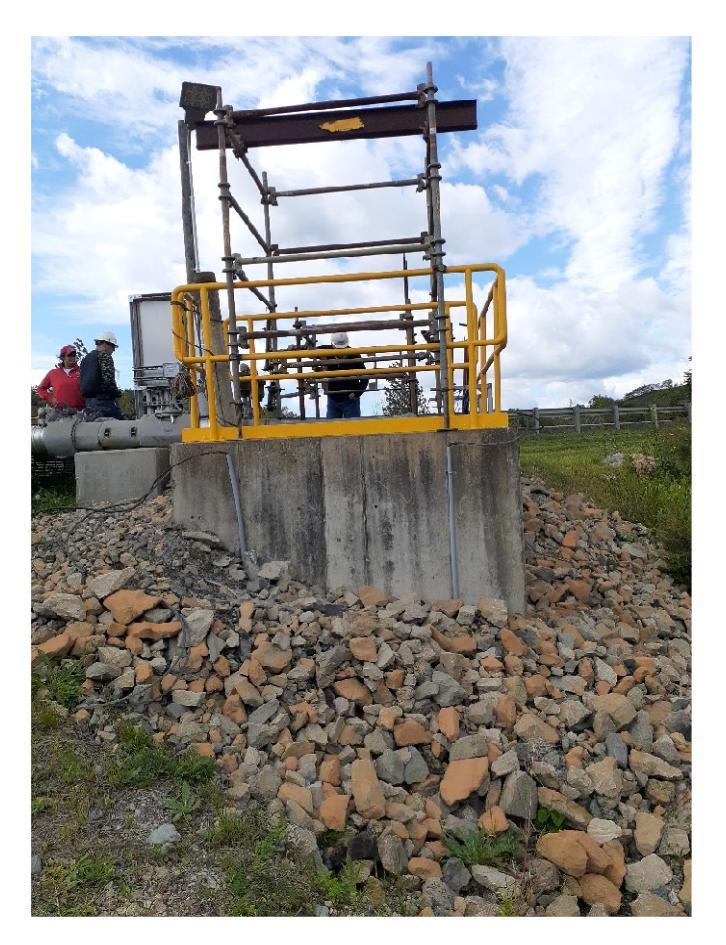
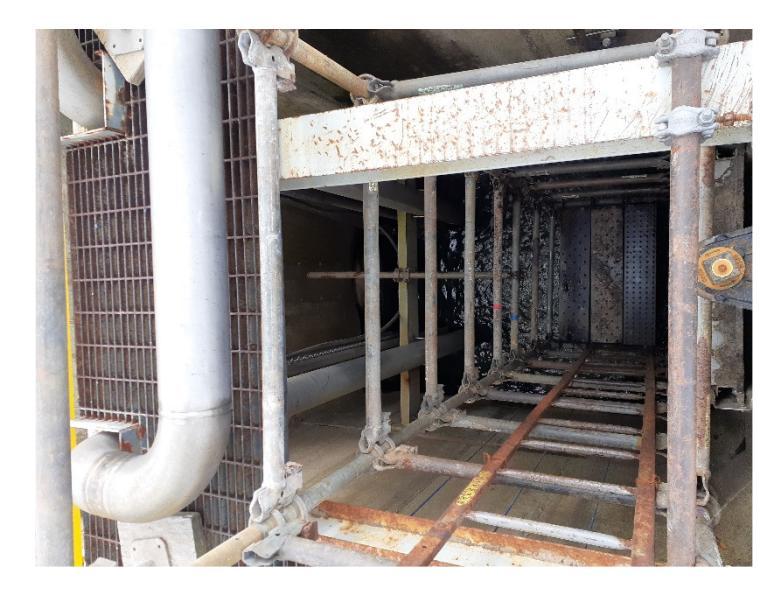
The leachate collection sump structure was observed to be in good condition and with leachate flowing freely into the concrete sump on the date of the inspection (Photos 28 and 29).

Photo 28 Typical view of the leachate collection sump showing excellent conditions.

Photo 29 View of the leachate collection sumps interior showing unobstructed flow of leachate into the sump.

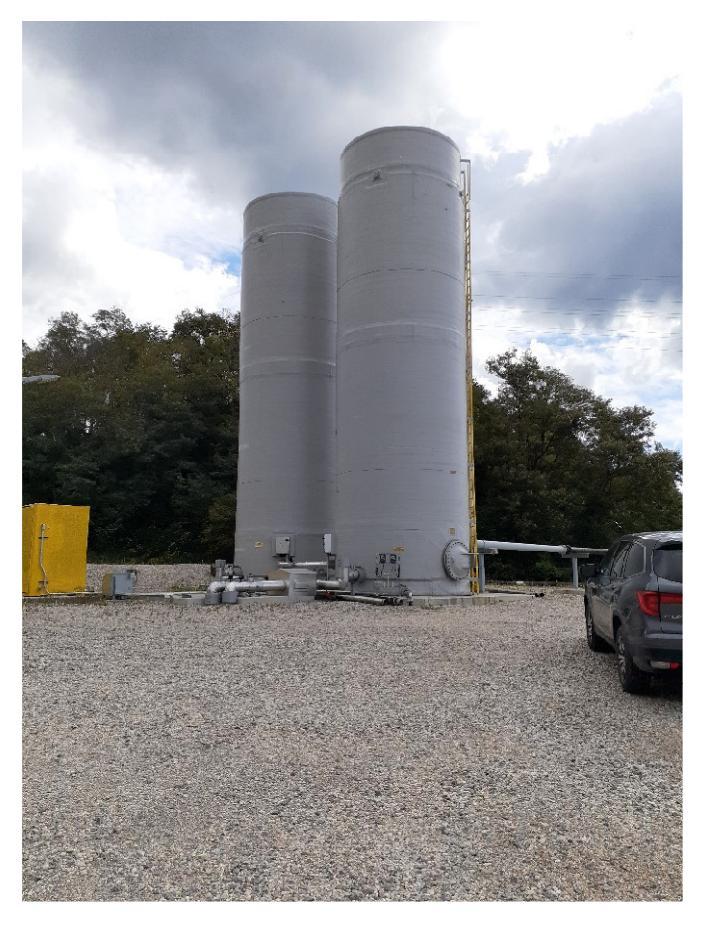
Photo 30

The leachate effluent is then discharged to pretreatment settling tanks in which temperature and effluent levels are monitored (Photo 30).

Typical view of the leachate collection tanks. The leachate is discharged to the Ohio River via an NPDES permitted outfall.
