2016 ANNUAL DAM AND DIKE INSPECTION REPORT

**Fly Ash Dams 1, 2
&
Bottom Ash Pond Complex**

**Cardinal PLANT
BRILLIANT, OHIO**

Dam & Dike Inspection Report Fly Ash Dams I, II, and Bottom Ash Complex

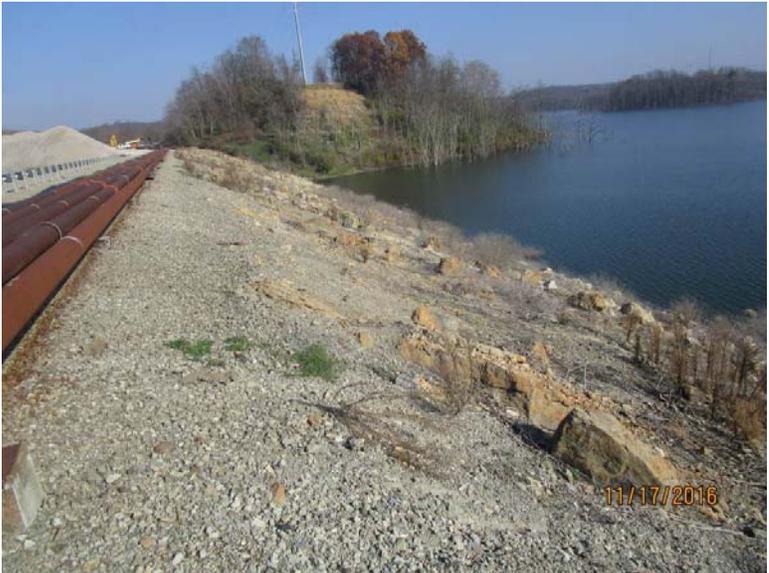
1. The downstream slope of FAD 1 was well protected with rockfill. Increase in vegetative growth was noticed (Photo Nos. 1 and 2). No significant erosion or slumping was observed.
2. Typical view of the FAD 1 emergency spillway showing minor vegetative growth (Photograph No. 3). No significant erosion was observed along the spillway (Note that the spillway conveys contact water from the FGD landfill and noncontact water from the upper reaches of the west branch of Blockhouse Hollow).
3. Surface water collection pipe installed at the right groin of FAD 1 is partially damaged and needs fix (Photograph No. 4).

<p>A photograph showing a typical view of the downstream slope of the FAR 1 dam. The slope is covered in gravel and rocks, with some sparse vegetation. A body of water is visible on the right side of the frame. The date '11/17/2016' is printed in the bottom right corner.</p>
<p>Photo # 3 FAD 1</p> <p>Typical view of the emergency spillway for the FAR 1 impoundment.</p>

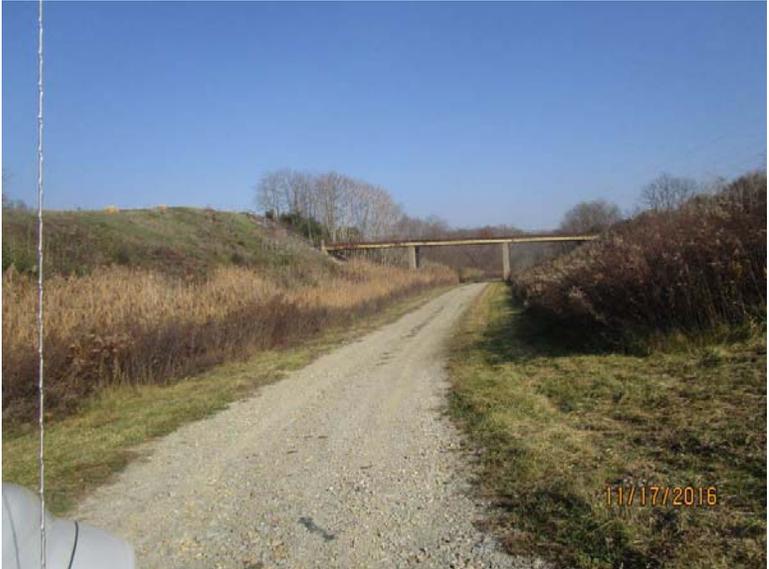
<p>A photograph showing a typical view of the emergency spillway for the FAR 1 impoundment. The spillway is a gravel path leading to a concrete structure. The date '11/17/2016' is printed in the bottom right corner.</p>

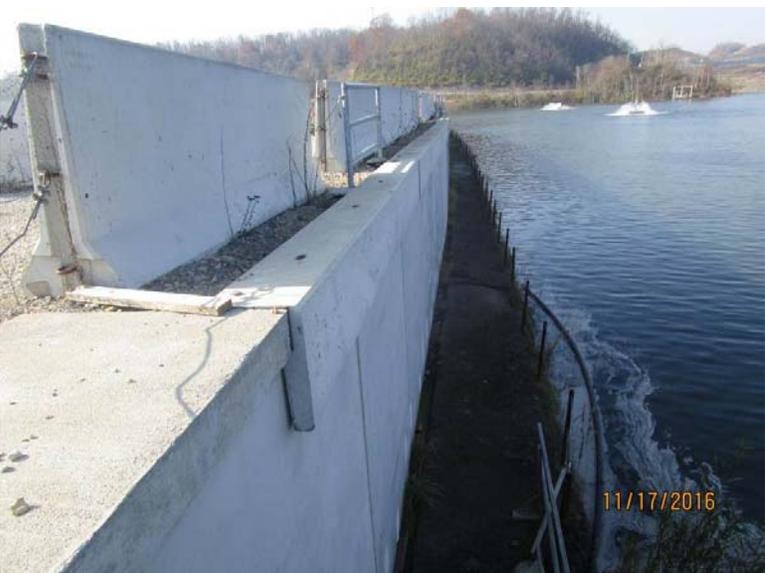
<p>Photo # 8 FAD 2</p>

<p>A photograph showing a close-up view of a concrete MSE wall on the upstream side of a dam. The wall is adjacent to a body of water. A date stamp '11/17/2016' is visible in the bottom right corner.</p>

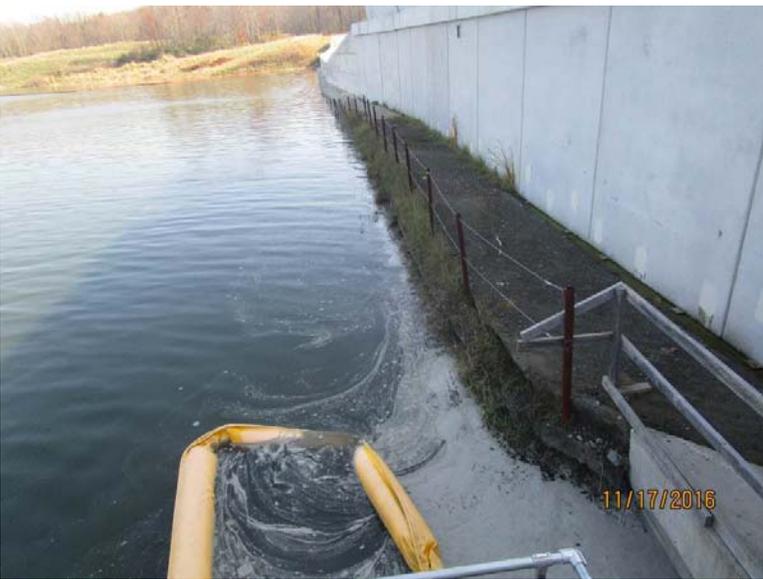
<p>A photograph of a long, straight concrete wall along a body of water. A yellow inflatable boat is in the foreground. A metal railing runs along the wall. The background shows a grassy bank and trees. A date stamp '11/17/2016' is in the bottom right corner.</p>
<p>Photo # 10 FAD 2</p> <p>Typical view of the west side of the decant structure, skimmer and stairs showing good conditions.</p>

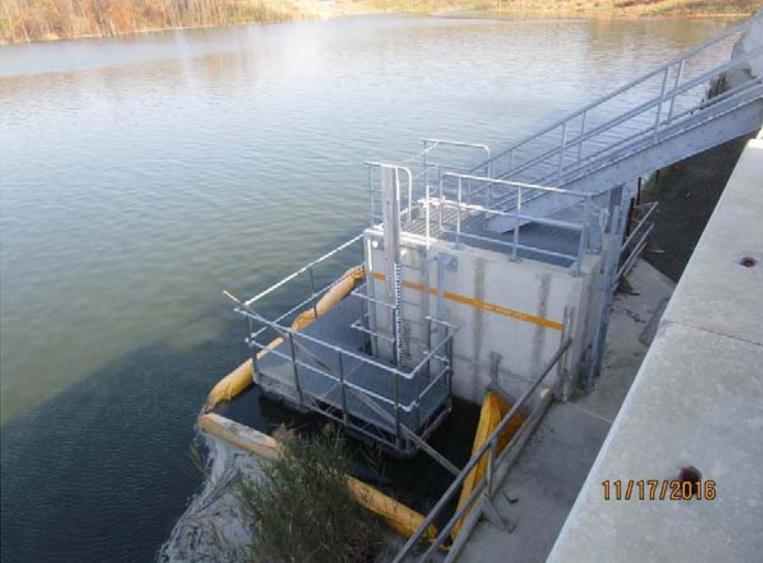
<p>Photo # 11 FAD 2</p>

<p>A photograph of a metal structure with stairs and a platform extending into a body of water. The structure appears to be a skimmer or part of a decanting system. The water is calm. A date stamp '11/17/2016' is in the bottom right corner.</p>

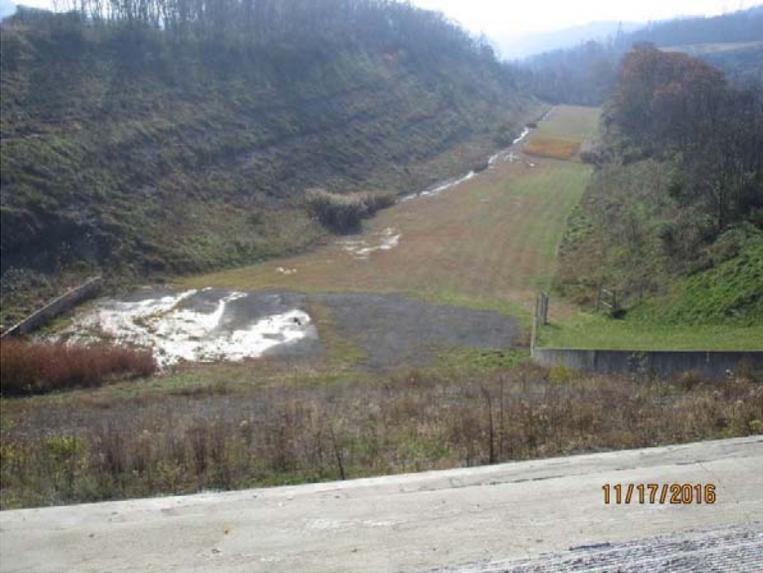
<p>11/17/2016</p>
<p>Photo # 15 FAD 2</p>

5. The emergency spillway channel is cut through natural high ground. The channel's left slope continues to have bank seepage that is conveyed to a shallow ditch along the toe of the slope with subsequent discharge through Drain No. 12 at the mouth of the emergency spillway channel. The channel abutment slopes appeared stable with no visible signs of slumping or significant erosion (Photograph No. 14).

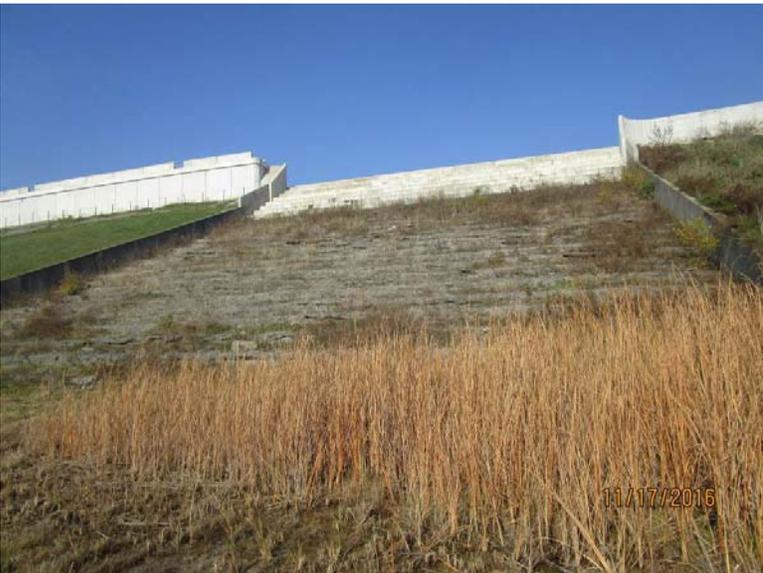
<p>11/17/2016</p>
<p>Photo # 16 FAD 2</p>

6. The emergency spillway has a downstream slope channel constructed of RCC steps and berms between the concrete retaining walls as shown in Photograph No. 15. The concrete walls and concrete steps appeared to be in good condition while the spillway's 2-ft high RCC steps continue to weather.

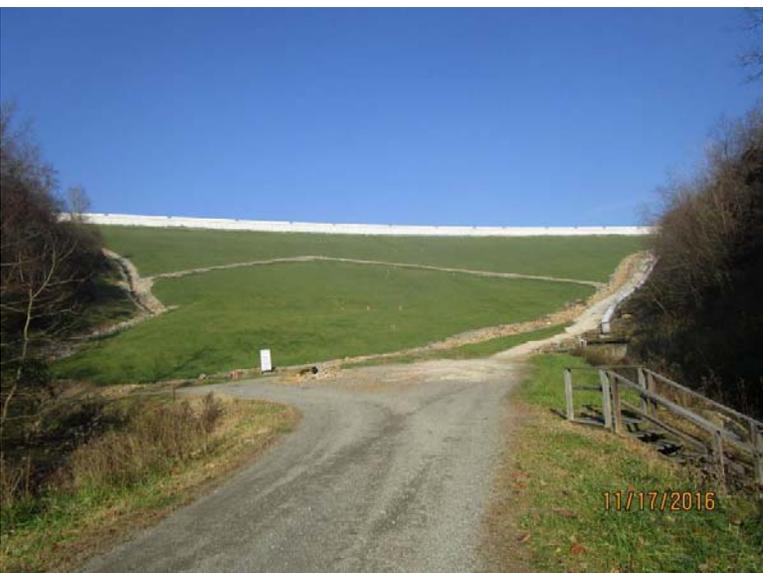
7. The downstream slope of the dam appeared to be in good condition with good vegetative growth as shown in Photograph Nos. 16& 17. No significant erosion was observed and the slopes appeared to be uniform with no slumping or bulges.

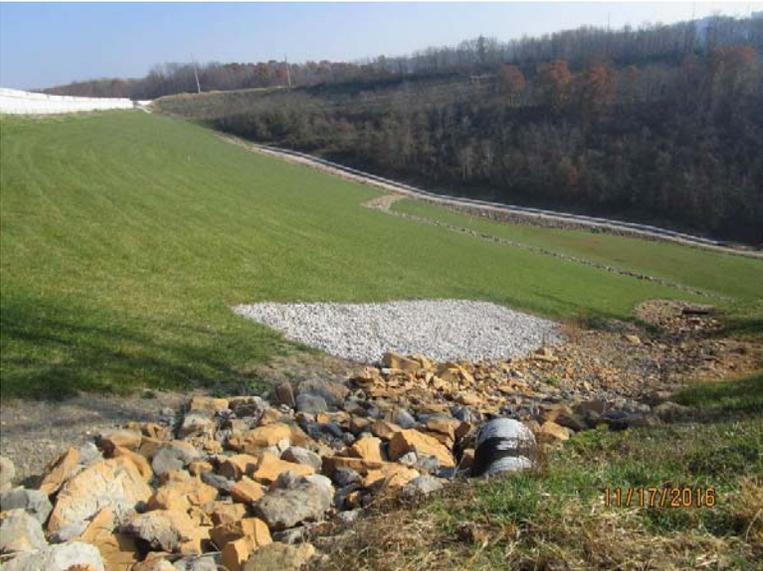
<p>Photo # 19 FAD 2</p> <p>Typical view of Drain No. 2 that discharges from the right abutment drainage blanket. The discharge was visually clear but has increased.</p>

14. Seepage along the right abutment at slightly higher elevations started in the fall of 2013 and was fixed with an installation of inverted filter (Photograph No. 18). A visually clear seepage was observed at an estimated flow rate of 0.6 gpm.

<p>A photograph of a right groin ditch. The ditch is filled with rip rap (limestone) and shows no significant weathering. A concrete structure is visible in the background. The date 11/17/2016 is printed in the bottom right corner.</p>

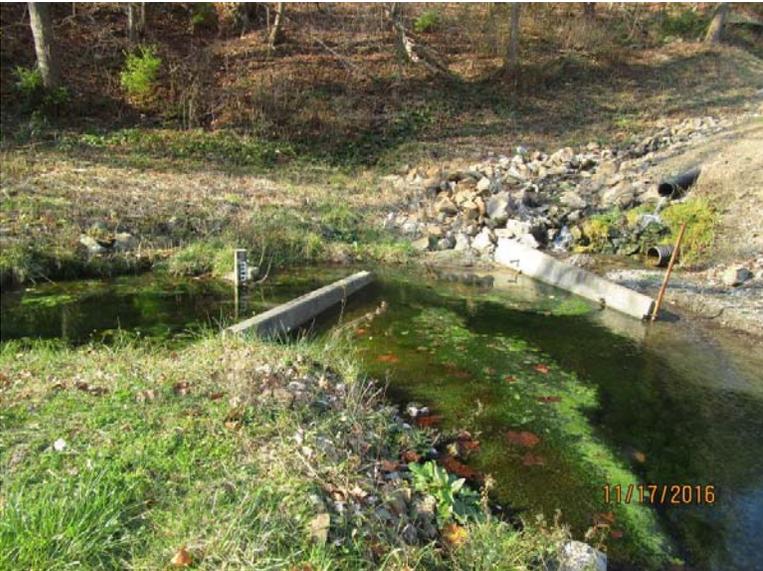
<p>Photo # 20 FAD 2</p>

9. Right abutment seepage is collected and measured from the open weir chimney/toe drain drainage blanket (Drain No. 1). Vegetation was removed along the slopes and adjacent to the stairwell and the downstream channel below the weir discharge point. The discharge was approximately the same as the previous inspection and was visually clear (Photographs 19 to 22).

<p>A photograph of Drain No. 2. The discharge is visually clear but has increased. The date 11/17/2016 is printed in the bottom right corner.</p>

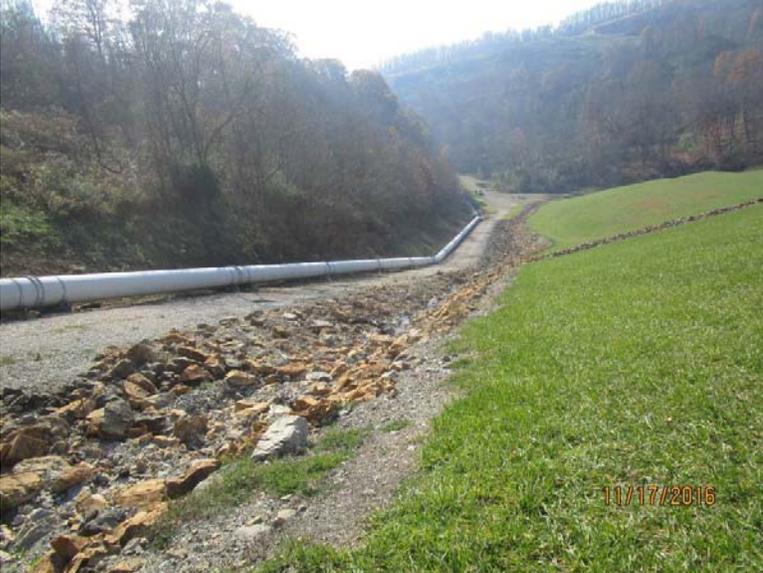
<p>Photo # 24 FAD 2</p>

10. The left groin ditches and discharge pipe were observed to be in good conditions. The vegetation was cut back to the left of the pipeline allowing excellent visual observation of the abutment. No significant uncontrolled seepage along this portion of the abutment or as the discharge pipe enters into the ground prior to its connection to the energy dissipater structure was observed. No significant erosion, slumping or bulges were observed. Minor vegetation growth within the groin ditch needs to be eliminated using spray chemicals (Photograph No. 23).

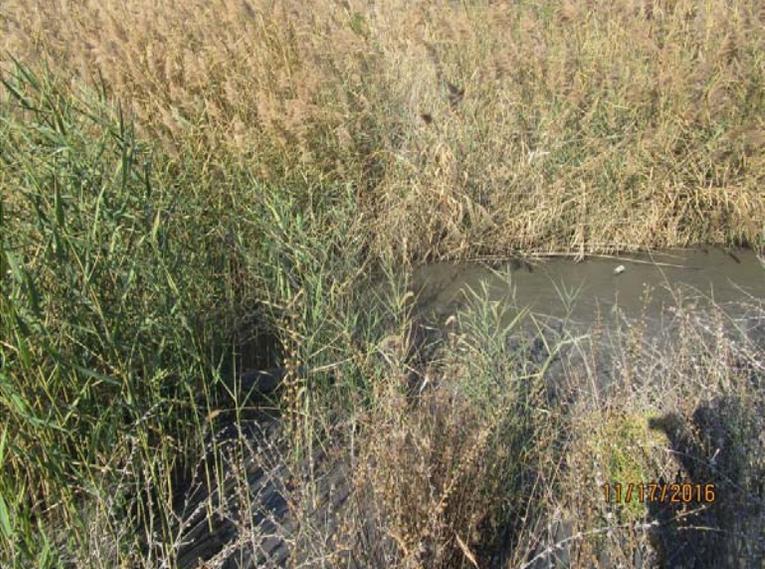
15. Typical view of the FAR 2 pond looking towards FAR 1 dam crest (Photograph No. 27). The pond stage was 968 ft NGVD at the time of the inspection.
16. The discharge lines sluicing ash at their discharge point into the pond were partially inundated because of the rise of the FAR 2 water level (Photograph No. 28). The lines need to be cut at a higher elevation.

<p>11/17/2016</p>
<p>Photo # 28 FAD 2</p> <p>Typical view of the ash sluice lines discharging into the FAR 2 pond. The increase in pool stage has inundated additional area including the discharge lines ends.</p>

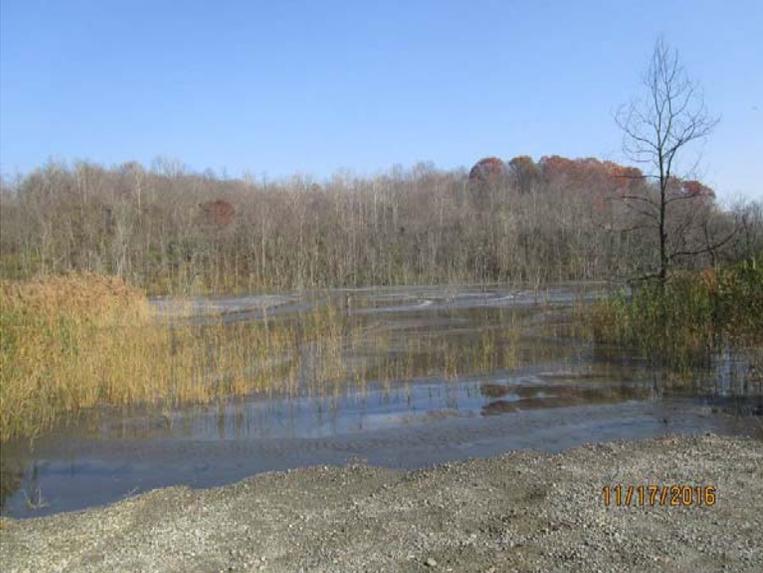
<p>11/17/2016</p>
<p>Photo # 30 FAD 2</p>

17. The ash delta is prograding away from its discharge point and generally follows the apex of the valley towards the decant structure located along the face of the dam (Photo No. 29).

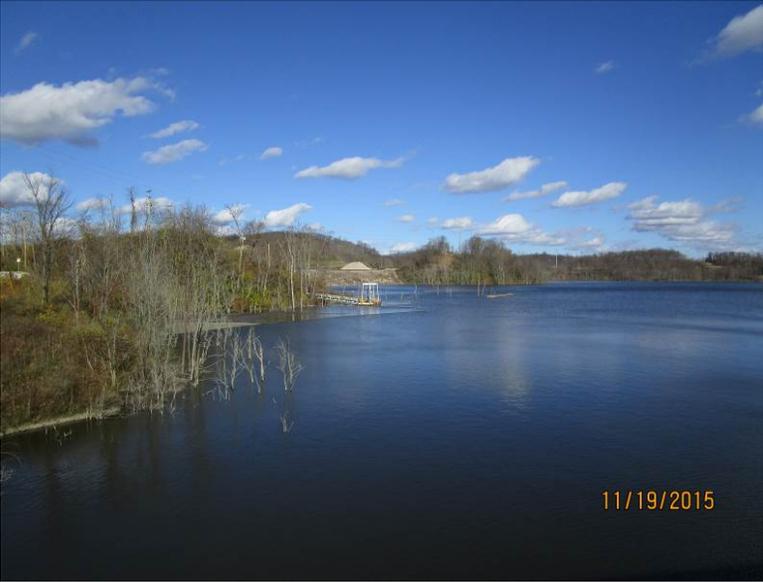
<p>Ash Dredging to the right corner of the upstream slope. The location of the pumping platform installed within the FAR 2 impoundment is shown in the background.</p>	
<p>Photo # 33 FAD 2</p>

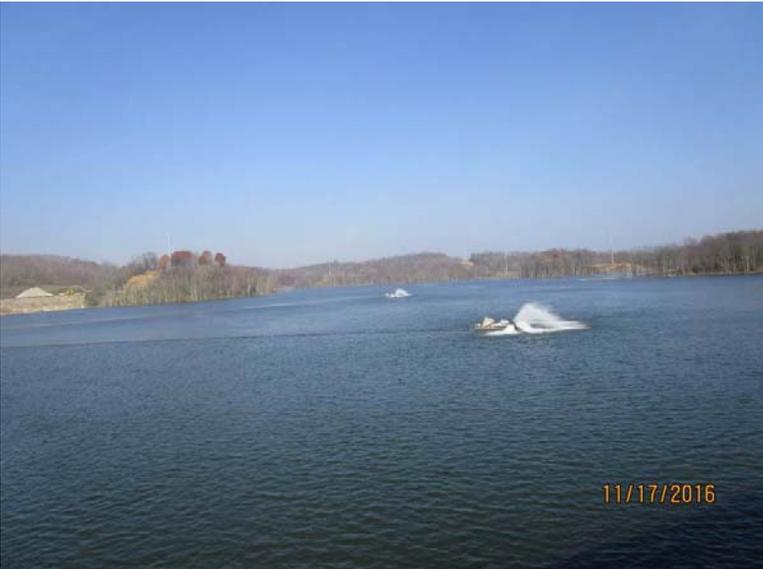
<p>Two aerators are operating in the FAR 2 pond and are used to keep the impoundment from stratifying and direct the cenospheres to move towards the shoreline allowing greater penetration of sunlight into the pond and promote the growth of algae.</p>

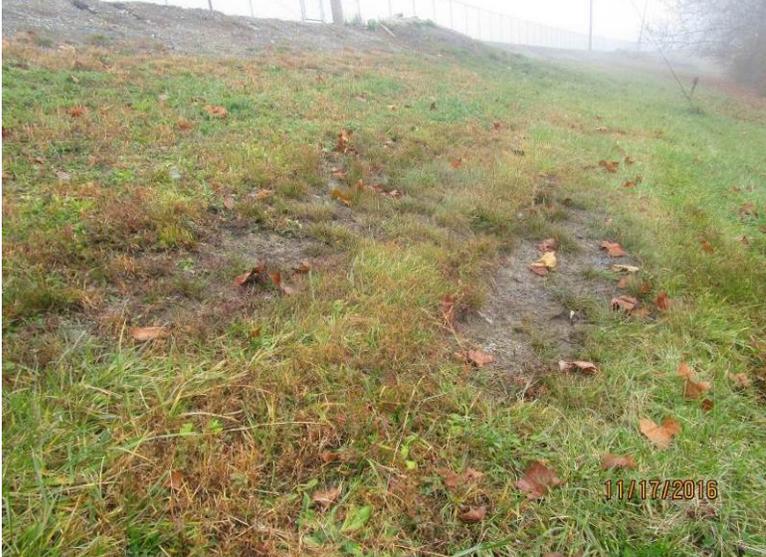
<p>Close-up of Seep #1.</p> <p>11/17/2016</p>
