**2015 INSPECTION REPORT
FLY ASH DAMS I, II
AND
BOTTOM ASH COMPLEX**

**CARDINAL PLANT
BRILLIANT, OHIO**

GERS-15-027

**Dam & Dike Inspection Report
Fly Ash Dams I, II, and
Bottom Ash Complex**

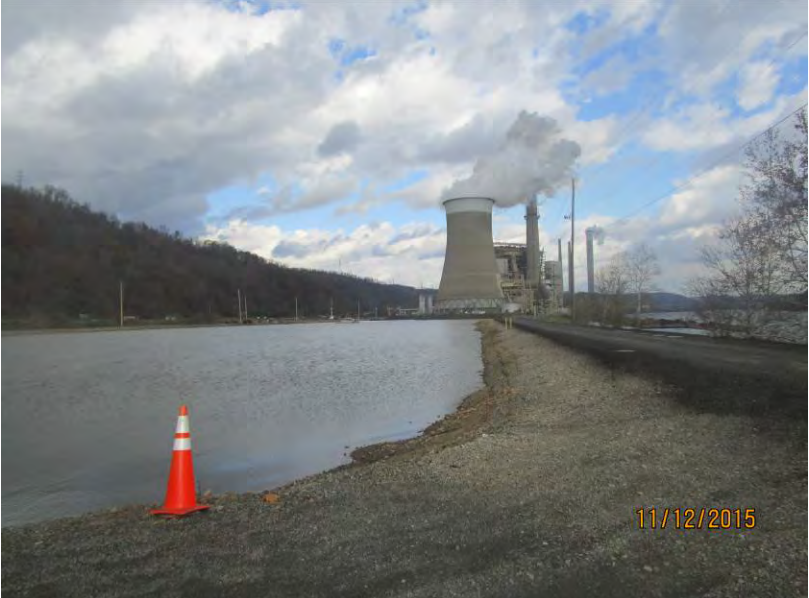
<p>Photo # 9 BAP</p>

3. The crest and interior slopes of the BAP and the Recirculation Pond were in generally good condition as shown in Photograph Nos. 7, 8, 9, and 15.
4. The BAP discharge structure concrete and steel platform were in good condition, as shown in Photograph No. 10. The railings are showing minor rust and the steel support members to the walkway are showing fair conditions with minor corrosion.

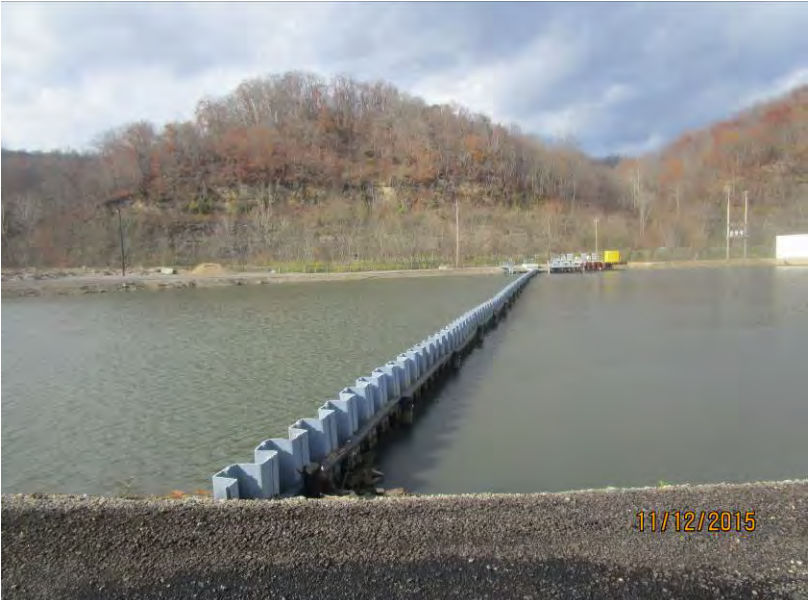
<p>11/12/2015</p>
<p>Photo # 15 BAP</p>

7. The PVC sheet piling installed across the width of the recirculation pond appears to be stable with no change noted along the slight bulge in the sheet pile alignment previously noted at the time of installation (Photo Nos. 14 and 15).

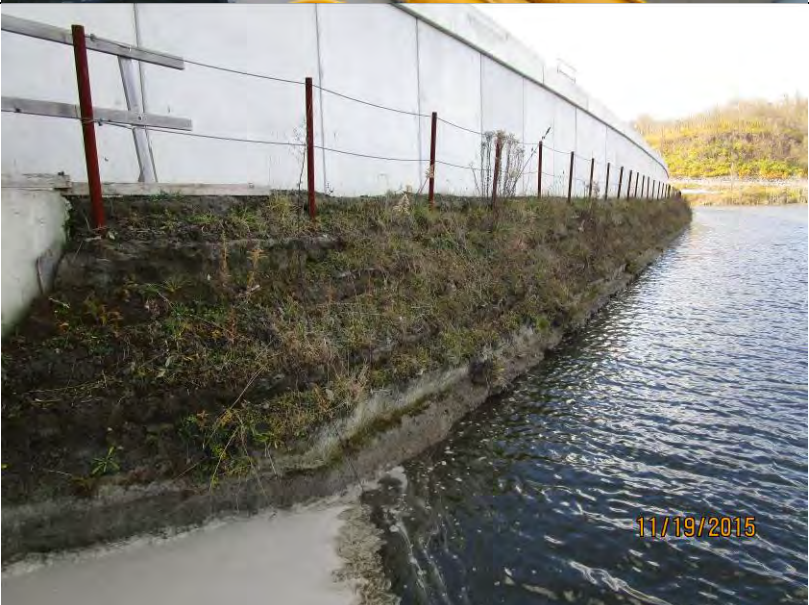
<p>Photo # 28 FAD 2</p>

5. The emergency spillway channel is cut through natural high ground. The channel's left slope continues to have bank seepage that is conveyed to a shallow ditch along the toe of the slope with subsequent discharge through Drain No. 12 at the mouth of the emergency spillway channel. The channel abutment slopes appeared stable with no visible signs of slumping or significant erosion (Photograph No. 28).

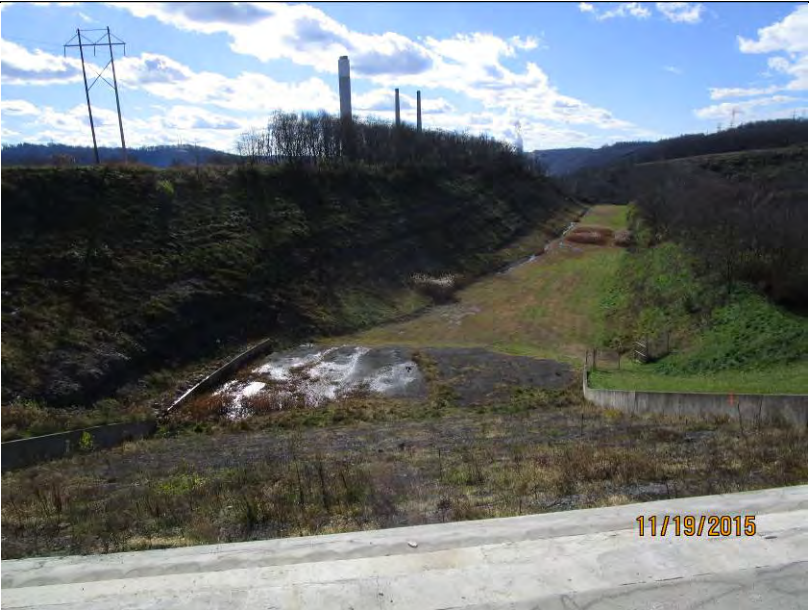
<p>11/19/2015</p>
<p>Photo # 29 FAD 2</p>

6. The emergency spillway has a downstream slope channel constructed of RCC steps and berms between the concrete retaining walls as shown in Photograph No. 29. The concrete walls and concrete steps appeared to be in good condition while the spillway's 2-ft high RCC steps continue to weather.

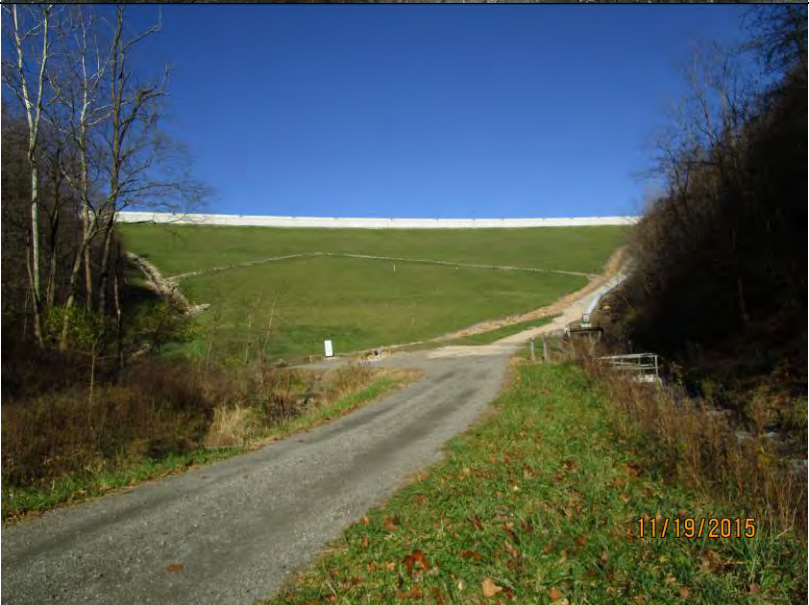
7. The downstream slope of the dam appeared to be in good condition with good vegetative growth as shown in Photograph Nos. 30& 31. No significant erosion was observed and the slopes appeared to be uniform with no slumping or bulges.

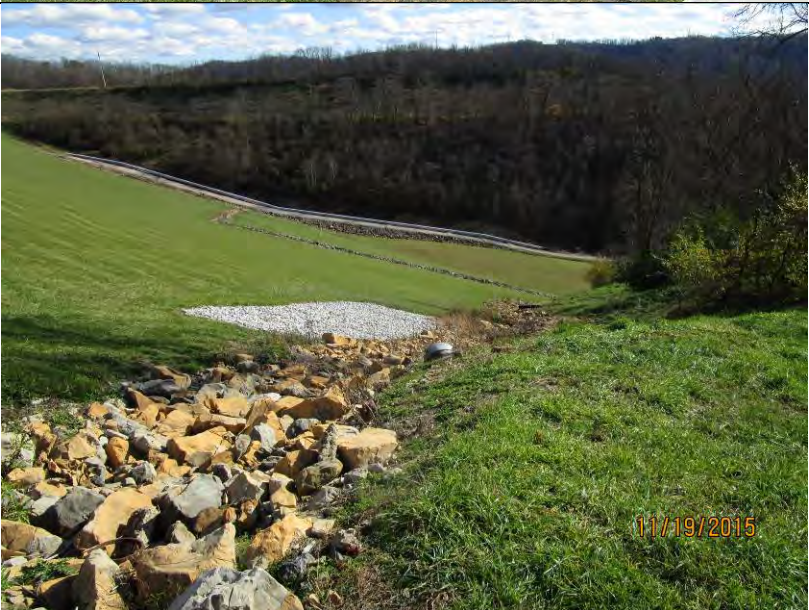
15. Seepage along the right abutment at slightly higher elevation started in fall 2013 and was fixed with an installation of inverted filter (Photograph No. 32). Visually clear seepage flow rate was ~0.6 gpm.

<p>A wide-angle photograph of a grassy downstream slope. A concrete drainage ditch runs diagonally across the middle of the frame. The slope is covered in green grass, and the background shows a wooded hillside. A date stamp '11/19/2015' is visible in the bottom right corner.</p>
<p>Photo # 32 FAD 2</p> <p>Typical view of the right groin ditch. The woody shrub/small tree growth has been removed from the ditch per previous recommendations. The rip rap is a hard limestone and showed no significant weathering or deterioration. Flow measurements was taken of the drain recently installed to monitor seep fix area at the upper right groin (See newly placed Riprap)</p>

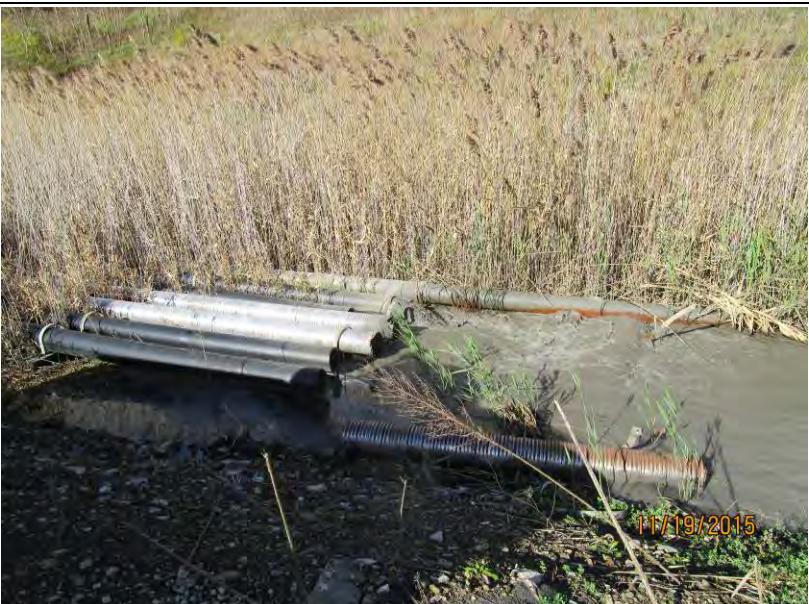
17. The discharge lines sluicing ash at their discharge point into the pond was also inspected and was observed to be in excellent condition. Note that the lines were cut at a higher elevation because of the rise of the FAR 2 water level (Photograph No. 42).

<p>11/19/2015</p>
<p>Photo # 42 FAD 2</p> <p>Typical view of the ash sluice lines discharging into the FAR 2 pond. The increase in pool stage has inundated additional area and necessitate the cutting of the discharge lines.</p>

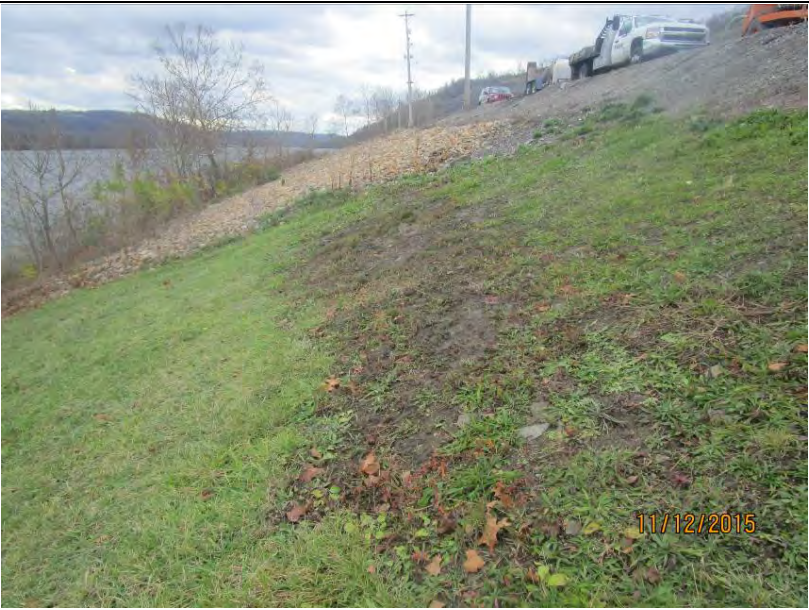
<p>Photo # 52 BAP</p>

8. The contractor constructed a bridge across the bottom ash pond channel to continue reclamation of the bottom ash from the pond (Photo No.16). The bottom ash sluice lines were generally clear allowing for unobstructed flow into the pond (Photo No.17).
9. Three seepage areas with minimal flow were found along the downstream of the eastern dike during quarterly inspections and persisted through this annual inspection. Piezometers are being installed to determine the source of the seeping water and to provide a fix (Photos No.52 through 56).

<p>A wide-angle photograph of a grassy embankment. In the background, a white pickup truck and other vehicles are parked on a gravel area. The sky is overcast. A date stamp '11/12/2015' is visible in the bottom right corner of the photo.</p>
<p>General View of the Location of Seep #1.</p>	
<p>Photo # 53 BAP</p>

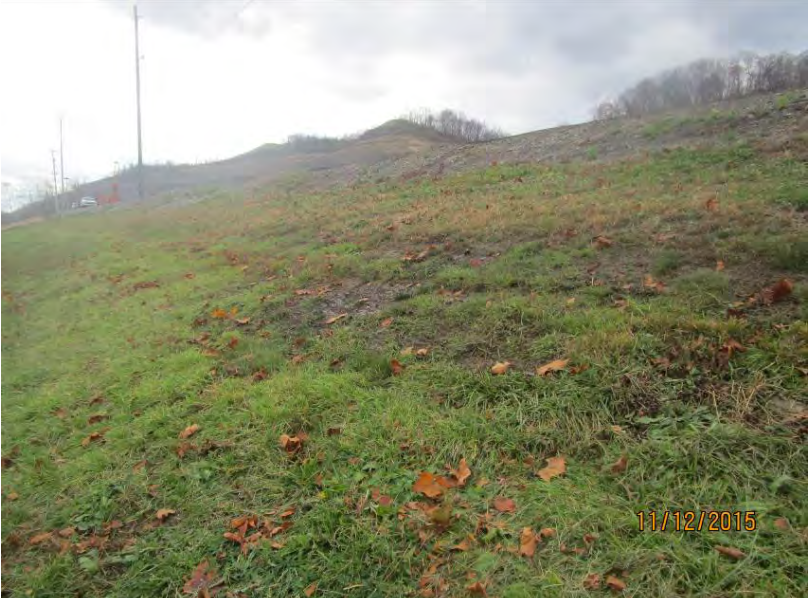
<p>A wide-angle photograph of a grassy embankment, similar to the first photo. The ground is covered with green grass and some fallen brown leaves. A date stamp '11/12/2015' is visible in the bottom right corner of the photo.</p>
<p>General View of the Location of Seep #2.</p>

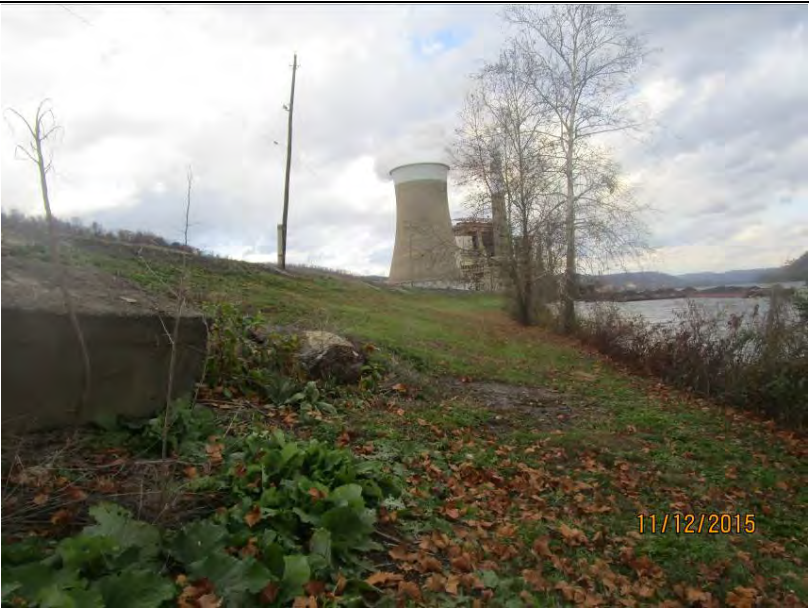
<p>Photo # 55 BAP</p>

<p>A wide-angle photograph showing a grassy embankment in the foreground with some green plants and fallen brown leaves. In the background, a large, cylindrical concrete structure, likely a dam or part of a dike, stands on a hill. A utility pole is visible to the left of the structure. The sky is overcast with grey clouds. A date stamp '11/12/2015' is visible in the bottom right corner of the photo.</p>
<p>General View of the Location of Seep #3.</p>	
<p>Photo # 56 BAP</p>

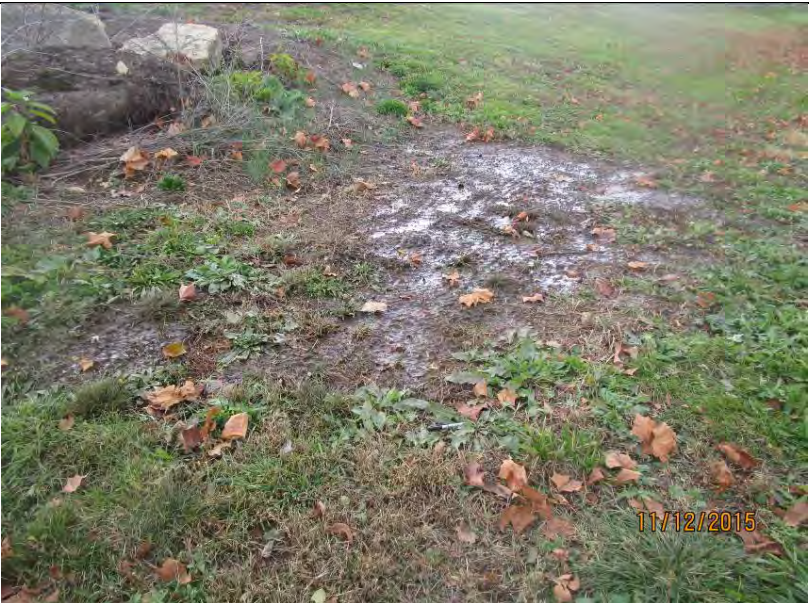
<p>A close-up photograph of a seep area. The ground is covered with green grass and many fallen brown leaves. A small, dark, wet patch of earth is visible in the center, indicating a seepage point. A date stamp '11/12/2015' is visible in the bottom right corner of the photo.</p>
<p>Close-up of Seep #3.</p>

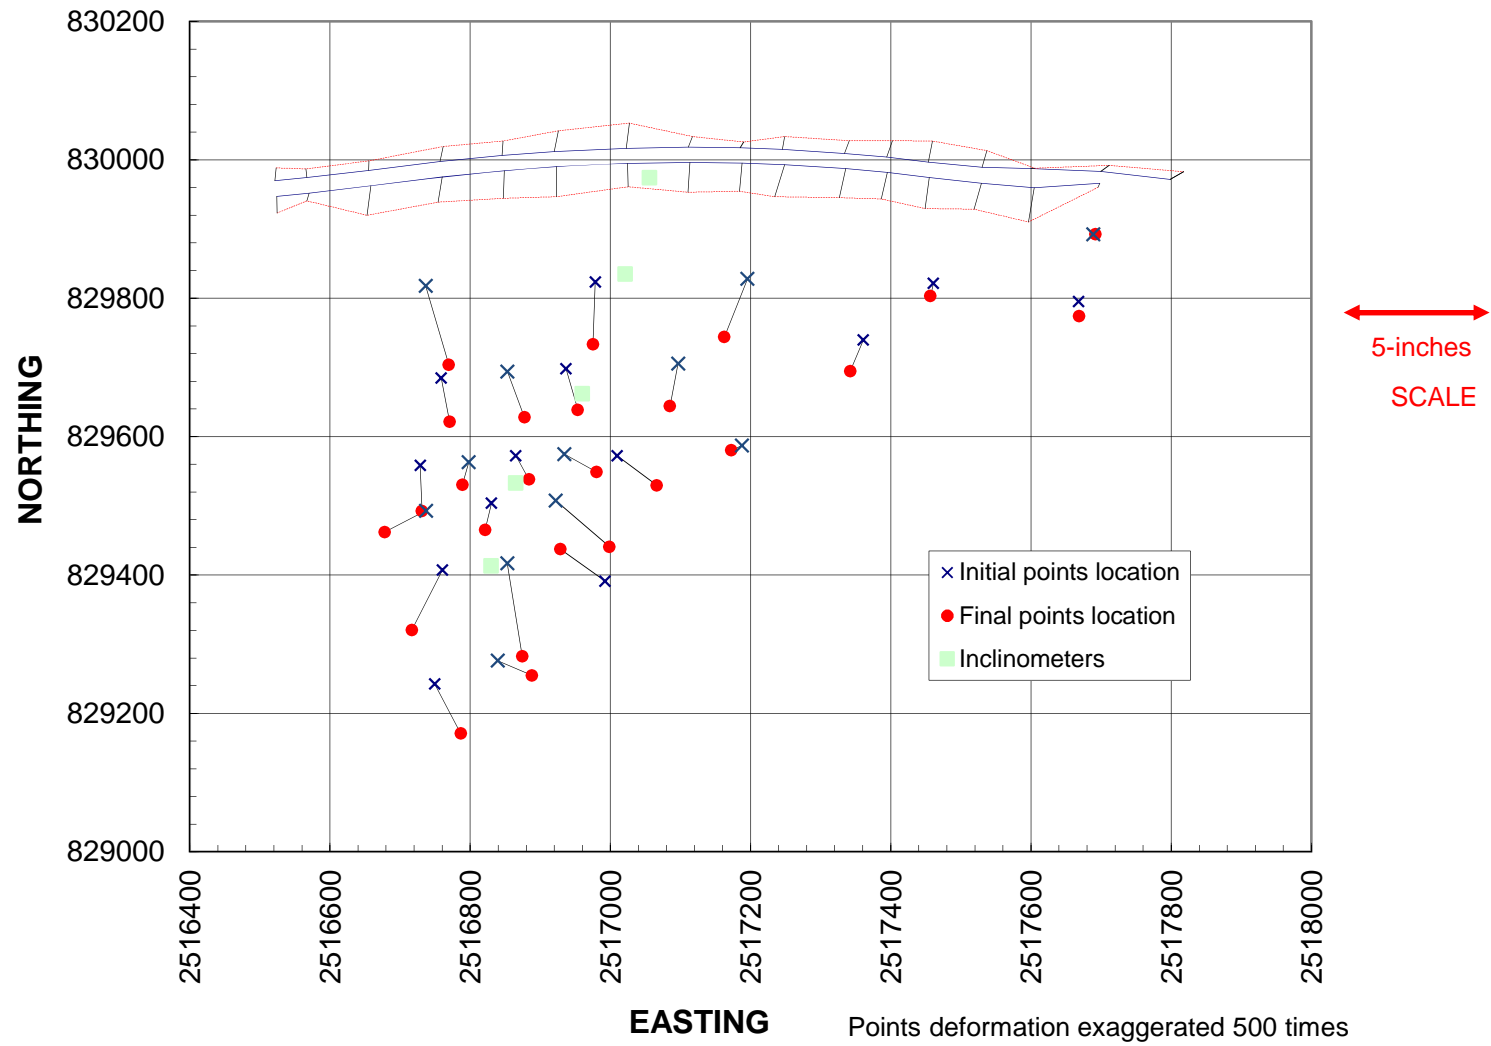
FIGURE 6A LATERAL MOVEMENT (October 2015)

In general, all horizontal movement is towards a downstream direction. Review of top of dam horizontal movement plots provided in the report indicates small movements in a southerly direction (downslope), - southeast at the center of the dam; and southeast to east along the left abutment (Figure 6a). Downstream face monuments show small movements generally in the downstream (south) direction. The least amount of movement is observed along the east end where the RCC is more fully supported by bedrock.
