# 2017 ANNUAL DAM AND DIKE INSPECTION REPORT

**Fly Ash Dams 1, 2  
&  
Bottom Ash Pond Complex**

**Cardinal PLANT  
BRILLIANT, OHIO**

**Dam & Dike Inspection Report  
Fly Ash Dams 1, 2, and  
Bottom Ash Pond Complex**

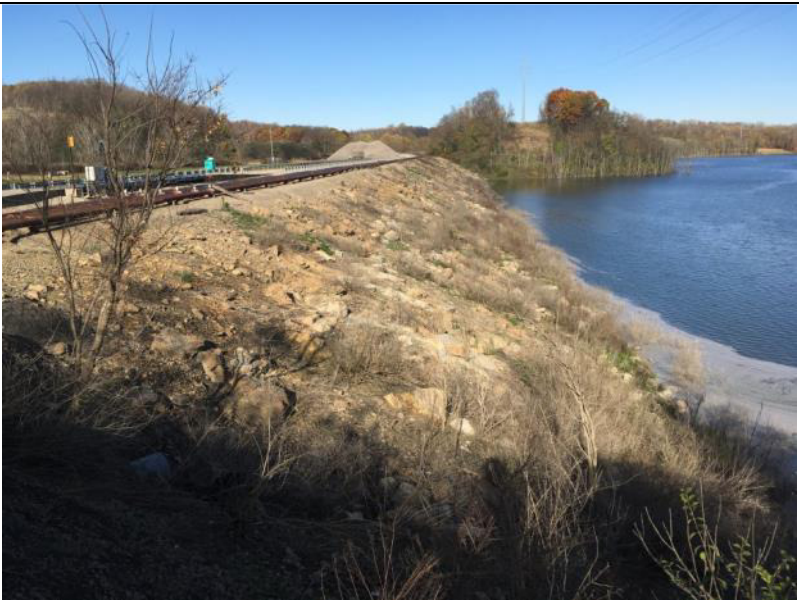
<p>Photo # 1 FAD 1</p> <p>View of the downstream slope of the FAR 1 dam.</p>

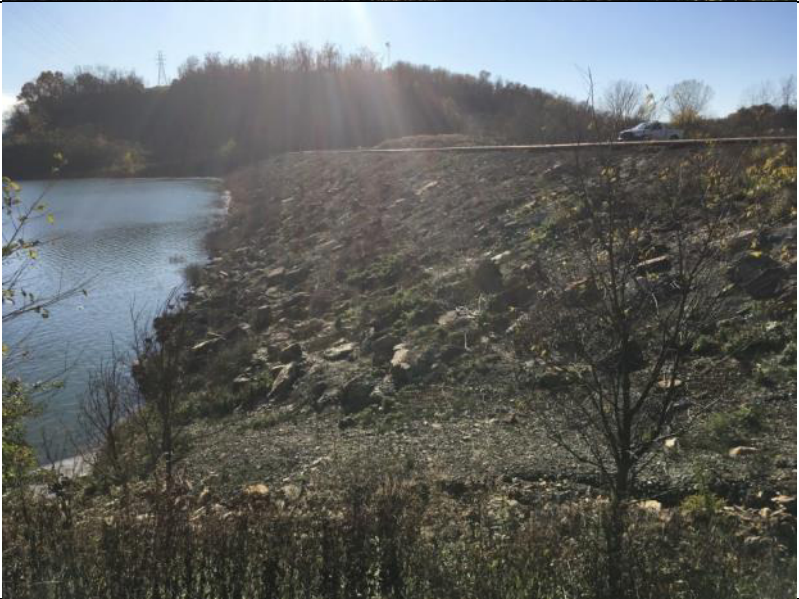
A photograph showing the downstream slope of the FAR 1 dam. The slope is composed of light-colored soil and rocks, with sparse, dry vegetation. A concrete structure, likely a spillway or roadway, runs along the top of the dam. In the background, there are trees and a clear blue sky. The water of the reservoir is visible on the right side of the frame.
<p>Photo # 2 FAD 1</p> <p>Typical view of the downstream slope of the FAR 1 dam.</p>

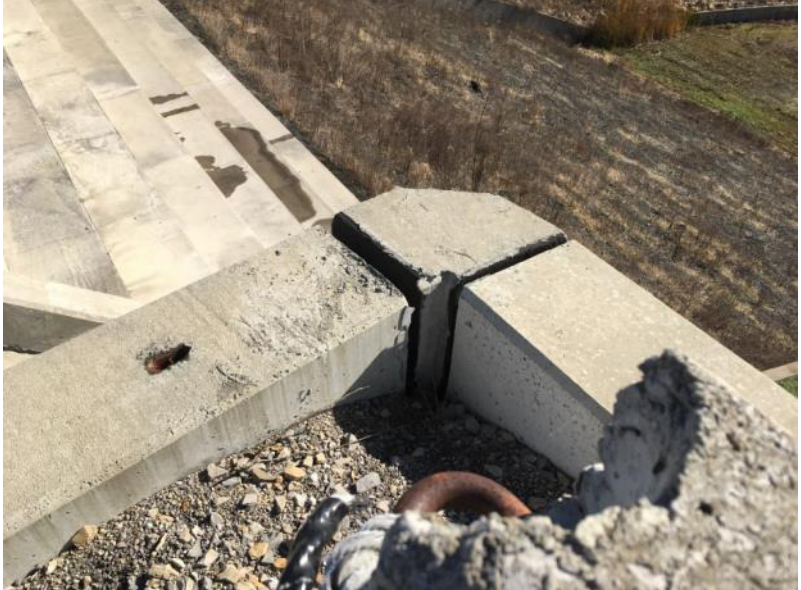
<p>Typical view of the staff gauge on principal spillway.</p>	
<p>Photo # 6 FAD 2</p>

3. The southeast corner of the MSE Wall where the wall panels meet the concrete coping, the corner piece is show signs of separation (Photograph No. 6).

<p>Typical view of the east side of MSE Wall looking at downstream corner where the wall panel meets concrete coping. Notice the separation at the corner piece.</p>

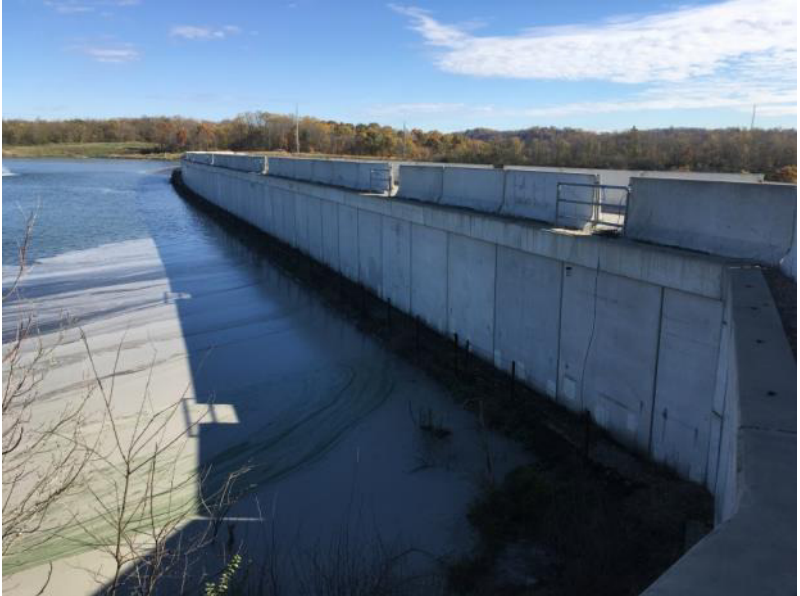
<p>Photo # 7 FAD 2</p>

4. The upstream RCC slope appeared to be stable with no significant wave cut erosion, slumping or cracking (Photographs Nos. 7 and 8).
5. The emergency spillway crest area consists of non-reinforced concrete material and appears to be in good shape (Photograph No. 9).

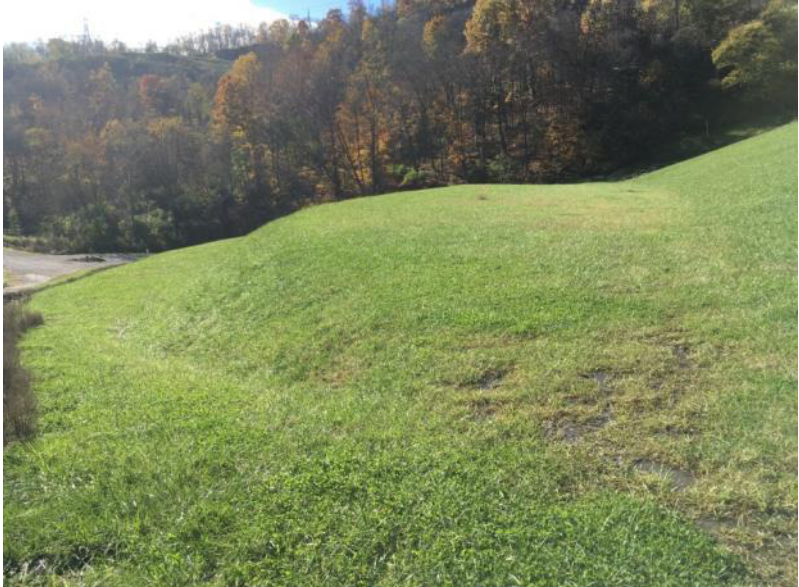
9. The downstream slope lower berm appeared to be in good condition with good vegetative growth (Photograph No. 15). There were signs of standing water on the bench of the lower berm indicating poor drainage from recent rains (Photograph No. 16).

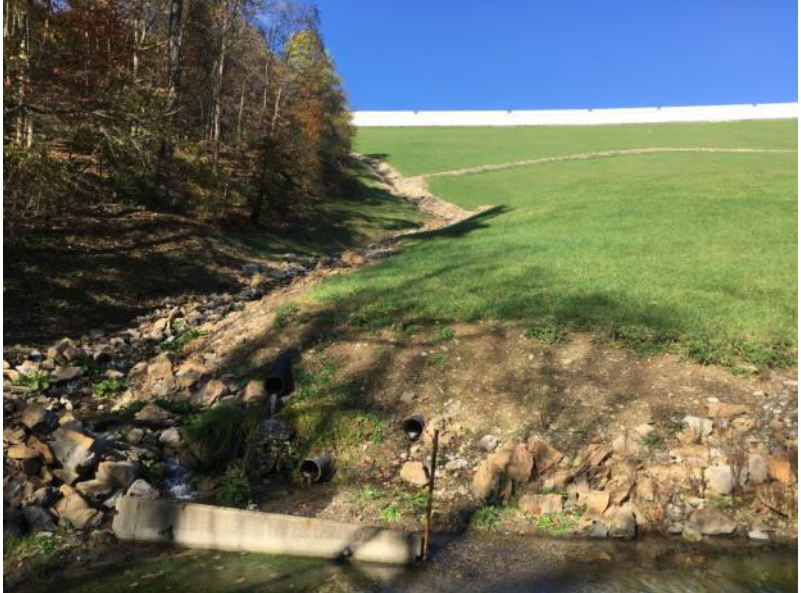
10. The right downstream groin ditch was in good condition (Photographs No. 17 and 18). The rip rap is a hard limestone and showed minor weathering or deterioration. The discharges from several seepage drains were clear and no sediment deposits were observed in the pooling area. The groin appeared to be generally in good condition (Photograph No. 19).

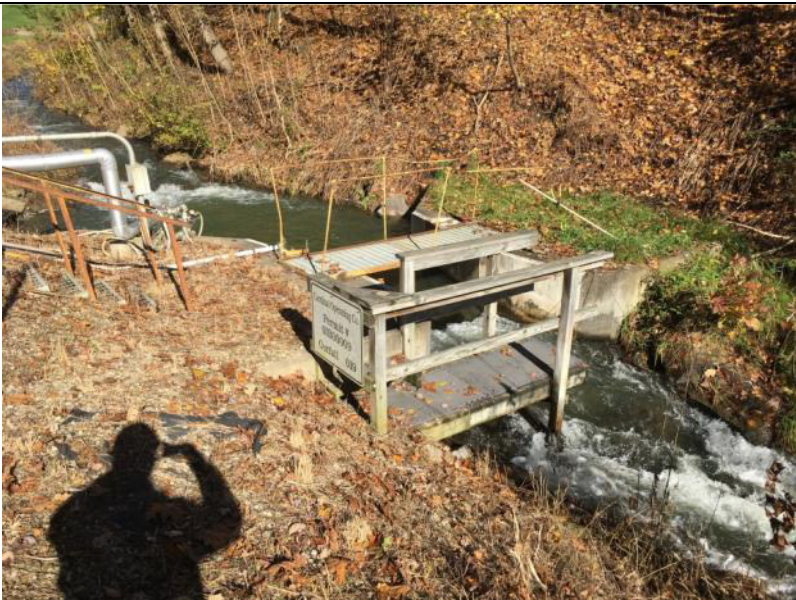
<p>Photo # 22 FAD 2</p>

12. The energy dissipater structure and downstream channel appeared to be in good condition (Photograph Nos. 21).
13. The dam's concrete flume (identified as Drain 14 (NPDES Permit Outfall # 019)) was observed to be in excellent condition and flow was unobstructed (Photograph No. 22).

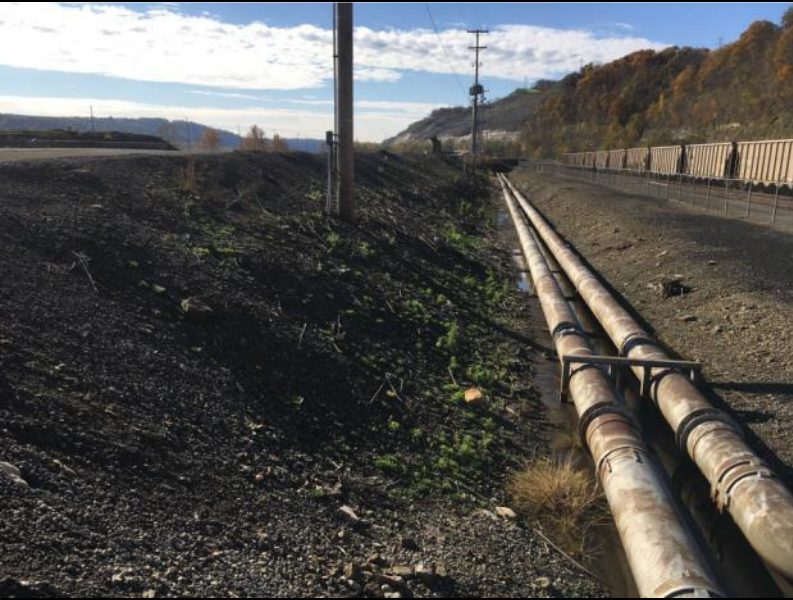
<p>Photo # 1 BAP</p>

<p>Typical view showing satisfactory condition of exterior slope and some minor seepage / drainage along toe of the embankment.</p> <p>No significant signs of erosion, slumping or bulges were observed.</p>	
<p>Photo # 2 BAP</p>

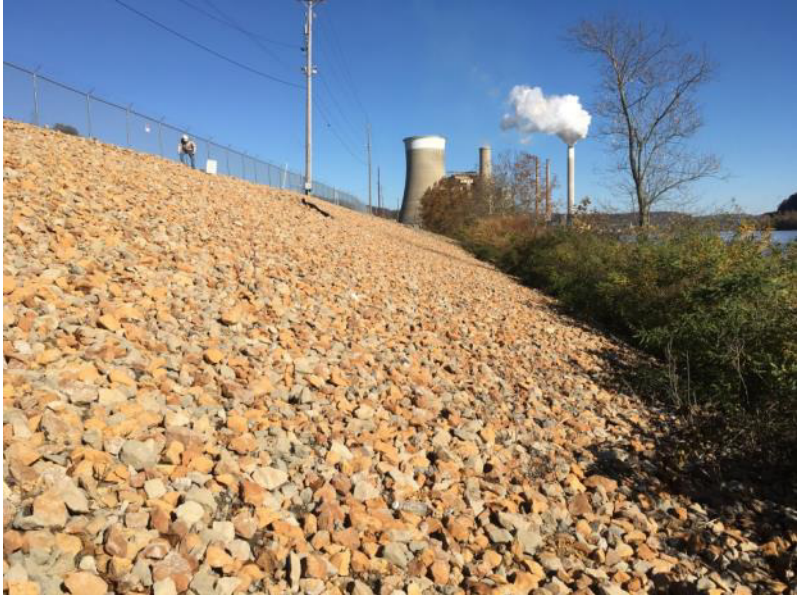
A photograph showing a gravel embankment with a chain-link fence on the left. In the background, there is an industrial facility with a large cooling tower emitting white steam under a clear blue sky.
<p>Photo # 5 BAP</p> <p>Typical view showing good condition of the rip rap. An inverted filter drain was extended in late 2009 through this area to control seepage emanating from the pond.</p>

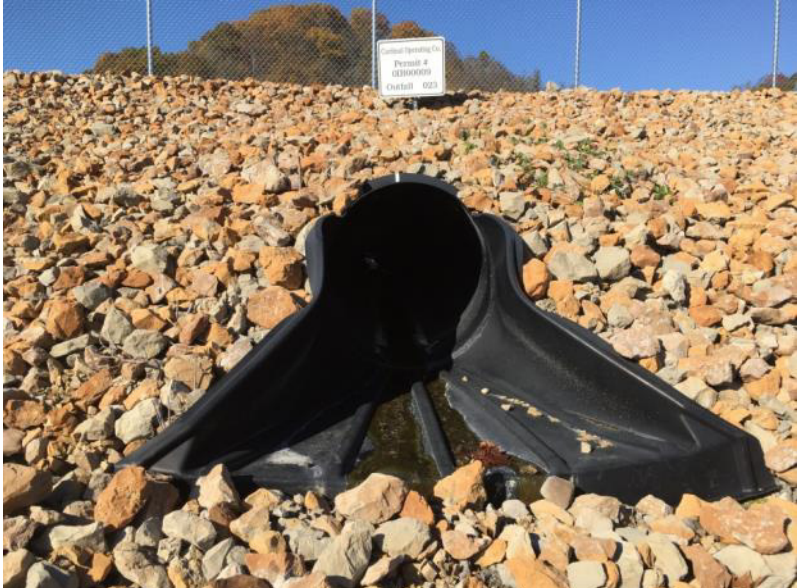
A photograph of a steep rip rap slope. A chain-link fence runs along the top edge. In the background, an industrial facility with a cooling tower is visible under a blue sky.
<p>Photo # 6 BAP</p> <p>Typical view showing good condition of the rip rap and downstream outlet of the RCP discharge pipe.</p>

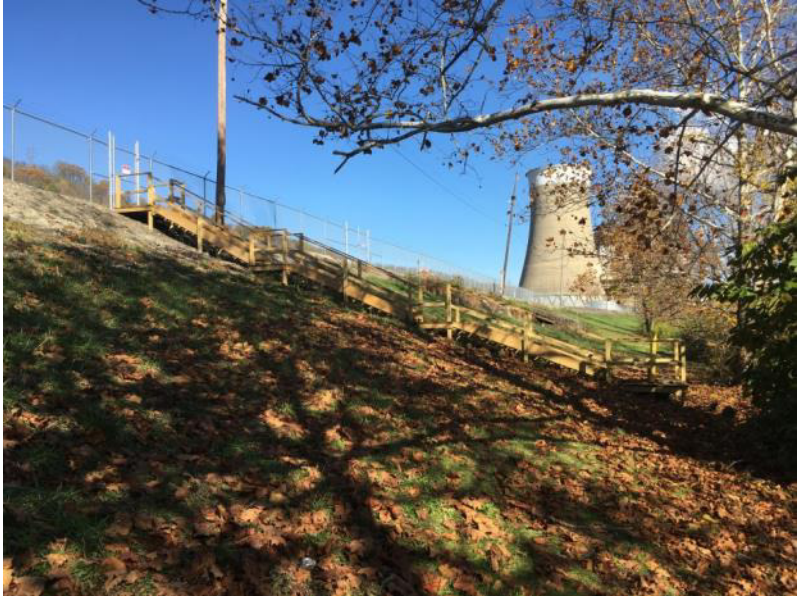
<p>Photo # 7 BAP</p>

<p>Typical view of the exterior slope along the Ohio River and access stairs down to a monitoring well. The piezometer in the foreground is well protected and is currently being monitored by plant personnel.</p>	
<p>Photo # 8 BAP</p>

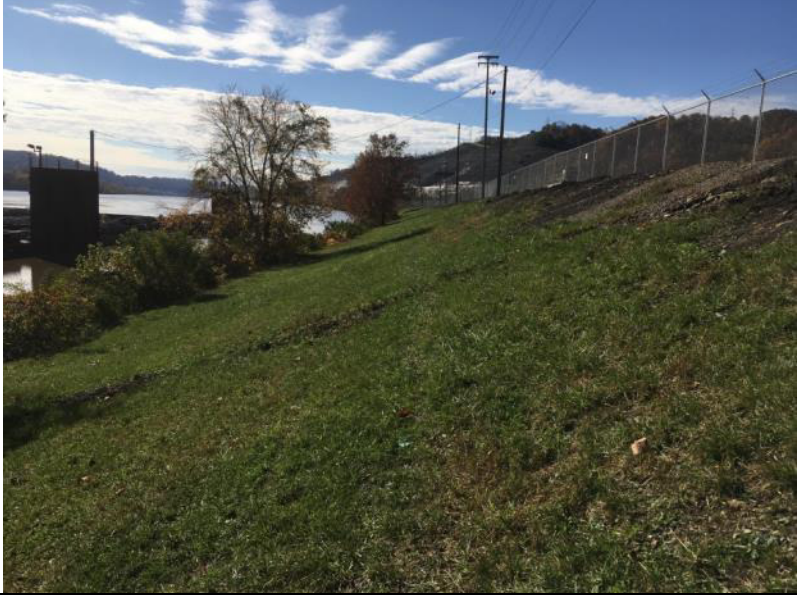
<p>The embankment along the Ohio River showed a good growth of vegetative cover and is regularly controlled by mowing. There were no signs of slumping, or bulges observed. The trees are located along the Ohio River and are being left in place to protect the riverbank.</p>	
<p>Photo # 9 BAP</p>

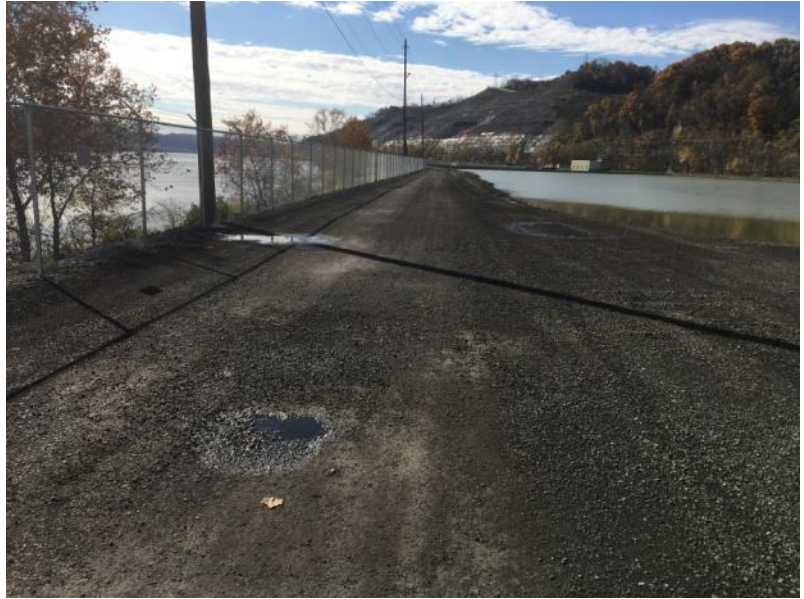
Photo # 10 BAP

Typical view of the crest area of the exterior slope long the Ohio River. There were no signs of rutting, pot holes or misalignment.

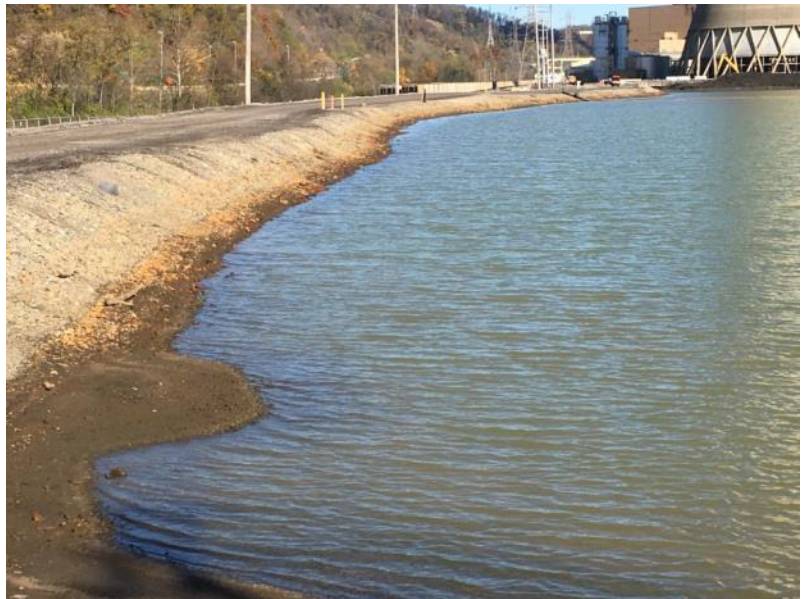
Photo # 14 BAP

Typical view showing good conditions of the interior slope areas of the bottom ash pond.

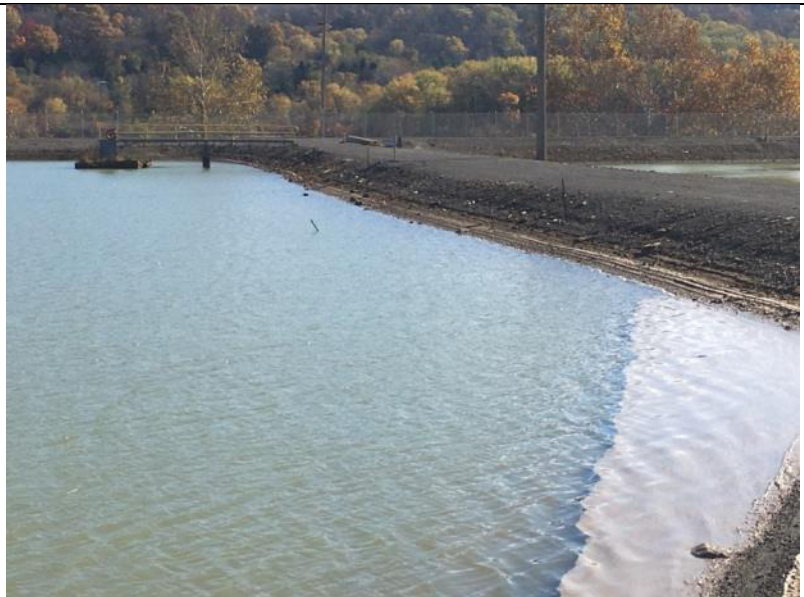
Photo # 15 BAP

Typical view showing good conditions of the interior slope areas of the bottom ash pond.

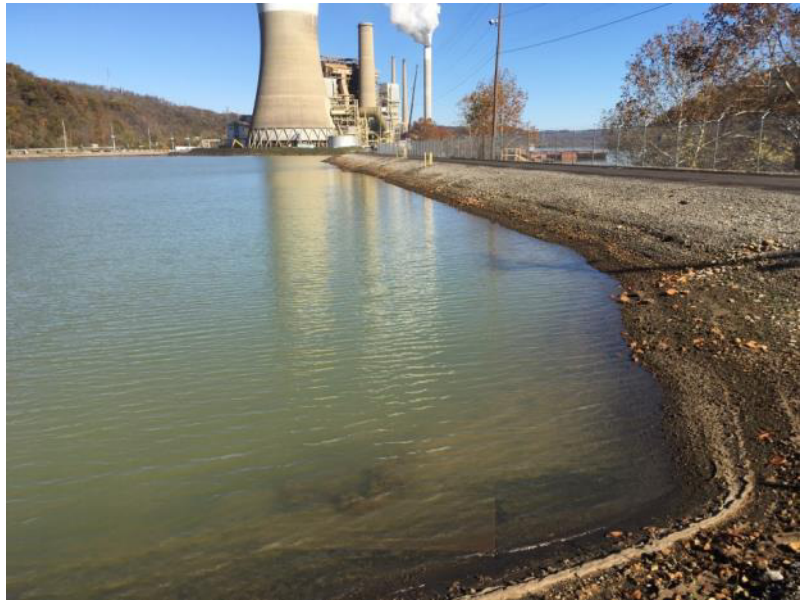
Photo # 16 BAP

Typical view showing good conditions of the interior slope areas of the bottom ash pond.

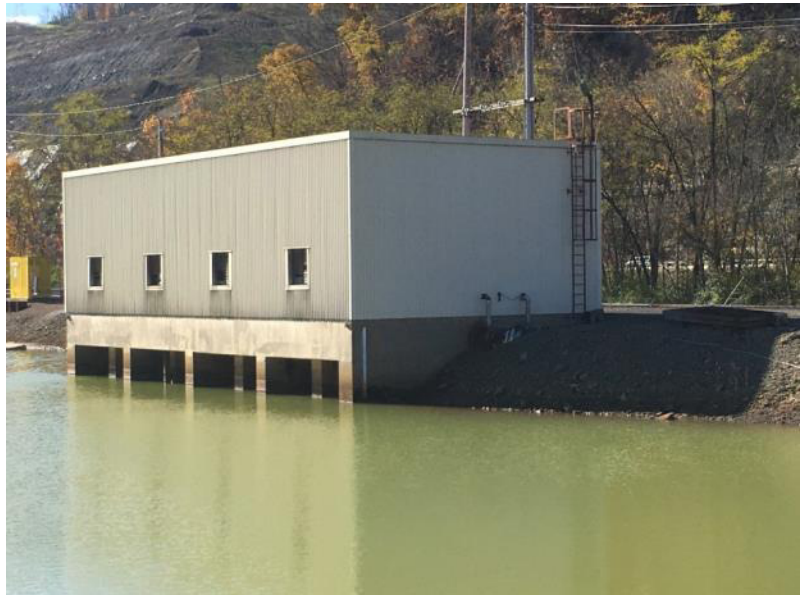
Photo # 17 BAP

Typical view of the pump house and intake structure at the RCP.

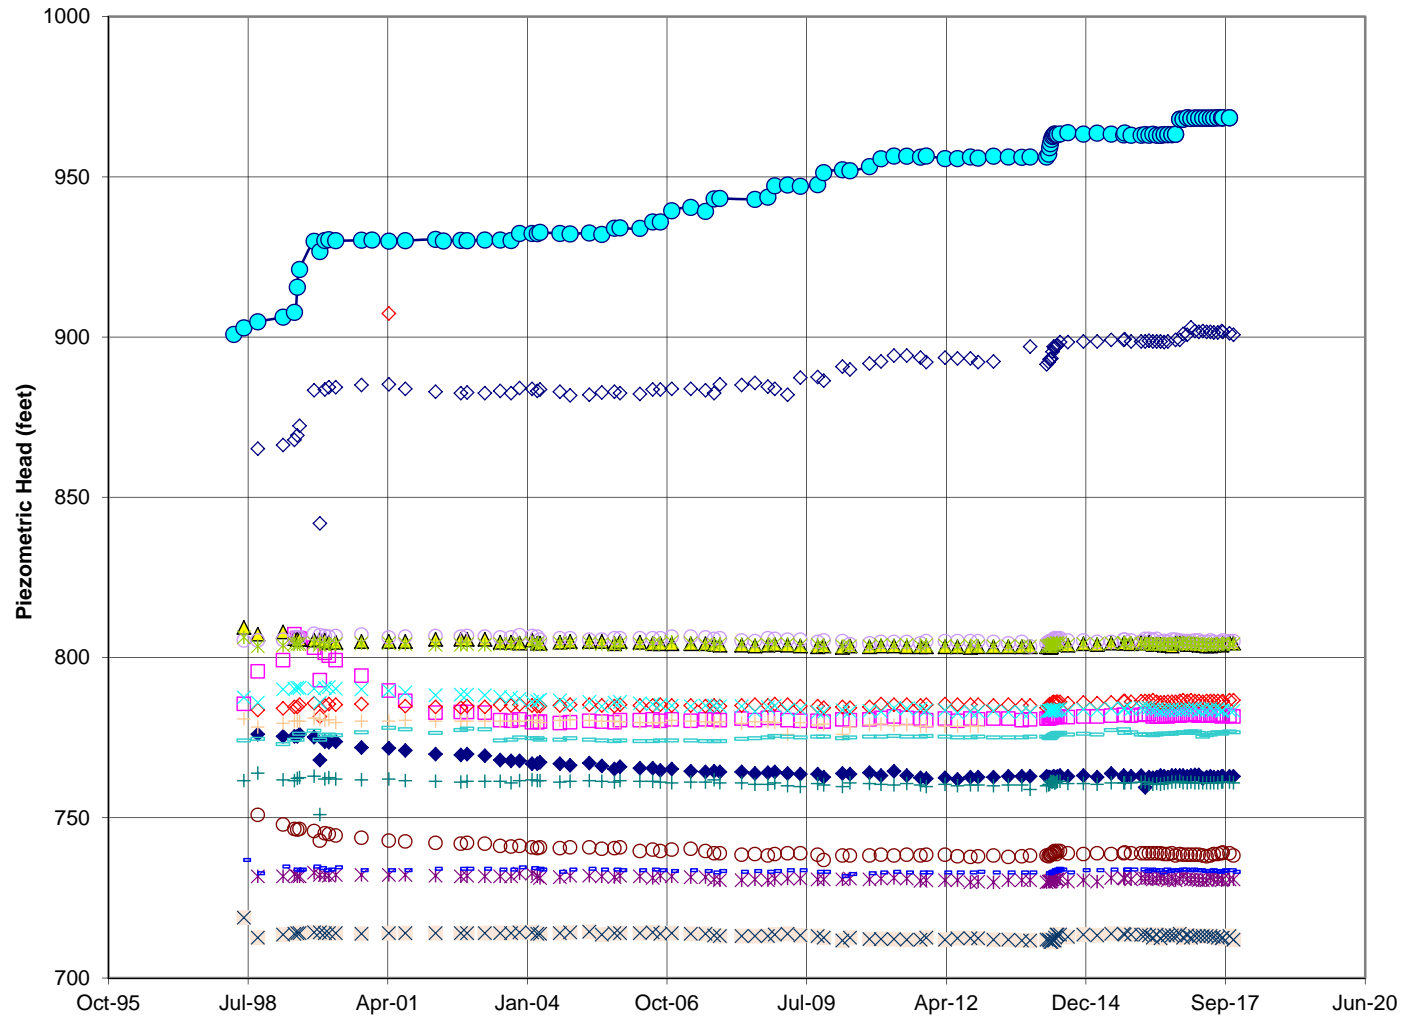
Figure 5b  
Pool Stage versus Discharge  
Cardinal FAD 2

The location and type of instrumentation is shown on Figure 2A. The results of the measurements of various piezometers are shown in Figure 5b through 5n. The maximum recorded readings of each instrument since the previous annual inspection is shown in Table 1.

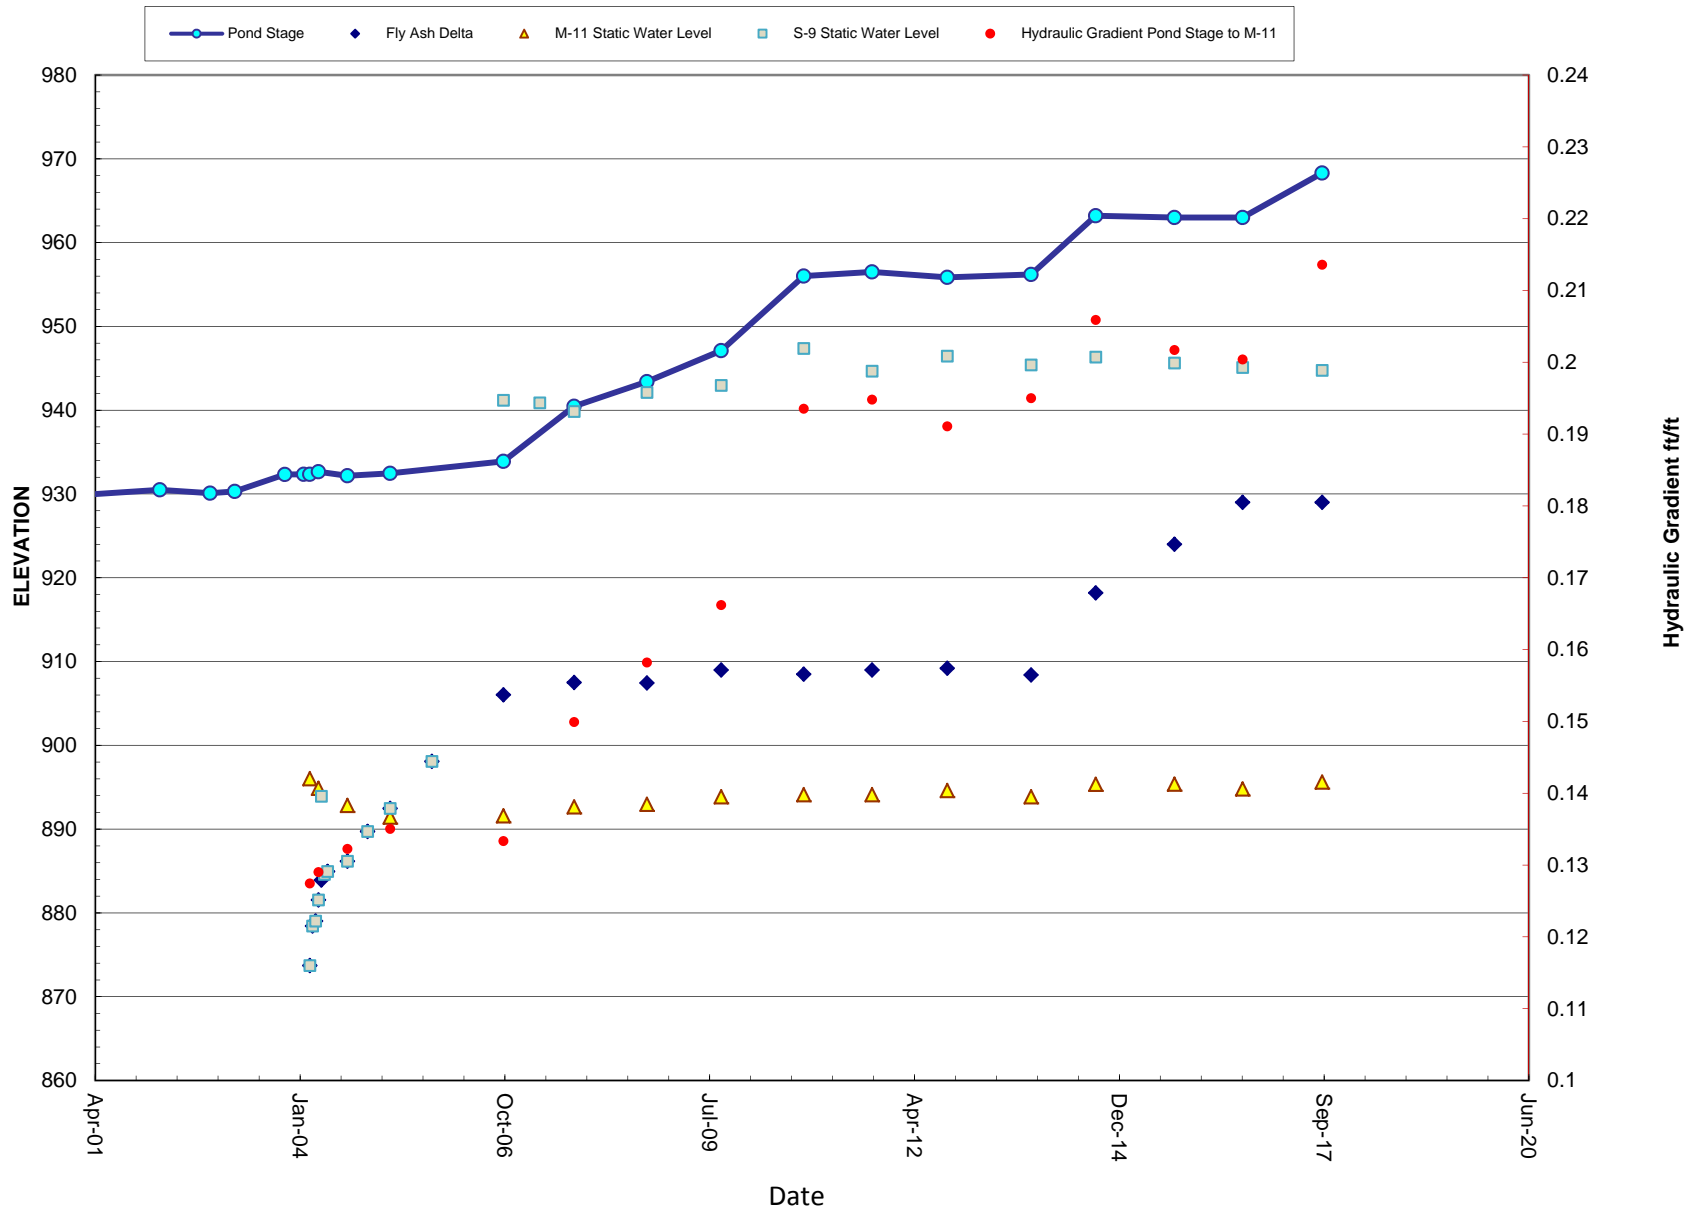
**Figure 6  
CARDINAL FAR 2  
Fly Ash Deposition**

Attachment D contains the most recent bathymetric survey. Fly ash deposition within the original (March 2004) mapped depression has increased over the last few years as a result of the sluicing ash close to the Dam’s right abutment (Figure 6). Over this same time period, the hydraulic gradient has remained practically constant between the Pond’s pool stage and ground water levels observed in M-11. Also, the direction of ground water flow in the upper portion of the bedrock has been reversed as noted by the gradient reversal between the pond stage and S-9 and M-11.
