2018 Annual Dam and Dike Inspection Report

Cardinal Plant Fly Ash Dams 1, 2 & Bottom Ash Complex

Project number: 60583548

January 9, 2019

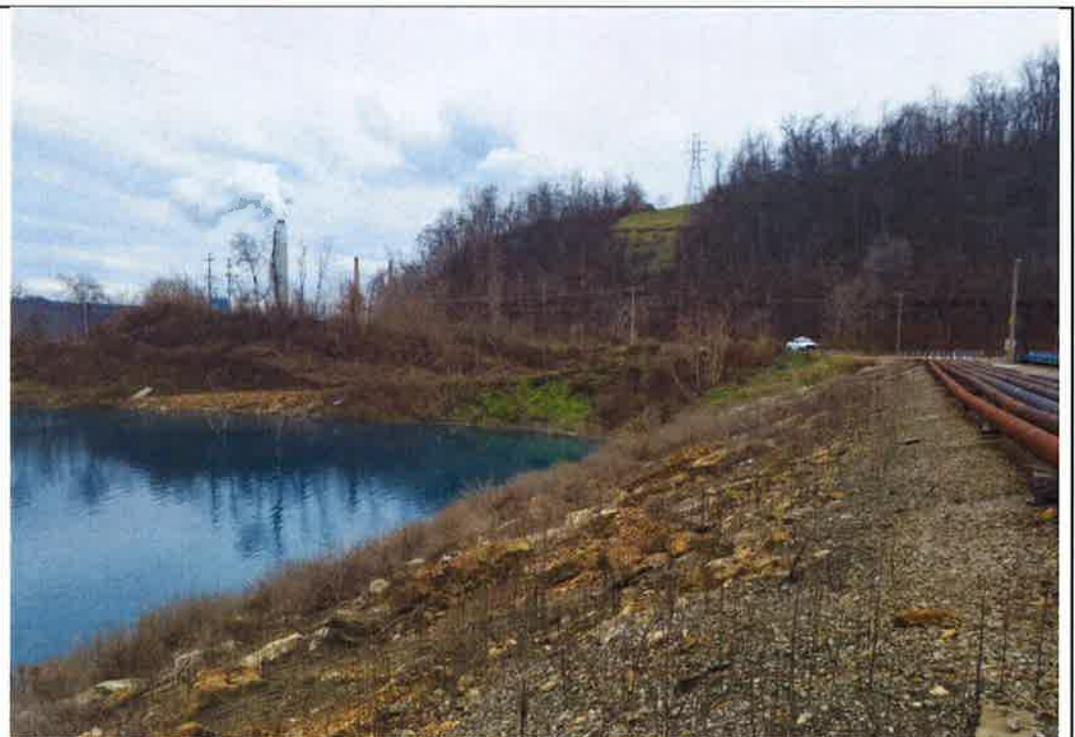
6. No woody vegetation was observed on the downstream slope.
7. No significant erosion was observed along the groin areas of the downstream slope (Photograph No. 1, 3 and 4). Both right and left abutments are protected with rock fill/rip-rap that is in good condition. Some brush was present near the right abutment of the dam, and some small trees were present near (not on) the left abutment.

Impoundment Name:
Cardinal Fly Ash Dam 1**Site Location:**
306 County Road 7 East, Brilliant, OH, 43913**Project No.**
60583548**Photo No.**
3**Date:**
12/4/18**Direction Photo
Taken:**
North**Description:**
View of rip rap let down at
the left groin area looking
upslope.

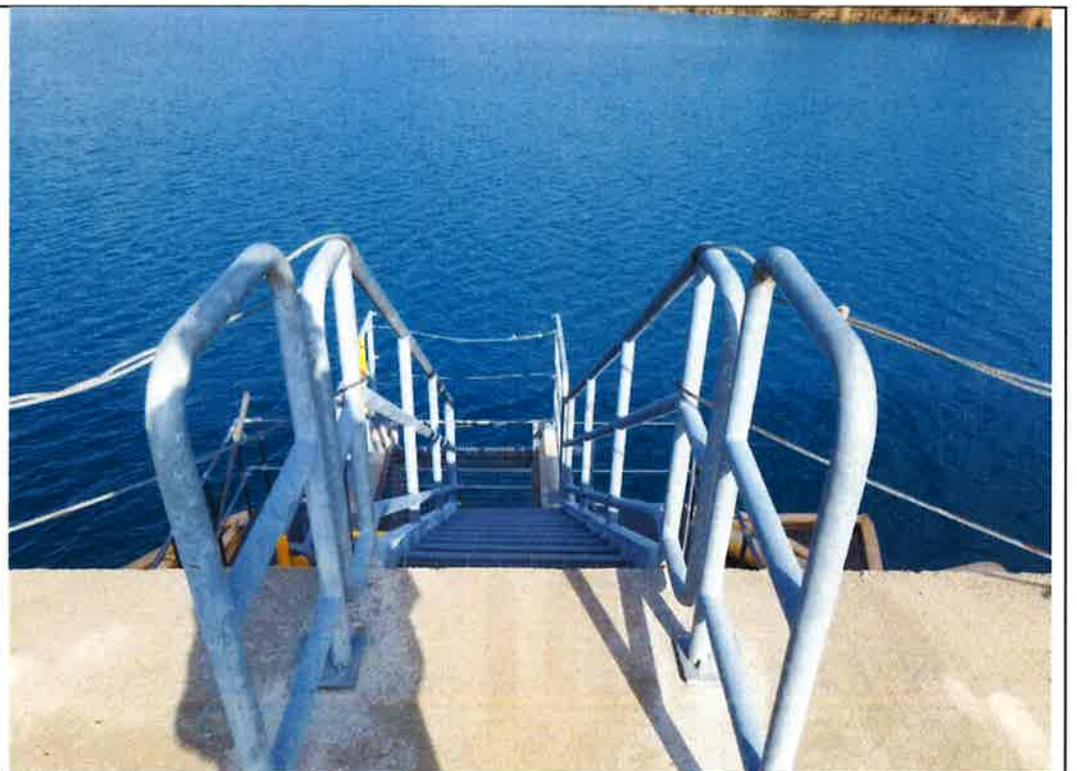
Photo No. 4	Date: 12/18/18
Direction Photo Taken:	
Description: View of the access stairway leading to the decant structure.

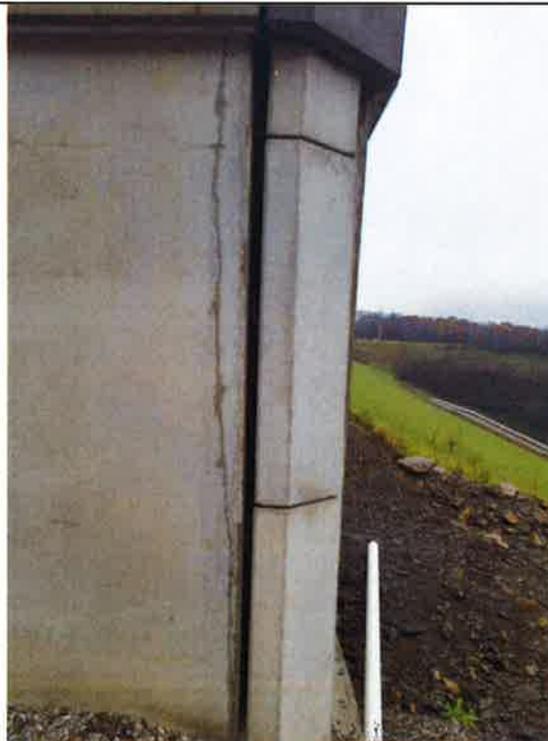
Photo No.
6

1. The main longitudinal MSE wall and return walls at both left and right ends of the dam were in good condition as shown in photograph #6-8 and as indicated by the tiltmeter data in Figure 5o of Appendix E. There are no signs of differential settlement (no displaced panels, open joints, cracking, etc.). There are relatively small separations at both the southwest and northeast corners of at the juncture between the main longitudinal wall and the orthogonal return wall sections, primarily seen at the coping beams at the top of the walls (see Photograph 6). These separations have been observed in previous inspections and are routinely monitored. They do not appear to have any adverse effect on serviceability, and it is noted that relative movement at MSE wall corners are a relatively common occurrence.

Description:
View of the downstream corner of the MSE Wall where the wall panel meets concrete coping. Note the separation at the corner piece.

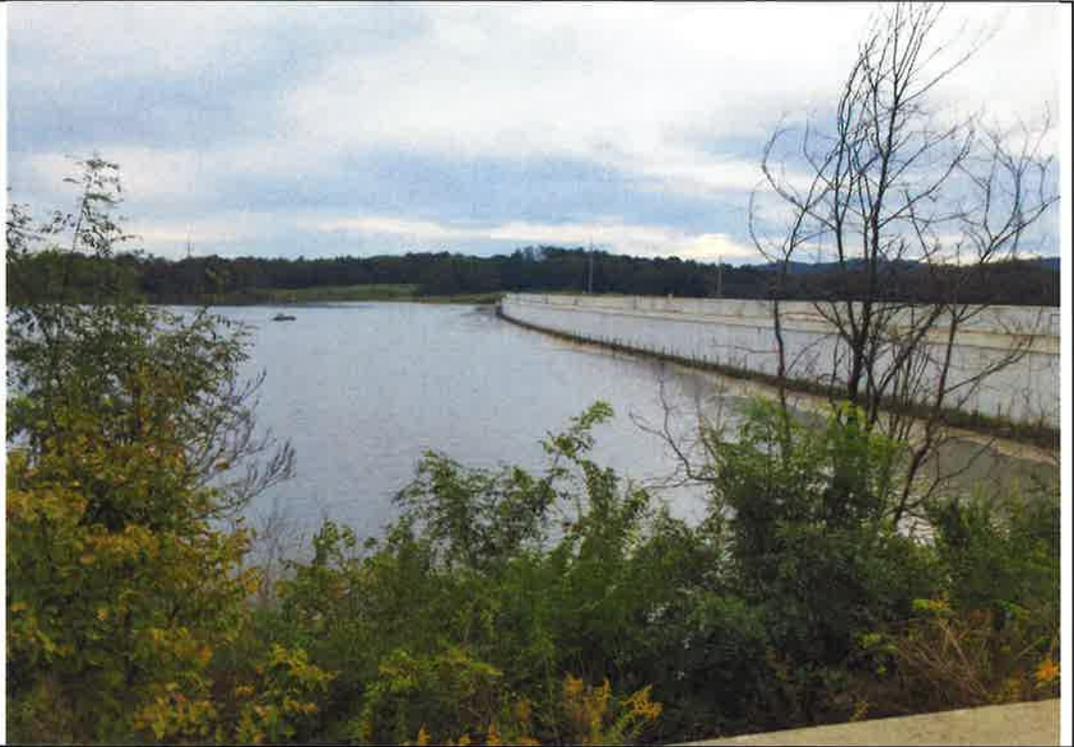
2. The RCC crest surface (at El. 970) is mostly covered by the new MSE wall construction and only limited observations were possible. The downstream RCC appears to have experienced some weathering and is in fair condition. However, neither significant cracking nor any seepage was observed at the RCC. The visible portion of the upstream RCC appeared to be stable with no signs of erosion from wave action, slumping, cracking, or settlement (see photograph #7).

Photo No. 7	Date: 11/20/18
Direction Photo Taken: East	
Description: View of the upstream MSE wall.

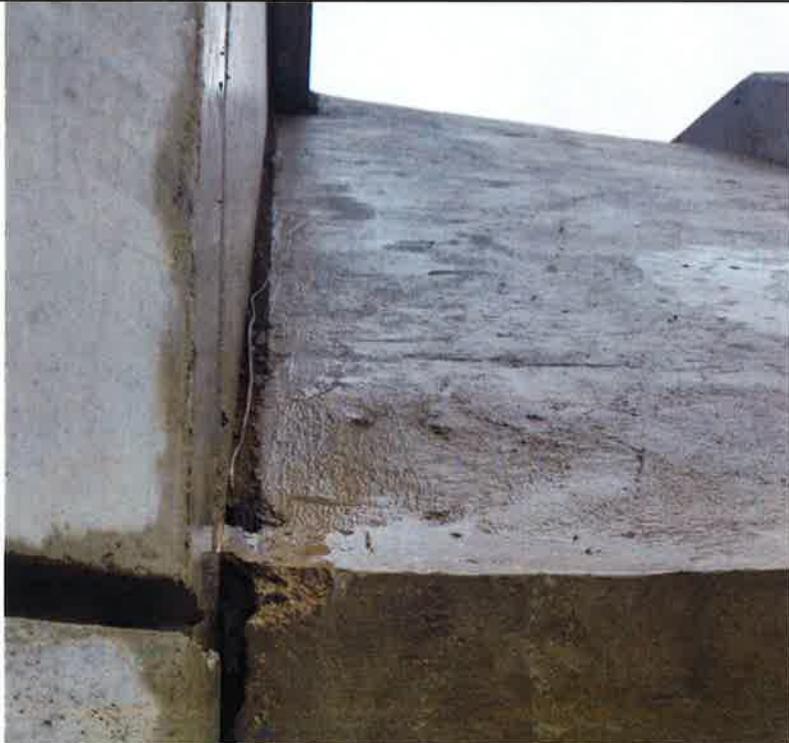
Photo No. 8	Date: 11/20/18
Direction Photo Taken: North	
Description: View of the MSE wall and emergency spillway.

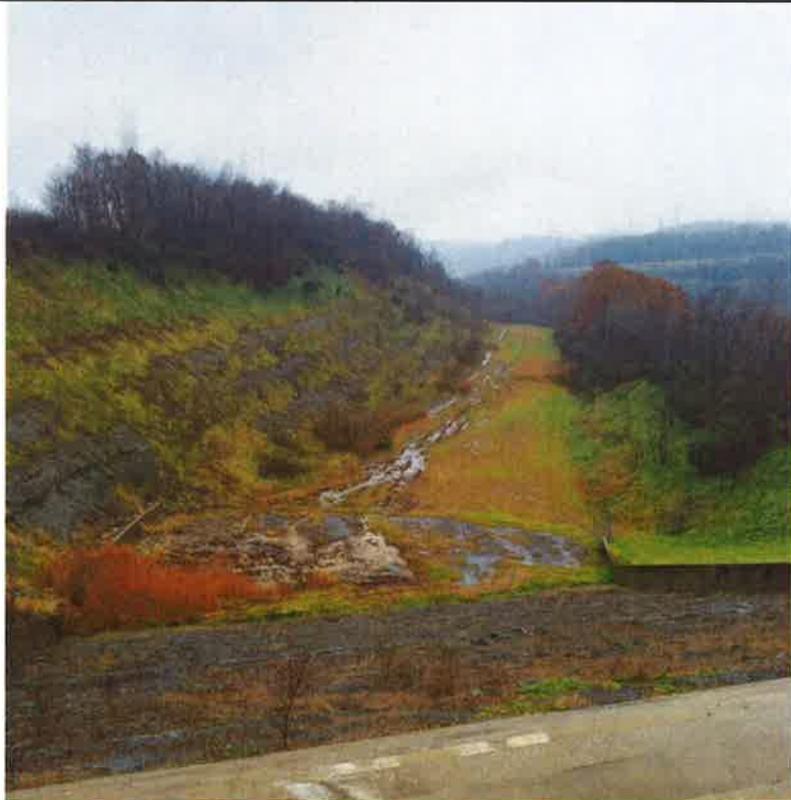
Photo No.:
10

Description:
View of the emergency discharge channel. Vegetation is well maintained and the spillway is clear of obstructions.

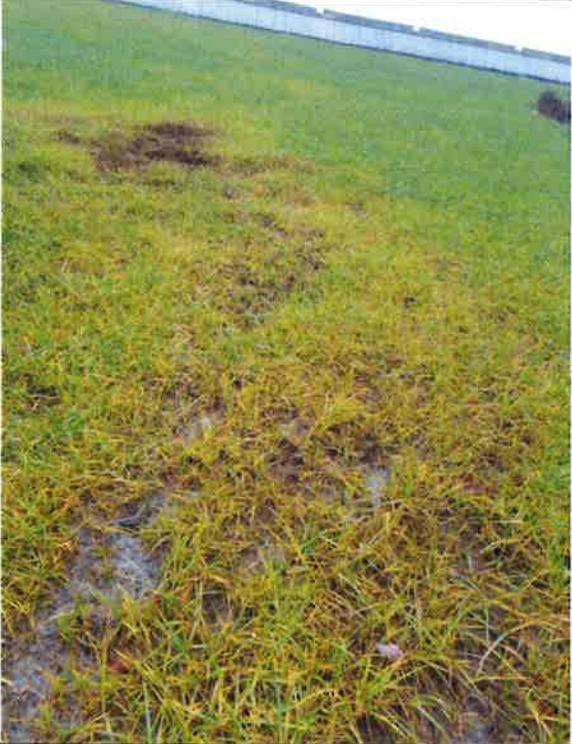
Direction Photo Taken: Northeast		
Description: View of wetness and brown grass on face of dam. Location should continue to be monitored. Wetness may be attributed to rain event at time of inspection. The vegetation initially appeared to have died in this area. However after a follow up inspection on 12-17-2018, the area was dry and the vegetation is not dead.

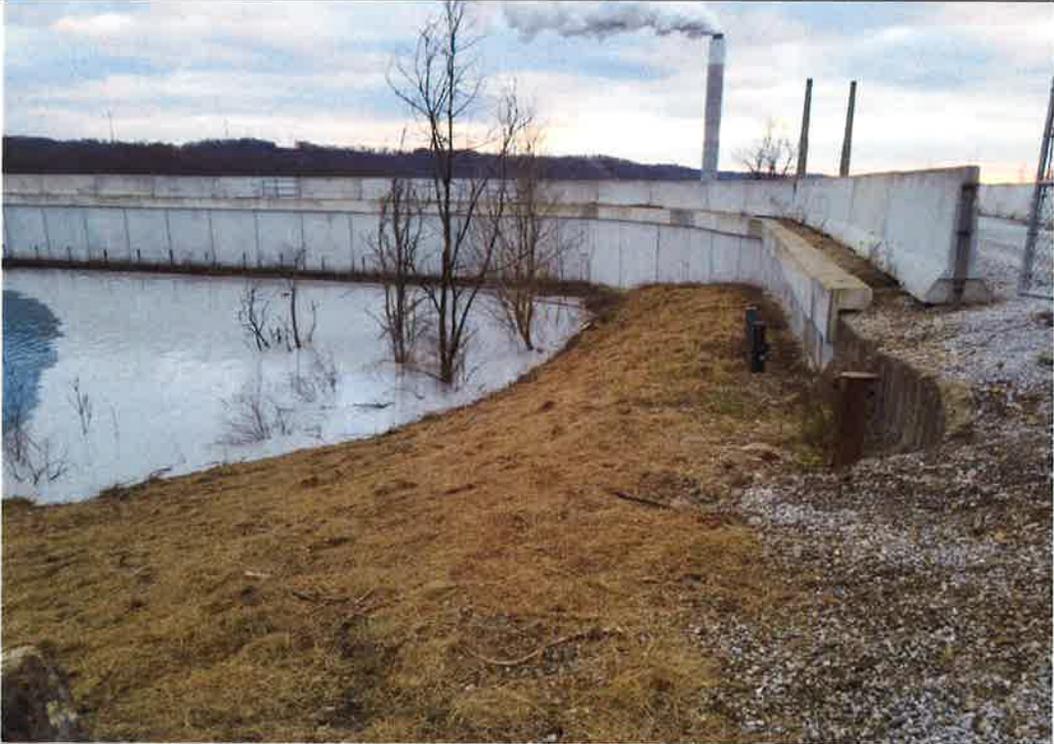
Direction Photo Taken: South		
Description: View of upstream side of the right abutment recently cleared of vegetation and seeded.

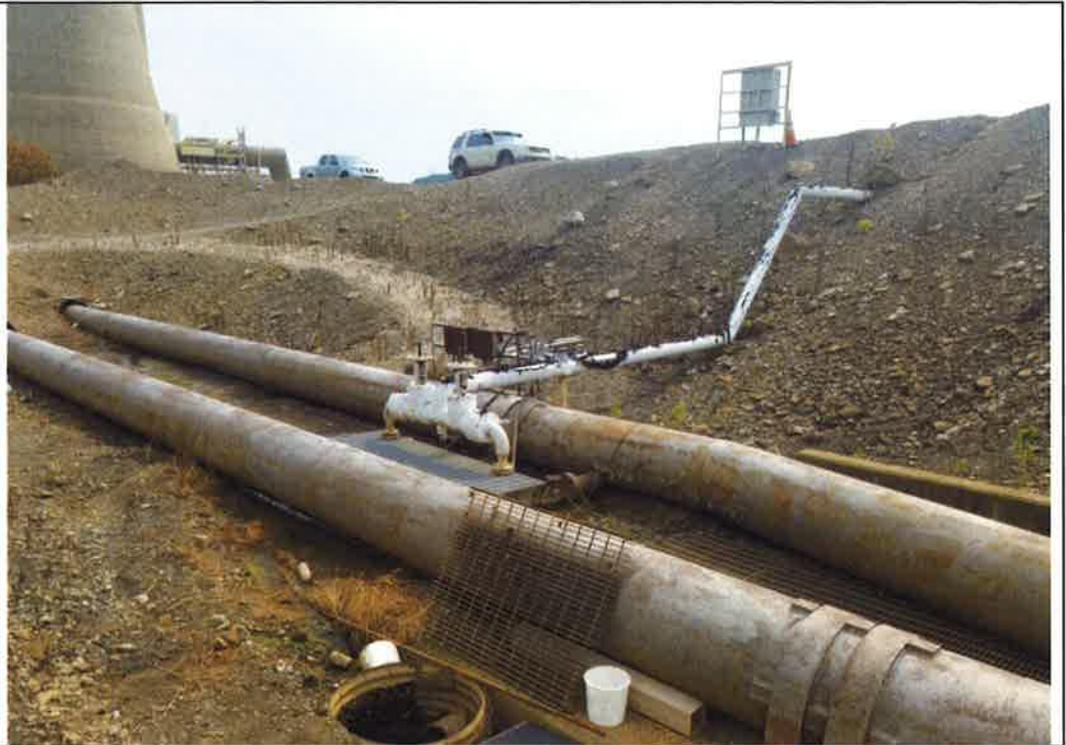
View of the exterior slope along the toe of the embankment.

Note surface water shown in photos 1 and 2 drain to this location.

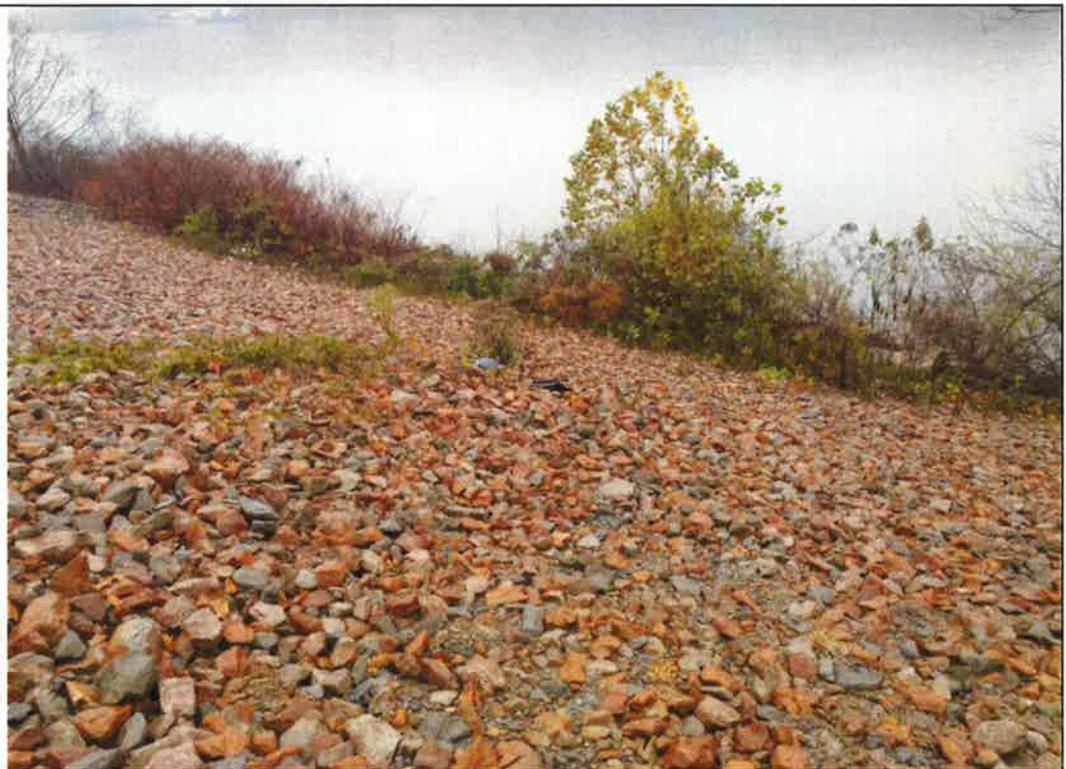
Photo No.
4

View of the inverted filter drain extended through this area in late 2009 to control seepage from the pond.

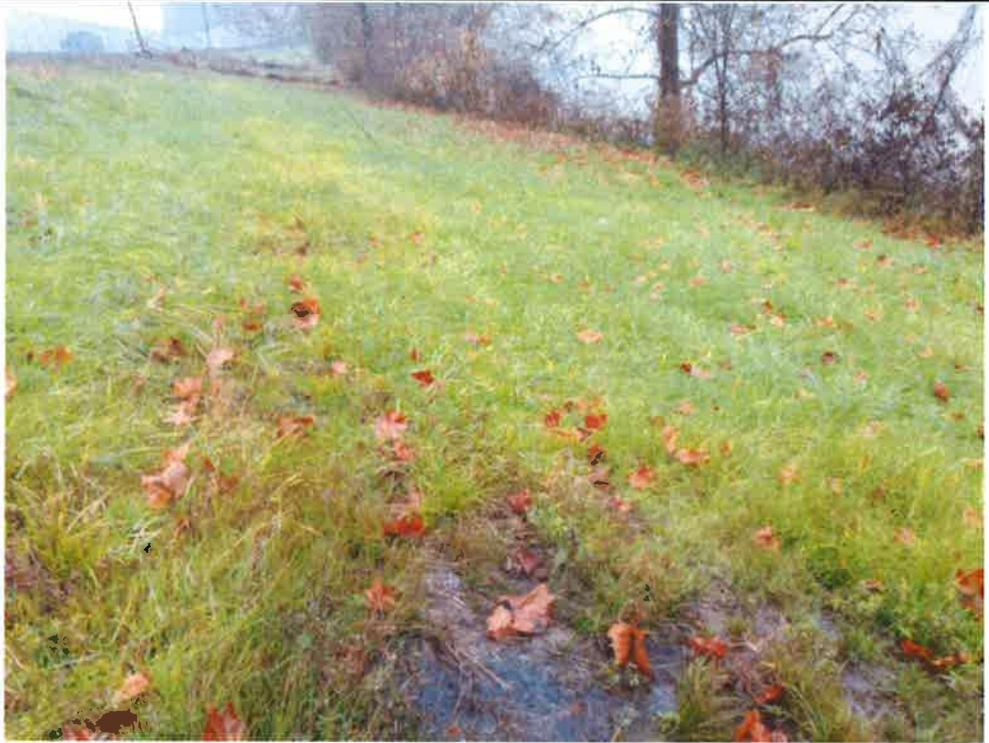
8. Two apparent seep areas were observed on the face of the eastern dike slope (see Photographs 21 and 22). No flowing seepage is present, but the areas are wet and the vegetation is discolored. These locations are known to Buckeye personnel and are routinely monitored.

Photo No. 21	Date: 11/20/18
Direction Photo Taken: North	
Description: View of seepage on the face of the eastern dike slope.

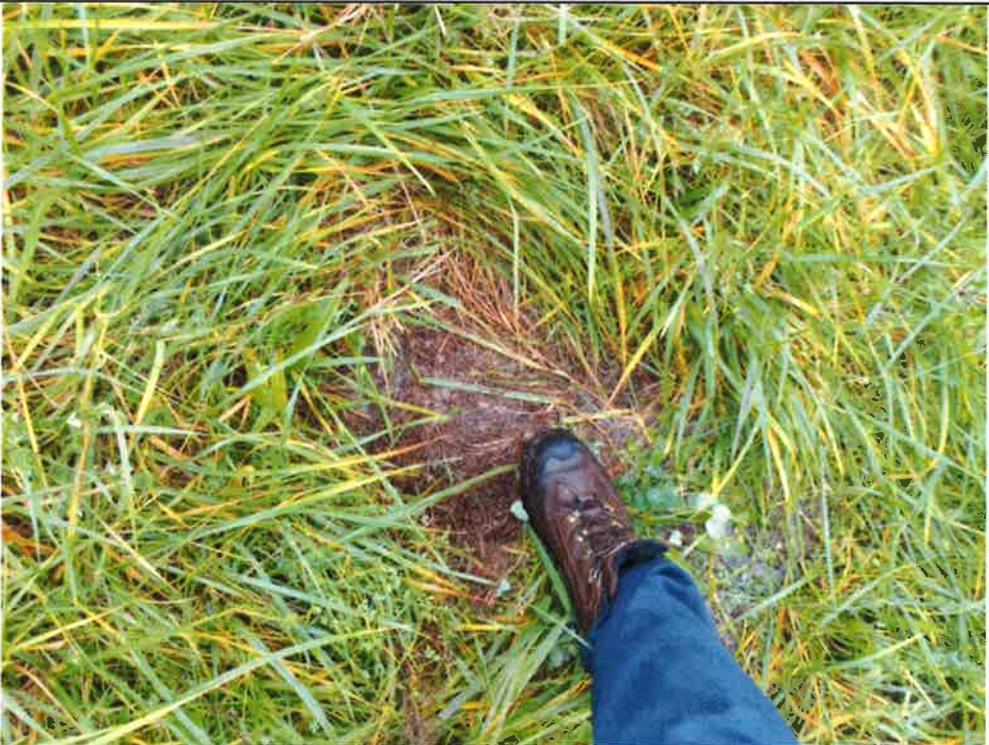
Photo No. 22	Date: 11/20/18
Direction Photo Taken: N/A	
Description: View of seepage on the face of the eastern dike slope.

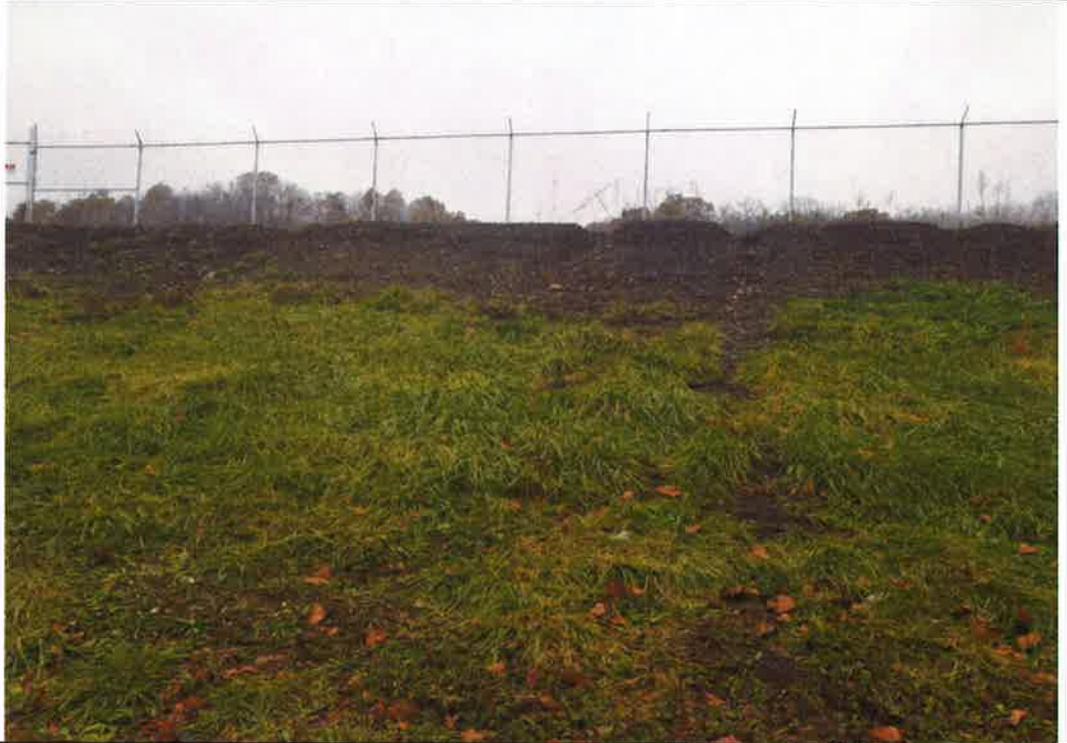
Photo No. 23	Date: 11/20/18

10. A few erosion rills are present along the eastern dike, originating at the crest of the slope at the BAP or RCP and extending down the slope towards the River. See Photograph 23 for a

Direction Photo Taken: N/A		
Description: View of erosion rills from runoff from the access road along the east dike of the Recirculation Pond.		
Photo No. 24	Date: 11/20/18
