2019 Annual Dam and Dike Inspection Report

Cardinal Plant Fly Ash Dams 1, 2 & Bottom Ash Complex

Project Number 60613809

January 2, 2020

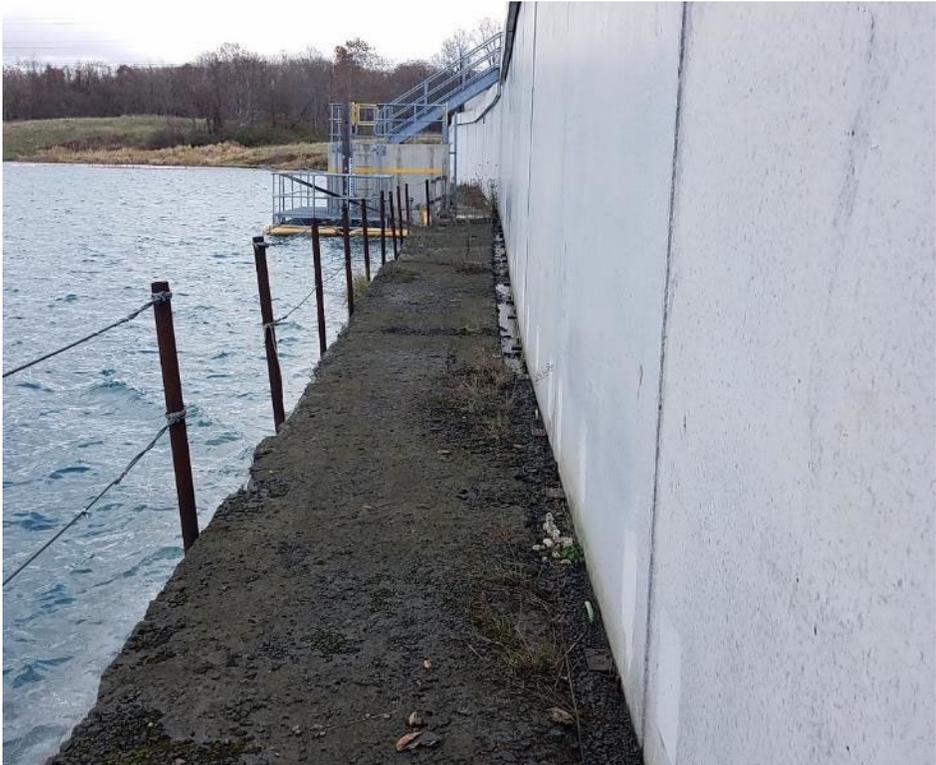
Photo No. 4	Date: 11/22/19

1. The principal spillway structure at the upstream dam crest appeared to be in good condition, with no obstructions at the stop-log structure and no signs of instability on the riser or staircase, as shown in Photograph No. 4. There was no visual evidence of significant differential movement of the structure/skimmer chute or steps. The principal spillway access walkway, stairways, depth gauge, and other metal structures were in good condition (Photograph Nos. 4 and 5).

Direction Photo Taken: East		
Description: View of upstream side of dam, looking east toward intake structure.

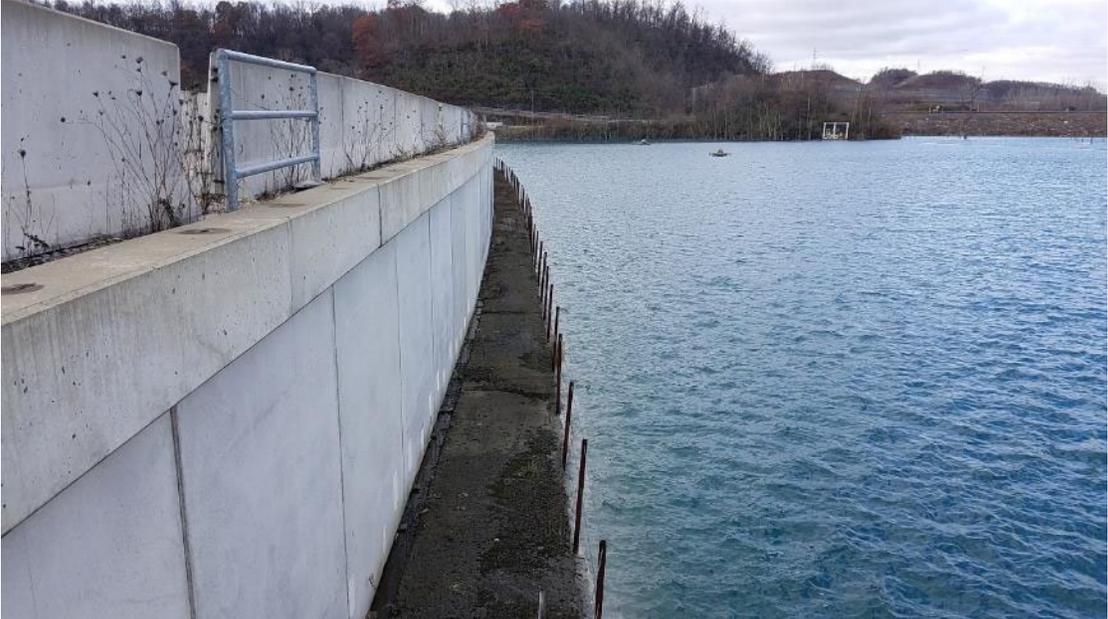
Photo No.: 7	Date: 11/22/19

1. The main longitudinal MSE wall and return walls at both left and right ends of the dam were in good condition as shown in Photograph 7 and 31 of Appendix B and as indicated by the tiltmeter data in Figure 5o of Appendix E. There are no signs of differential settlement (no displaced panels, open joints, cracking, etc.) across the length of the wall. As noted in the 2018 inspection, there are relatively small separations at both the southwest and northeast corners of the wall, at the junction of the main longitudinal wall and the orthogonal return wall sections (see Photograph 6). The separations are most pronounced at coping beams at the top of the walls. These separations do not appear to have any adverse effect on serviceability, and it is noted that relative movement at MSE wall corners is a relatively common occurrence. The separations observed in 2019 do not appear to have worsened relative to previous inspections.

Direction Photo Taken: West		
Description: View of the upstream MSE wall.

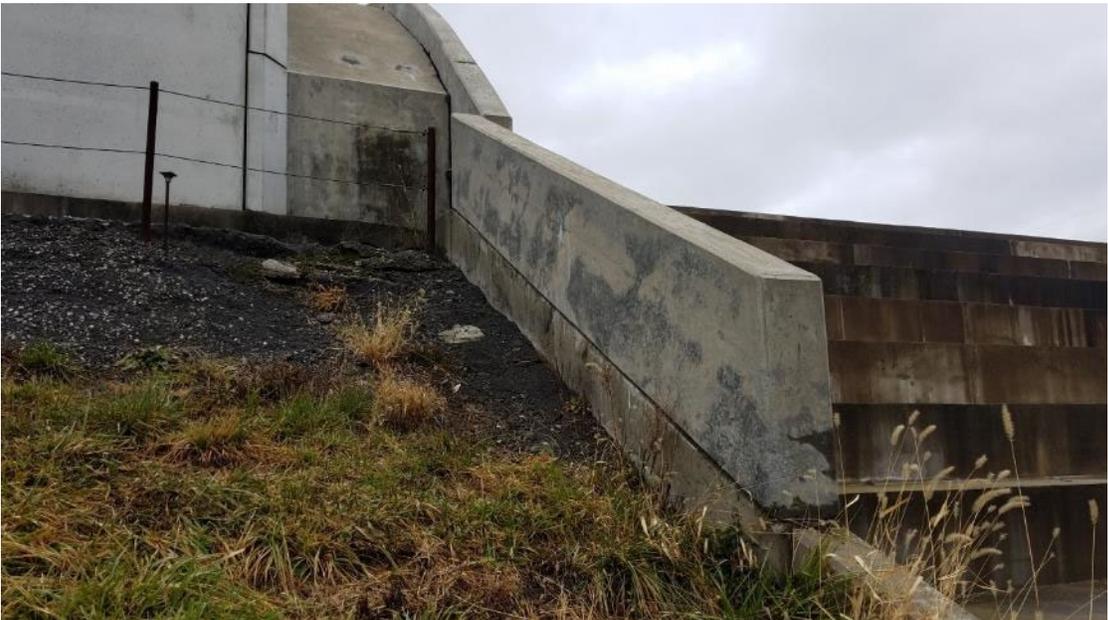
Photo No.: 8	Date: 11/22/19

Direction Photo Taken: North		
Description: View of abutment between MSE wall and emergency spillway.

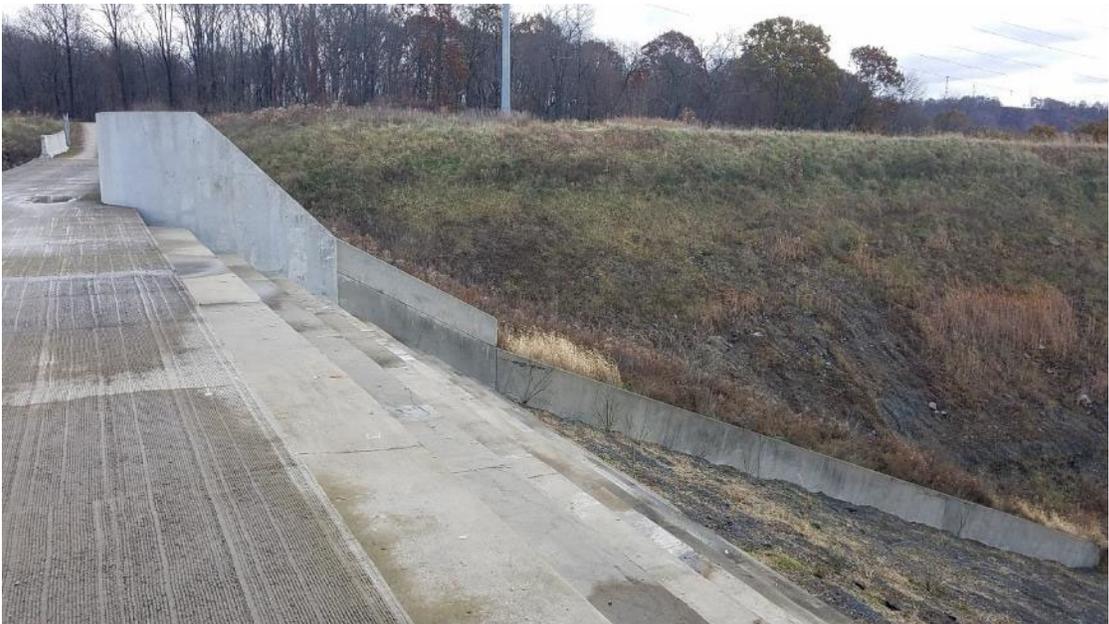
Photo No.: 9	Date: 11/22/19

Direction Photo Taken: East		
Description: View of the Emergency Spillway crest area.

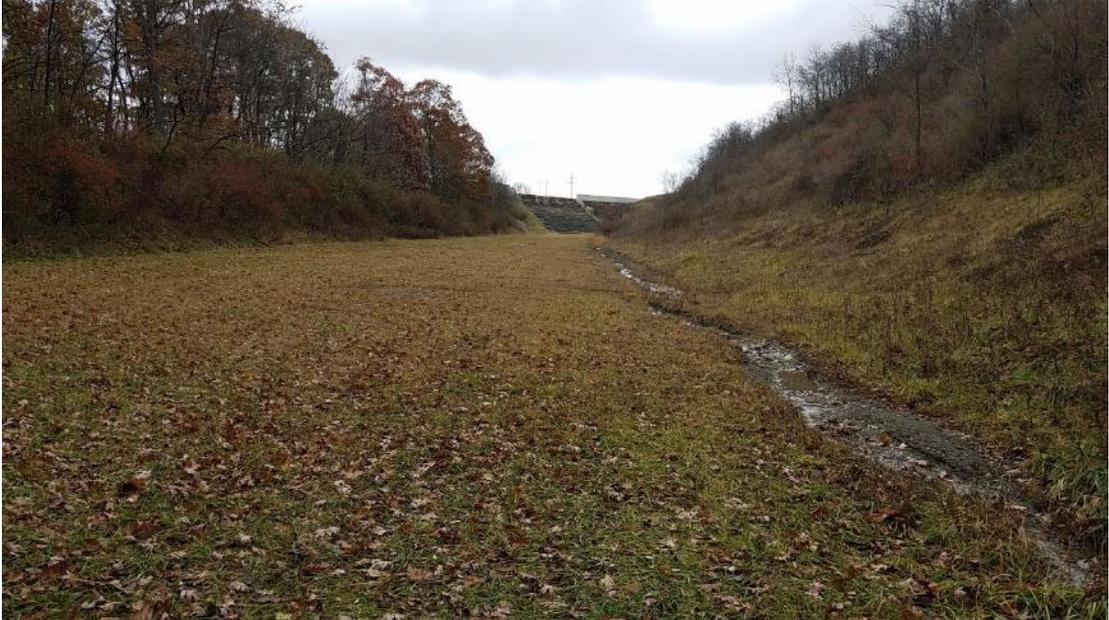
Photo No. 11	Date: 11/22/19

7. The Emergency Spillway channel floor is well vegetated but was in a wet condition at places, due to the aforementioned seepage. No signs of erosion, uplift, or other issues were noted. Overall the exit channel is in good condition. (Photograph No. 11).

Direction Photo Taken: North		
Description: View of the emergency discharge channel.

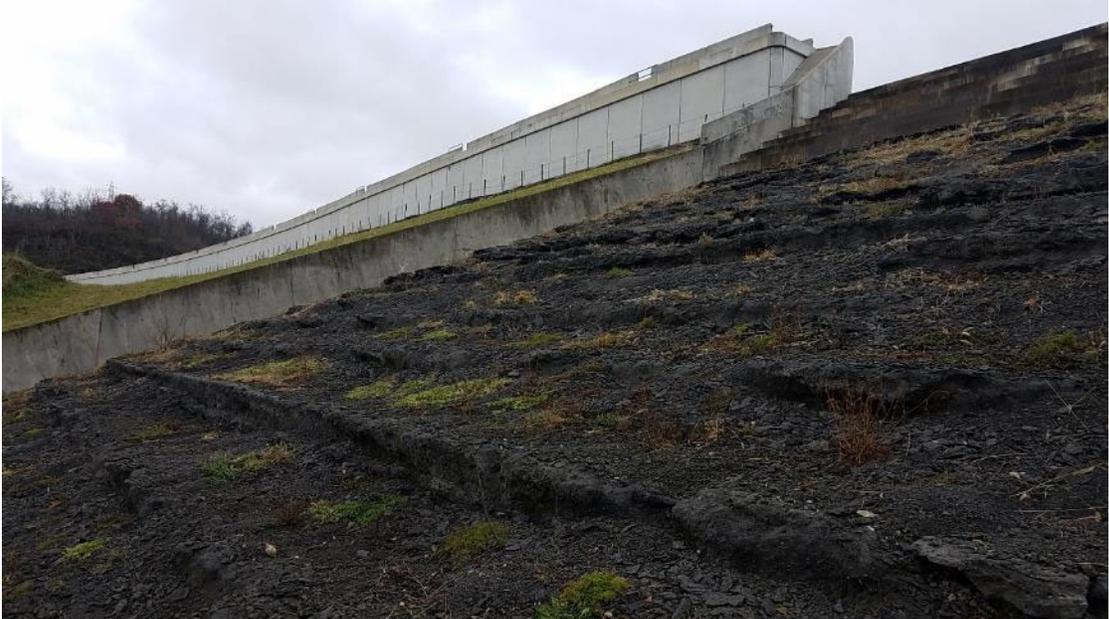
Photo No. 12	Date: 11/22/19

Direction Photo Taken: North-Northwest		
Description: View of the Concrete and RCC emergency spillway discharge channel steps. The steps have weathered since construction and are monitored per ODNR inspection comment.

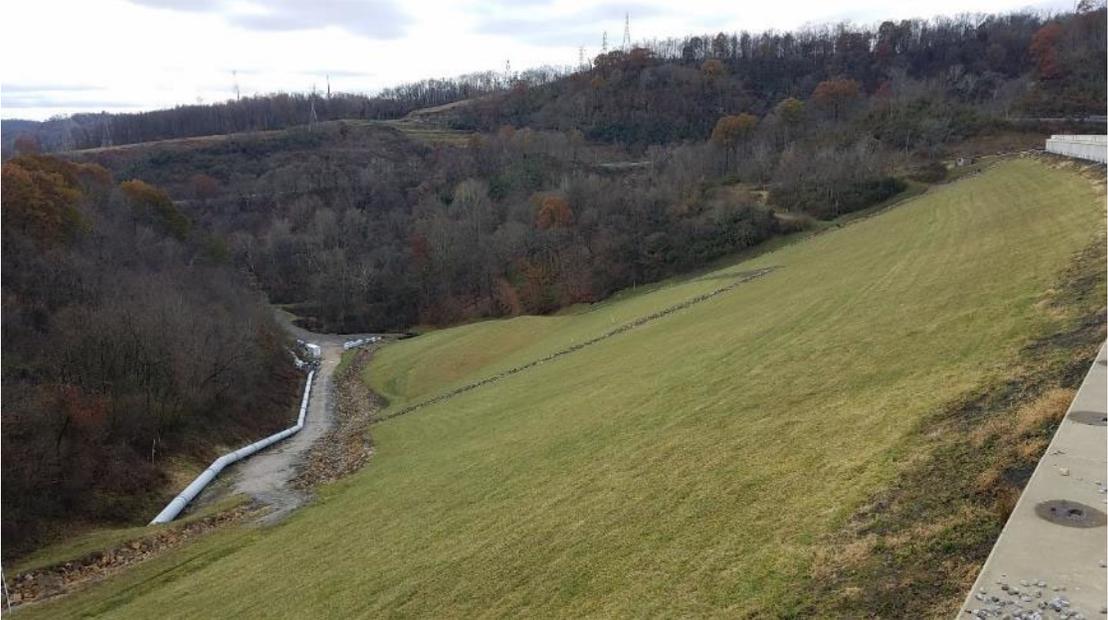
Photo No. 13	Date: 11/22/19

Direction Photo Taken: Southwest		
Description: View of the downstream slope. Showing good vegetative cover and no signs of erosion or instability.

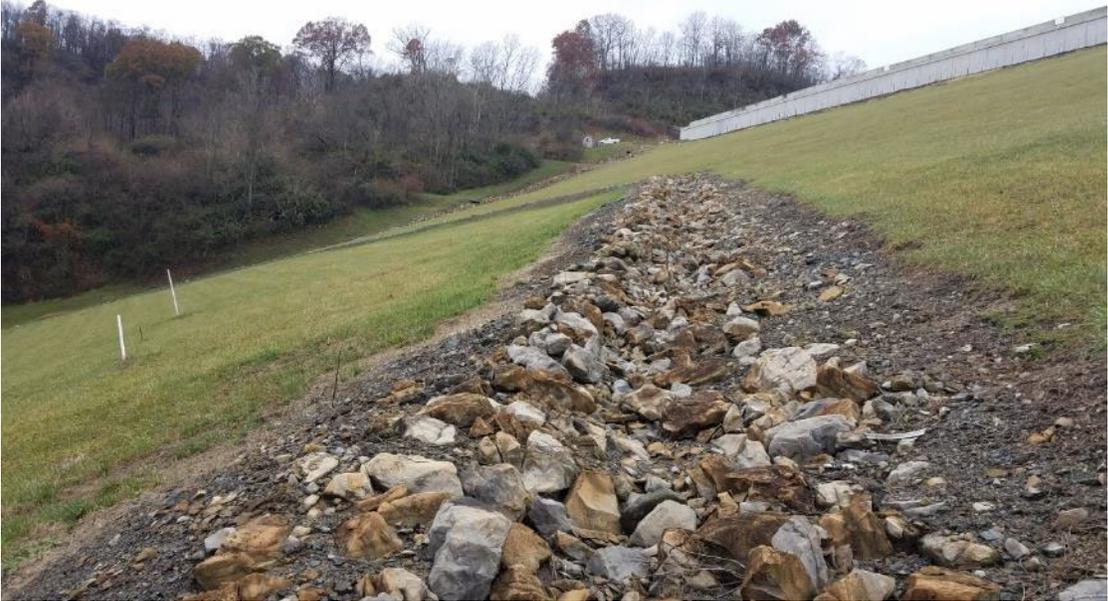
Photo No. 14	Date: 11/22/19

Direction Photo Taken: Northwest		
Description: View of the downstream slope and stormwater collection channel.

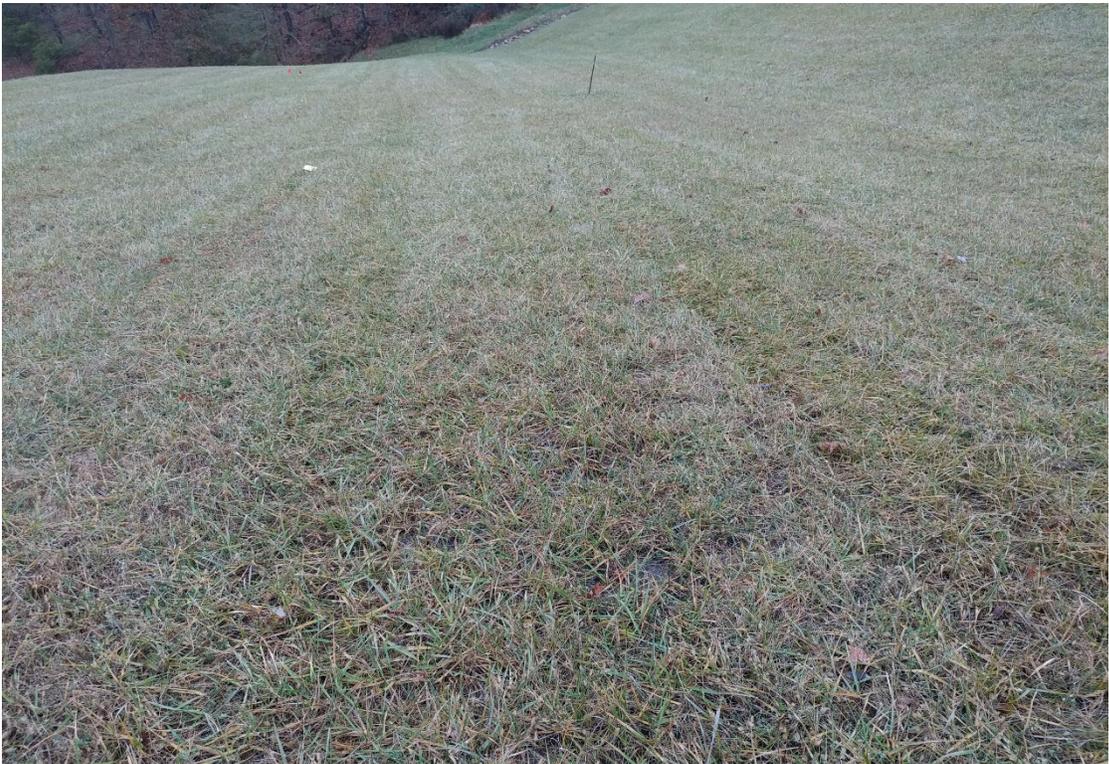
Photo No. 15	Date: 11/22/19

1. Overall, the downstream slope of the dam appeared to be in good condition with healthy vegetative growth (Photograph No. 15, 16, 18, 20). No significant signs of erosion, sloughing or seepage were observed at any location and the slopes appeared to be stable.

Direction Photo Taken: West		
Description: Typical vegetative surface conditions on downstream slope of dam.

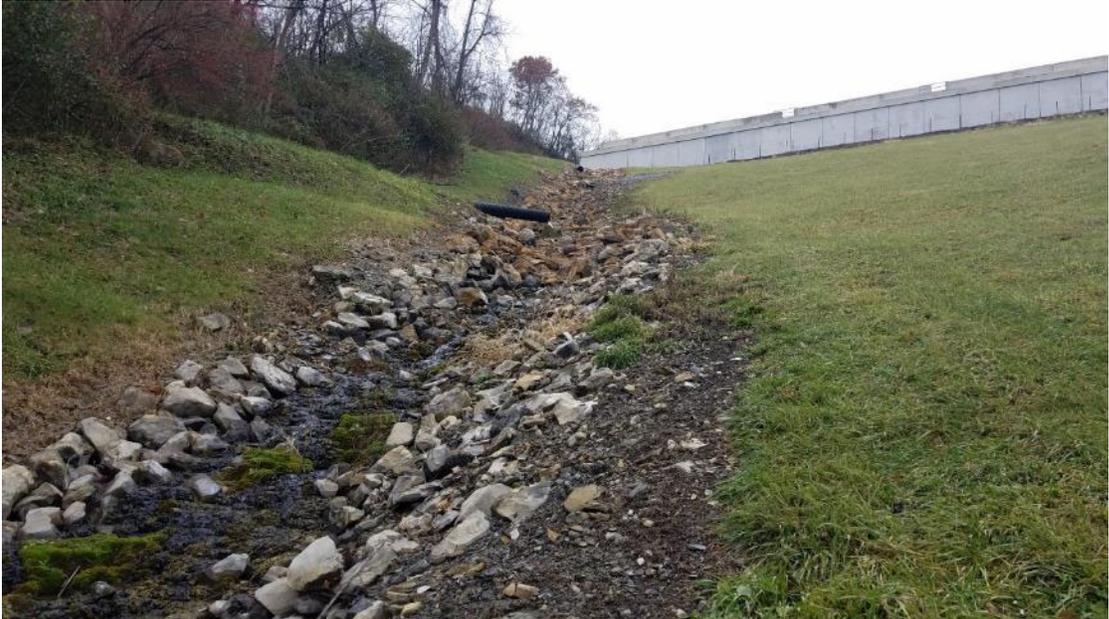
Photo No. 17	Date: 11/22/19

1. The right downstream groin ditch was in generally good condition (Photographs No. 17 and 18). The rip rap showed only minor weathering or deterioration. The discharges from the several seepage drains that are monitored in the area were clear and no sediment deposits were observed in the pooling area (see Photo No. 28 as an example). The groin appeared to be well maintained (no woody or brushy vegetation was present) and was generally in good condition (Photograph No. 17).
2. The left groin ditches and dam discharge pipe were observed to be in good condition. No seepage or erosion was observed (Photo No. 20).

Direction Photo Taken: Northwest		
Description: View of right groin ditch and seepage drain.

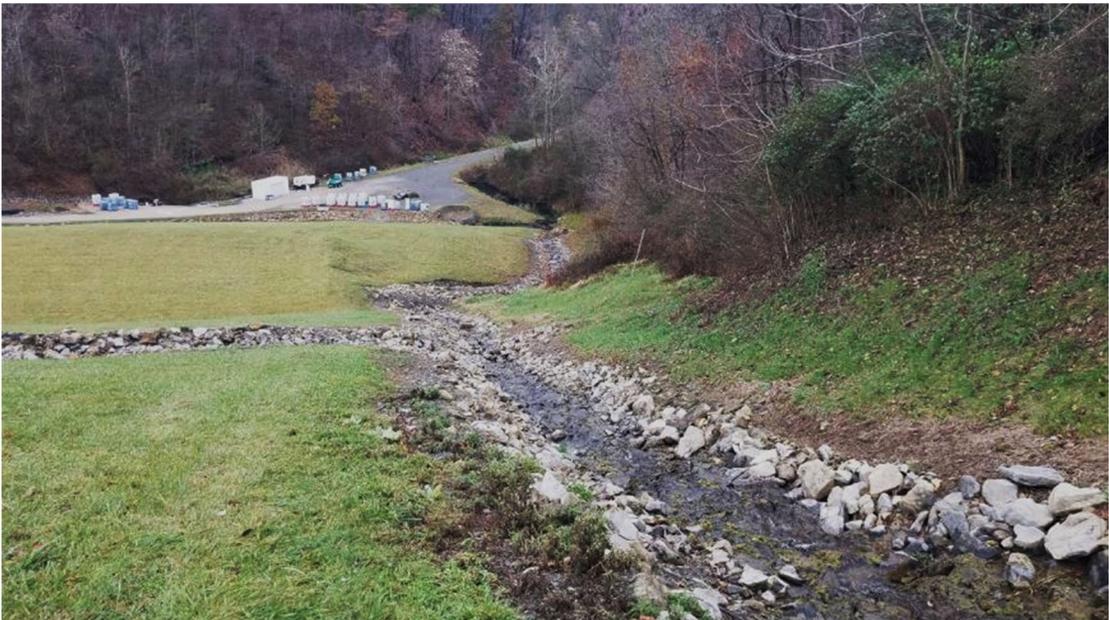
Photo No. 18	Date: 11/22/19

Direction Photo Taken: Southeast		
Description: View of right groin ditch.

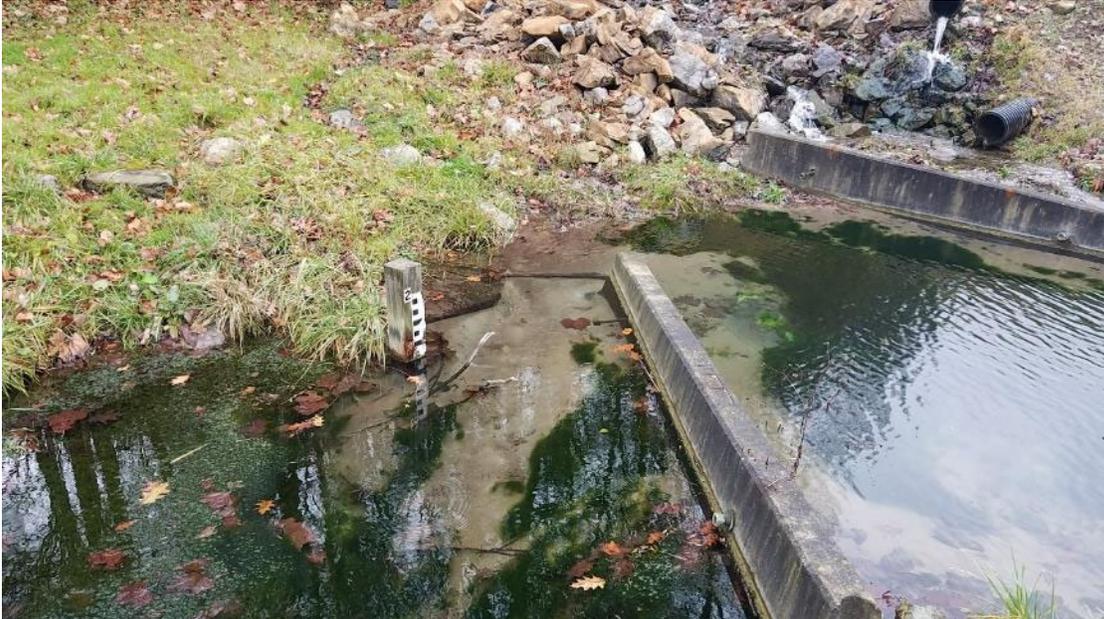
Photo No. 19	Date: 11/22/19

A photograph showing a concrete drainage structure with a v-notch weir. Water is flowing through the weir into a pool. The surrounding area is rocky and grassy with some fallen leaves. A black pipe is visible on the right side of the structure.
Direction Photo Taken: West-Northwest		
Description: View of Drain no. 2 that discharges from the right abutment drainage blanket. A v-notch weir just downstream of the baffling is used to measure flow.

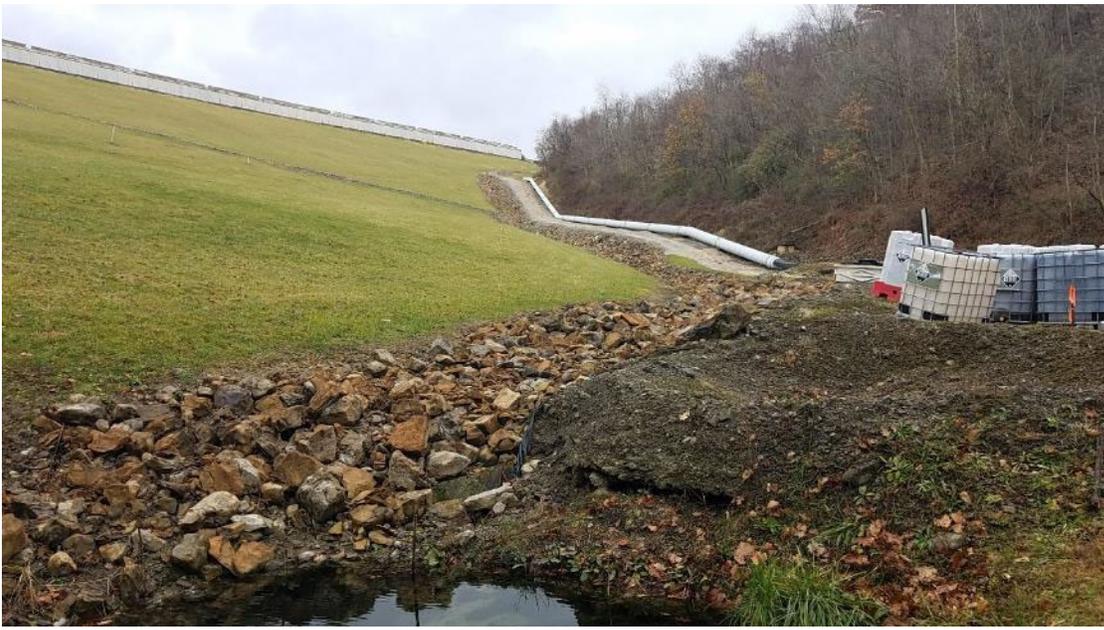
Photo No. 20	Date: 11/20/18

A wide-angle photograph of a grassy embankment. A concrete drainage ditch runs along the base of the embankment. In the foreground, there is a rocky area with a small pool of water. To the right, there are several large blue and white storage containers.
Direction Photo Taken: Northeast		
Description: View of the left groin ditch.

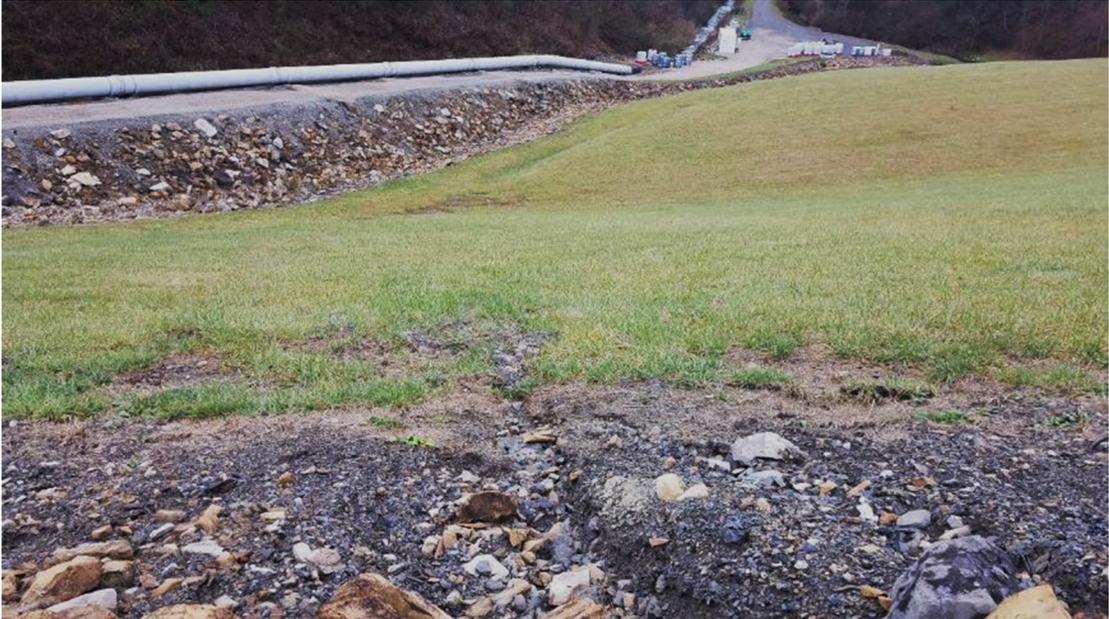
Photo No. 27	Date: 11/22/19

3. The surface water collection channels running across the body of the dam appear to be in generally good condition. Rip-rap is present in all channels and shows only minor deterioration. No significant bare, unprotected areas were observed, and the channels appear to be clean and well maintained. Erosion rills (perhaps 6-inches in width) were intermittently observed at the channel crest (Photo No. 27) but are minor and are not considered to require action at this time.

Direction Photo Taken: South		
Description: View of the surface water collection channel on the face of dam. The channel protection was sparse in a section allowing surface water erode the side of the channel. Additional channel protection should be placed to contain surface water to the channel.

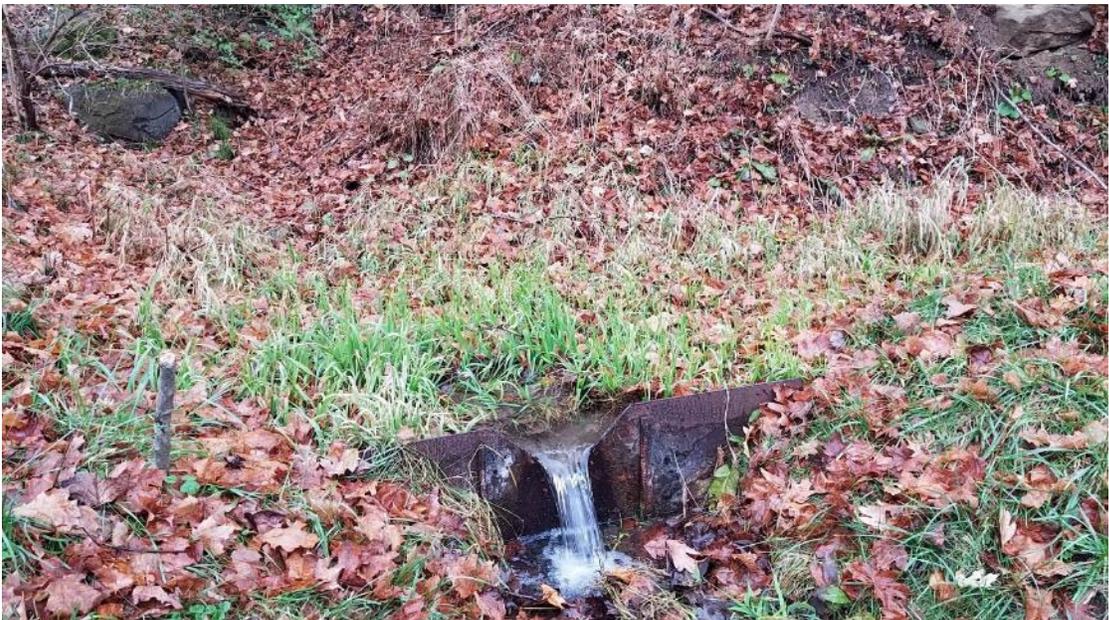
Photo No. 28	Date: 11/22/19

Direction Photo Taken: West		
Description: V-notch weir from seepage drain and seepage zone on the right abutment.

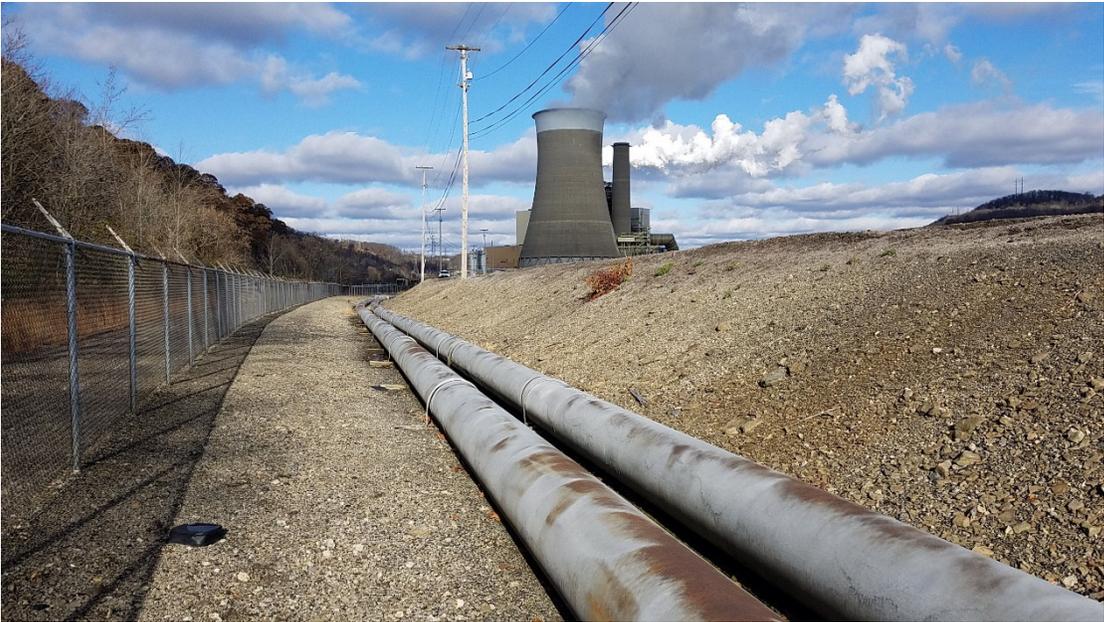
Photo No. 2	Date: 11/22/19

Direction Photo Taken: North		
Description: View of the exterior slope and ash sluice lines.

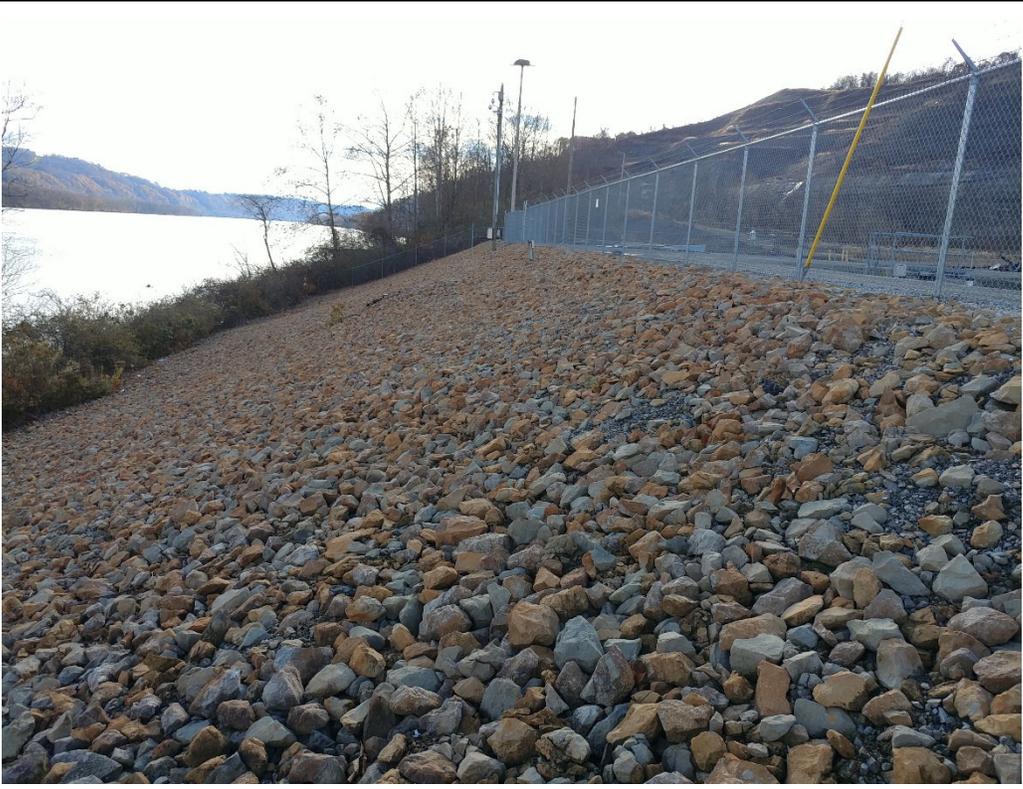
Photo No. 4	Date: 11/22/19

Direction Photo Taken: South		
Description: View of the inverted filter drain extended through this area in late 2009 to control seepage from the pond.

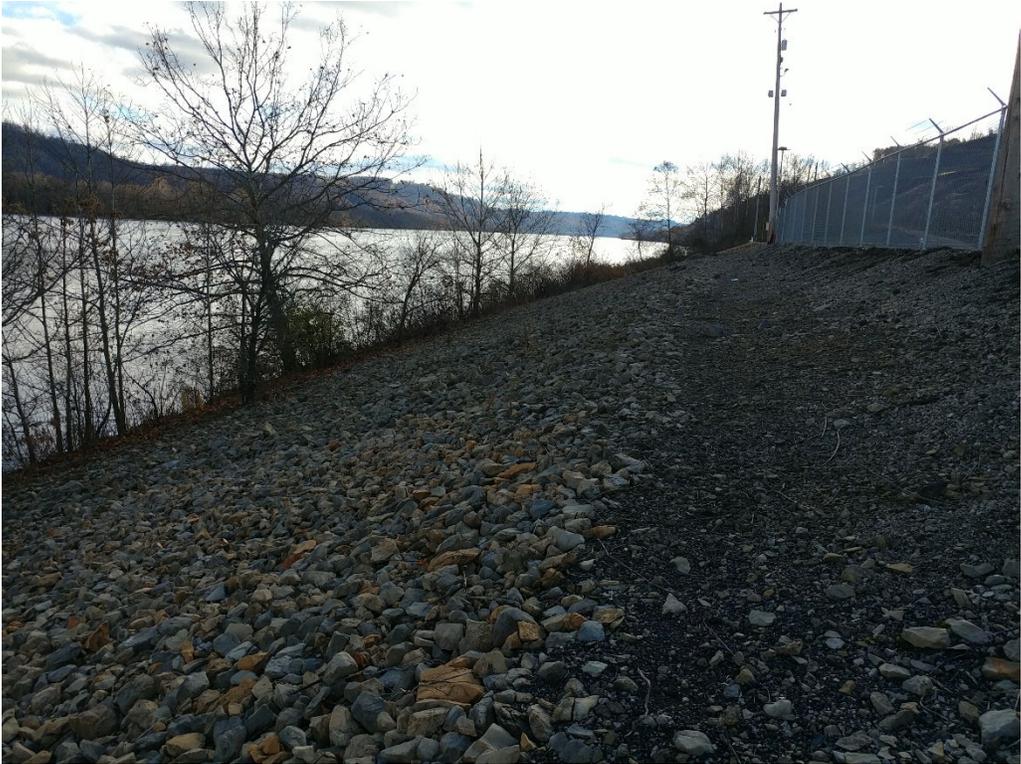
Photo No. 5	Date: 11/22/19

6. The outlet structure and discharge pipe from the RCP (NPDES Outfall 023) were unobstructed and in good condition. See Photograph 14 and 15.
7. The BAP and RCP downstream (eastern dike) slopes along the Ohio River were well vegetated or protected by riprap as typically shown in Photographs Nos. 4 thru 8, and 11. The slopes are in good condition, with no signs of instability.

Direction Photo Taken: South		
Description: View of the rip rap armoring along the embankment.

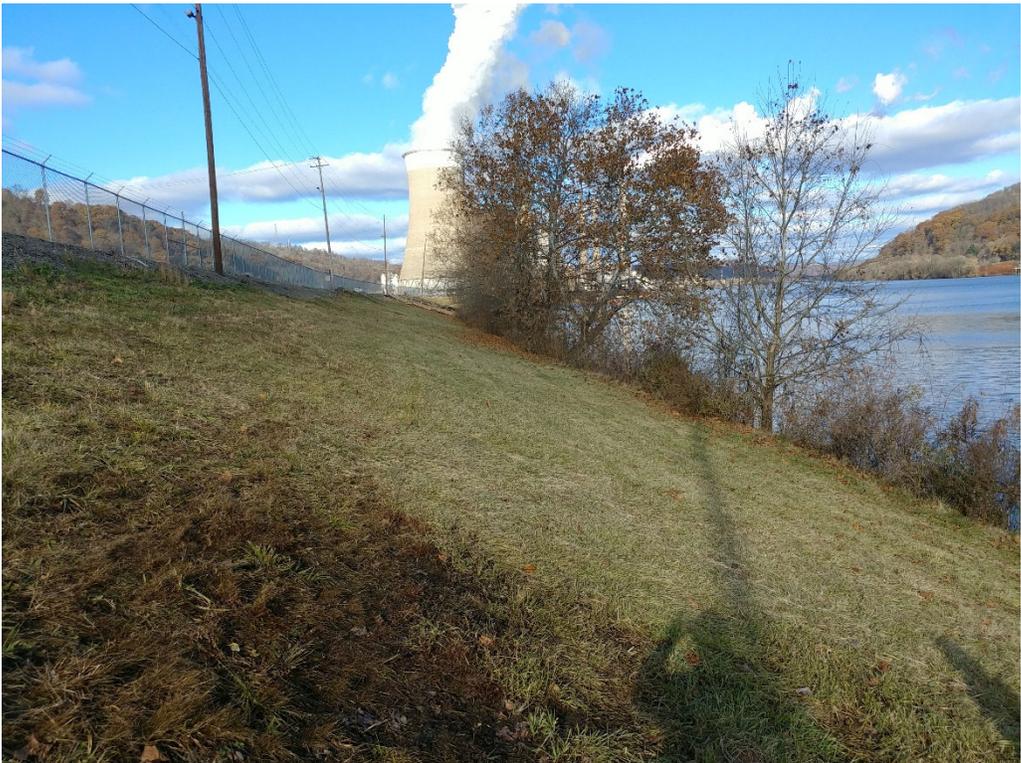
Photo No. 6	Date: 11/22/19

Direction Photo Taken: North		
Description: View of the embankment along the Ohio River.

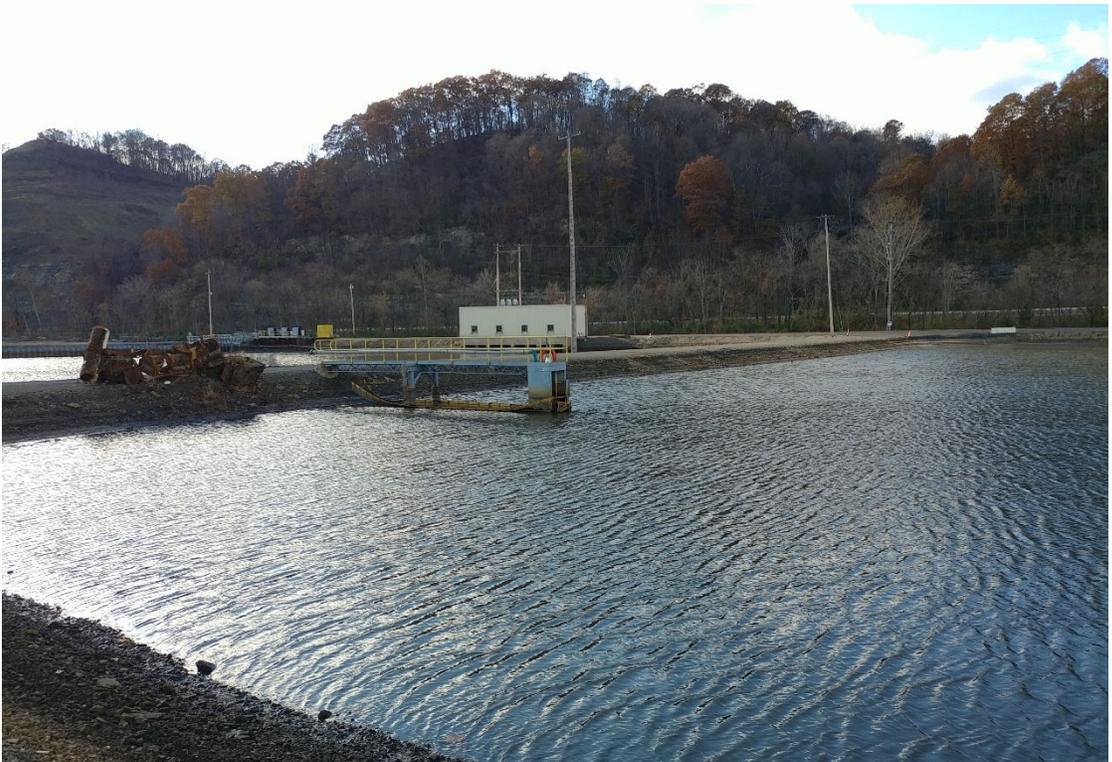
Photo No. 11	Date: 11/22/19

A wide-angle photograph of a large body of water, likely an ash pond. In the middle ground, there is a blue and yellow metal structure, possibly a gate or outlet. The background shows a hillside with trees in autumn colors. The sky is overcast.
Direction Photo Taken: North		
Description: Outlet structure between BAP and RCP.

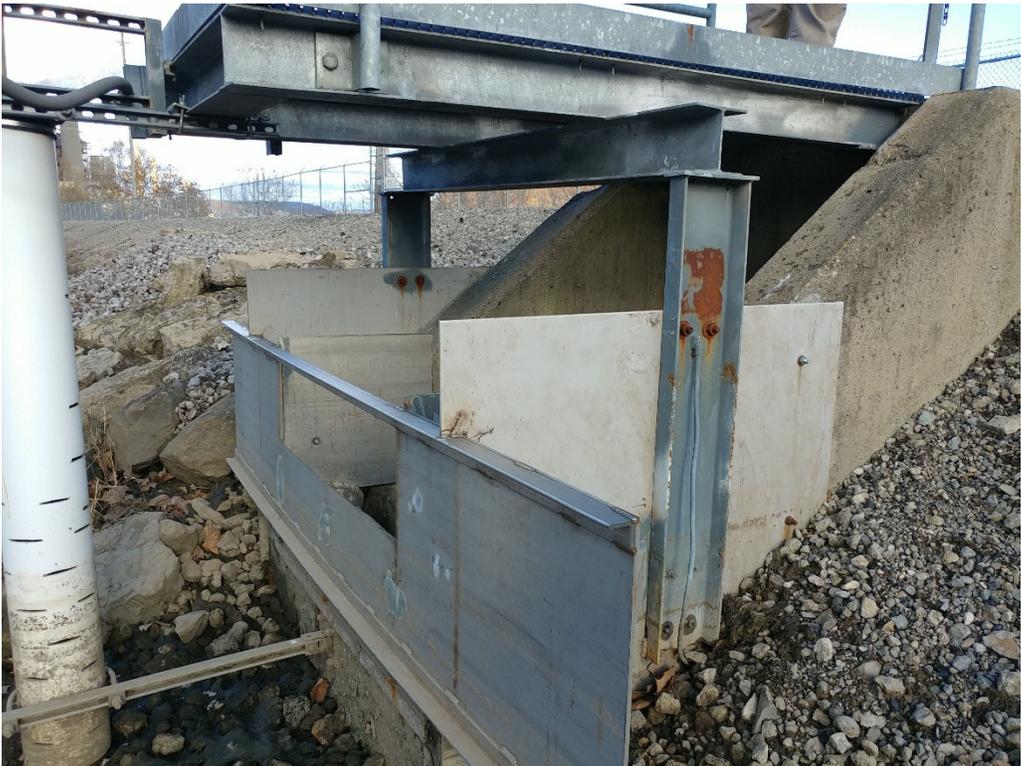
Photo No.: 14	Date: 11/22/19

Direction Photo Taken: Northeast		
Description: View of existing overflow intake structure.

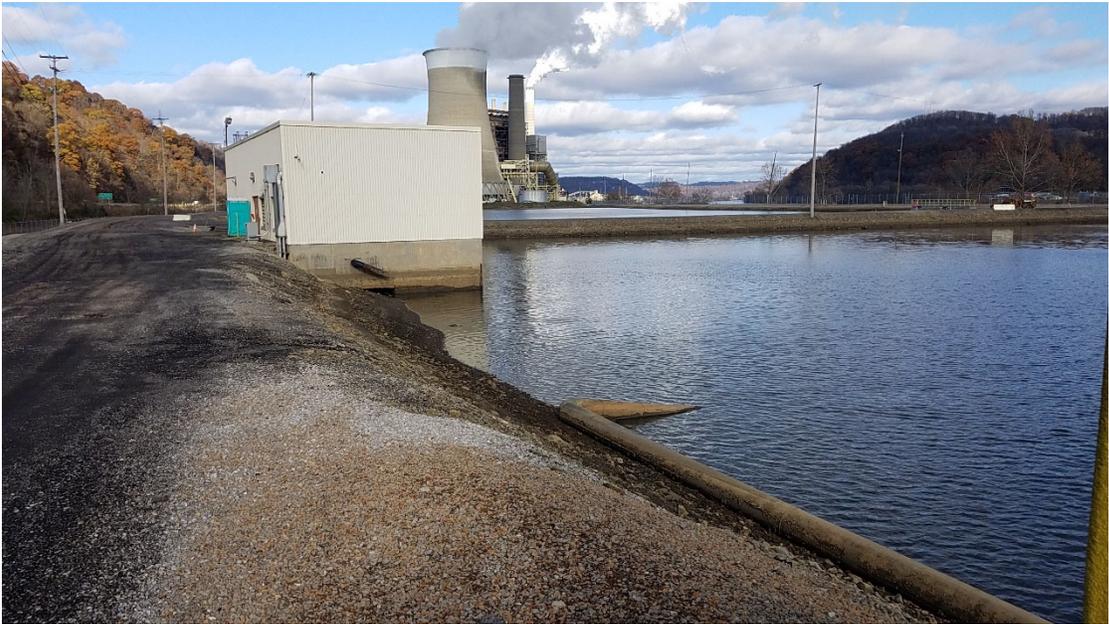
Photo No.: 16	Date: 11/22/19

Direction Photo Taken: North		
Description: View of the pump house at the RCP.

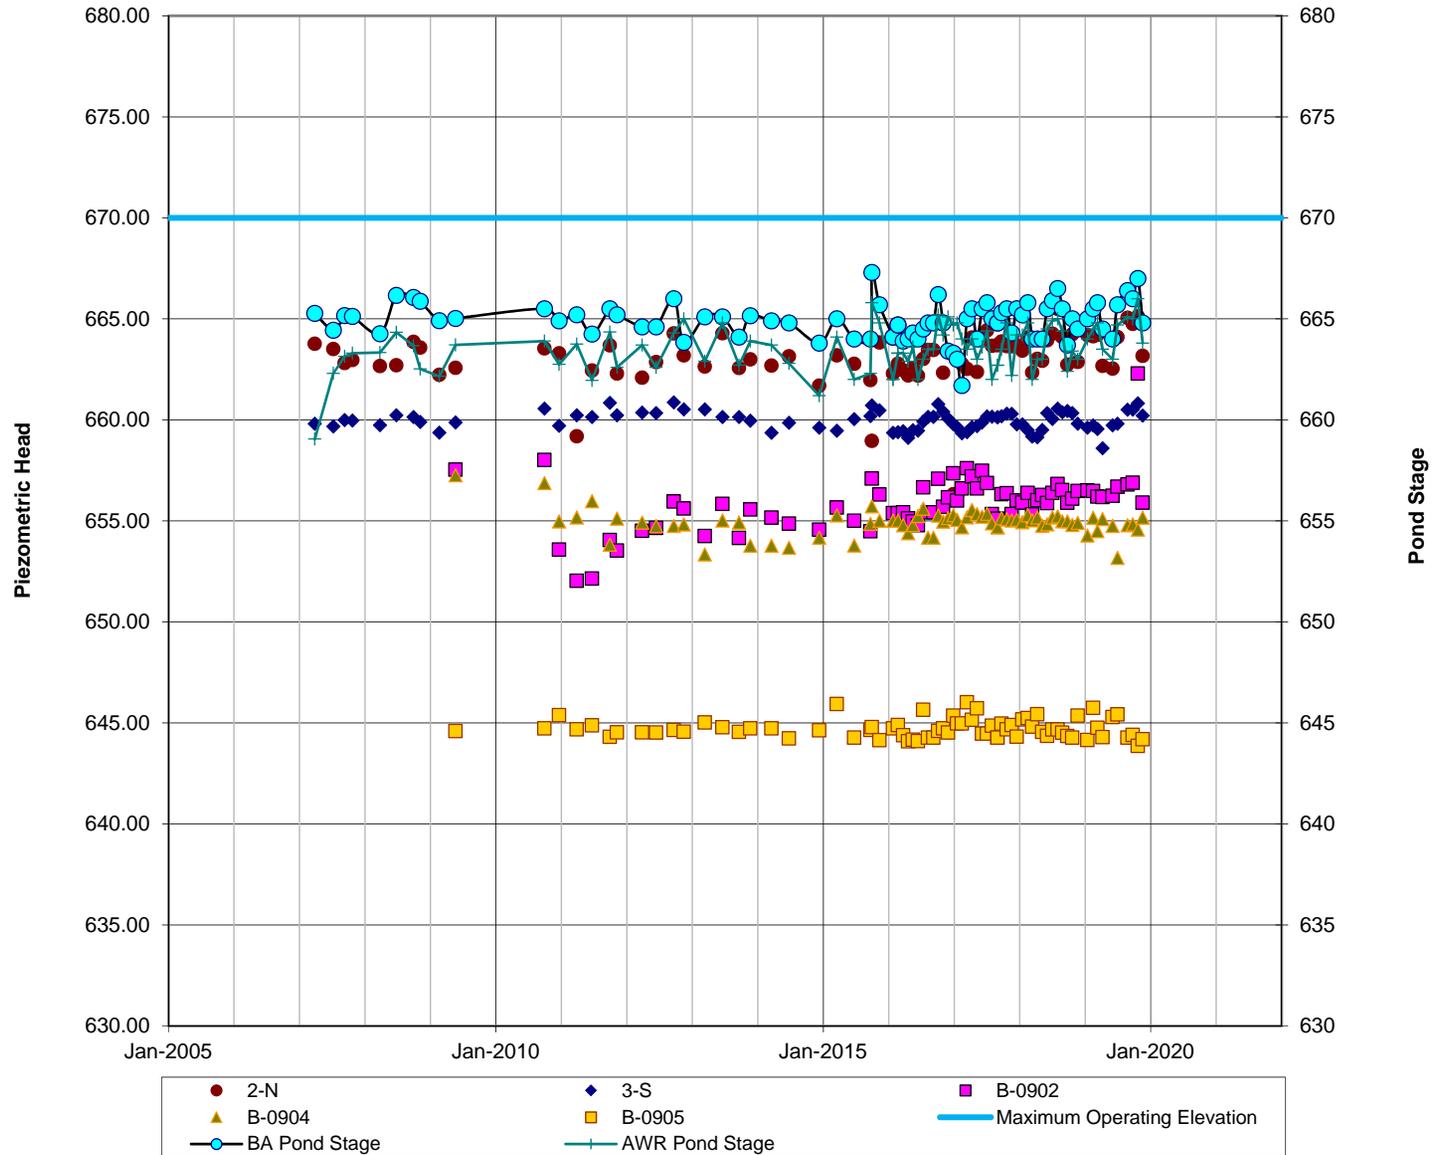
Figure 5p
 Bottom Ash Pond Complex
 Piezometers & Ponds Stages

Instrumentation at the BAP complex consists of a network of five piezometers. The location of this instrumentation is shown on Figure 3 of Appendix E. The results of the measurements of the piezometers are shown in Figure 5p. Piezometers 3-S and B-0902 are located on the east perimeter road of the Recirculation Pond. Piezometer 2-N is on the west perimeter road adjacent to the Bottom Ash Pond. B-0904 and B-0905 are located on the upstream and downstream slope of the east perimeter road, respectively. The maximum operating elevation of the Bottom Ash Pond is El. 670, but was substantially lower than this on the date of the inspection. The maximum recorded readings of each instrument since the previous annual inspection is shown in Table 3 below.
