2019 Annual Dam and Dike Inspection Report

Cardinal Plant Fly Ash Dams 1, 2 & Bottom Ash Complex

Project Number 60613809

January 2, 2020

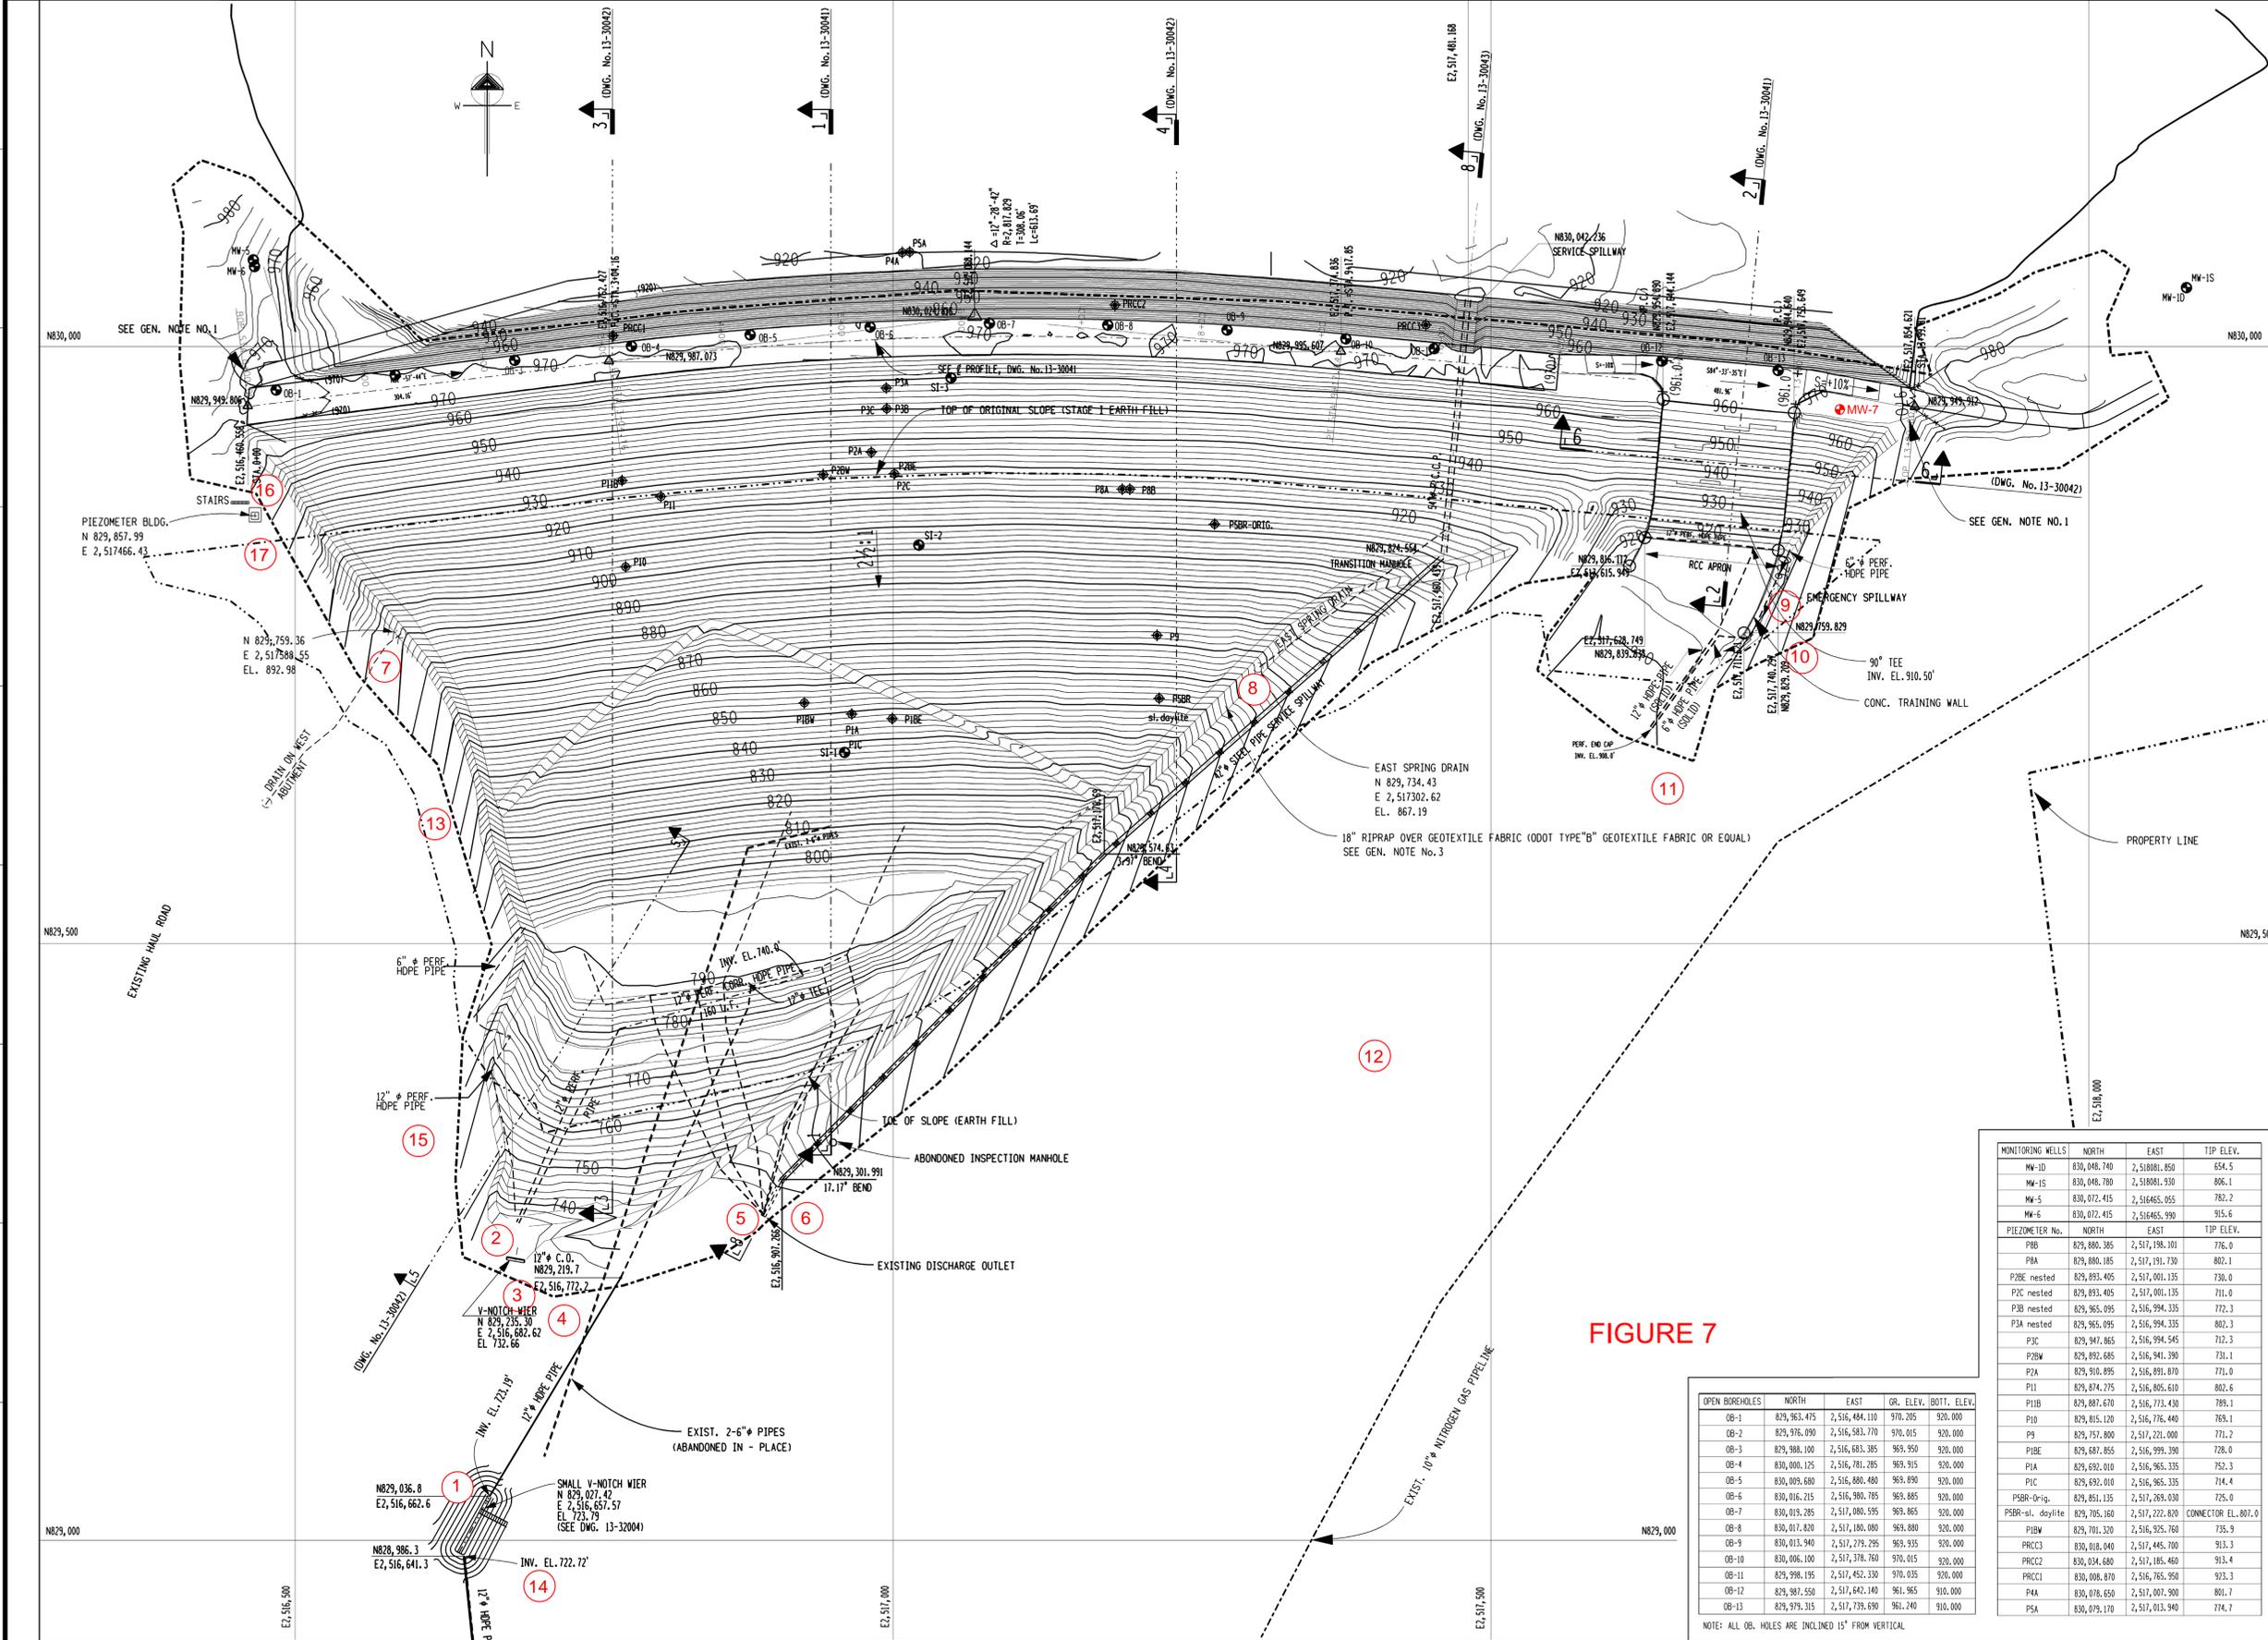
FIGURE 7

The most recent flow volumes are presented in tables in Appendix F, along with the locations of the seepage drains in Figure 7. Figure 5b presents historical pond discharge at the Parshall Flume (Drain No. 14) versus the pond stage. Discharge rates in 2019 have generally been within the previously observed range.
