2020 Annual Dam and Dike Inspection Report

Cardinal Plant
Fly Ash Dams 1, 2 & Bottom
Ash Complex

Cardinal Operating Company
306 County Rd. 7E
Brilliant, Ohio 43913

January 10, 2021

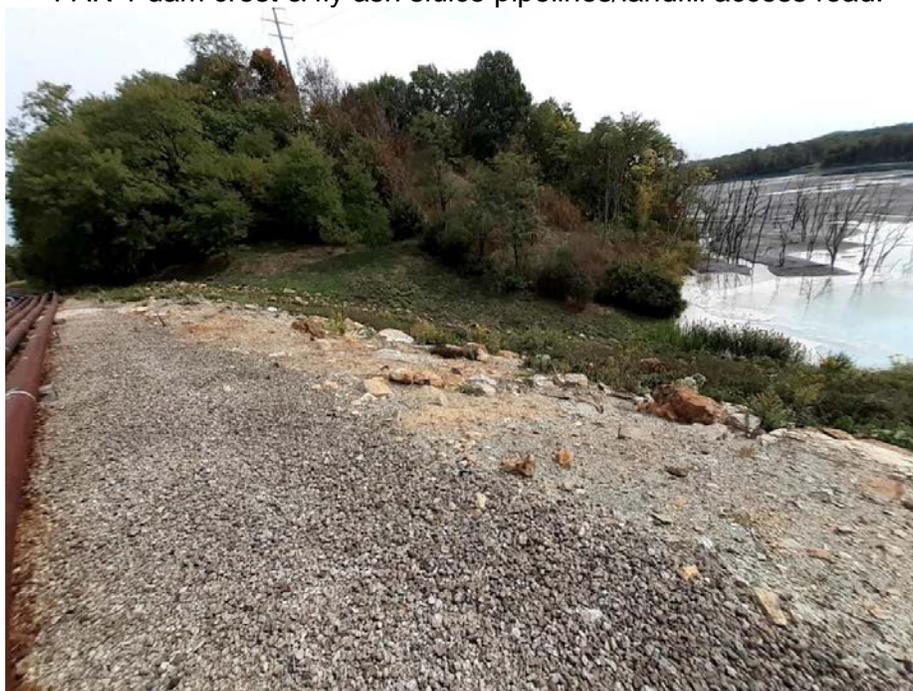
Photo No.1

FAR 1 dam crest & fly ash sluice pipelines/landfill access road.

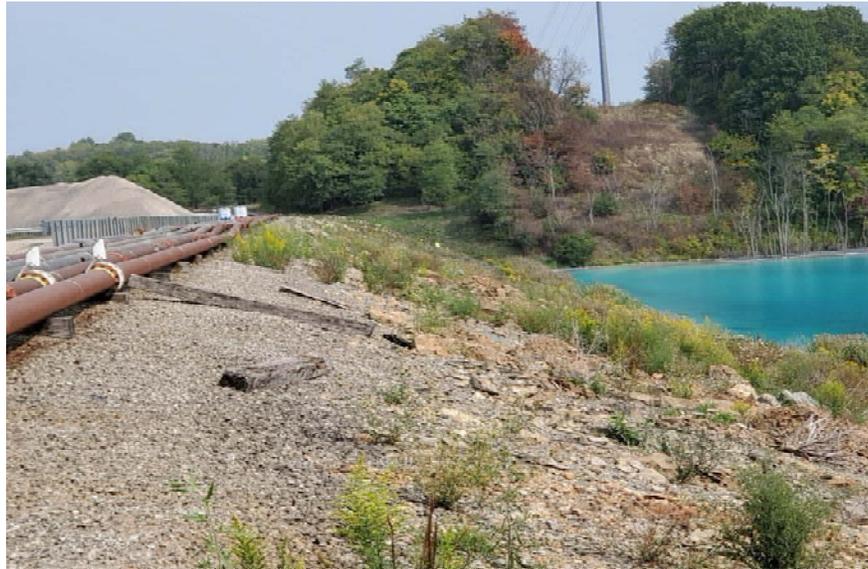
Photo No.4

Typical view showing the right groin ditch and alignment of road culvert.

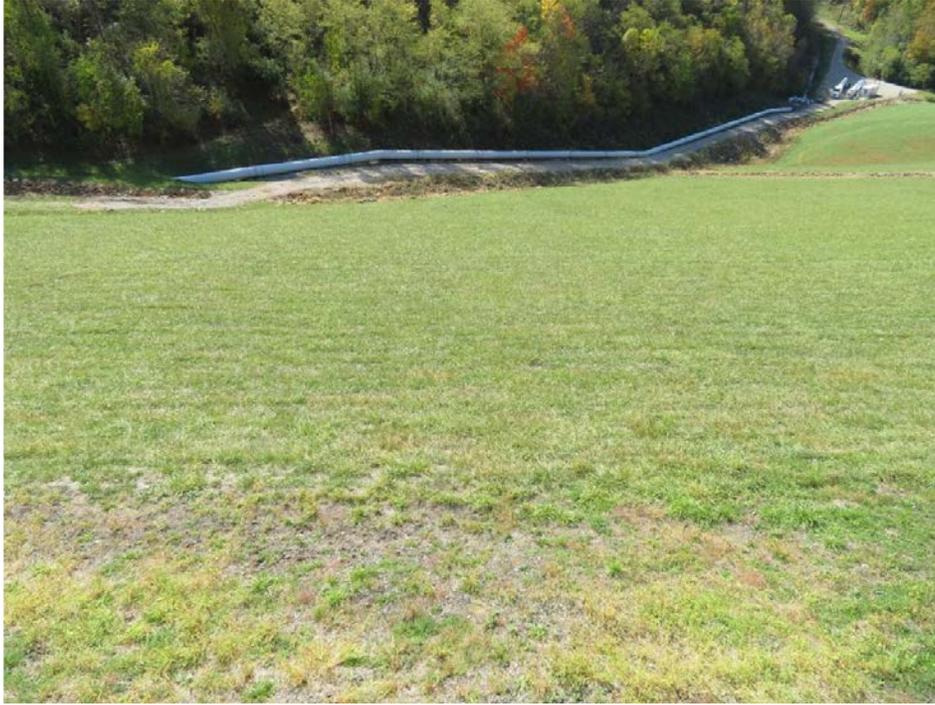
Photo No.1

Typical view of the downstream slope of the FAR 2 dam. and the storm water diversion berm located about mid-slope.

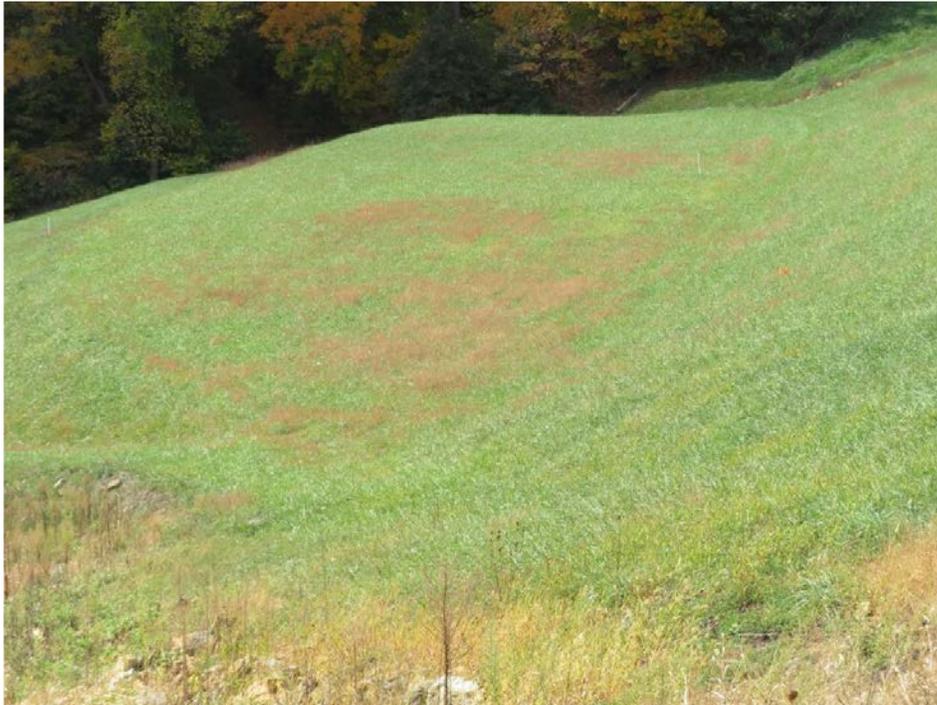
Photo No.2

View of the storm water diversion berm located about mid-slope that diverts storm water to the right and left groin ditches.

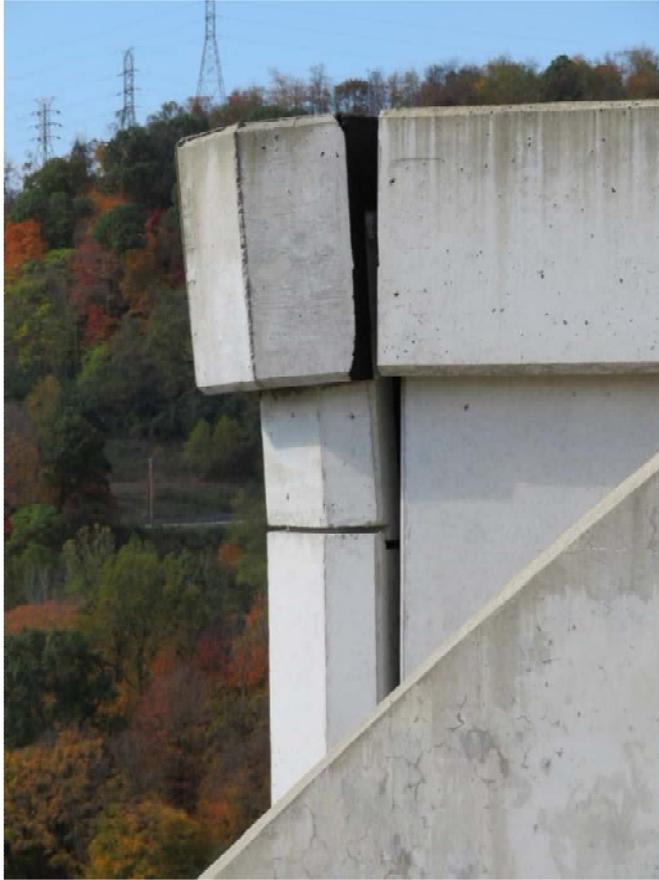
Photo No.13

View of the right retaining wall and the terminal end point of the Stage 3 MSE wall showing separation at the corner post.

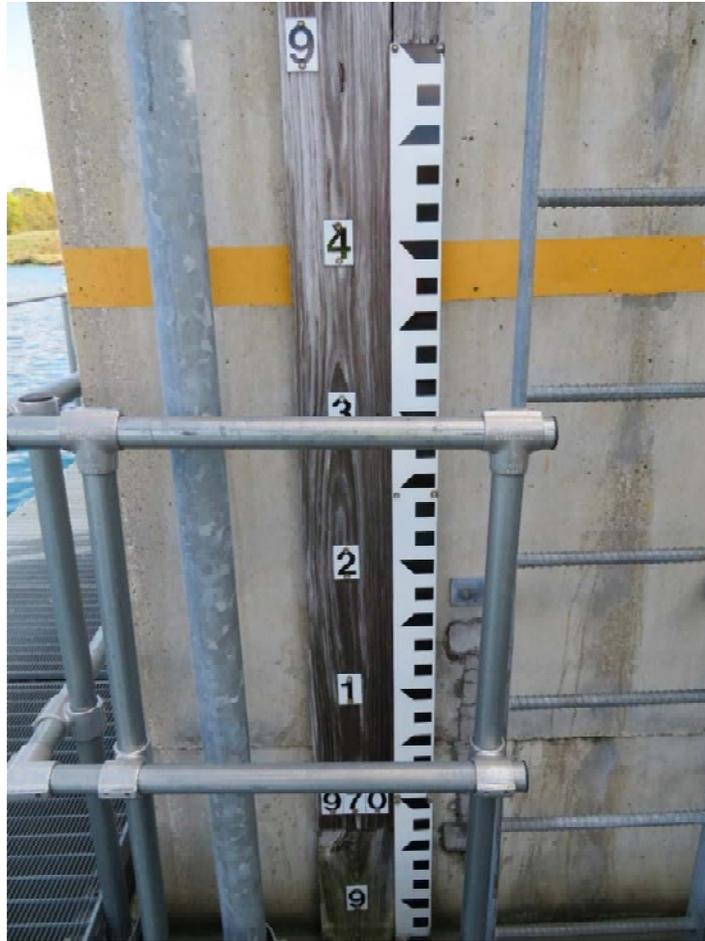
Photo No.18

View of staff gage to measure FAR 2 pool stage. Note the orange band that marks the maximum operating pool stage.

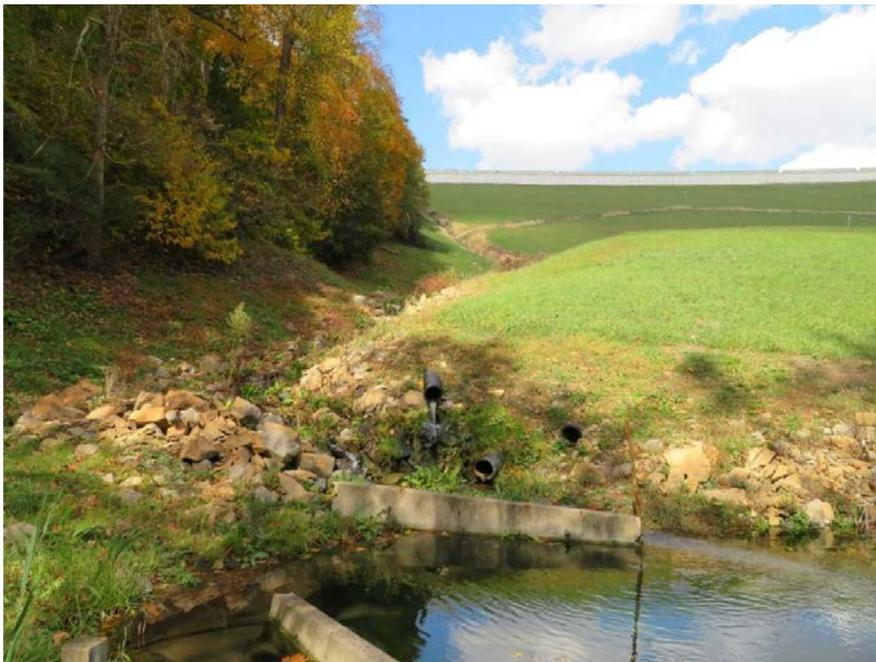
Photo No.27

View of drain # 1 of the chimney/toe drain system with a measured discharge approximately 23 gpm.

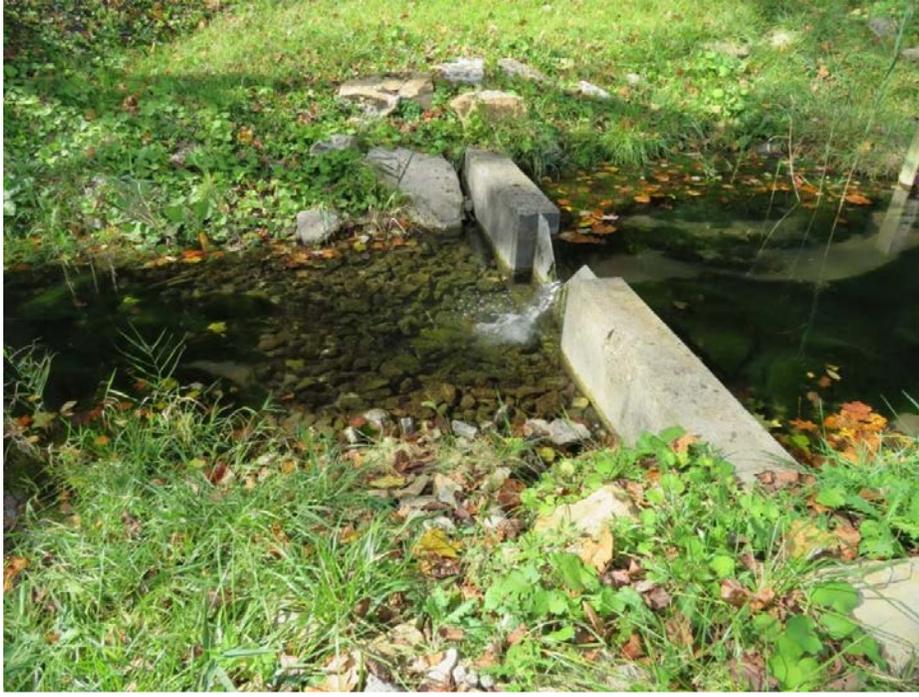
Photo No.28

View of drains discharging into collection pool at the right groin ditch. The discharge was unobstructed and was visually clear.

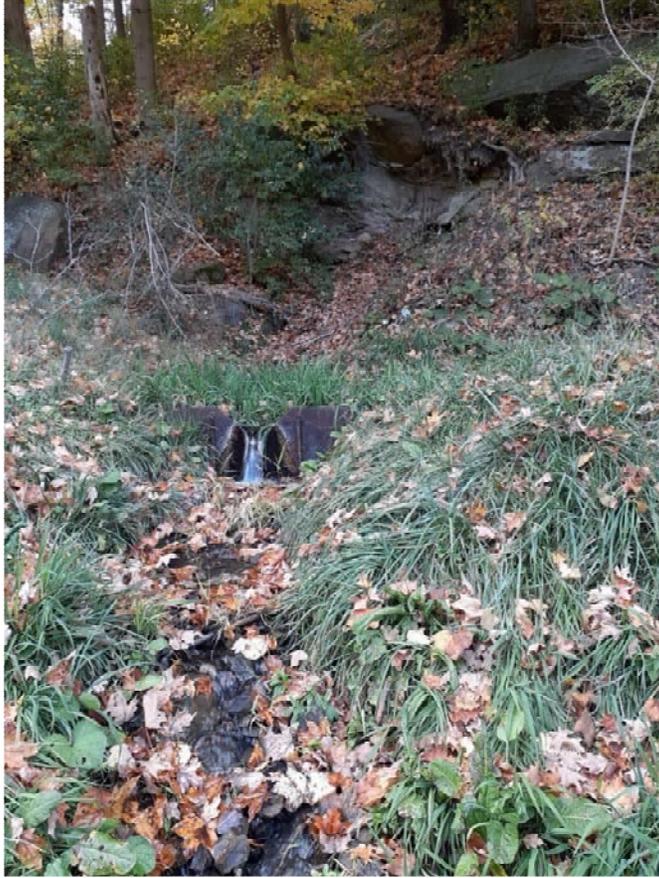
Photo No.29

View of drain # 2 V-notched weir that collects all the seepage from the right abutment. See figure 5m for a graphical display of its discharge

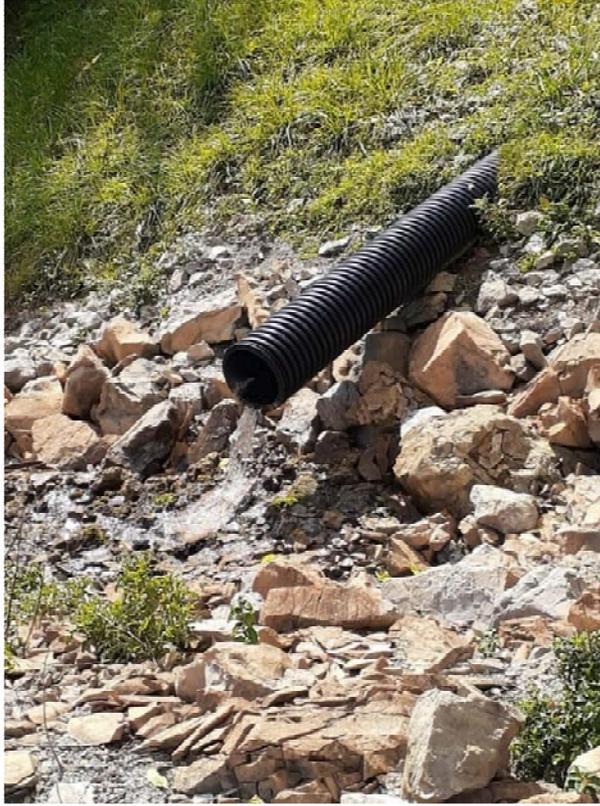
Photo No.30

1. Silt and brush is present behind the V-notch weir of the seepage monitoring point (Drain No 15) (See Photo 30, Appendix B). The area immediately upstream of the weir should be kept clear of obstructions to ensure accurate flow measurements.
2. Consideration should be given to fill/repair cracking on the sidewalls within the emergency spillway.
3. Continue with regularly scheduled mowing and reseeding minor barren areas.

View of drain # 15 showing a V-notched weir to measure flow emanating from the Morgantown sandstone.

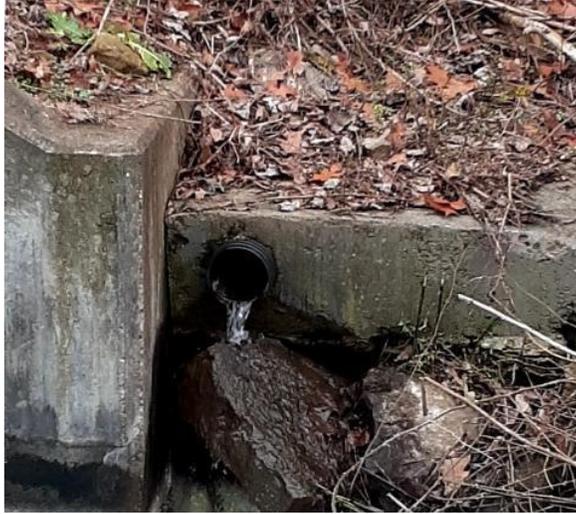
Photo No.35

View of drain # 5 located along the right side of the dissipator structure showing a negligible discharge.

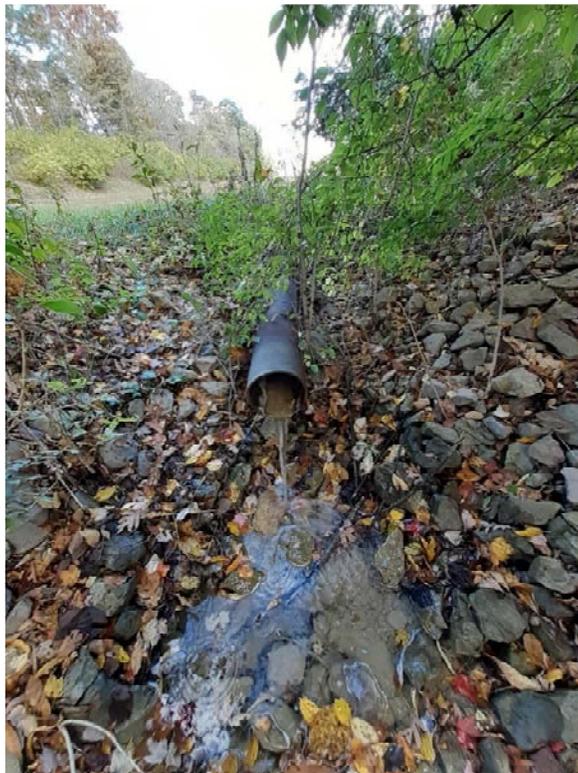
Photo No.36

View of drain # 6 located along the left side of the dissipator structure discharging approximately 5 gpm.

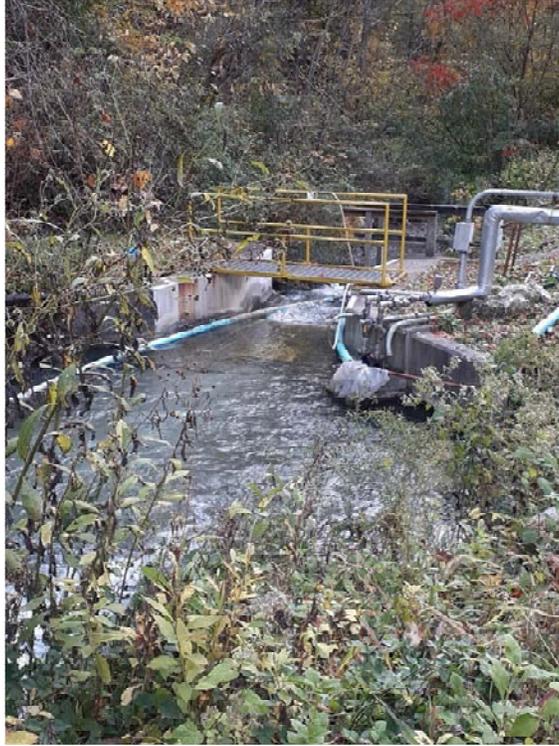
Photo No.41

10. The energy dissipator structure discharges into a channel that flows through a concrete flume (NPDES Permit Outfall # 019) (Photos 41 and 42). The condition of these features was essentially the same as was observed in previous inspections.

View of main channel showing flow towards the concrete flume.

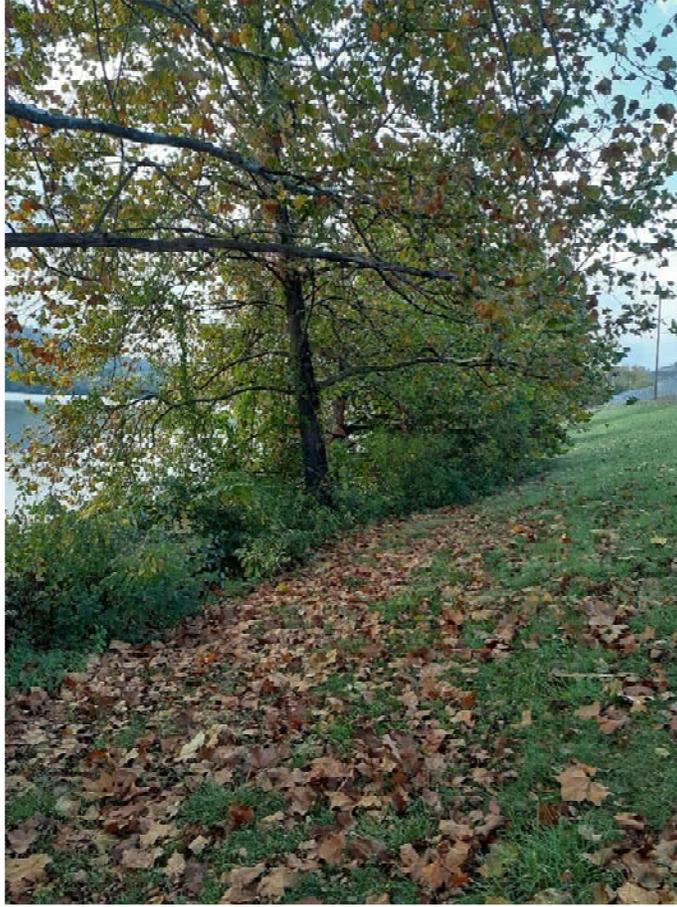
Photo No.8

8. The exterior eastern slope along the Ohio River was observed to be in good condition, with a well-established grass cover that is regularly mowed and maintained. The slope appeared to be uniform with no slumping or bulges indicative of movement (Photo 8). There were a few minor erosion rills near the crest of the slope.

View of exterior slope along the Ohio River showing well established vegetative growth that is also regularly mowed.

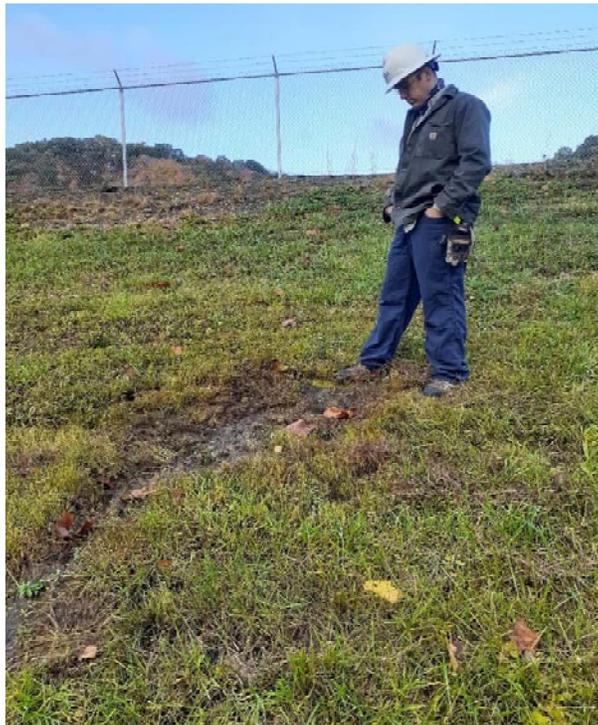
Photo No.9

9. The mature trees along the riverbank have been kept in place to mitigate bank erosion potentially caused by the river (Photo 9).
10. The two apparent seep areas observed in 2018 and 2019 were also present during the current inspection as well (see Photos 10 and 11). No flowing seepage is present, but the

Mature trees are also being retained along the riverbank to minimize scour and erosion.

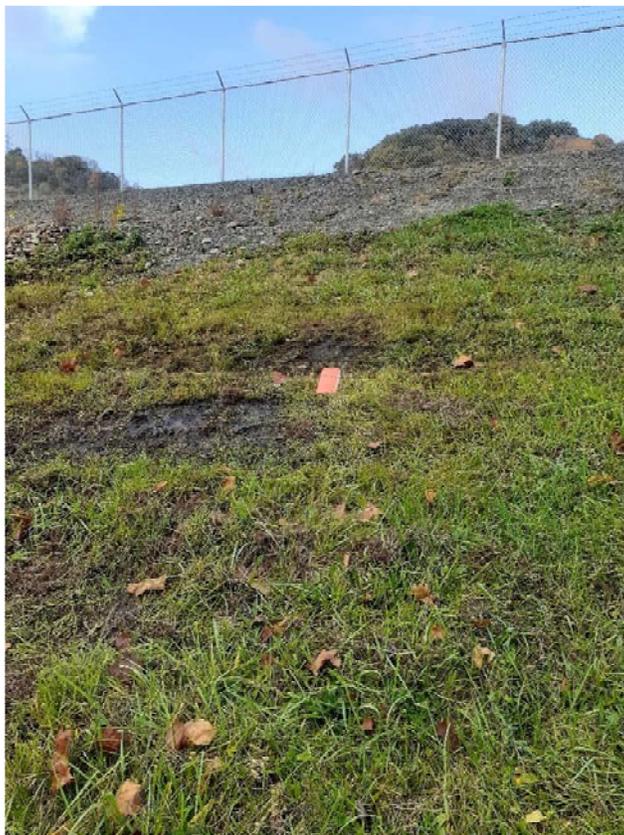
Photo No.10

View of emergent spring located approximately mid slope along the Ohio River.

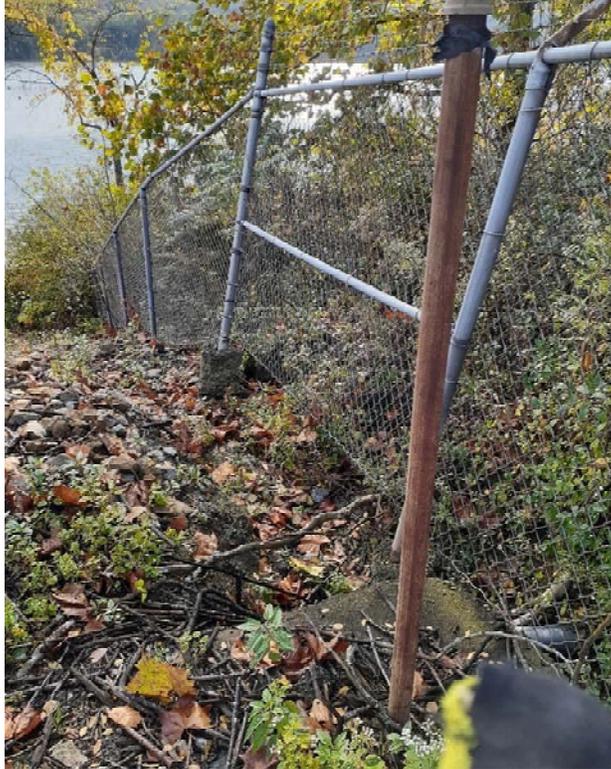
Photo No.15

12. The outlet structure and discharge pipe from the RCP (NPDES Outfall 023) were unobstructed and in good condition (Photos 14 and 15).
13. Moderate gully erosion was observed along the perimeter fence at the southernmost end of the riprap slope (Photo 16).

View of discharge pipe and splash apron.

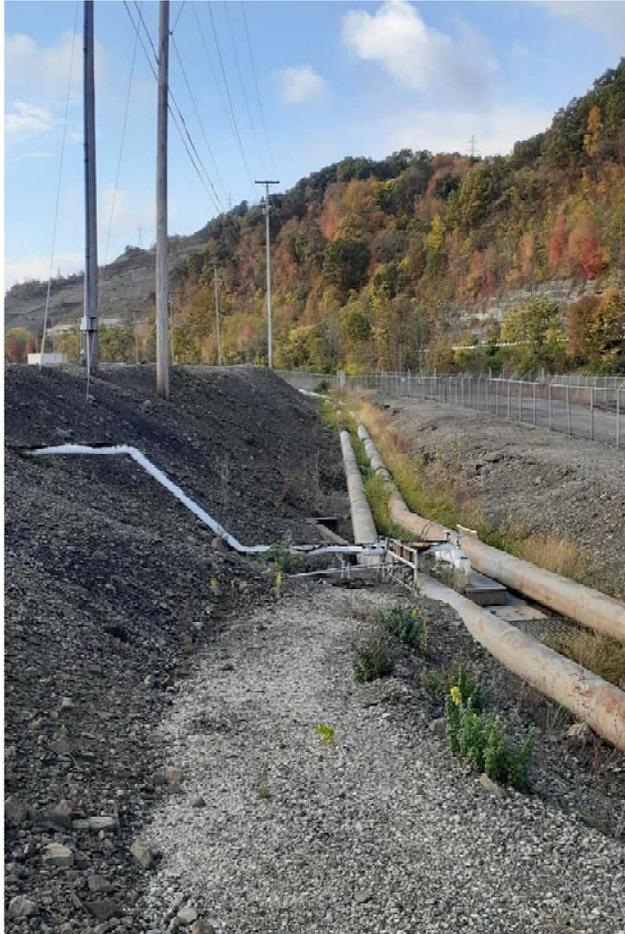
Photo No.18

14. The western exterior slope was observed to be in good condition showing uniform slopes with no significant erosion, slumping or bulges (Photo 17).
15. Ponded water was observed at the toe of the west embankment and has been observed in previous inspections. The ditch has a relatively flat slope, and sluice pipes run within and adjacent to it, so ponding water is also intermittently observed along its length (Photo 18).

Emergent spring along the toe of the exterior slope. No noticeable change in from previous reports in regard to the spring location or discharge.
