Emergency Action Plan for the  
Fly Ash Dams I and II and  
Bottom Ash/Reclaim Dikes

Cardinal Operating Company  
306 County Road 7E  
Brilliant, Ohio 43913

June 2019  
Revised September 2019

**ODNR File Nos. 0205-009, 0205-010 & 0105-004**

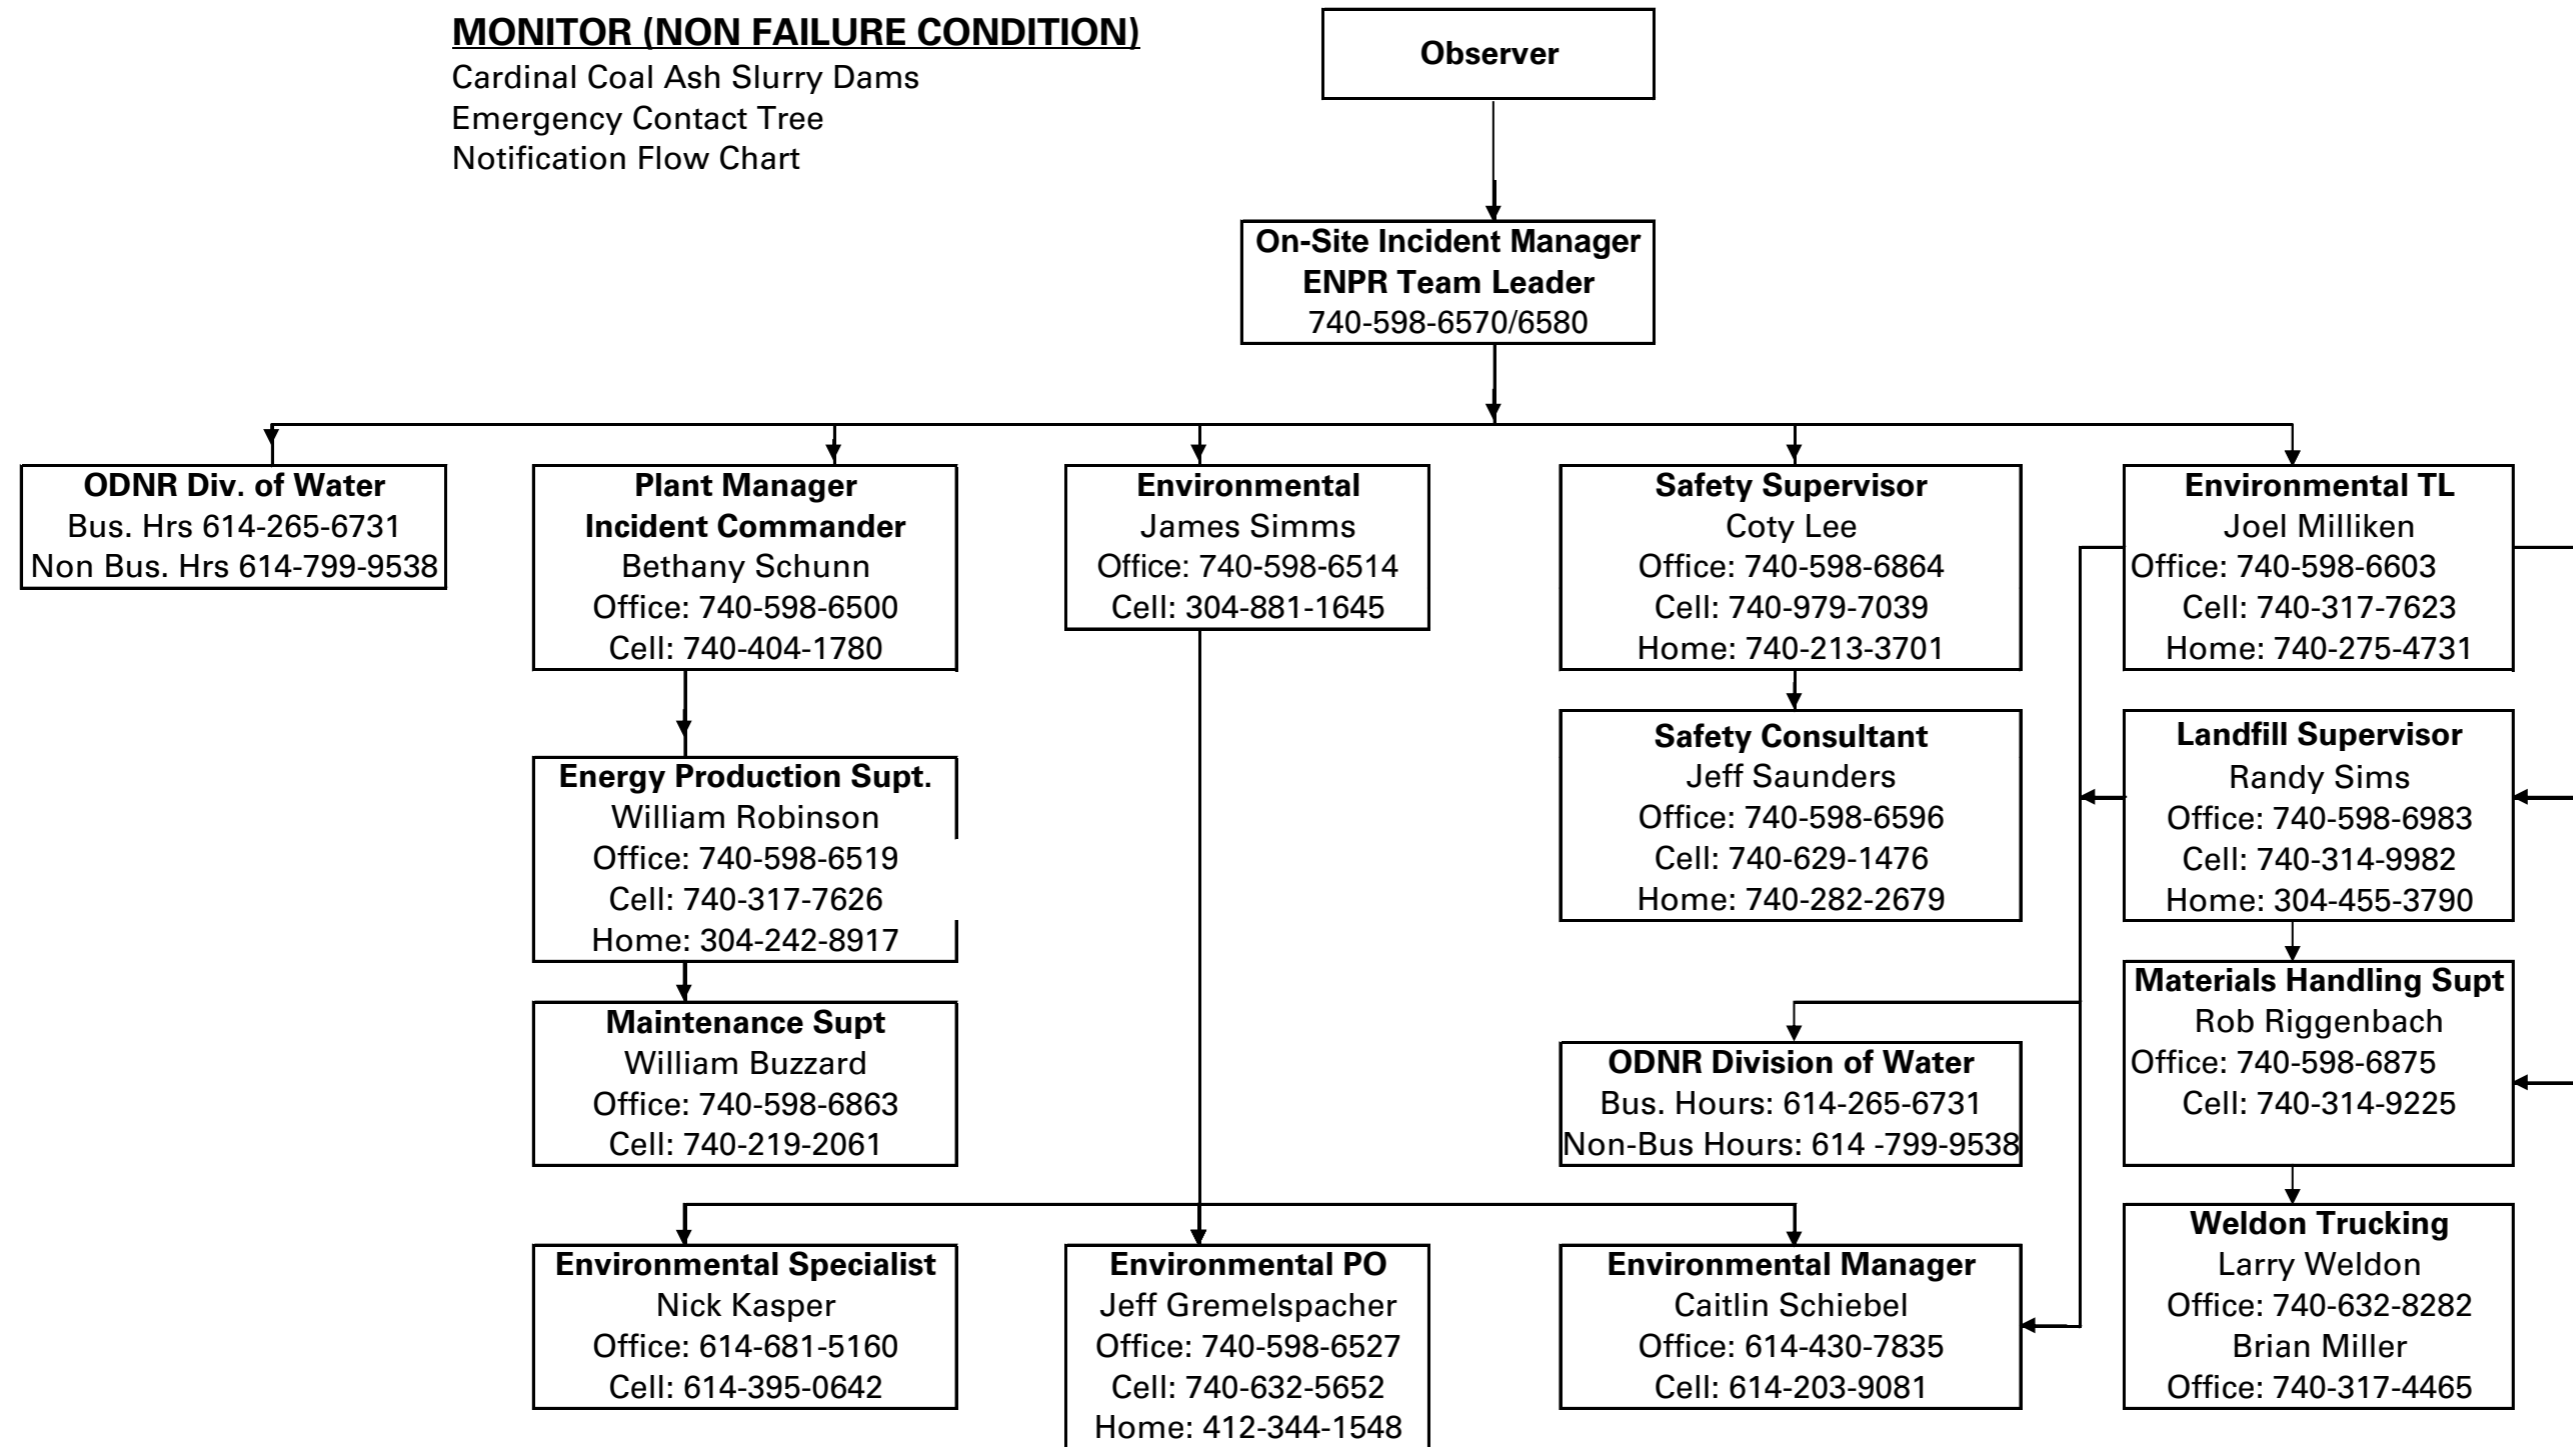
Cardinal Coal Ash Slurry Dams  
Emergency Contact Tree  
Notification Flow Chart

Exhibits 1 and 2 are the Notification Flowcharts for potential emergency conditions at the Cardinal Plant's fly ash and bottom ash dams located in Jefferson County, Ohio. The plant is co-owned by Buckeye Power and American Electric Power (AEP) and is operated by the Cardinal Operating Company. The Notification Flowchart provides the hierarchy for notification in the event of an emergency for the following conditions:
