Emergency Action Plan for the  
Fly Ash Dams I and II and  
Low Volume Waste and rBAP Dikes

Cardinal Operating Company  
306 County Road 7E  
Brilliant, Ohio 43913

**EMERGENCY ACTION PLAN  
FOR THE FLY ASH DAMS I AND II  
AND LOW VOLUME WASTE/BAP DIKES  
CARDINAL OPERATING COMPANY**

**ODNR File Nos. 0205-009, 0205-010 & 0105-004**

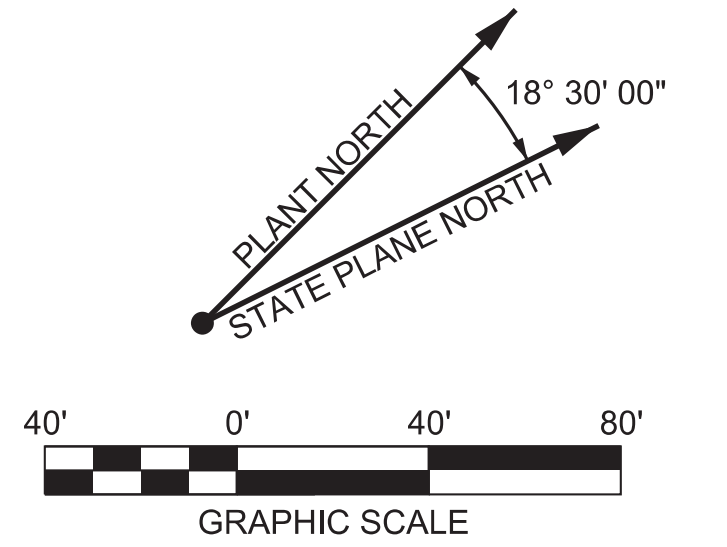
## **Exhibit 5 - South BAP Retrofit Design**

- FOOTPRINT, SIDE SLOPES, AND SURFACE OF DEWATERING AND STAGING AREA SHOWN REPRESENT THE INITIAL CONFIGURATION TO BE INSTALLED BY SPECIFICATION C-5413. AFTER THE POND BEGINS TO RECEIVE WASTE WATER STREAMS THE FUTURE ASH MANAGEMENT CONTRACTOR MAY PROPOSE ALTERATIONS TO THE DEWATERING AND STAGING AREA FOR OWNER'S REVIEW AND APPROVAL TO OPTIMIZE THE AREA FOR BOTTOM ASH EXCAVATION AND/OR HYDRAULIC DREDGING ACTIVITIES AND SUIT THE AVAILABLE EQUIPMENT.

BOTTOM ASH CLOSURE AND LINING PROJECT  
 SOUTH POND  
 BOTTOM ASH DEWATERING AND STAGING AREA PLAN  
 CARDINAL PLANT  
 BUCKEYE POWER INC.
