2015 LANDFILL INSPECTION REPORT

GERS-15-021

CARDINAL PLANT BRILLIANT, OHIO

Landfill Inspection Report Fly Ash Reservoir Landfill

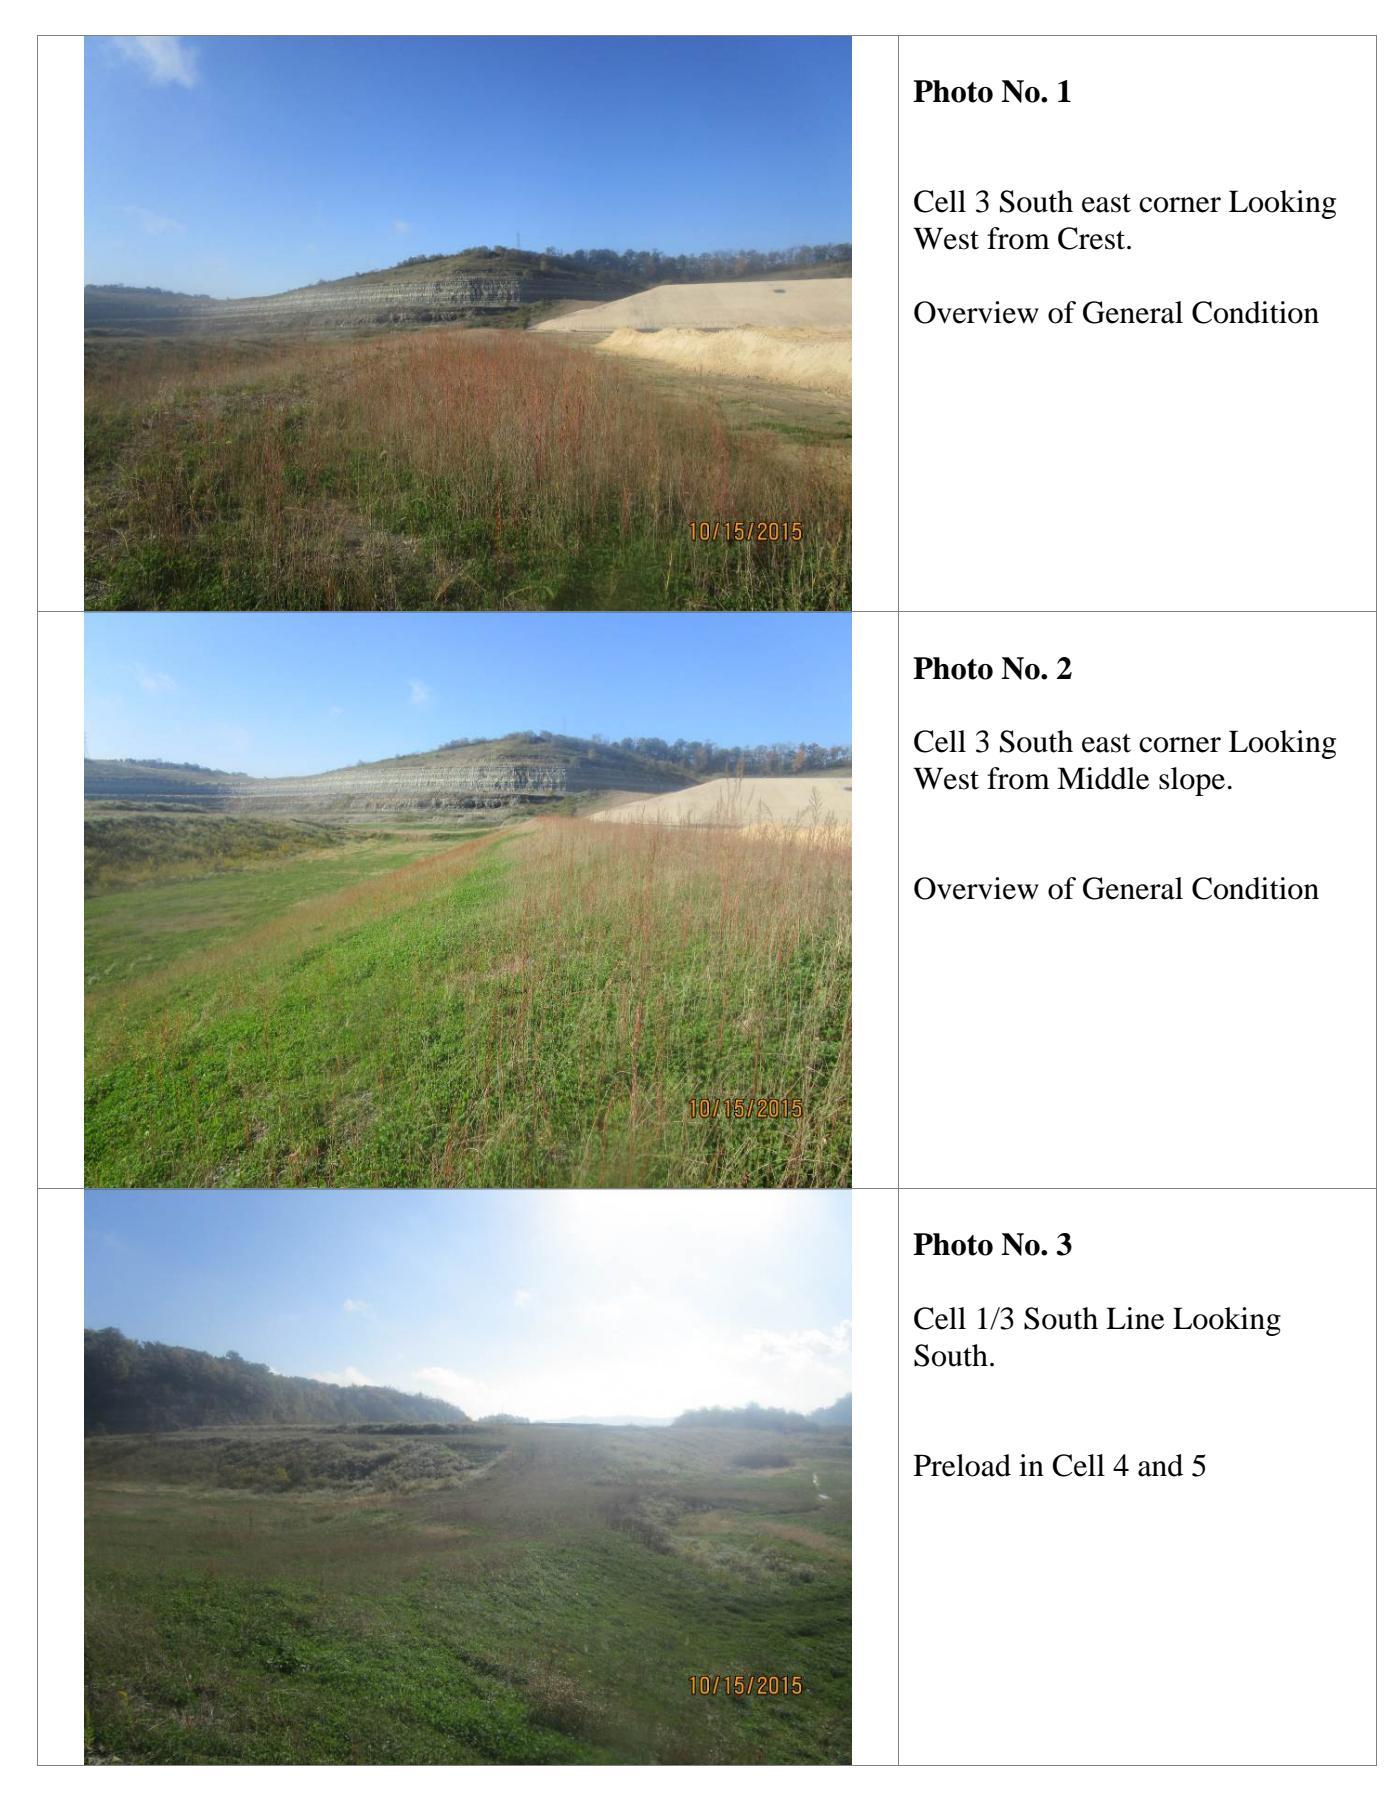
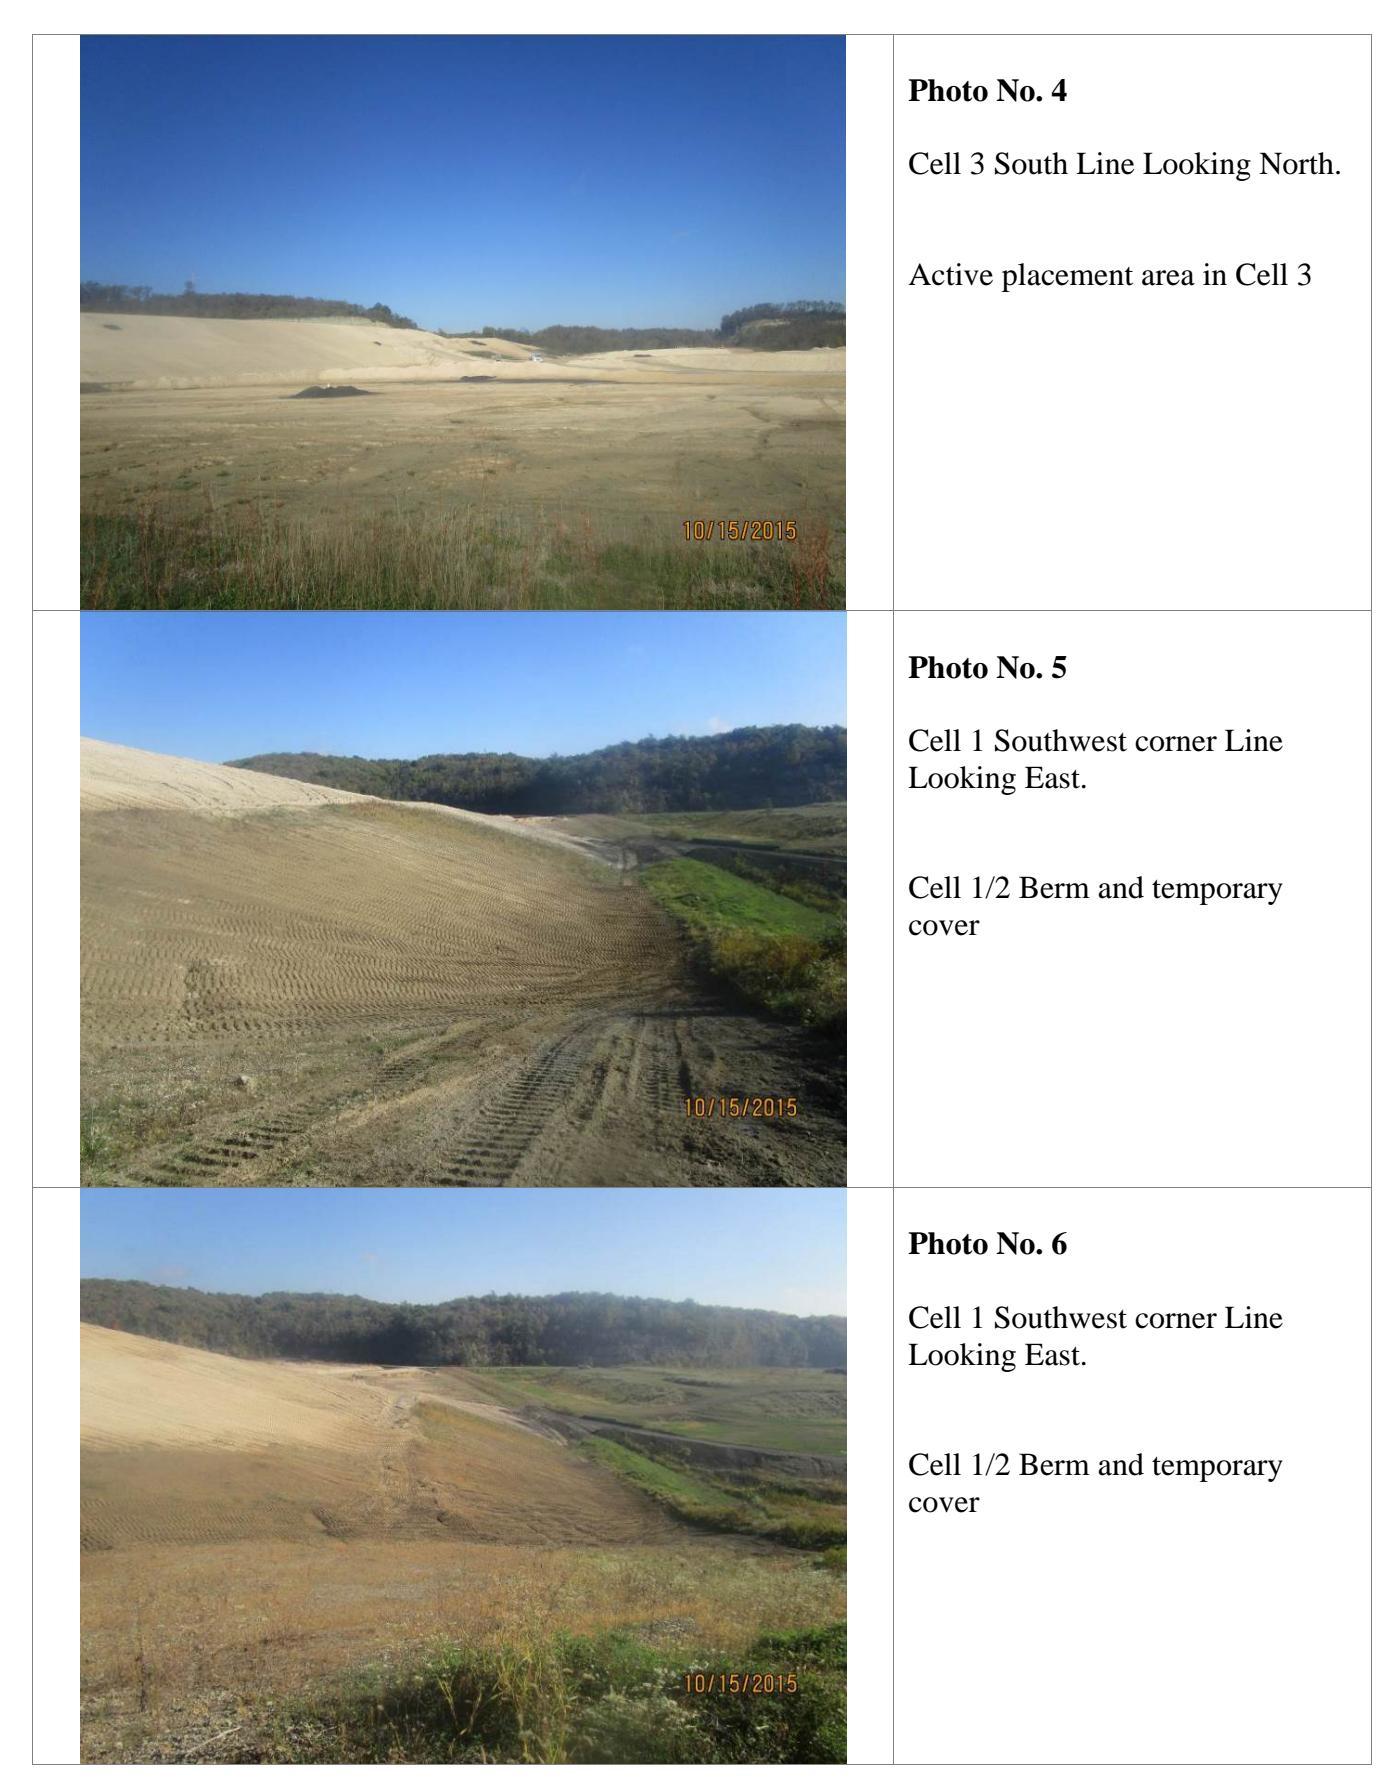
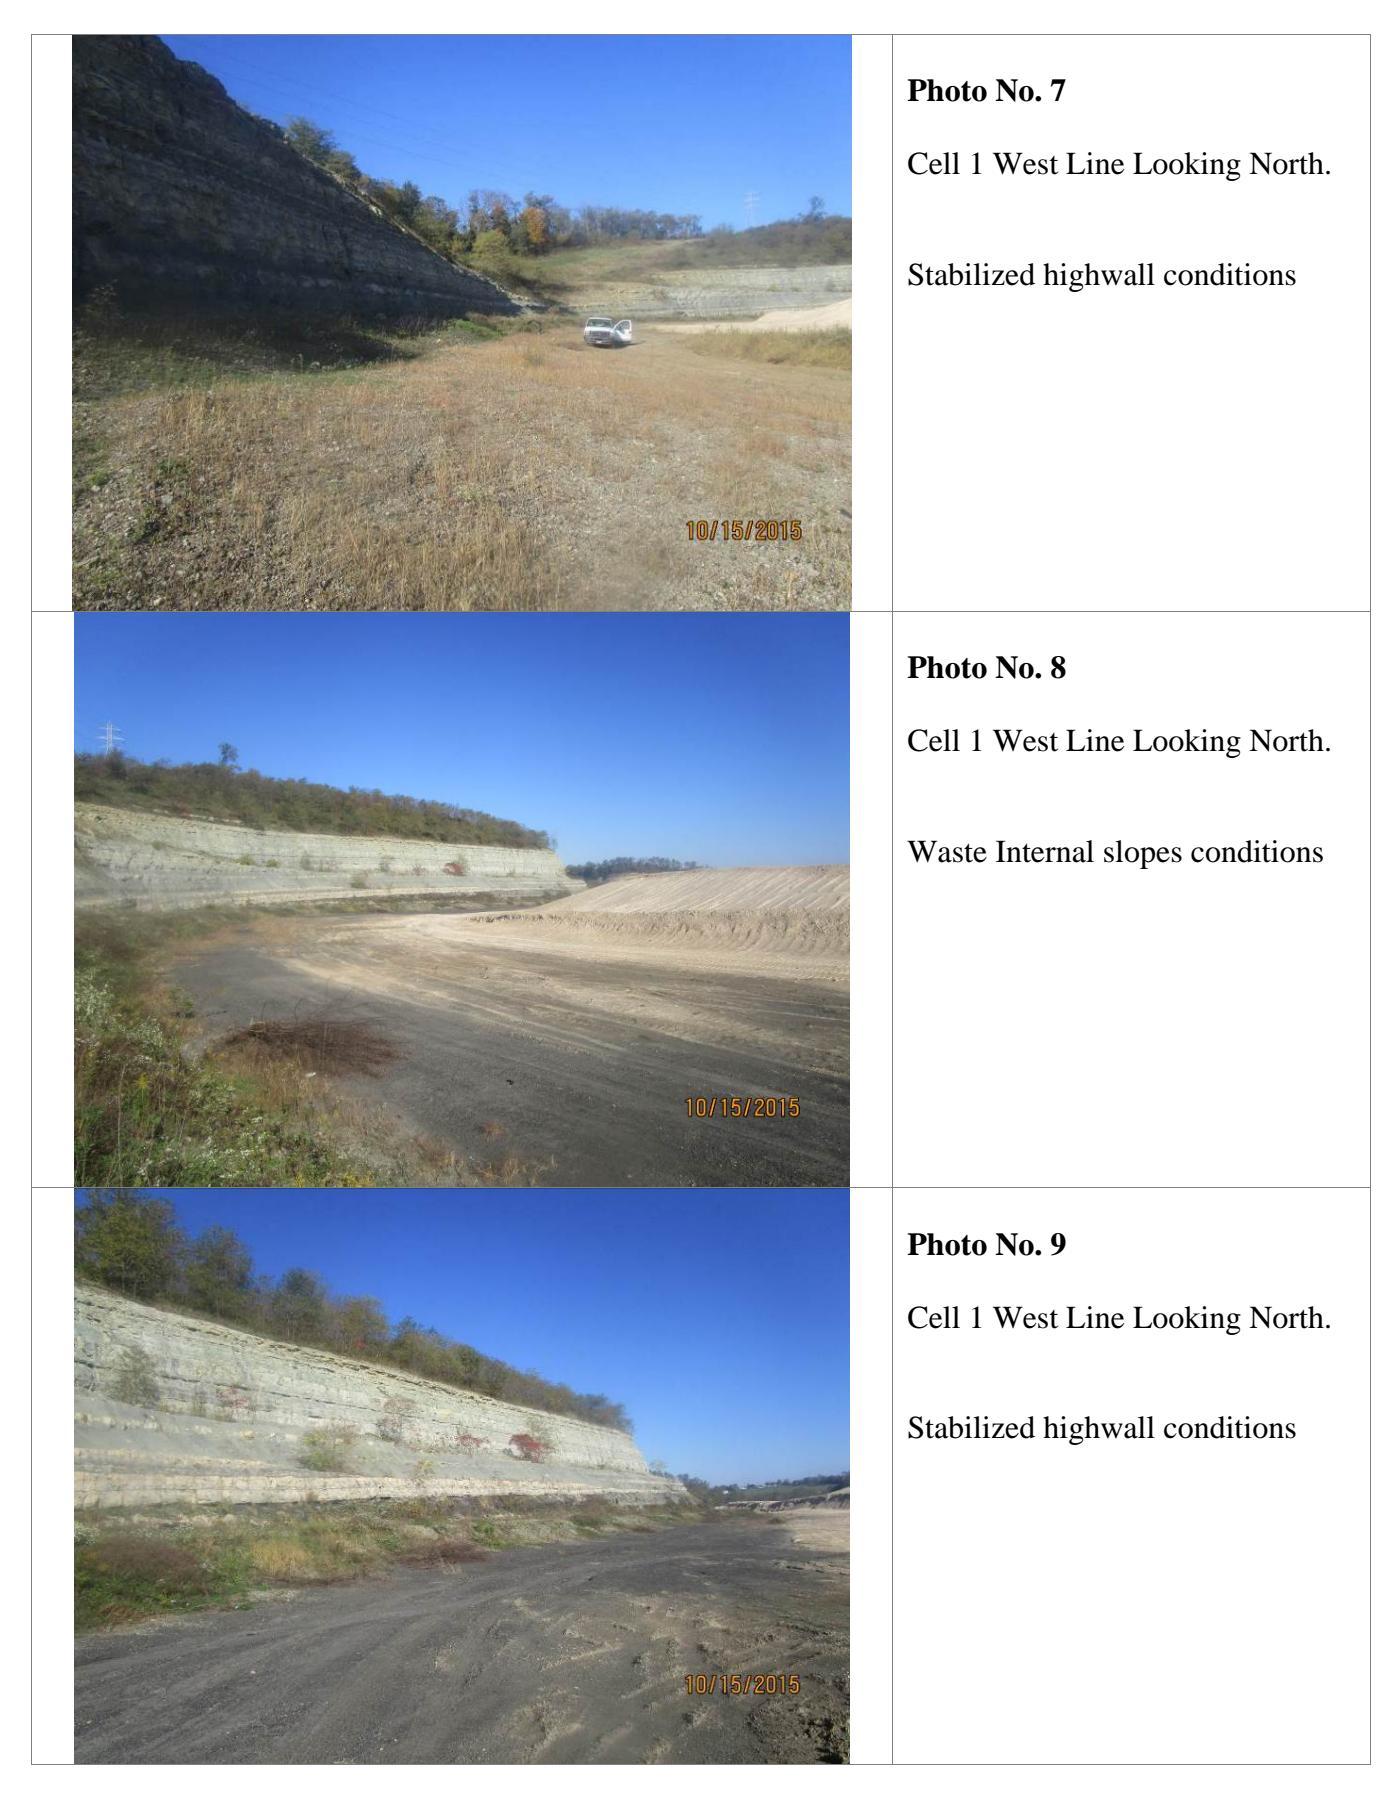
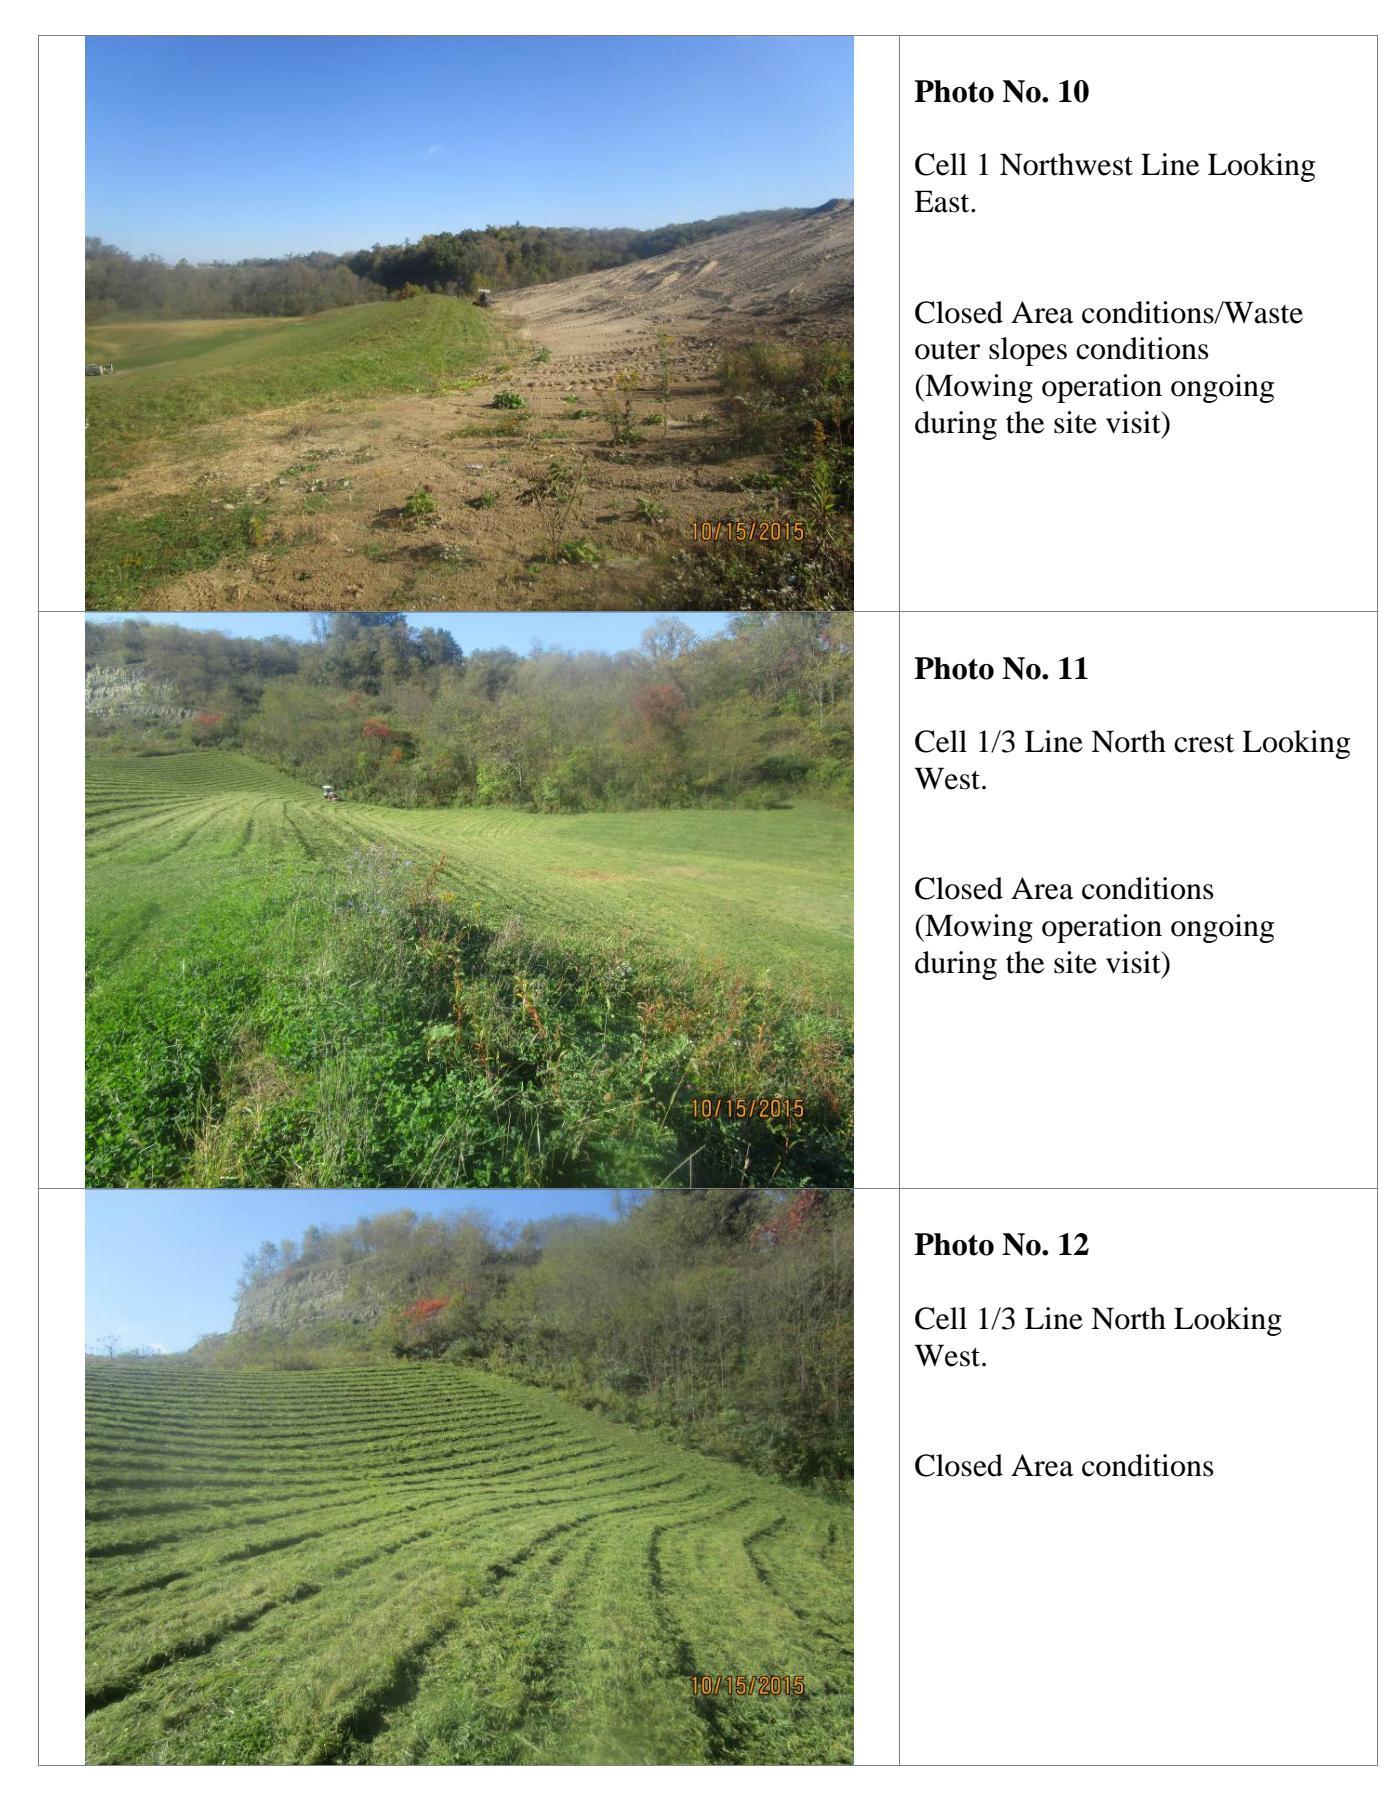
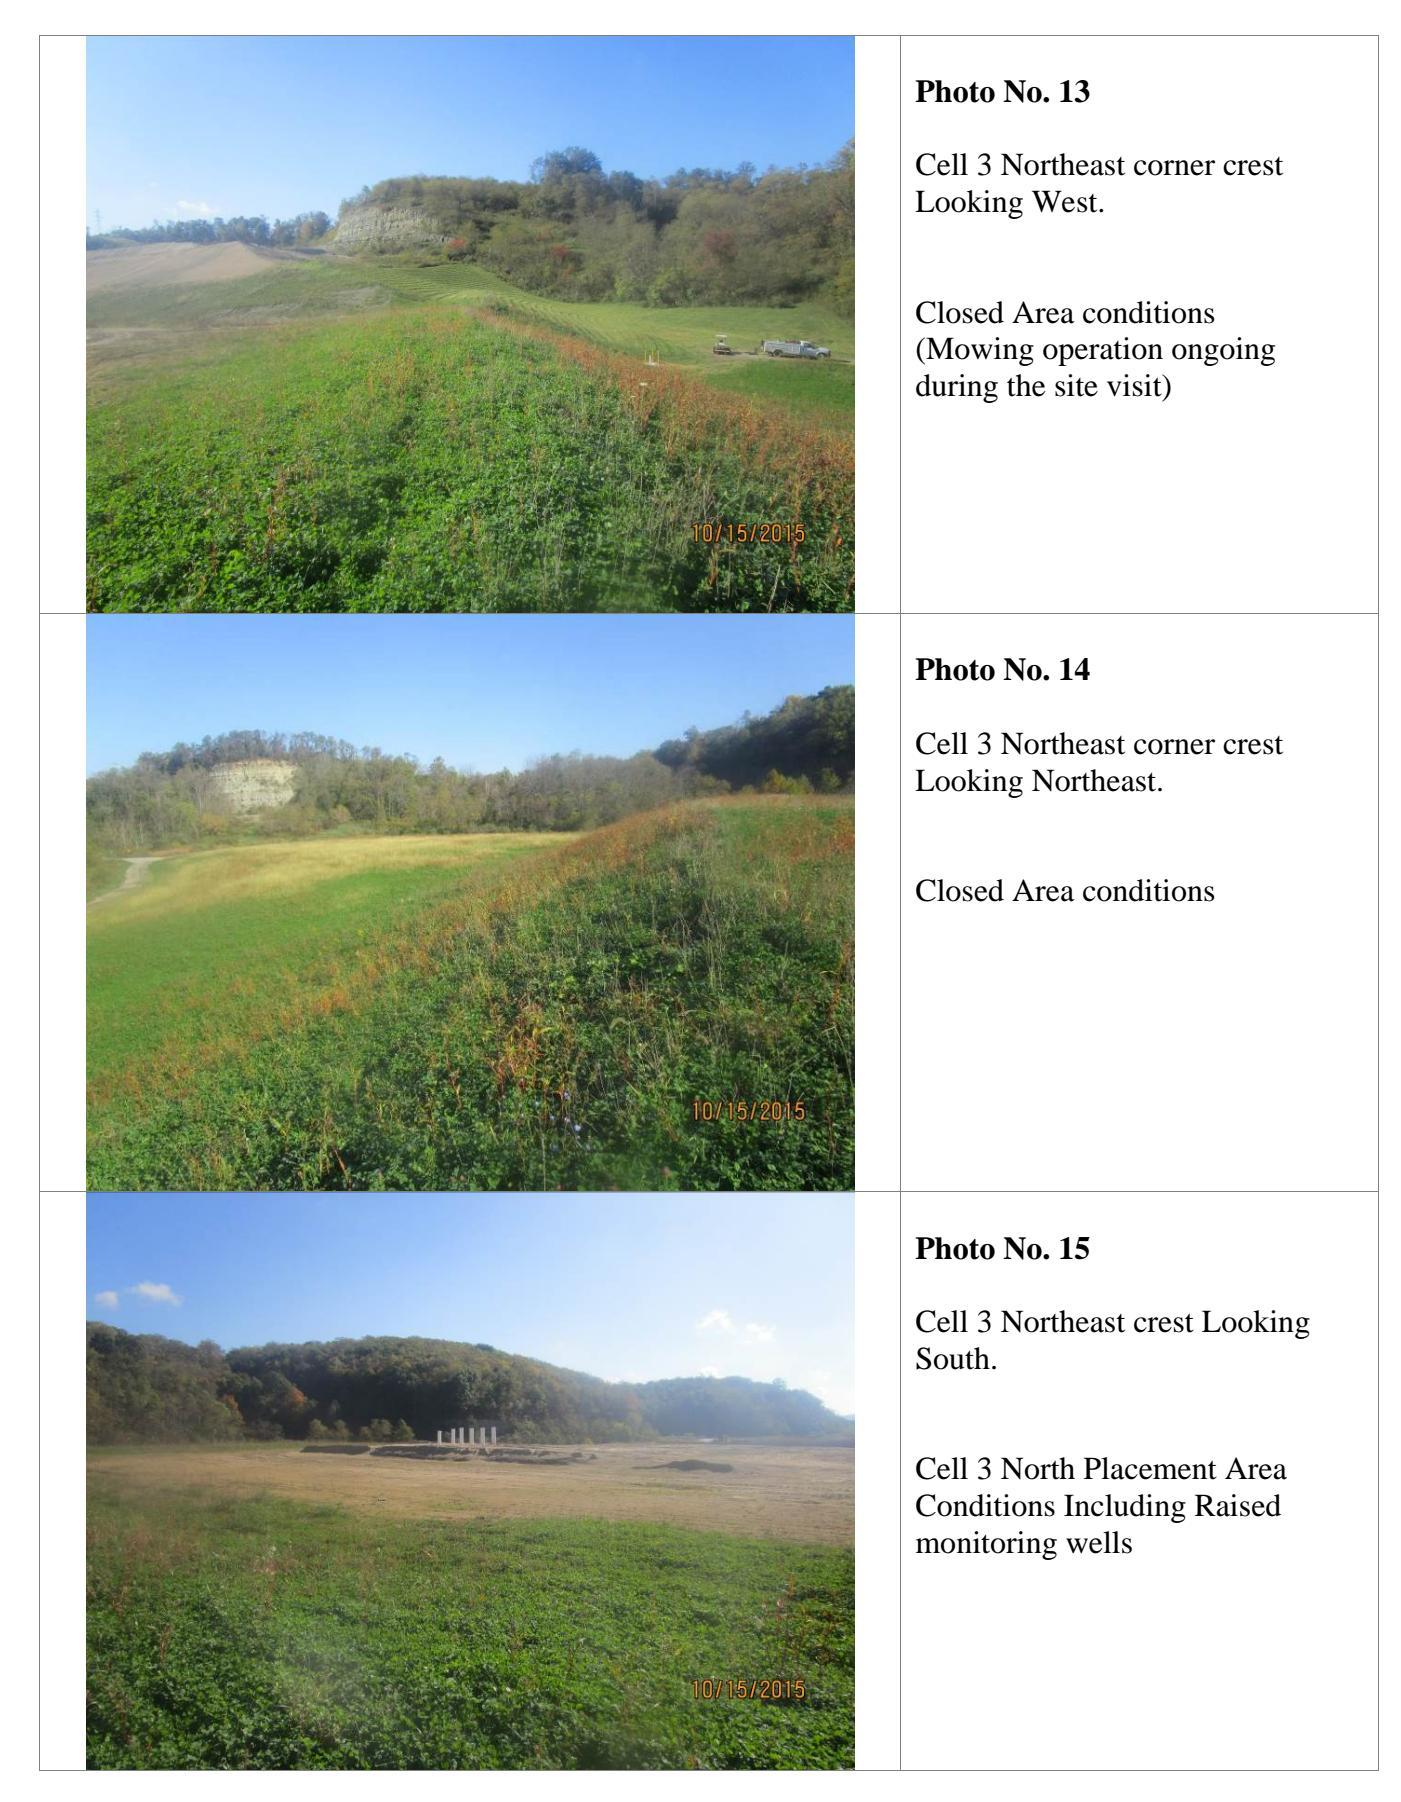
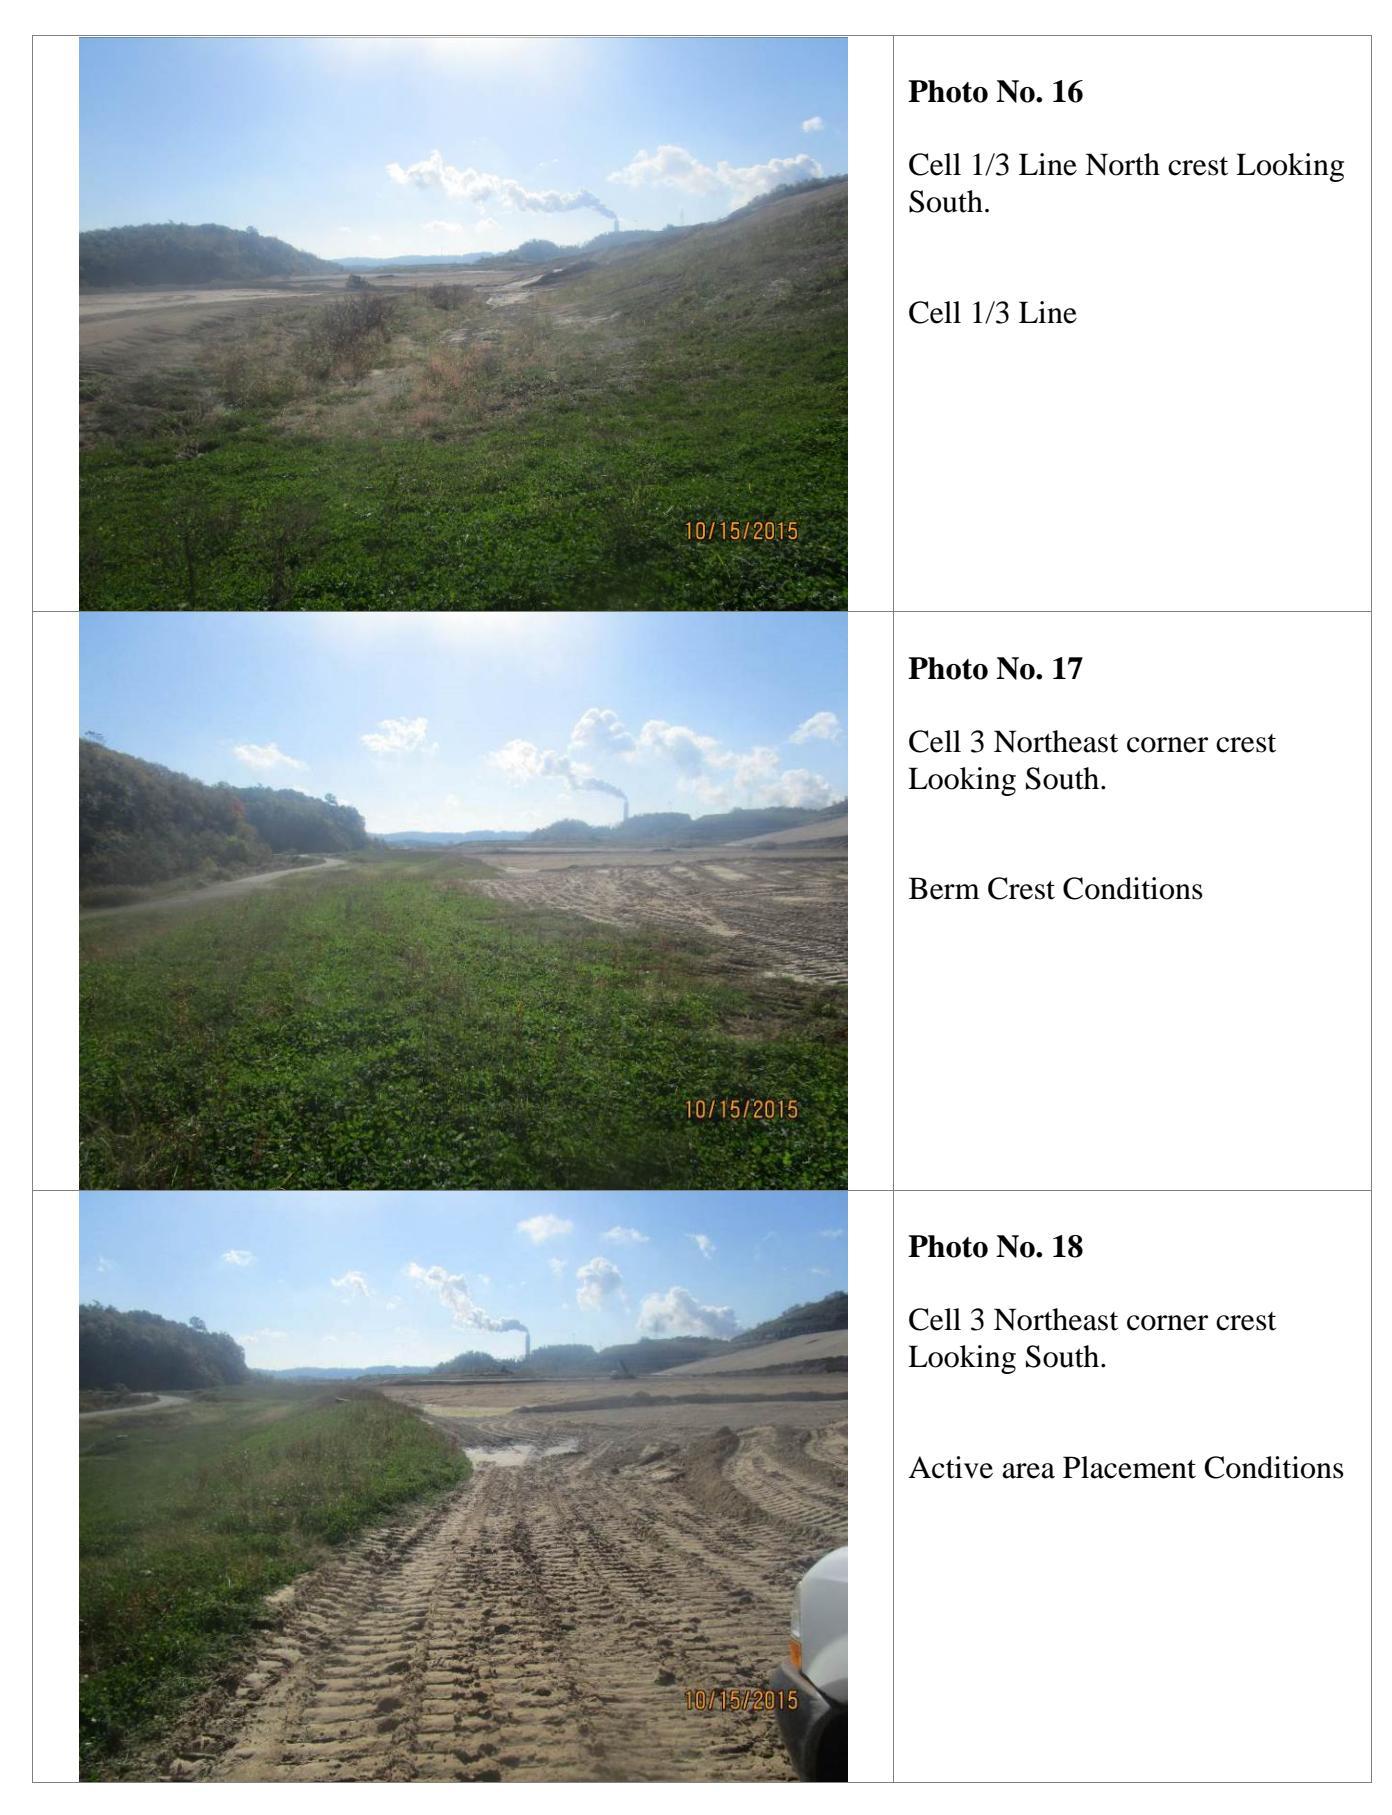
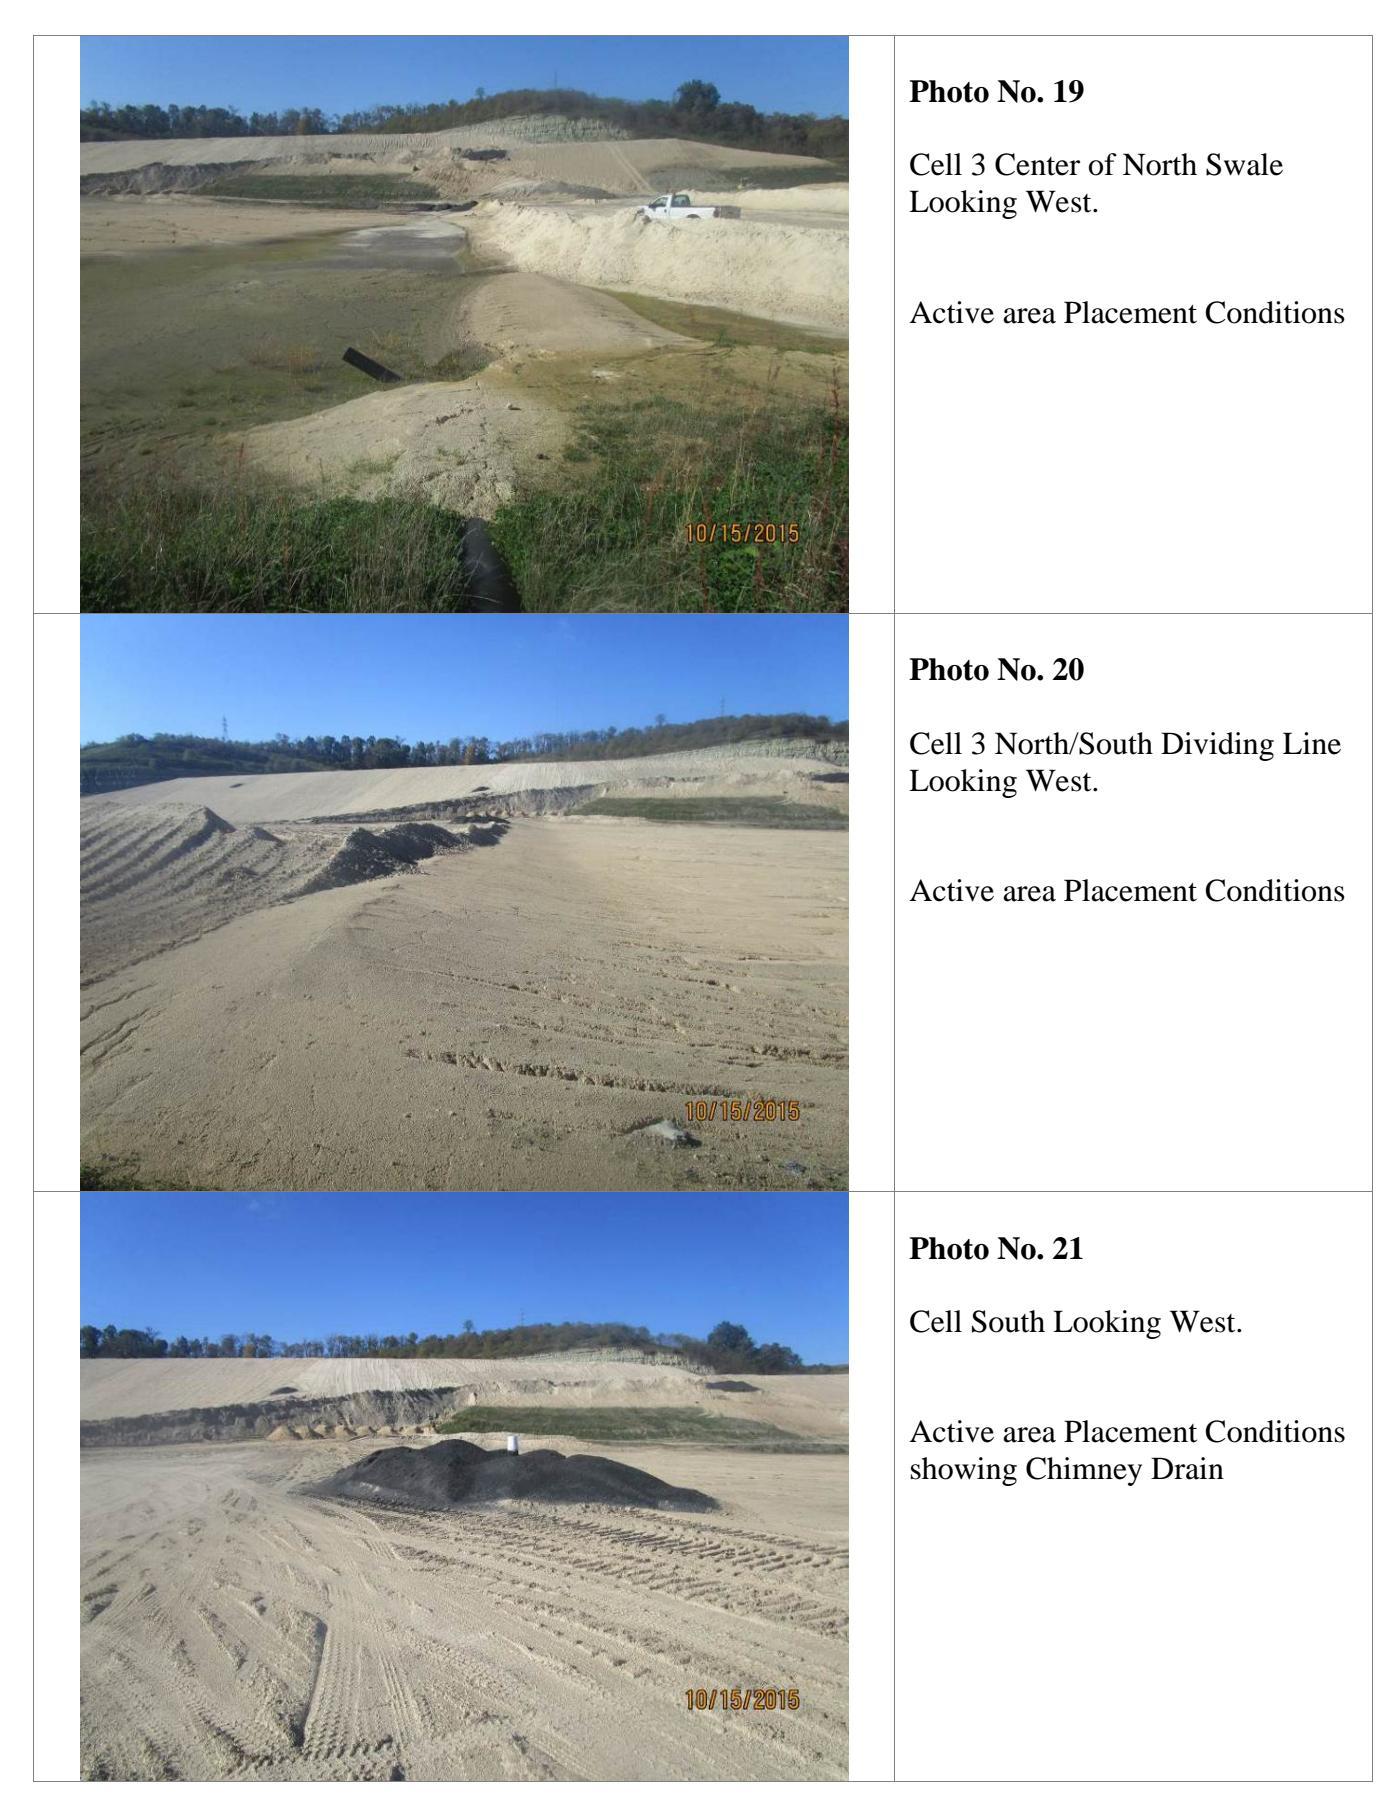
CARDINAL FAR I LANDFILL INSPECTION PHOTOGRAPHS

Parts of the landfill's constructed areas that are currently active showed no significant erosional activity. Parts of the landfill's constructed areas that are currently inactive slopes (Cell 1/2 line-see photos 5 and 6) have a temporary cover of cohesive soil that also showed no signs of significant erosion. Parts of the landfill's constructed areas that are currently inactive (other than Cell 1/2 line) have been treated with an approved polymer to prevent or reduce erosion. The vegetation growth along the downstream slopes of the earthen berms was in acceptable conditions (See photos 1, 2, 23 and 25).

Surface of the constructed areas (active and inactive) are sloped towards the designed chimney drains (see photos 4 and 21) to minimize surface water quantities going towards the perimeter ditches (see photos 18, 22 and 24). All of the runoff from the active areas is collected via leachate collected layers and transmitted vial riser/manholes (see photo 26)/transmission pipes (see photo 32) and directed to the FAR II Pond (see photo 33). No water ponding was present during the time of the inspection even with the high precipitation took place during the week preceding the inspection.

The majority of the Cardinal Plant CCR Landfill is not developed yet and serves as stockpiling/staging area (See photos 3, 27, 28 and 29). All permanent cover areas (North of Cells 1 and 3) were in good condition with little to no sign of erosion and good vegetative cover (See photos 10, 11, 12, 13 and 29). The vegetative cover was composed of consistent length grasses with no woody type bushes or trees evident in the landfill areas.

- 1. Continue annual mowing of all berms with vegetation control to prevent the growth of excessive woody plants and brushes.
- Continue following the applicable requirements outlined in the AEPSC Dam and Dike Inspection and Maintenance Program Circular Letter and submit Inspection Reports to Mohammad Ajlouni within one week of the end of the field inspection.

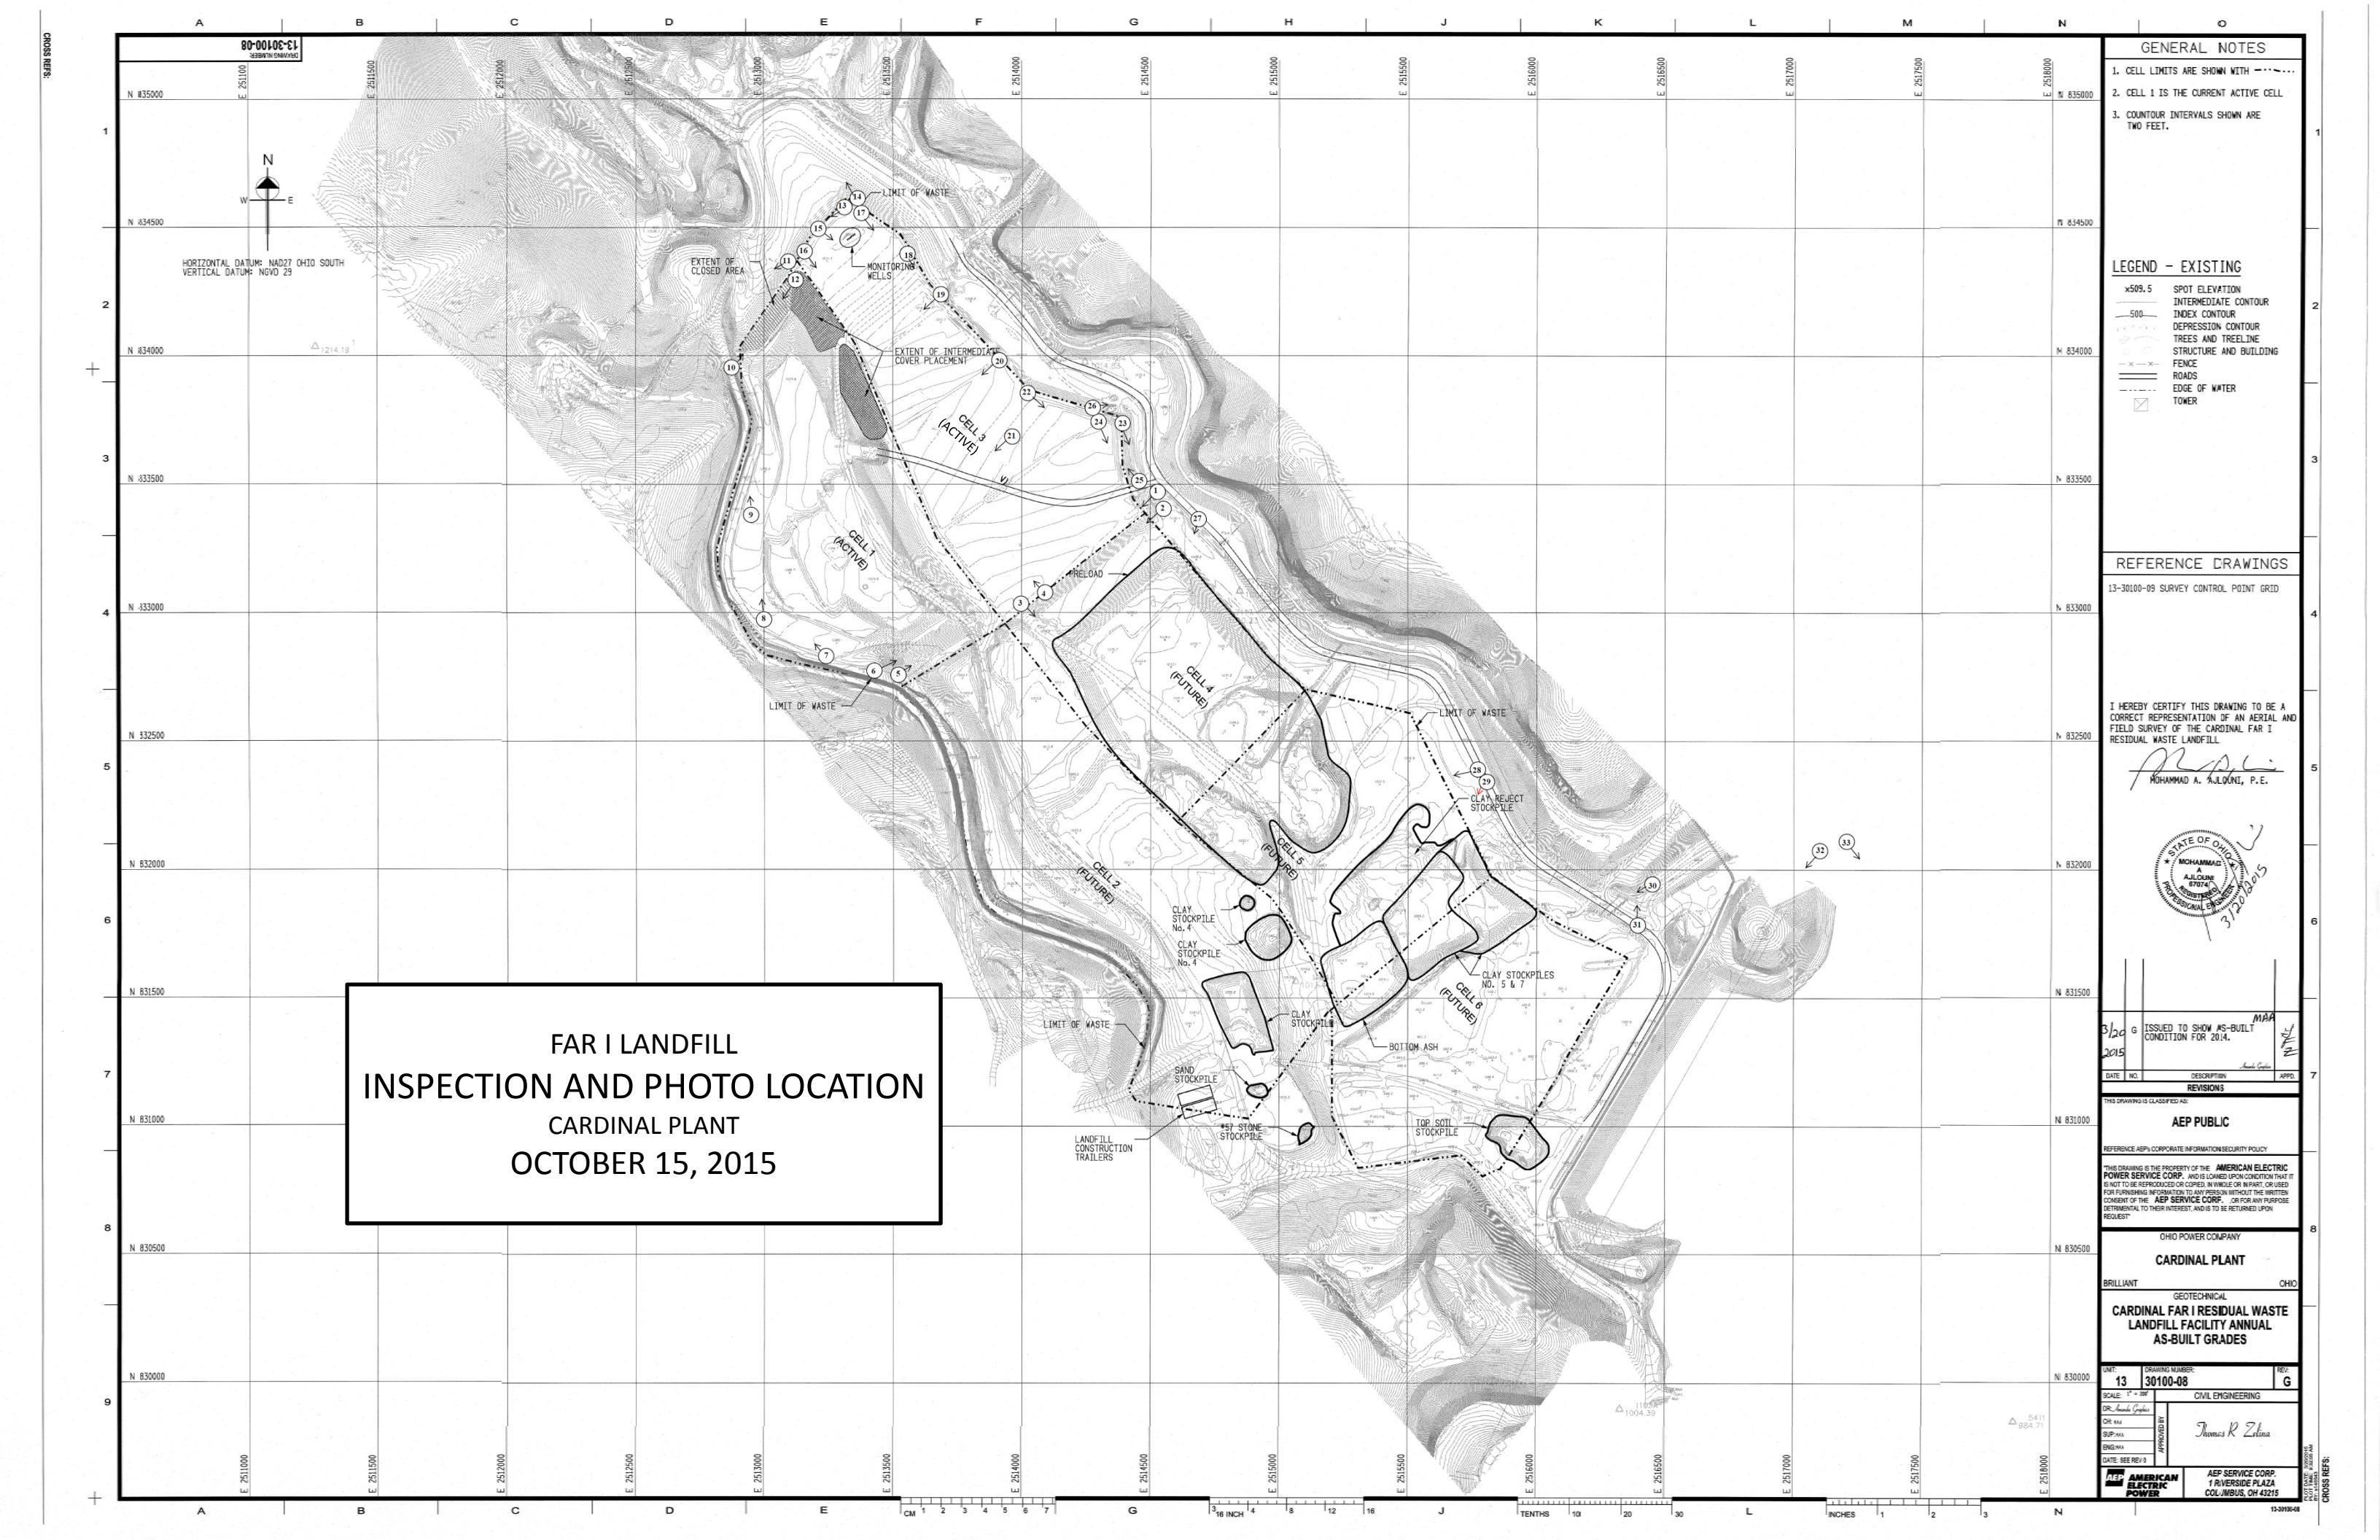
LOCATION PLAN

Results of the visual inspection performed on October 15, 2015, are summarized below, with inspection photographs included in Appendices A. The photos location map is shown in Appendix B.
